LOWER MARSH FARM LANDULPH, CORNWALL

ASSESSMENT, REPAIR AND MANAGEMENT PLAN FOR THE WATERWHEEL

January 2011

Project LMF 190/2010

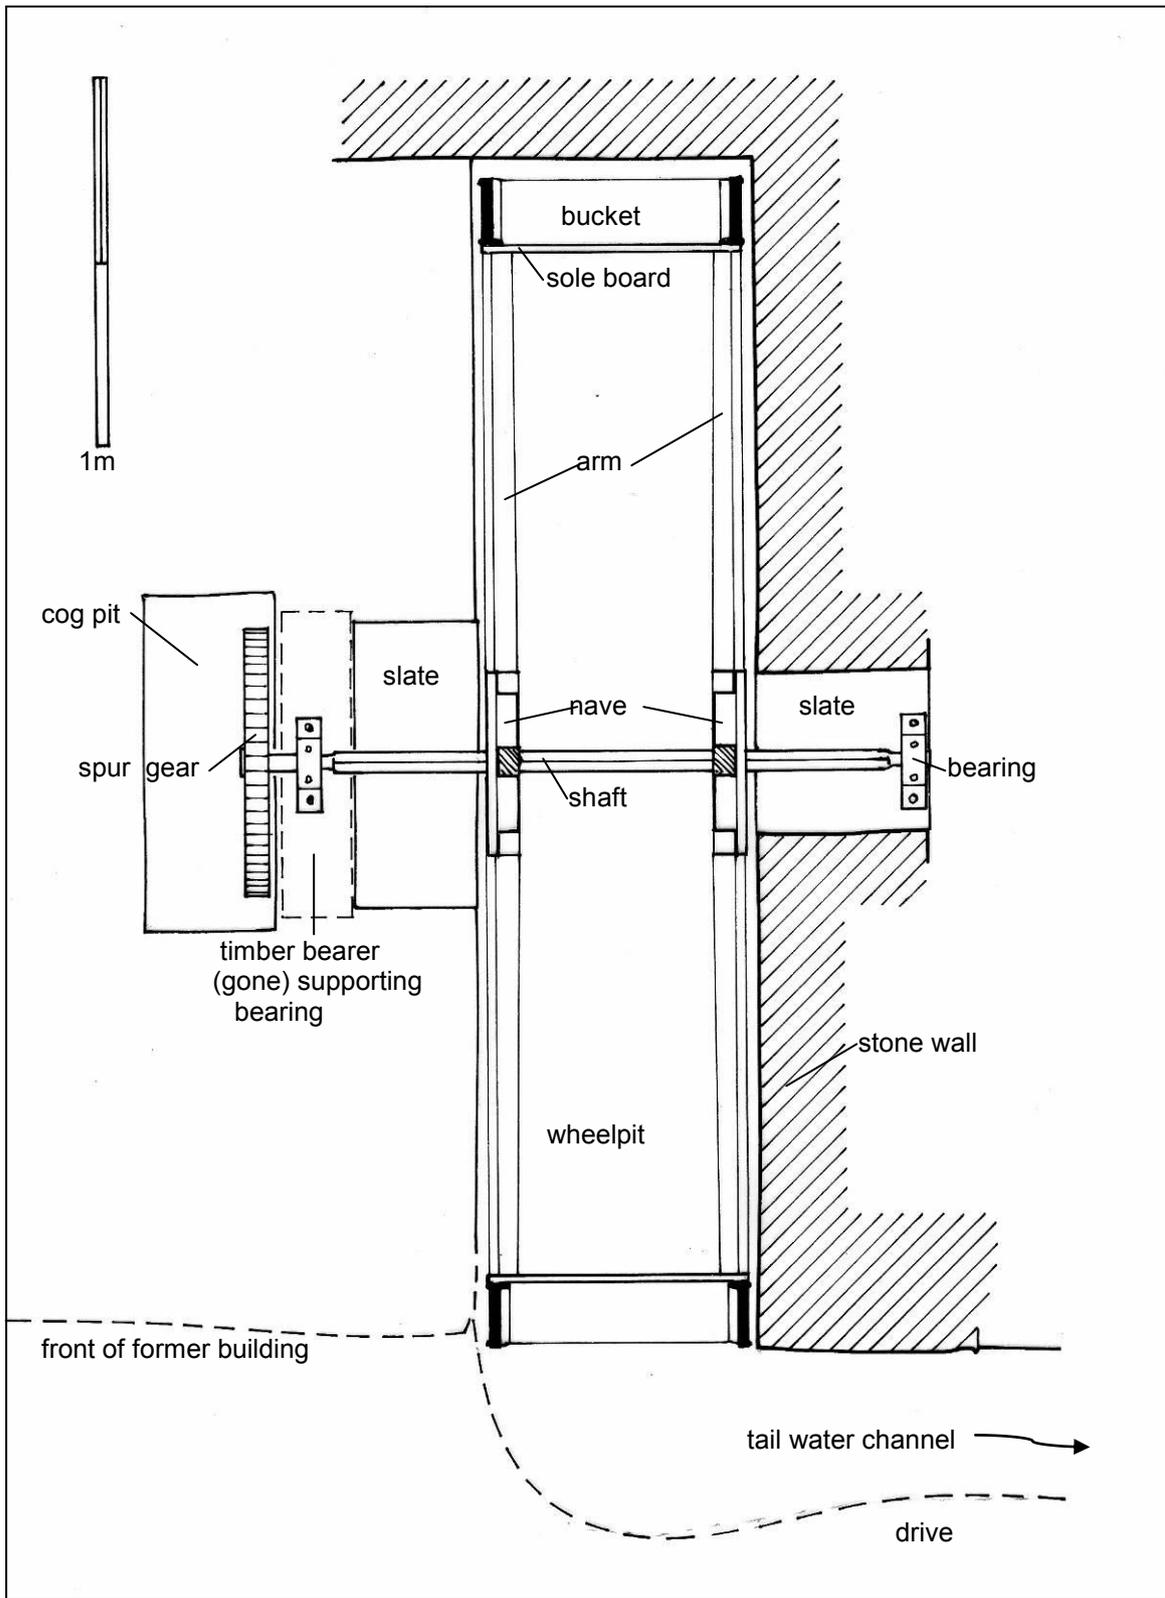
Figure 4: Lower Marsh Farm. Plan of wheelpit and waterwheel

The wheelpit is about 0.76m wide, and has silt and standing water in it to a depth of about 0.85m (Figure 4). The bottom of the wheel is obscured in the silt and water. The wheel was formerly fed from the north end of the pit and the tail water ran away from the wheelpit along a channel between the bank on the north side and the road surface of the drive. This channel, which although silted up still carries some water, runs for about 30m eastwards along the drive and is then piped or culverted under the drive, emerging in an open stone-lined channel across the end of the walled garden (Figure 3 and photographs). The tail water must then be piped or culverted under the public footpath running to the south of the garden, and water eventually runs out onto the marsh.

between the west nave of the wheel and the drive pinion. This bearing appears to have been formerly bolted down to a timber pillow or sleeper block, which has rotted away (Figure 4). At the west end of the wheelshaft is a cast-iron spur pinion of about 0.74m overall diameter with six + section arms and about 90 closely pitched teeth. About one third of the gear ring and one arm have been broken off, although the broken segments are still on site.

- Overhaul both wheelshaft bearings, allowing for renewal of bearing shells and fastenings
- Fix a new timber sleeper or pillow block in place on the stone wall on the west side of the wheelpit

- Fix down the west wheelshaft bearing to a new timber pillow block
- Allow for repairs to the ironwork structure of the waterwheel, if required
- Clean and paint the iron structure of waterwheel

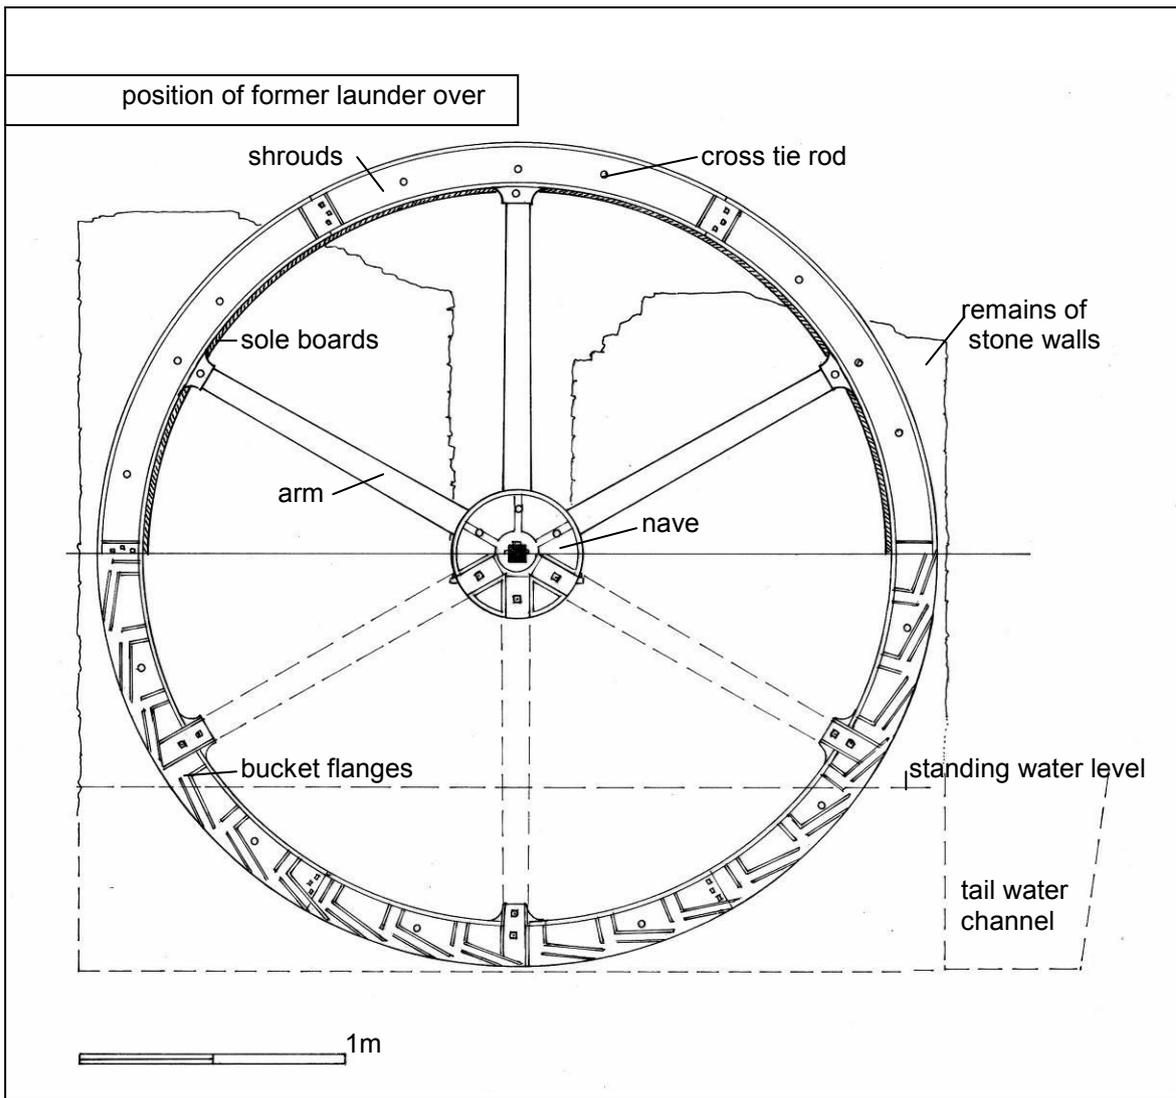
Figure 5: Lower Marsh Farm. Elevation and section of waterwheel, with arms reconstructed. Depth and shape of wheelpit and tail water channel are conjectural

The waterwheel was overshot, although all evidence of the trough or launder that fed water onto the top of the wheel and any related water-control mechanisms have disappeared (Figure 5). The wheel is 10ft 6in (3.2m) in diameter by 2ft 3in (0.68m) overall width. Its construction is typical of many mid-late 19th century waterwheels in the south-west of England, being a mixture of iron and timber. There are six cast-iron sections forming the shrouds on each side, the sections being bolted end to end midway between the arms. The shrouds carried timber bucket and sole boards, most of which have gone. The buckets were formed of two boards, forming elbow-shaped buckets, with a wide outer or float board fitted to a short, shaped riser. The risers and float boards were located in flanges cast integrally with the inner faces of the shrouds and held in place by the cross-tie rods. Timber sole boards were bolted at each end to a return flange on the inner circumference of the shrouds. The surviving sole boards appear to be of pine. An unusual feature is a series of countersunk holes drilled through the shrouds, indicating that the outer bucket boards were at some time fixed with either screws or nails driven into the end grain. Whether this is an original feature, or the holes were drilled at a later date, to stop decaying timber boards working loose, is unknown.

- Supply and fit 36 new timber buckets, complete with new fastenings and tie rods
- Design and construct a new timber launder, to feed water to top of wheel, with appropriate water control mechanism

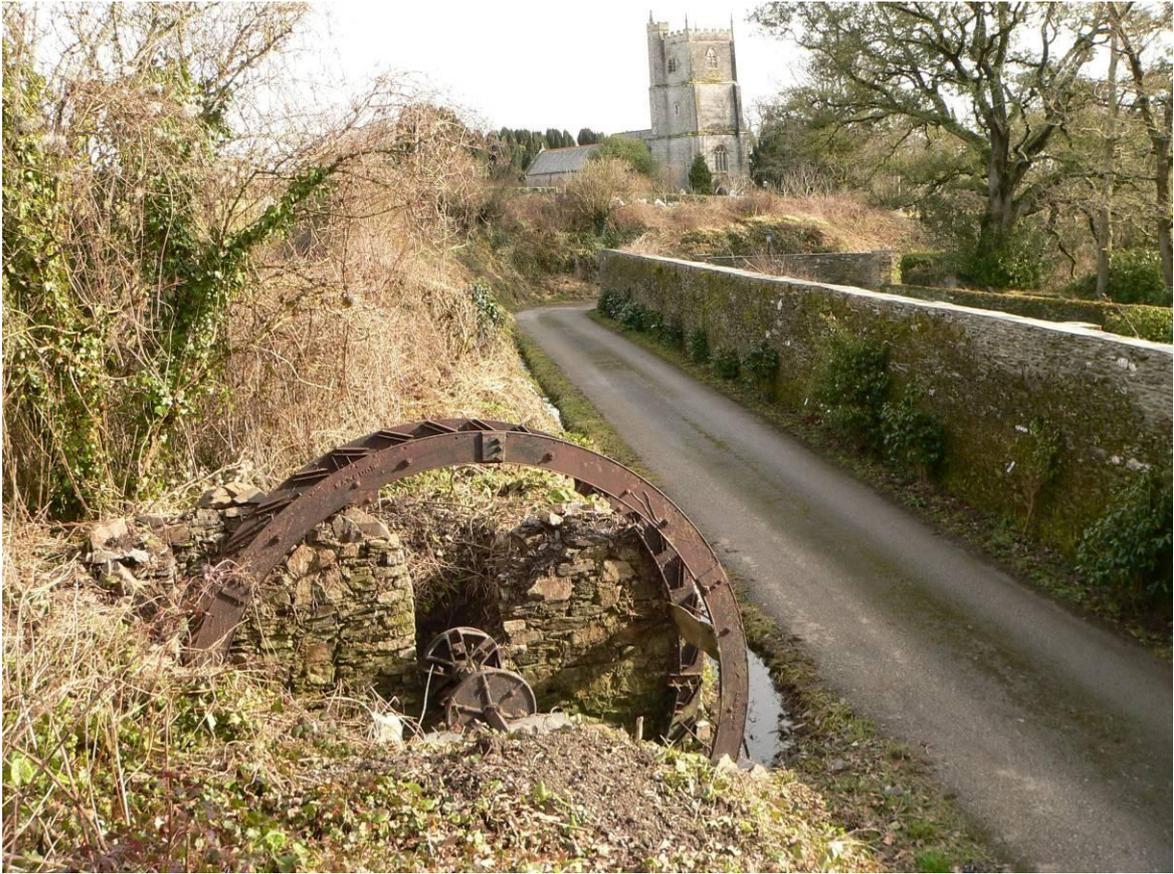
Lower Marsh Farm, Landulph: waterwheel from west, showing its position and the course of tailwater channel running along the edge of the drive

- Carry out clearance and any repairs necessary to ensure a clear flow of tail water away from the wheelpit, to include the channel alongside the drive and across the end of the garden, and any piped or culverted sections

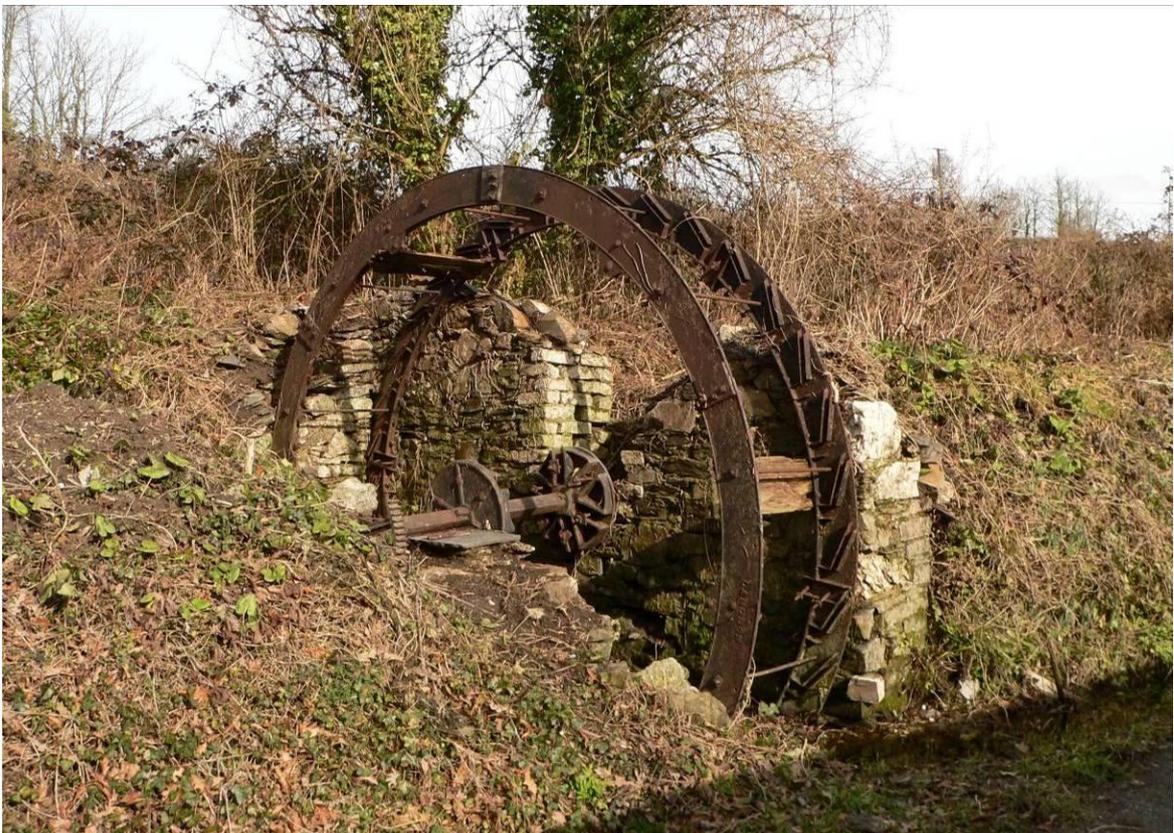
The waterwheel with remains of building and wheelpit walls

- Clear and excavate the plan of the building to the west of the wheelpit – the extent of this work to be determined
- Consolidate, repair and rebuild the stone walls of the wheelpit and supporting wall for the inner (west) shaft bearing

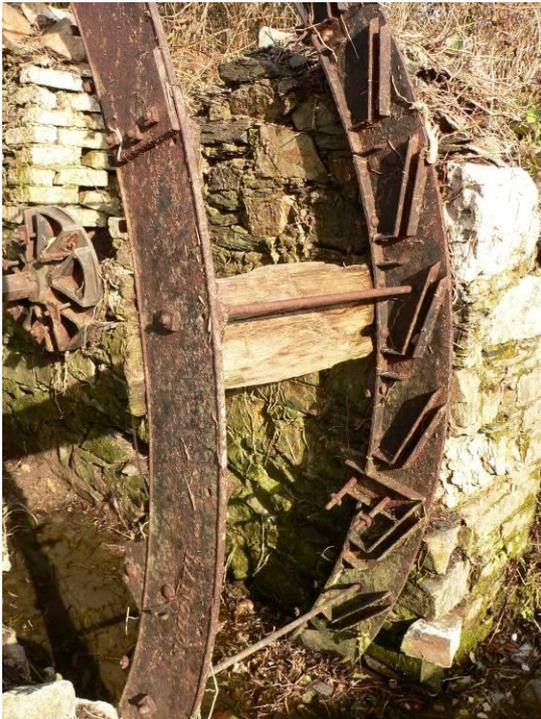
The timber arms have all rotted away, as have most of the buckets and sole boards. These elements are relatively straightforward to replace; repairs and minor replacements would have been carried out during the working life of the wheel. The cross-tie rods have deteriorated, but again these can be easily renewed.

Detail of shroud castings with cross tie rods and remains of sole boarding

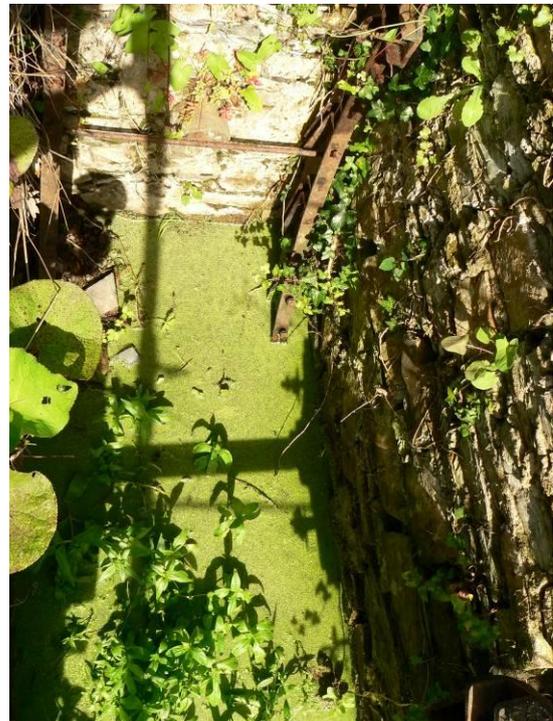
Standing water in wheelpit

- Carry out clearance as necessary to provide clear access to the wheel and wheelpit area
- Carefully remove silt and debris from bottom of wheelpit
- Carefully lift out the ironwork of the waterwheel, with the shroud sections either as complete rings or with partial dismantling to make handling easier

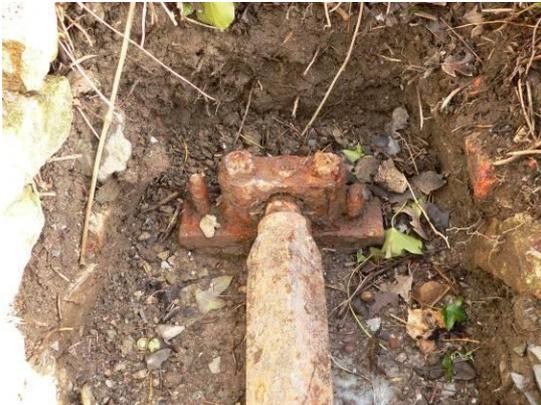
Outer wheelshaft bearing, fixed down to slate

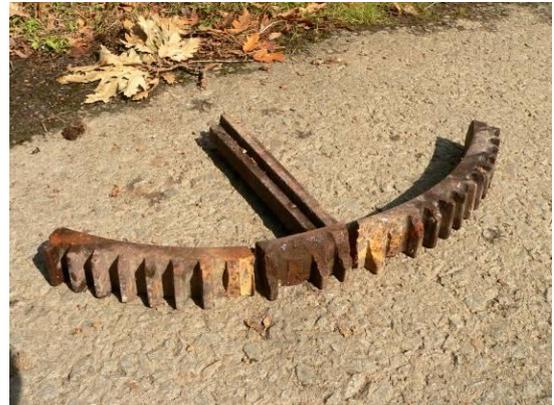
Broken sections of spur gear

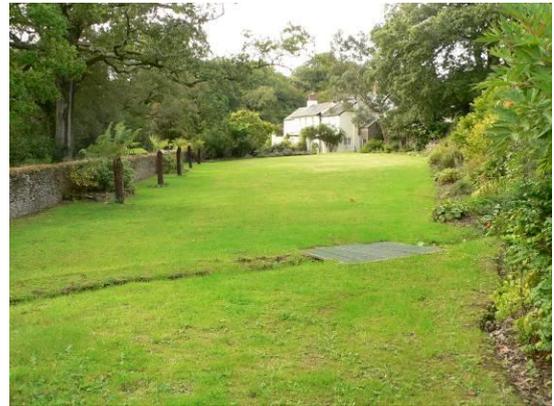
The wheelpit and tail water channel need to be cleaned out, so that water can run away as freely as possible from the wheel. There are some implications with clearing the tail water channel as it runs alongside the driveway to property. It may be considered appropriate to build a low kerb between it and road surface, to preclude the possibility of vehicles driving into it and also to protect pedestrians. The final part of the tail water channel, which runs across the end of the garden and under the footpath, may also require cleaning and possibly some repair.

Tailwater channel across end of garden
