Countryside Properties (Northern) Ltd

Victory Works, Heywood

Historic Building Recording

March 2008

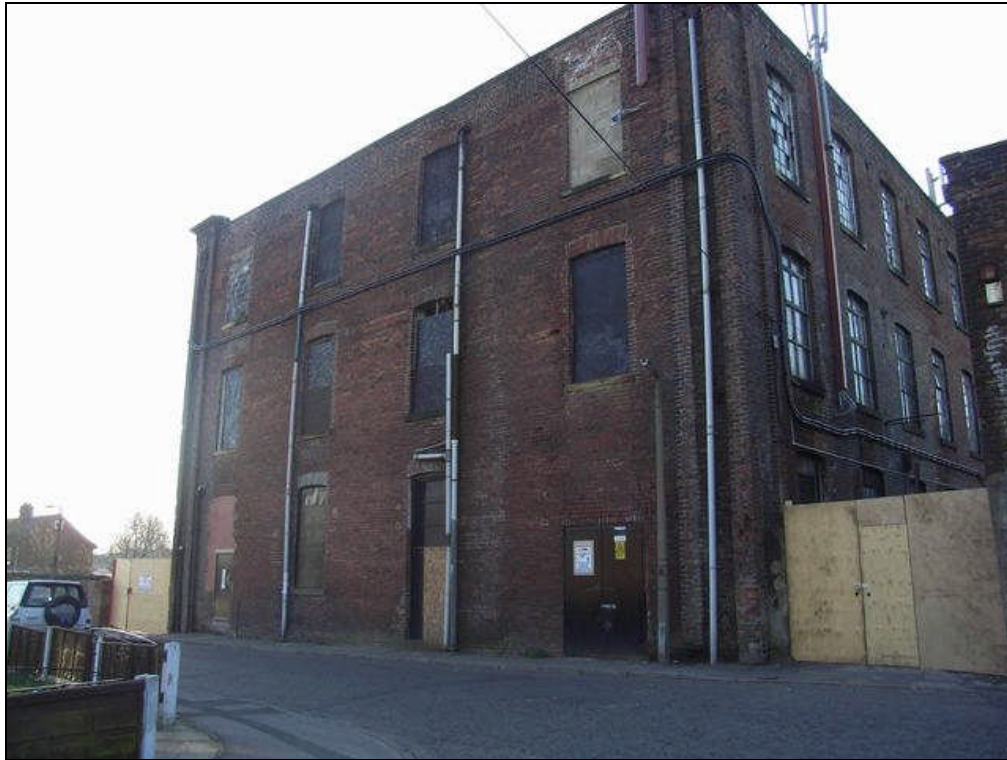
- 4.3 The east elevation fronts directly on to Rose Hill Street, and is designed to appear as four wide bays in width (Plate 3). Each bay originally contained a single window at ground, first and second floor level; each window has a segmental arched brick lintel and projecting stone sill, and all of the windows are currently boarded over. However, at ground-floor level, the northernmost window has been blocked with brick, with a double metal door inserted below. This provides access into an inserted electric substation, within the northeast corner of the building. The flanking window has been lengthened to form a doorway. The southernmost window had also been lengthened, and at a later stage blocked with modern red brick. A single fire door with concrete lintel has been inserted into the bay. To the second floor, the northernmost and southernmost windows have both been infilled with concrete blocks and their original lintels removed. Areas of rebuilding are evident above both blocked windows.

Plate 3: East elevation, Building A

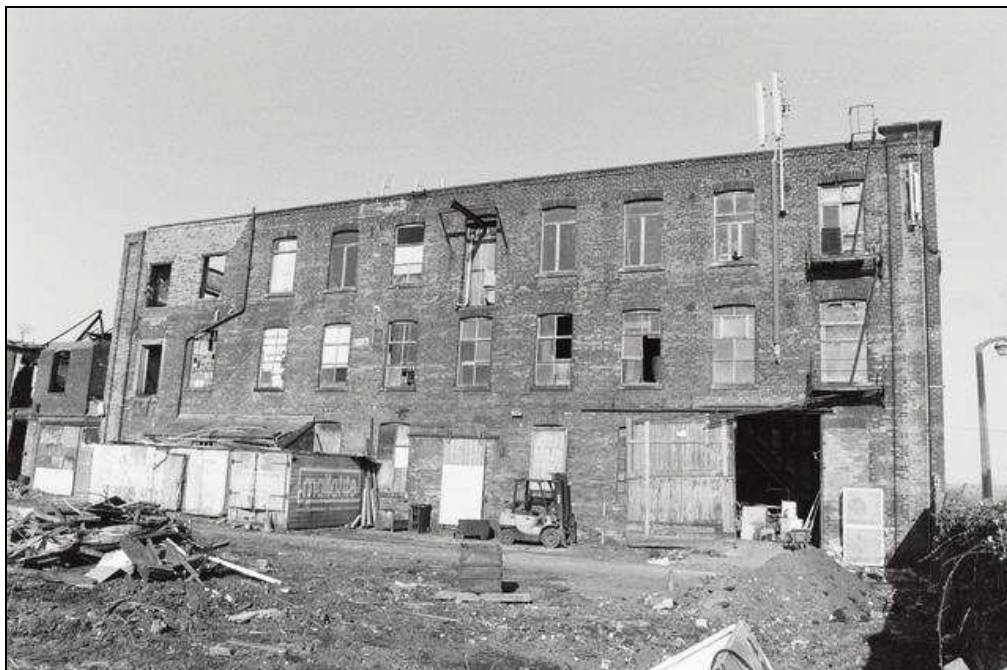
- 4.4 The south elevation is ten bays in length (Plate 4). A shallow brick-built lean-to with corrugated asbestos roof obscures the second and third bays. In turn, this is presently obscured by modern hoarding. To the west, the lean-to is flanked by a blocked window, below which a doorway with iron lintel has been inserted. To the east, bays 4 to 8 each contain a single window with segmental arched brick lintel to the ground floor. That to the sixth bay has been converted to a doorway with sliding timber door, whilst that to the eighth has been blocked with concrete blocks. A window in the tenth bay is blocked with red brick. This relates to the insertion of a large loading door into the ninth bay, with iron lintel and timber sliding door, which partially truncates the window opening.

Plate 4: South elevation, Building A

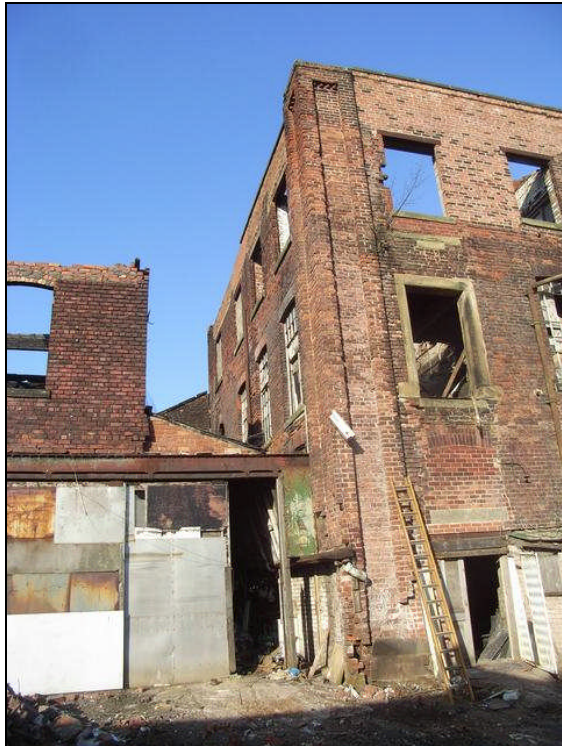
4.6 The west elevation retains window openings to the ground floor (Plate 7). These are only partially visible, due to the abutting Building D. However, the roof structure of Building D has been designed so that the window openings to the ground floor remain external and thus can still provide light to the interior of the mill building. A further four window openings are evident at first-floor level. The northernmost of these is semi-circular headed, whilst the remaining three have segmental arched heads. The second floor retains four windows, of which the northern two are blocked with concrete blocks. Each opening is housed under a replacement iron lintel, and the parapet above has also been rebuilt. There is a wider space between the northernmost window and the remaining fenestration to each level. This is likely to relate to the presence of another substantial internal wall. The a semi-circular headed window, as distinctive from the remaining fenestration, strongly suggests the presence of an engine house within this bay as such rooms were typically lit by windows of this form. This is supported by the indication of an internal chimney on aerial photographs rising from the southwest corner of the building, and the substantial internal walls.

Plate 7: West elevation of Building A

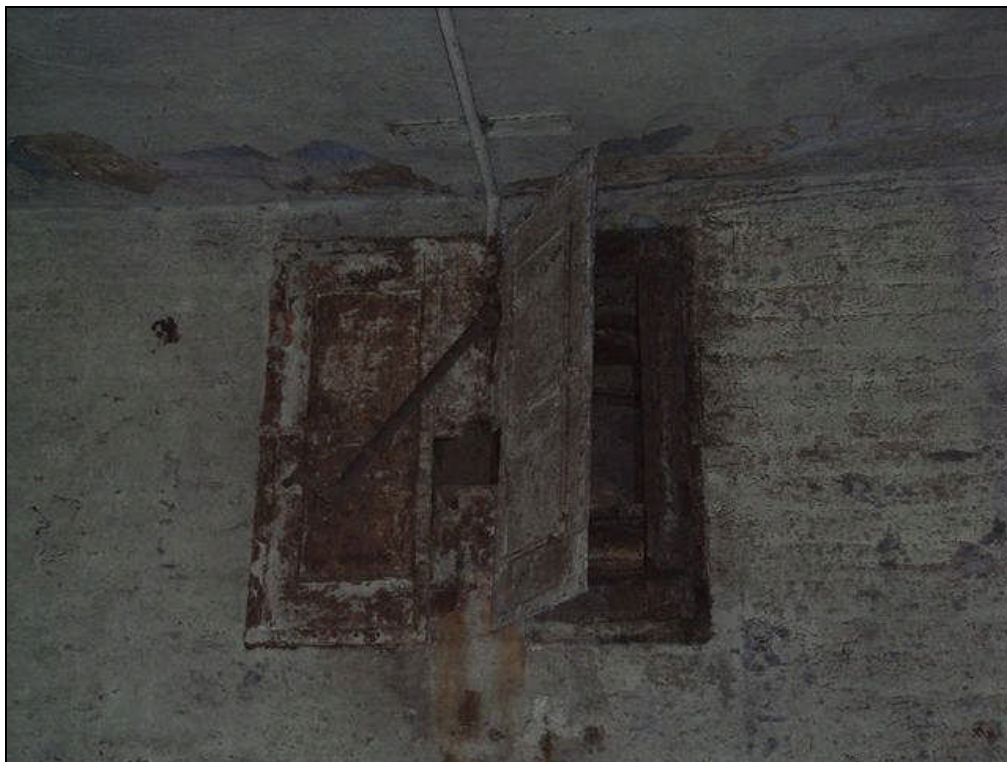
- 4.8 Internal access was only possible to parts of the ground floor, with the lower portion of the stair tower visible through the doorway.
- 4.9 The majority of the ground floor is comprised of one open space, with a timber floor and plaster ceiling supported on three rows of cast iron columns (Plate 9). None of the columns retain evidence for power transmission, and it is likely this was instead supported on hangar beams between the columns. The northwest corner of the room is obscured by an inserted concrete block structure. To the south of this, along the west elevation, are three blocked openings, related to the engine house located immediately beyond this wall. To the south of this are two large, square, cast iron wall boxes with shutters (Plate 10).

The presence of the shutters indicates that lineshafting did not pass all the way through the wall boxes. It may therefore be the case that the wall boxes housed fans, run off the main system of lineshafting and which could be closed-off using the shutters on one side. This possibly indicates the use of a ventilation system in this part of the mill. At the southern end of the elevation is a segmental arched doorway. A further doorway is also located in the westernmost bay of the south elevation. This retains a cast iron fire door. This provides access into the one-storey lean-to structure along the external south elevation.

Plate 10: Cast iron wall box with shutters, ground floor interior, Building A

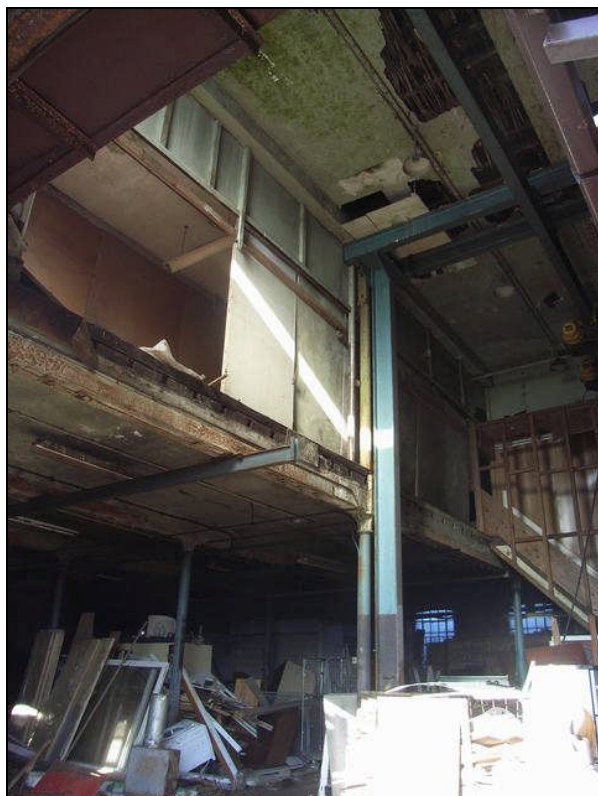
- 4.10 A modern steel structure has been inserted into the southeast corner of the mill, removing the original floors and cast iron columns to create a space open to two storeys in height (Plate 11). This relates to the inserted loading door at the eastern end of the south elevation, and retains a travelling winch mechanism. A timber stair has been inserted to the north of this, providing access to the first floor.

Plate 11: Modern inserted steel structure to southeast corner, Building A

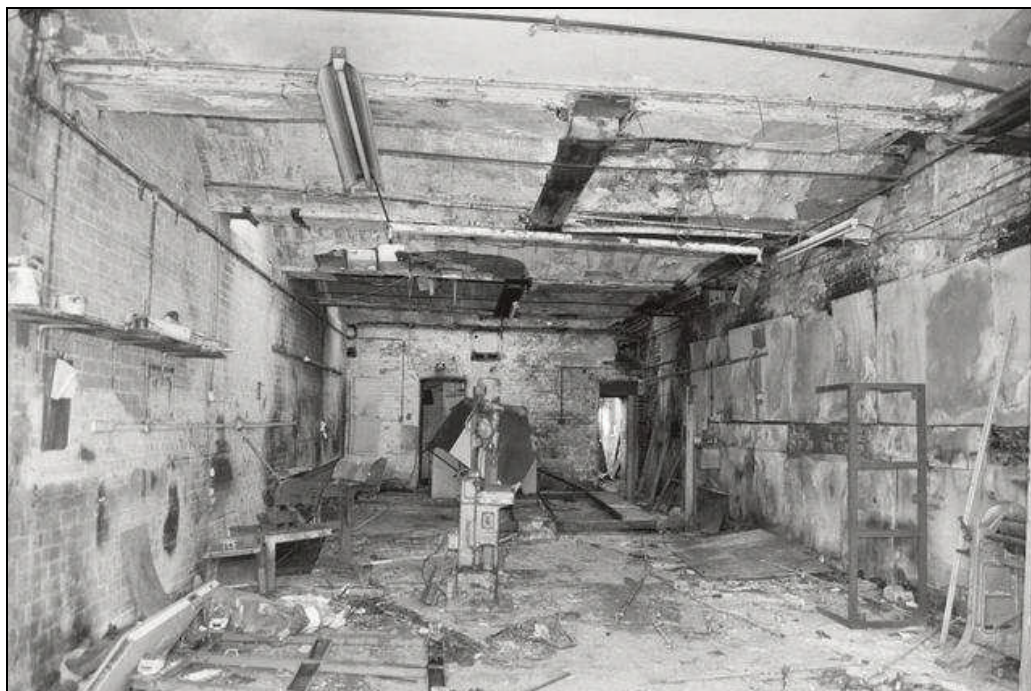
- 4.20 The southern half of the shed is four bays deep. It is divided into five internal spaces by inserted brick walls (Plate 15). A series of cast iron wall boxes are evident along the south wall; these are regularly spaced, with one corresponding with each row of columns, and a further wall box positioned centrally to each bays (Plate 16). Evidence for hangar beams corresponding to these central wall boxes survives. The location of these wall boxes suggests that Building C to the immediate south of this wall formed the engine house and rope alley, from where power was generated and distributed across the site. The density of power transmission in this building suggests that it was used for weaving. Three segmental arched doorways are located towards the west of the south elevation, providing access into the rope alley (rope alley described under Building C). These appear to be original to the design.

Plate 15: Interior of south half of Building B, westernmost portion, showing doorways to rope alley

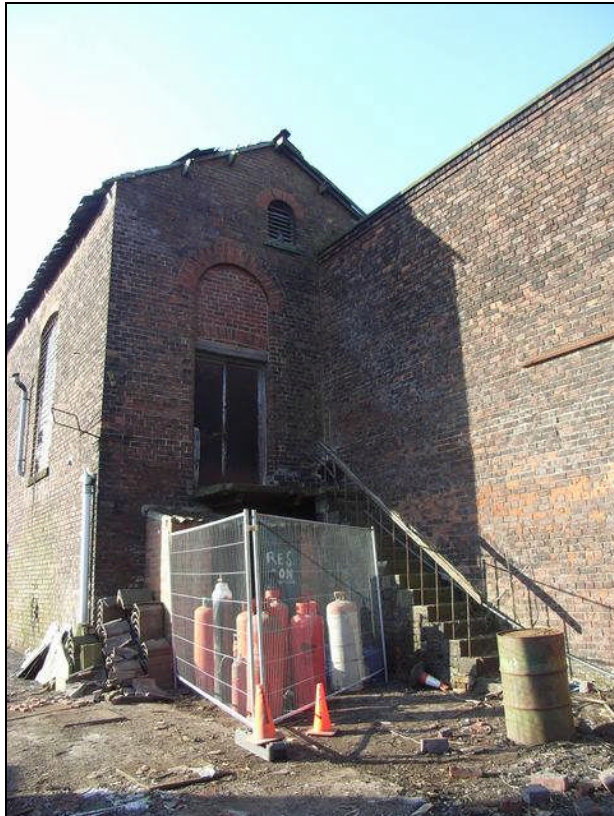
- 4.22 The east elevation of the engine house contains a large semi-circular headed opening, which has been partially blocked, with a segmental arched lintel set at a lower level (Plate 18). Below this lintel, a double door with timber lintel has been inserted. This provides access to the main floor of the engine house, and is itself accessed *via* a stone platform and flight of steps. The steps have stone treads, with brick below. They are built into the south wall of the rope alley, and retain a simple timber and iron baluster. A modern brick-built structure has been constructed beneath the platform at basement level. Above, a

Plate 18: East elevation of engine house, Building C

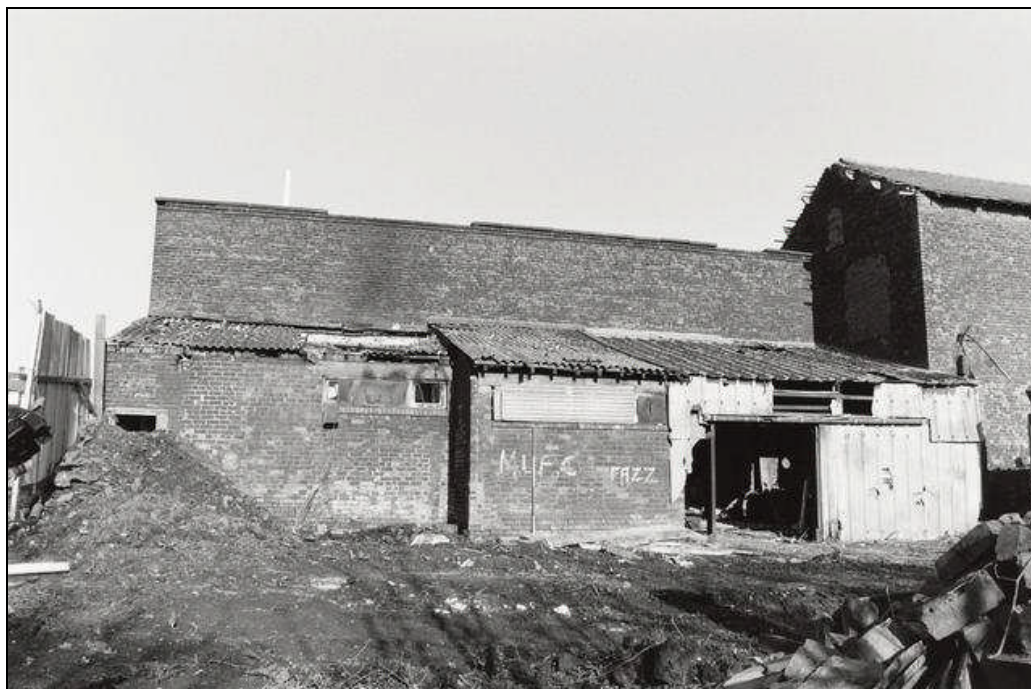
- 4.25 The shed structures comprise three adjoining sheds, housed under mono-pitched corrugated asbestos roofs (see Plate 19). The eastern and central sheds are housed under one roof. The eastern half is accessed *via* an opening in the south elevation. It is metal-framed with modern cladding to the walls. It abuts the engine house to the east and the rope alley to the north. The central shed has no external access. It is brick-built, and retains high-level fenestration with a bullnose brick sill to the south wall.

Plate 19: South elevation of west portion of rope alley, and sheds, Building C

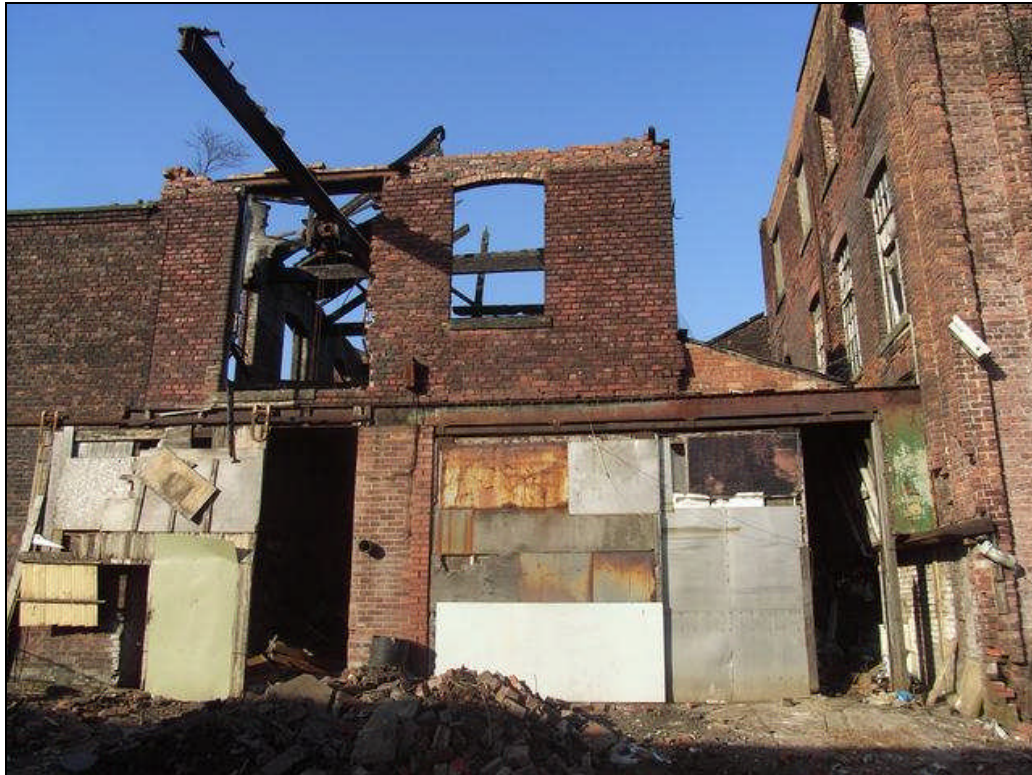
Plate 25: South elevation, Building D

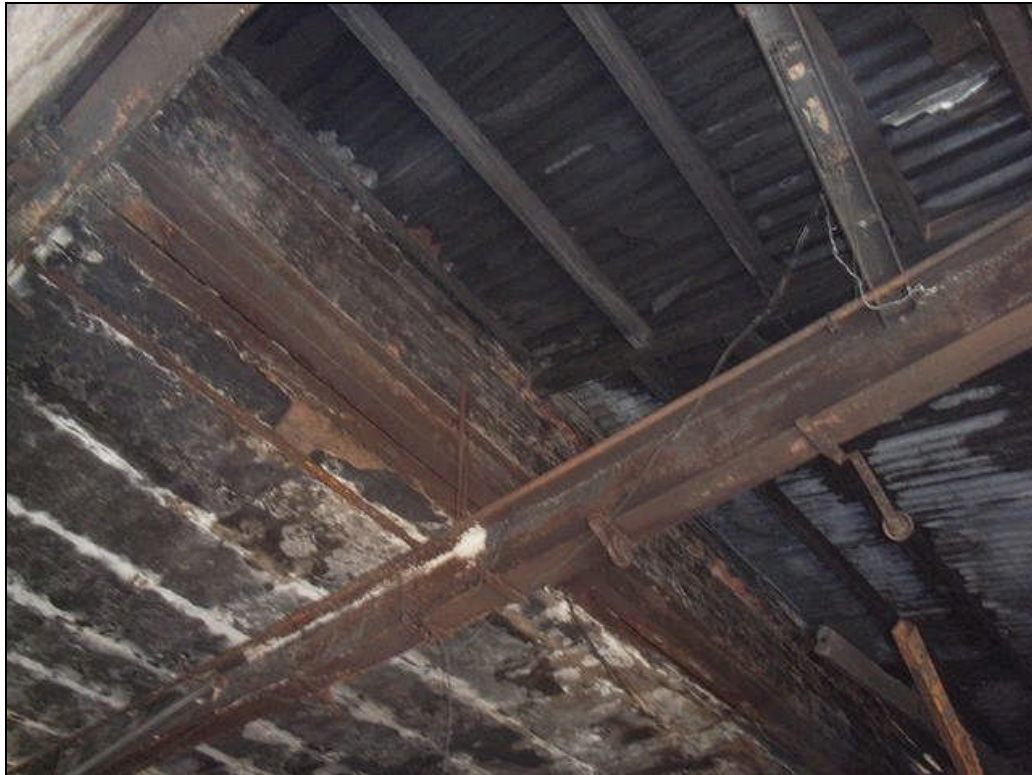
Plate 27: Interior of Building D, showing inserted girder supporting originally external wall of 2-storey portion

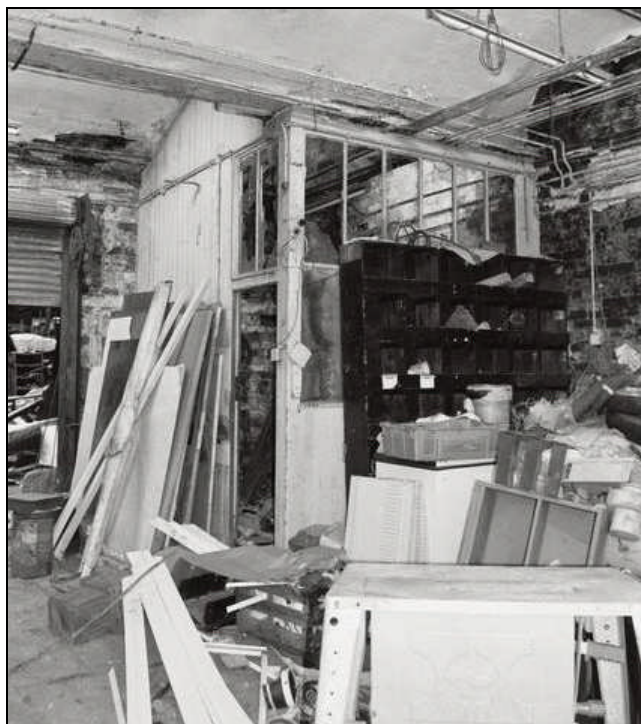
- 4.45 The warehouse structure was not fully accessible internally. The north light shed is divided into two spaces by a single brick wall. The north light roof structure is supported on split head cast iron columns. At least two rows of these retain D-shaped bracket heads (Plate 32), of which one corresponds with the position of the wall box, viewed externally. One other row of columns has been replaced with plain columns with bent heads, which allow for the passage of a later heating pipe. A small part-glazed, part-timber office is situated in the southwest corner, and may have operated as an overseers office (Plate 33).

Plate 33: Overseers office, interior of Building F
