Orford House, Ugley, Essex

Historic Buildings Recording

November 2009

OA East Report No: 1068
OASIS No: oxfodar3-52941
NGR: TL 5155 2705

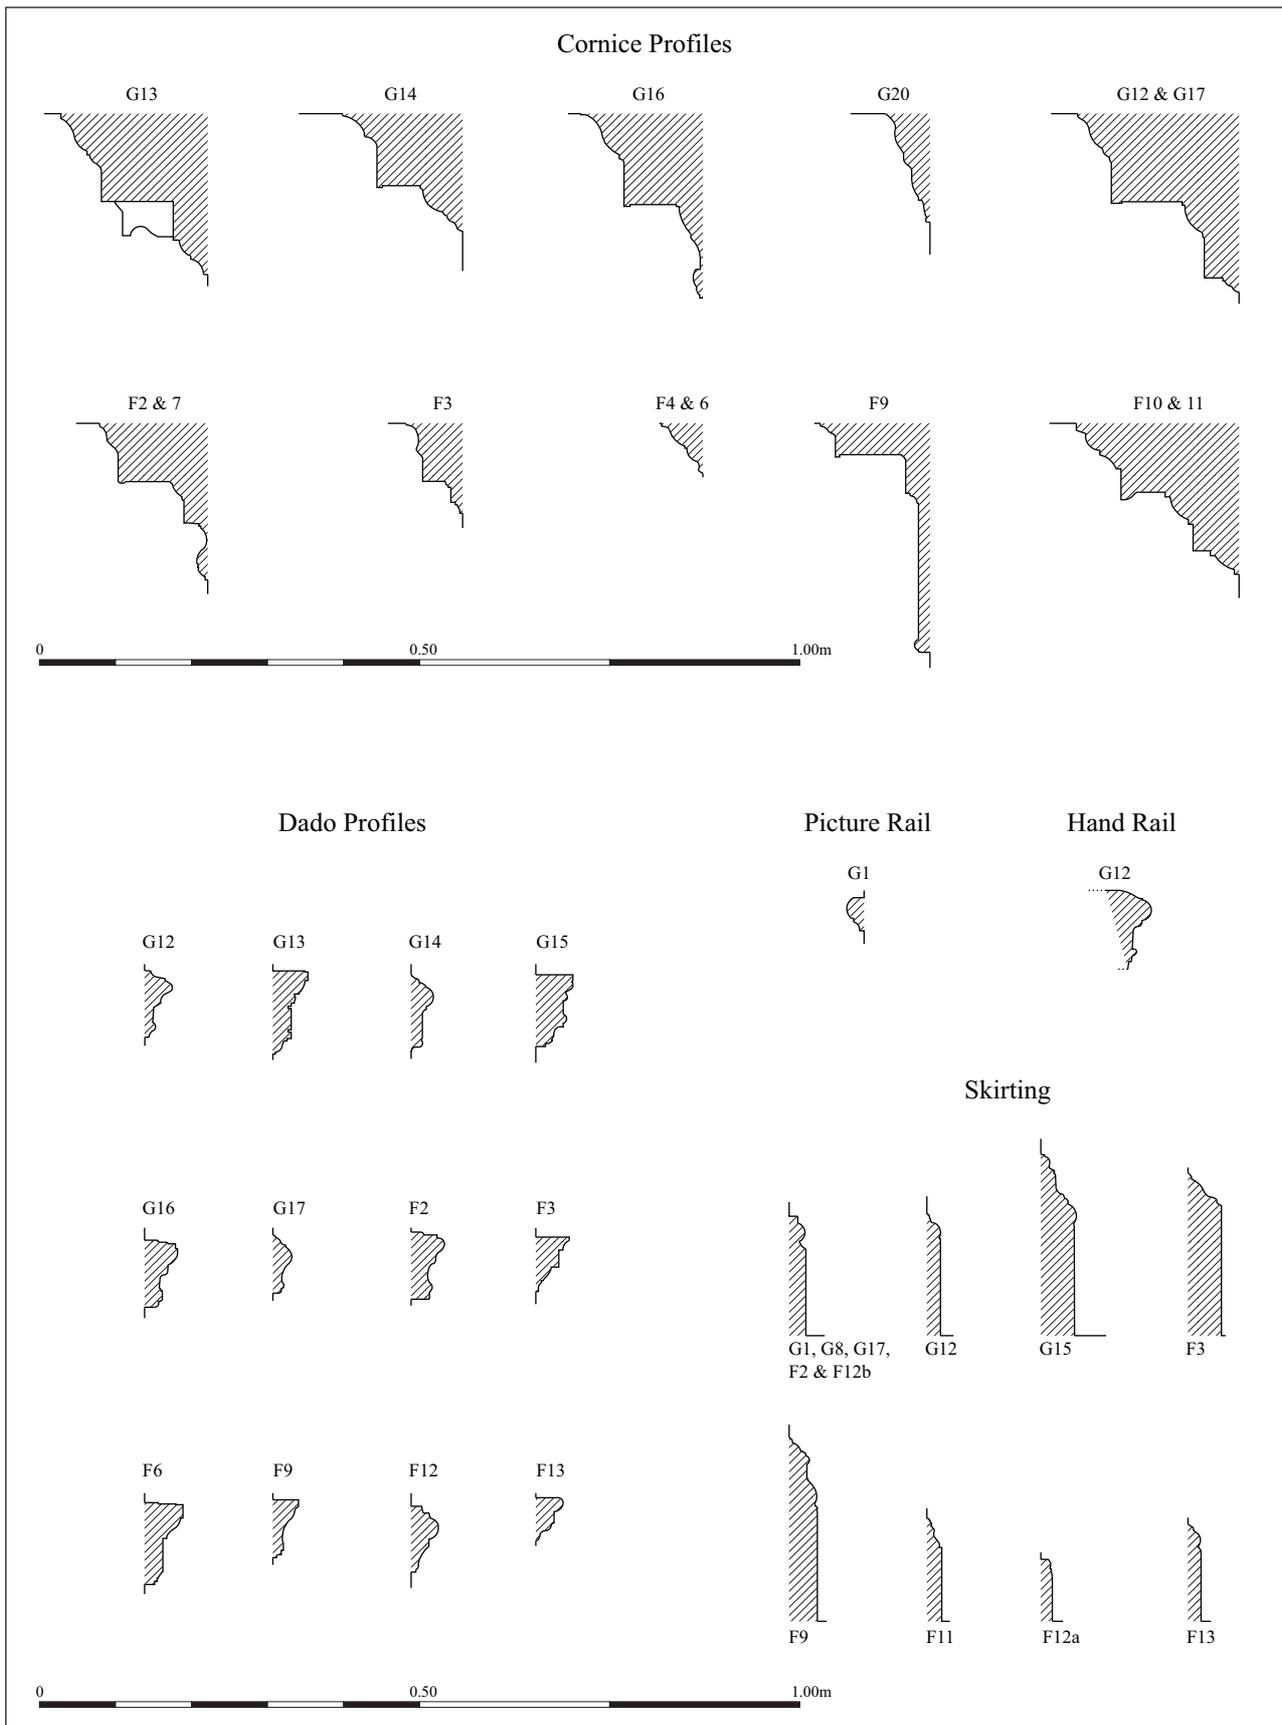
Figure 11: Profiles of cornices, dado rails, picture rails, hand rails and skirting boards

- 4.2.111 This room had an plaster ceiling cornice with tiny dentil detail (Figure 11) which had been concealed and damaged by several layers of paint and damp. A wooden chair/dado rail and moulded skirting board was also present around the room (Figure 11).

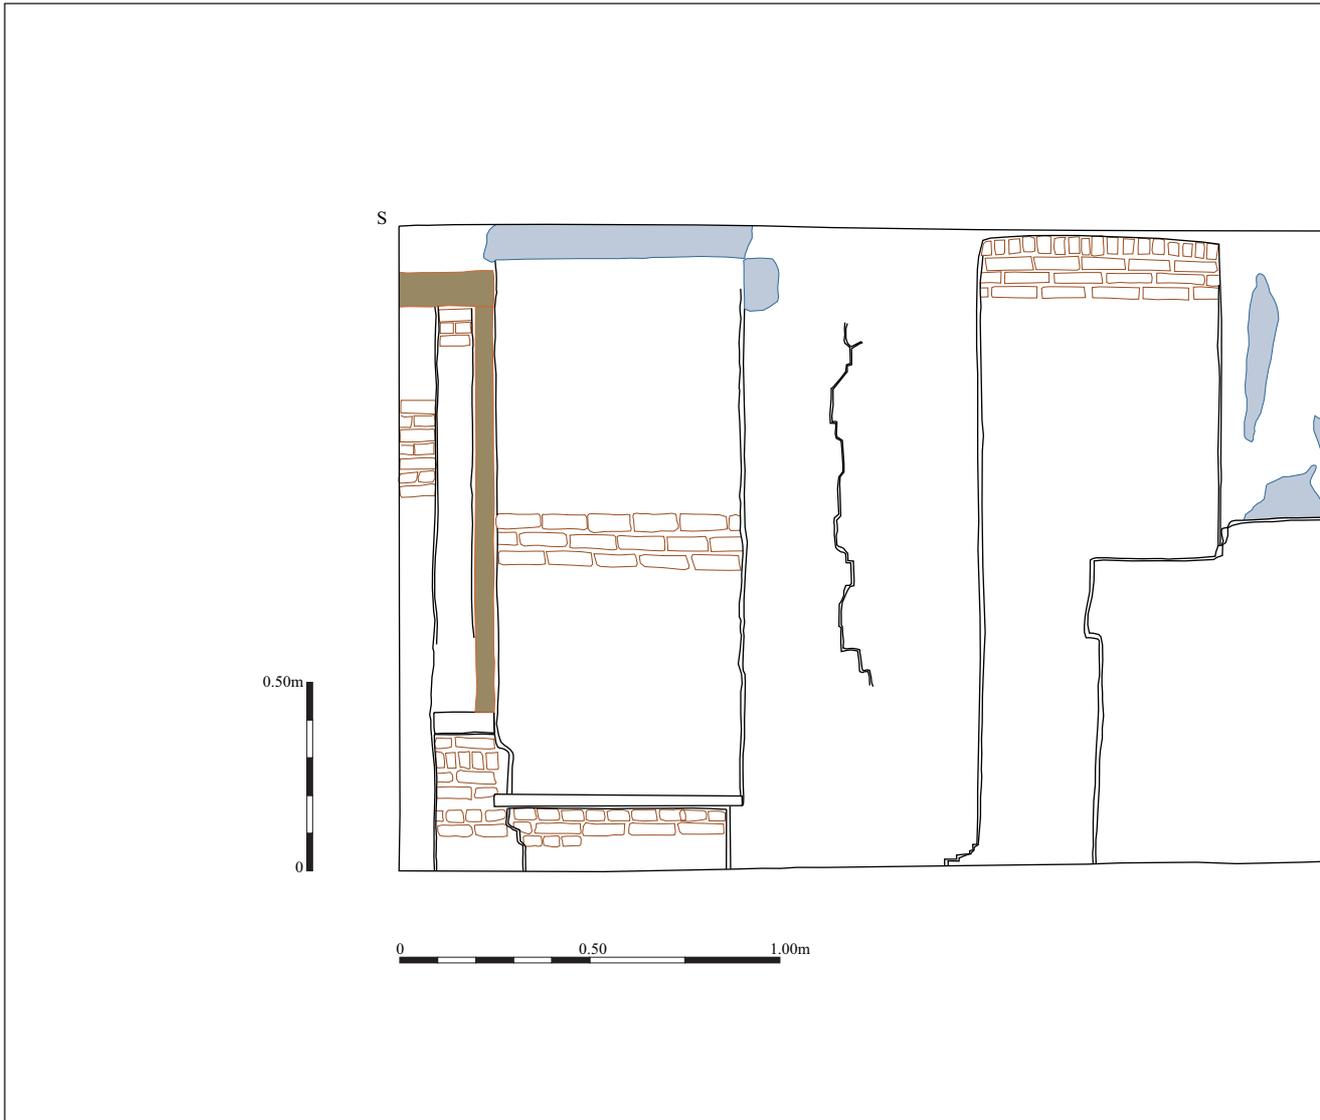
Figure 14: Exposed brickwork on east facing elevation G14

- 4.2.53 The exposed brickwork on the western elevation revealed evidence about the origins of this part of the house and subsequent alteration and repair (Figure 14). Two blocked up windows were recorded and beneath the one on the left was evidence of a blocked up door which must have been in existence prior to that. This evidence ties in with that recorded on the external elevation where the blocked door could be seen and the “blind” windows were noted. These windows may have been concealed to avoid window tax, yet retained on the outside to maintain symmetry and especially as this was part of the house visible from the main road. Alternatively, the windows on the south-facing elevation may have been added at a later date and those on the other elevation no longer needed but retained on the outside for aesthetic reasons.

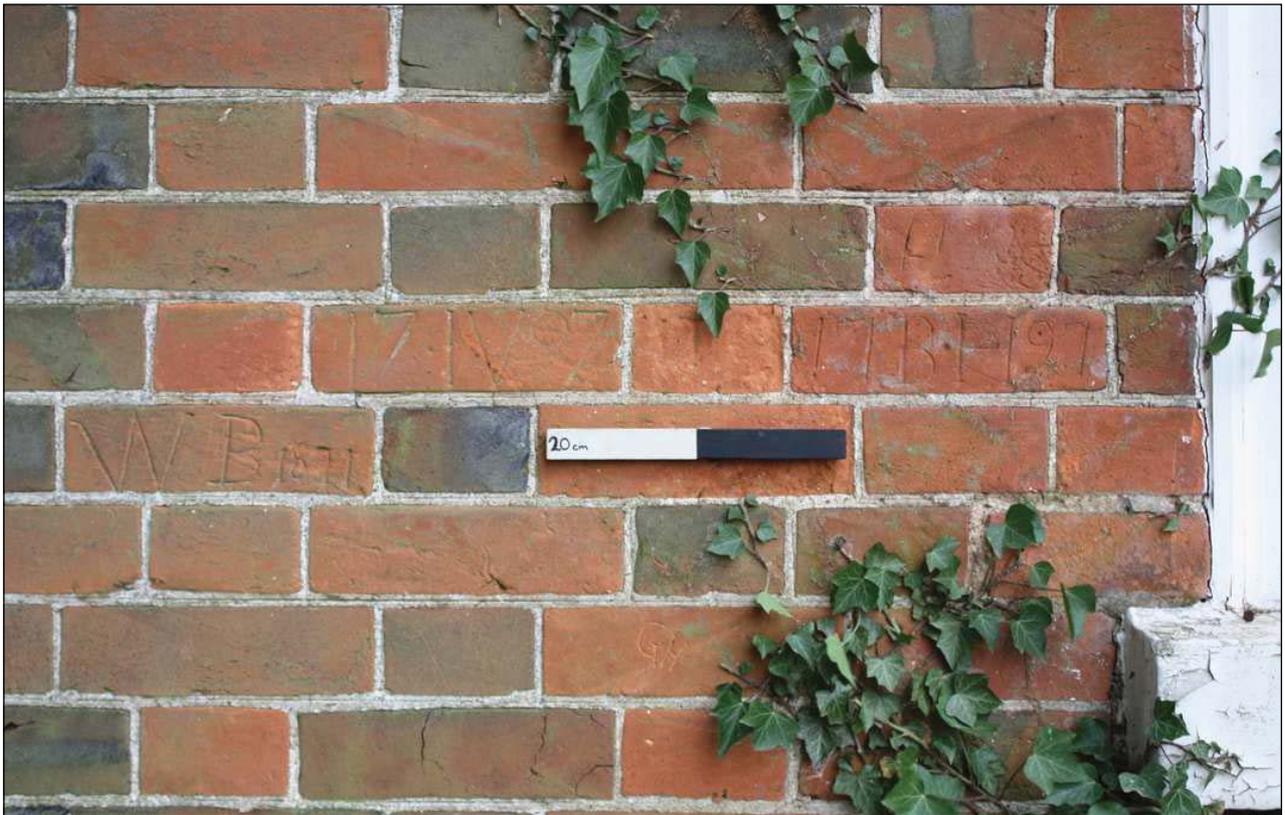
- 4.1.2 Dated graffiti was recorded on the single storey extension which dates this element of the building to 1797. A number of initials, together with the date were found which may represent the builders who worked on this extension (plate 3). Below this another date and initials (WB 1871) may indicate a date of alteration, building work or simply someone unconnected inscribing their initials.

Plate 3: Dated graffiti on exterior wall of G2

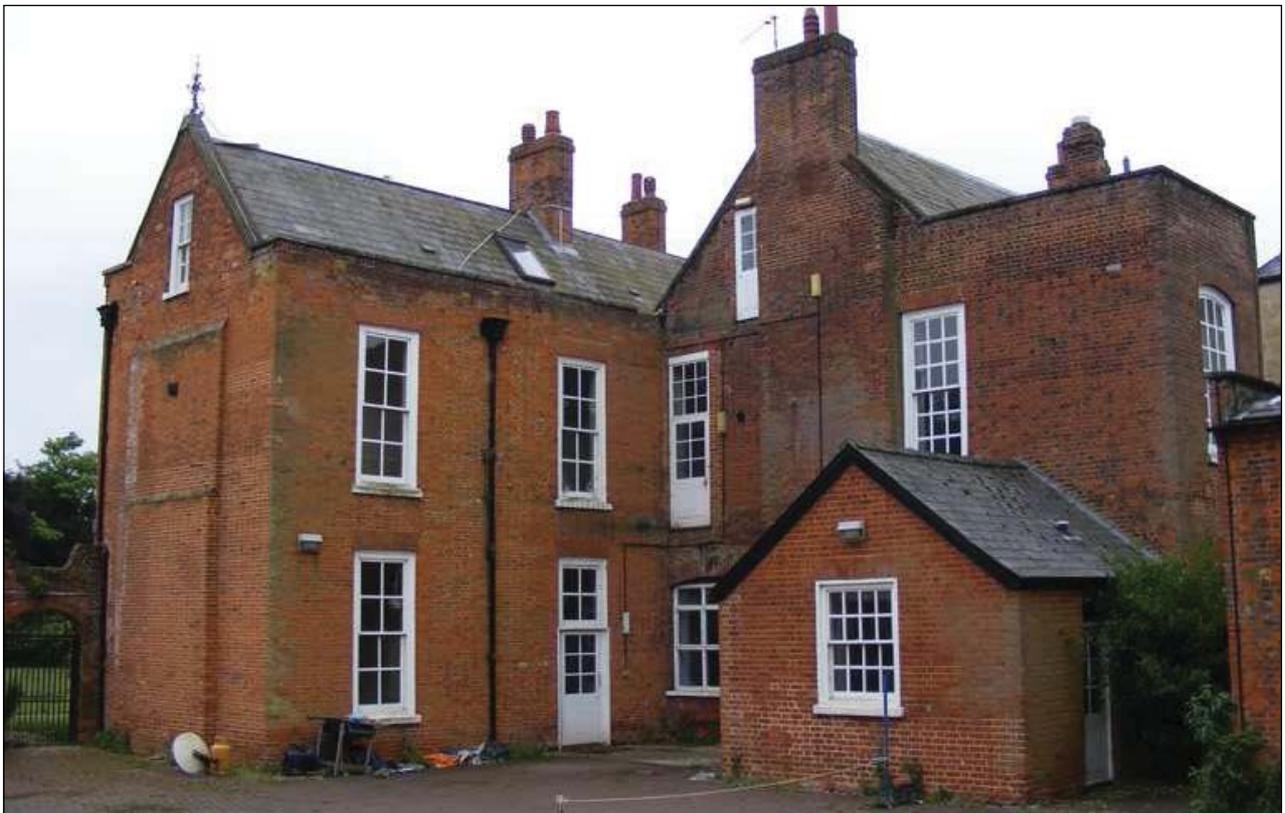
- 4.1.6 The east-facing elevation is located at the rear of the house, and faces the coachman's cottage (plate 4). Like the north-facing elevation, there are a number of phases and alterations noted, Figure 8 shows these more clearly along with the later discussion and phased floor plans.

Plate 4: East facing elevation, Orford House

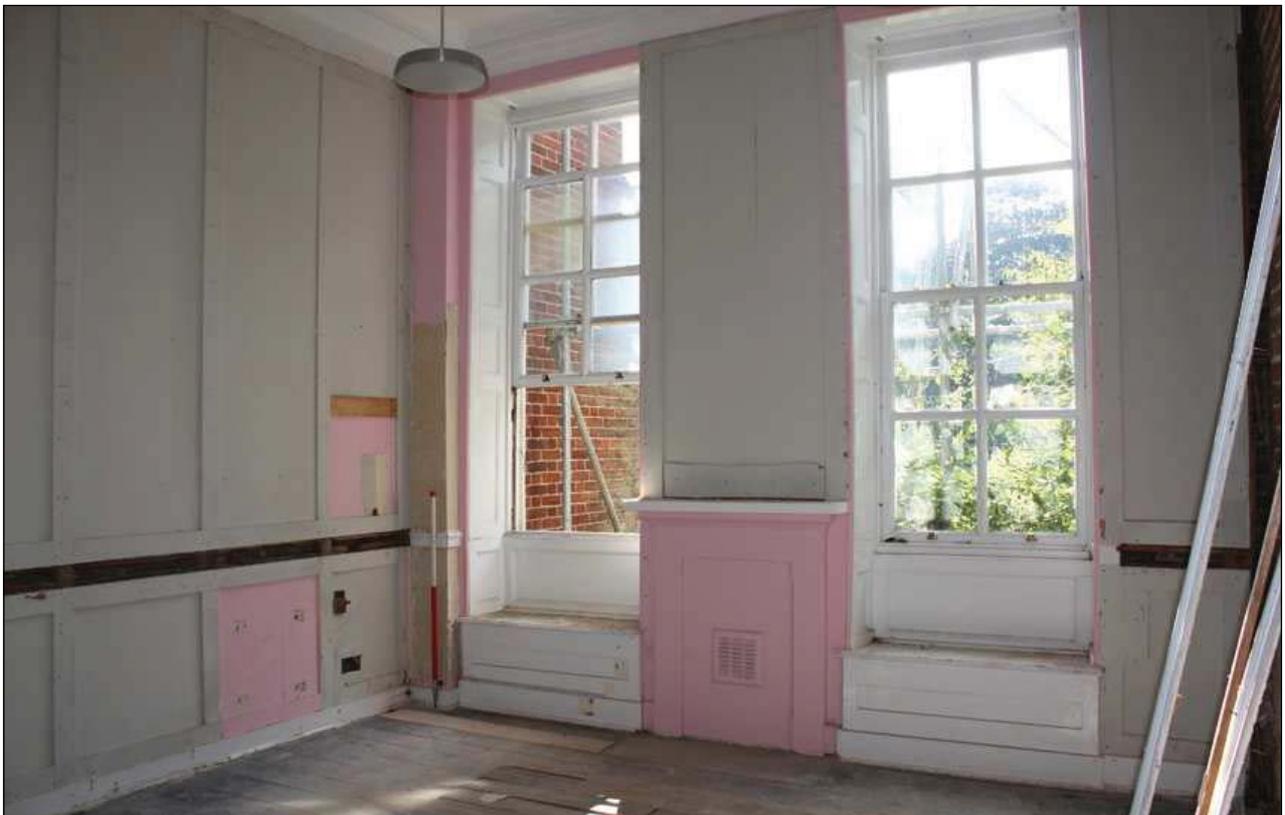
- 4.2.54 The two windows recorded in this room were located on the southern elevation (plate 27). They were both elongated double-hung sash window with four panes per sash in a two-two arrangement. The windows were within shutterboxes, however the shutters had been sealed in place by several layers of gloss paint. Window seats were located below, built within the recess with opening seats to allow for storage. Window seats were often set within panelled splayed recess of a window, often with boxed-in space below for storage and was a feature particularly found in modest houses in the Late

Plate 27: G14

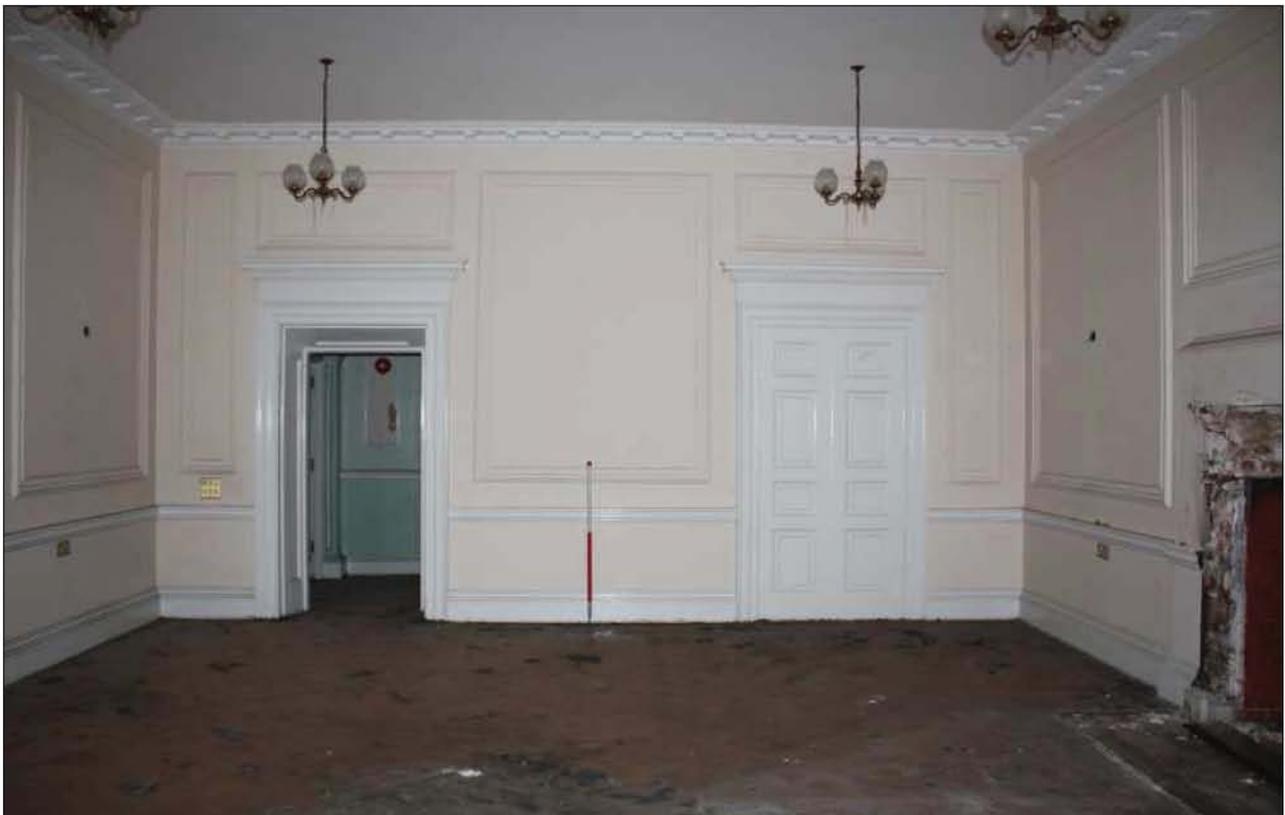
- 4.2.60 This room had two doors leading from the corridor (G12) (plate 29), although the door on the left (as viewed from within G15) was missing and the door on the right had been sealed shut and no longer in use. The doorcase was still present on the left door which was panelled in the reveals (one on each side and one above) and flared slightly outwards into the room. The architrave was wide and moulded and a plain, elegant pediment with tiny blocks with small drilled holes rested on the top, the same as one recorded in G13 and likely to date to c.1730s (Calloway, 2005). The doorcase on the right side was the same as was the pediment above. The door was comprised of two vertically hung parts which would presumably open out into the room. No hinges or fittings were visible.

Plate 29: Internal view of doors, G15

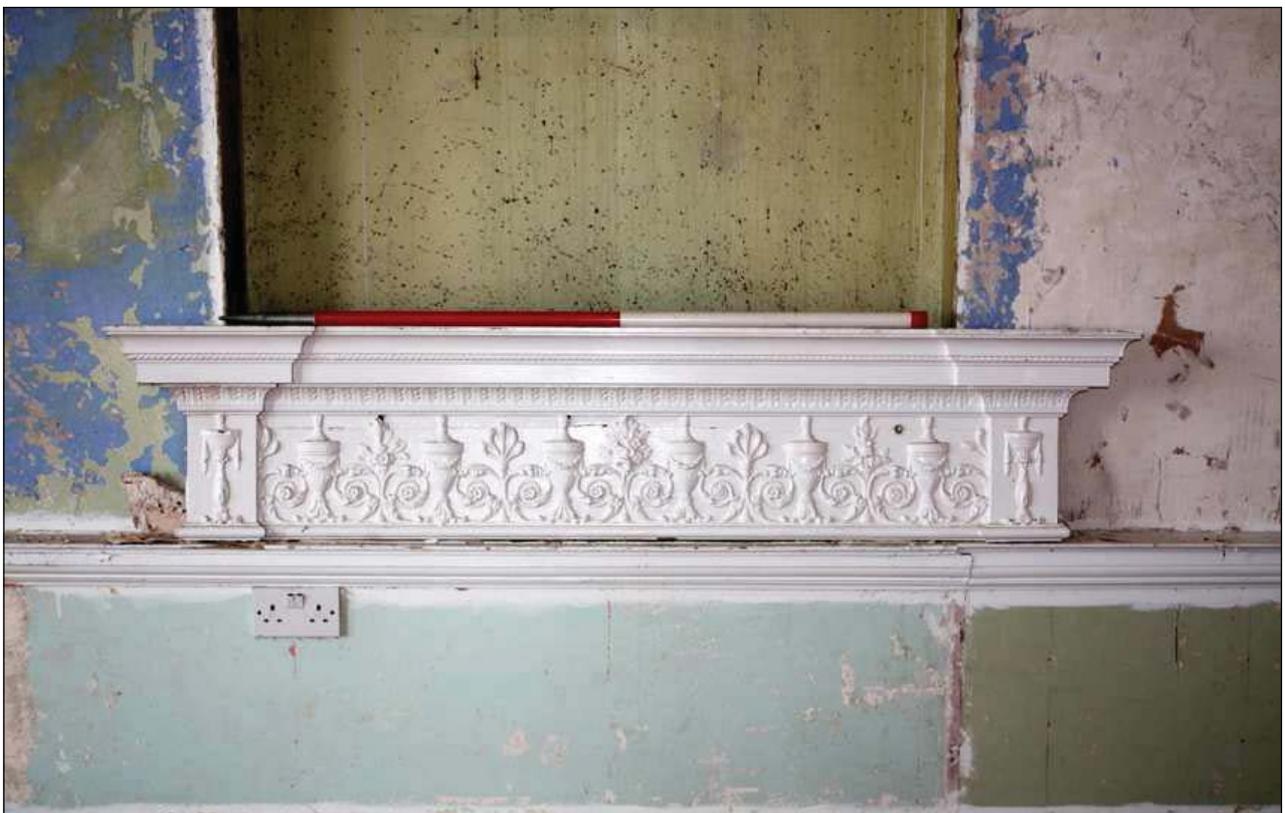
- 4.2.110 Although the fireplace had recently been removed from this room, the listed building entry (Appendix D) provides a very good description : "late 18th century chimneypiece with marble fireplace with moulded edge and anthemion decoration to frieze above". Fragments of the frieze were found in the room and it is assumed that this is where they were from as they fitted the impression left on the wall and also the listed building description (plate 42).

Plate 42: Detail from fireplace, F3
