**Chedworth Roman Villa**

**Conservation Management and  
Maintenance Plan Gazetteer**

**September 2007**  
**Revised November 2009**

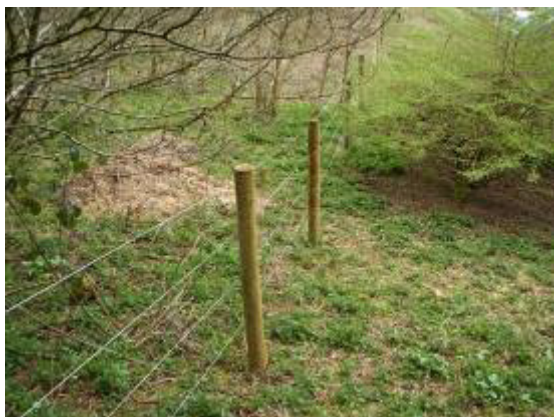
001.004

D – varied styles and states of repair look poor.

No single style; parts in poor repair; some fencing not erected by skilled operatives, looks uneven; does not mark whole boundary.

Remedial: Repair gaps in fences.

Long-term: Replace various fence types with a single type; replace posts where not vertical.

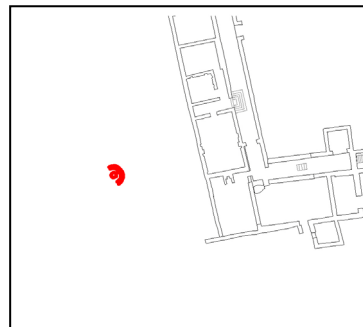
Small limestone lime kiln, built c. 1995 to illustrate ancient lime-production techniques. Left to decay, gradually collapsing;

N/D (not important to significance, but could be hazard/not aesthetically pleasing)

If collapses more, could cause obstruction; not interpreted.

Remedial: Some simple interpretation will be added; any loose stones fallen on the path will be removed, and the stability of the structure assessed.

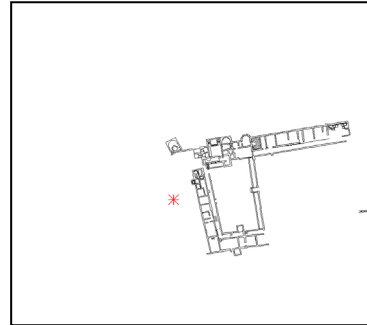
A series of small mounds with holes, set in the top of the spoil heap mound by the large shed. Have decaying clay walls, evidence of burning.

N/D (not important to significance, but could be hazard/not aesthetically pleasing)

Possible trip hazards, not explained, look untidy.

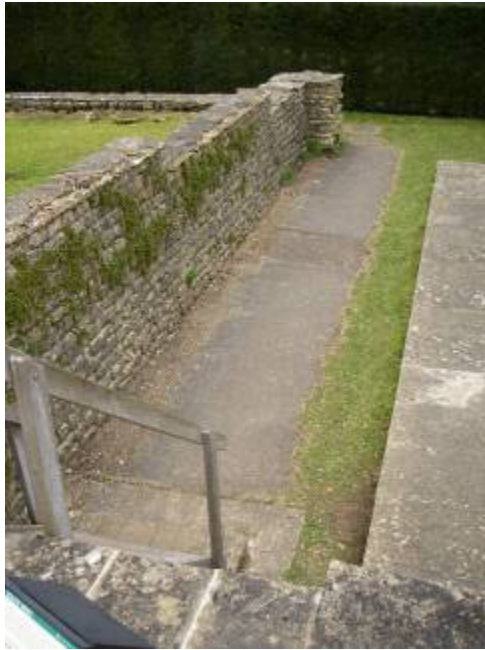
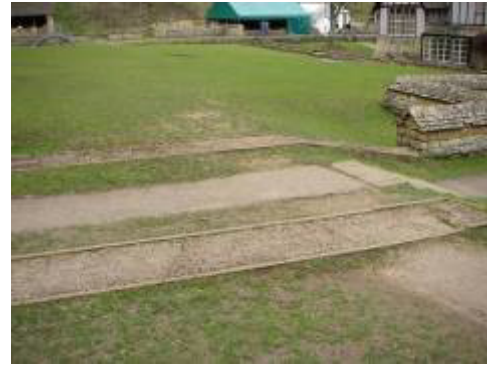
003.005

Not much known about archaeology below tarmac (no mosaics present); north wall of lower part also acts as retaining wall for garden court, and is the tallest area of wall surviving on the site - requires more careful monitoring and repair regime. Used as visitor route. Link to east portico blocked by a blank wall (see 010.003). Width of corridor differs above and below wooden steps. Unclear whether concrete steps reflect an original change of levels.

Remedial: Ensure paths are repaired, and staircase sound.

Short-term cyclical: Wooden staircase needs to be surveyed regularly and repaired as necessary. Grass needs to be cut regularly.

Long-term: Original corridor levels need to be established and surfaces grassed. The area laid as a path will be extended to fill the width of the corridor, so it is easier to interpret.

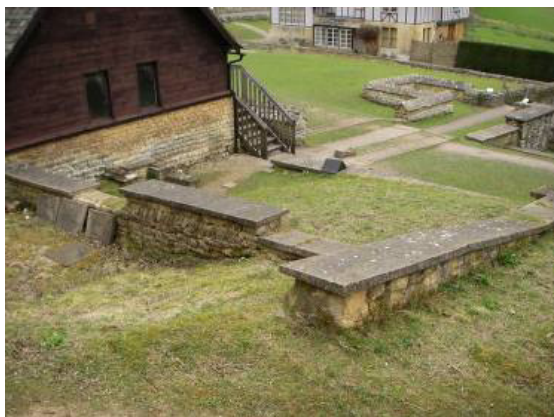
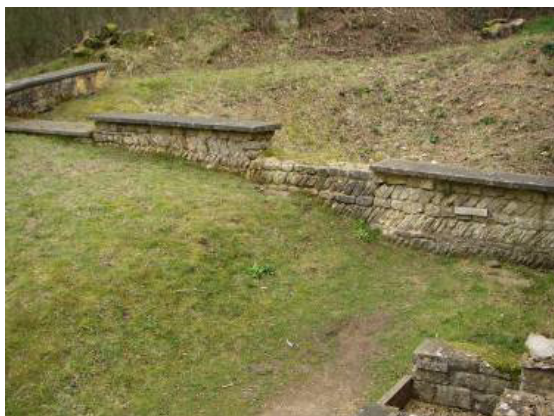
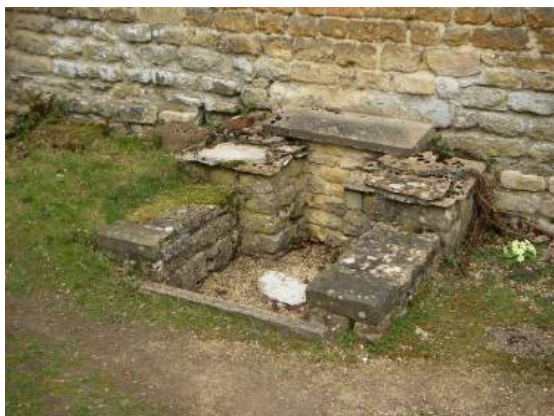
004.001

Exposed to the elements; wall-capping is unattractive and loose; grassy turf is uneven, detracts from understanding of room as an internal space; underlying archaeology not known.

Remedial: Cut turf away at wall junctions, repair wall-cappings.

Short-term cyclical: Grass needs to be cut regularly, walls need to be inspected as part of regular site monitoring. Environmental condition to be monitored and controlled using the Hanwell controller linked to BMSS.

Long-term: Retain turf but soil level lowered by careful excavation to match that around stokehole, so that it is one level all over room.

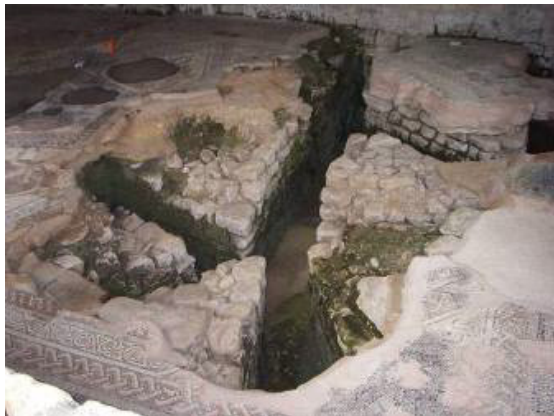
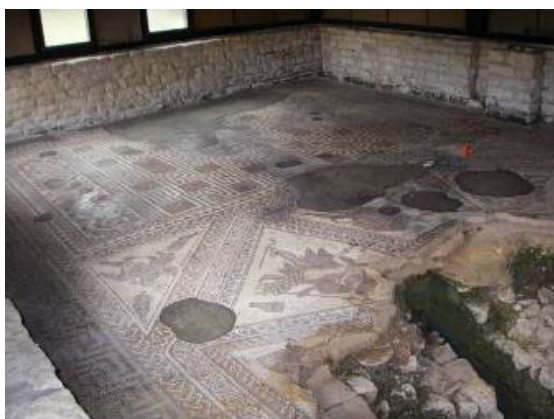
004.002

Wooden shed provides weather cover but not good access for viewing; mosaic needs regular monitoring and cleaning, as capillary action brings moisture to surface causing efflorescence;

Remedial: Environmental monitoring system needs to be serviced to ensure accurate calibration of humidistat. Mosaic will be inspected daily for any dropped items or litter such as blown-in leaves, which will be removed.

Short-term cyclical: Mosaic will be inspected regularly for surface dust, salt efflorescence, and algal growth, as part of regular monitoring regime of site. Mosaic surface needs dry cleaning twice annually, or more frequently as necessary (depending on dust deposits). Wet cleaning required annually. Condition survey by qualified conservator required annually. Environmental condition to be monitored and controlled using the Hanwell controller linked to BMSS.

Long-term: The existing wooden shed, although it has been modified from the original, does not provide a fully controllable internal environment (especially as the windows are opened to allow public viewing). In the long term the mosaic needs better protection, and improved access for viewing and maintenance. The cement lacunae will be removed, and replaced with a softer lime-based mortar, to help 'wick the soluble salts away from the mosaic itself. The edges around the hole at the north end need to be consolidated.

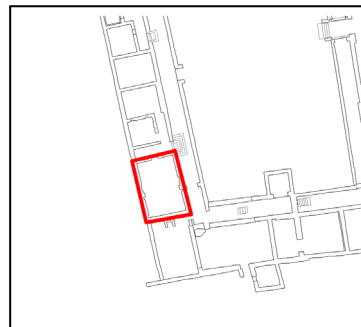
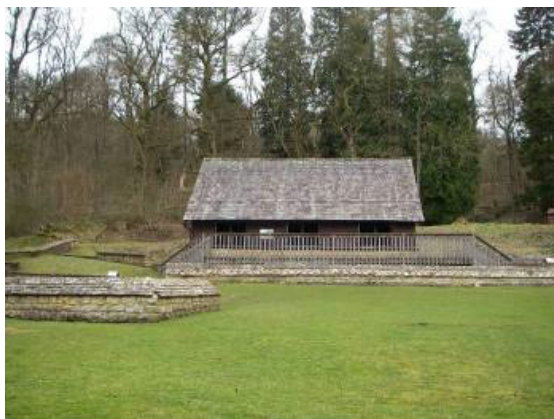
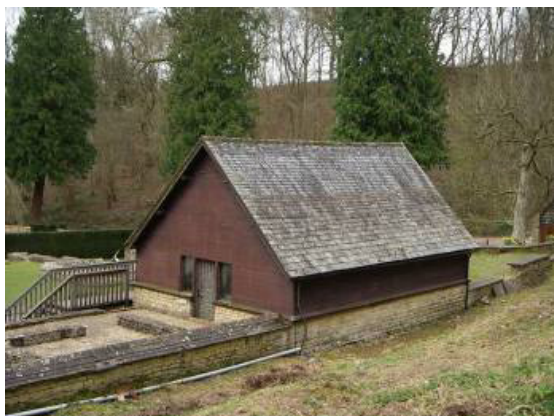
004.003

Shed with wooden frame resting on restored Roman walls, with steeply-pitched, double-pitched slate roof; covers whole of room 5; door in north end gives access to interior; 3 windows along east wall give viewing access from wooden walkway in corridor/portico; shed built in 1860s soon after excavation; now insulated inside roof, and provided with overhead radiant heating system controlled via humidistat. Treatment of doorway on north wall and adjacent window reveals is of interest because of use of burr wood infills in panels.

Remedial: Windows will be replaced with easier-opening type. Access needs to be improved to the door, so that maintenance access is easier.

Short-term cyclical: Shed will be inspected as part of regular site monitoring programme, to ensure it remains sound (e.g. any loose roof tiles noted and repaired). Shed needs full survey on 5-yearly cycle, and repair as necessary. Exterior will be re-stained every 10-years. Interior requires regular inspection as part of regular site monitoring, and through cleaning of all surfaces annually to remove dust, bat faeces, etc. This may be carried out more regularly if necessary, depending on level of build-up.

Long-term: Although it has been modified from the original, it does not provide a fully controllable internal environment (especially as the windows are opened to allow public viewing), or good access for viewing or maintenance. Long-term this shed will require extensive modification, or replacement with a building that can provide demonstrably better internal environmental control, and visitor access.

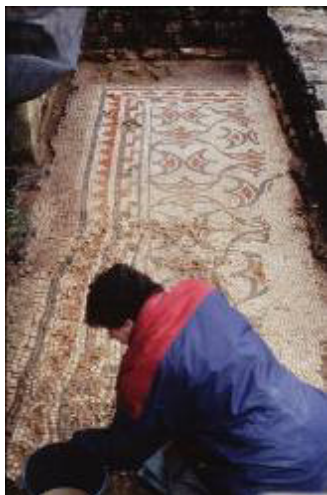
004.004 Mosaic

Internal corridor or ante-room to the dining-room (Room 5); has 4th-century geometric mosaic floor, originally part of larger mosaic but with signs of repair on north edge; steps down to corridor/portico; mosaic is re-buried under soil layer, geotextile marker, and coarse gravel.

Buried mosaic not accessible to view; mosaic not easily accessible for monitoring and condition recording.

Short-term cyclical: The walls and cappings need to be inspected a part of regular site monitoring programme, and repaired as necessary. Gravel needs to be kept free of plant growth. Buried surface temperature monitor needs to be regularly checked and serviced as part of environmental monitoring system service. Consideration will be given to a regular cycle of limited excavation and uncovering to assess condition, probably on a 10-year cycle, but advice will be sought from a qualified conservator.

Long-term: A long-term management aim to ensure the proper care of, and access to, the mosaic, would be to enclose the room within a suitable shelter building, and expose the surviving Roman features. Otherwise, regular condition survey must determine the effectiveness of the burial regime, which will be maintained or adjusted as necessary.

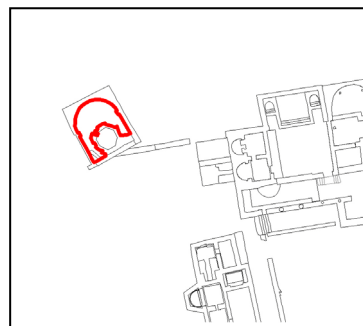
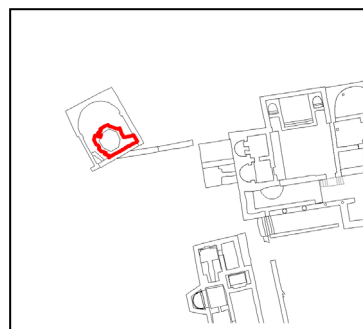
The cistern has been colonised by aquatic life, including frogs, water boatmen, dragonfly larvae, and algae, making it look unsightly.

Remedial: Plant growth will be removed from the gravel. The cistern edges will be repaired. The cistern will be drained, cleaned, its condition surveyed, and repairs carried out as appropriate. Mole hills in the grassed area could be levelled.

Long-term: A system of frost protection as at present is required during the winter months. The surface treatment of the interior needs to be the same as the other internal rooms. Consideration will be given to lifting turf and laying a gravel base of geotextile barrier to deter moles; the drainage from the cistern could also be better controlled, through the provision of a formal soakaway, or piping. This would require excavation and exposure of the sub-surface features.
