Two Weirs on Colne Water, Cotton Tree, Colne, Lancashire

An Archaeological Recording Programme

By J.M. Trippier Archaeological and Surveying Consultancy

November 2011

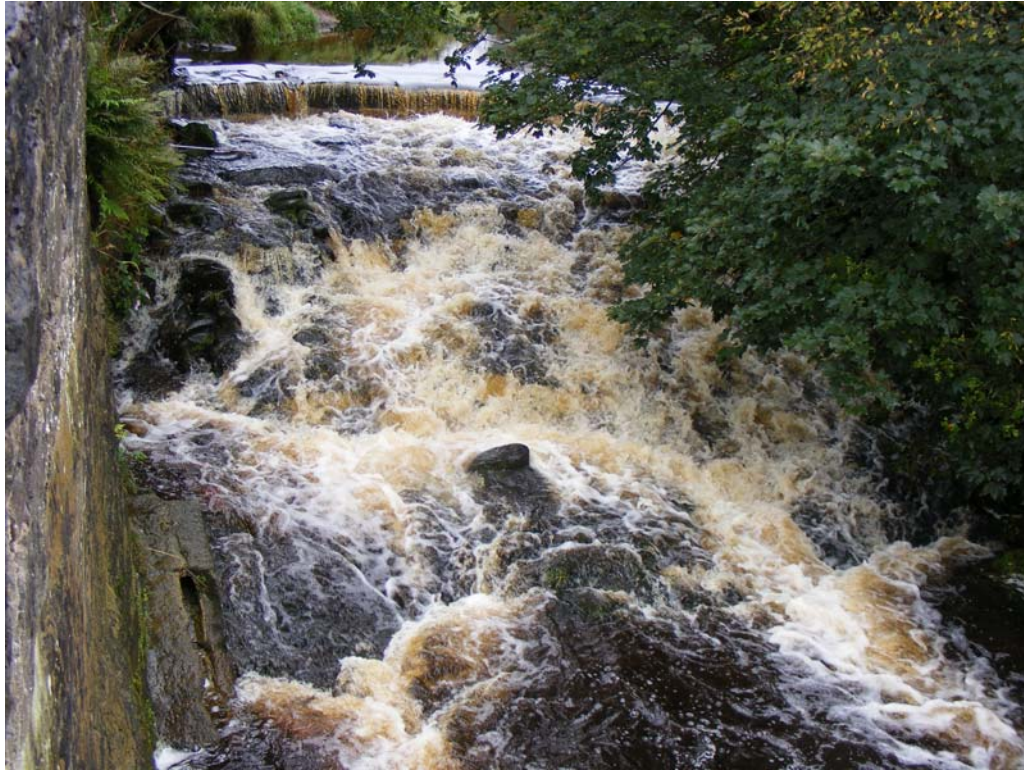
Plate 1: Weir 1 looking upstream

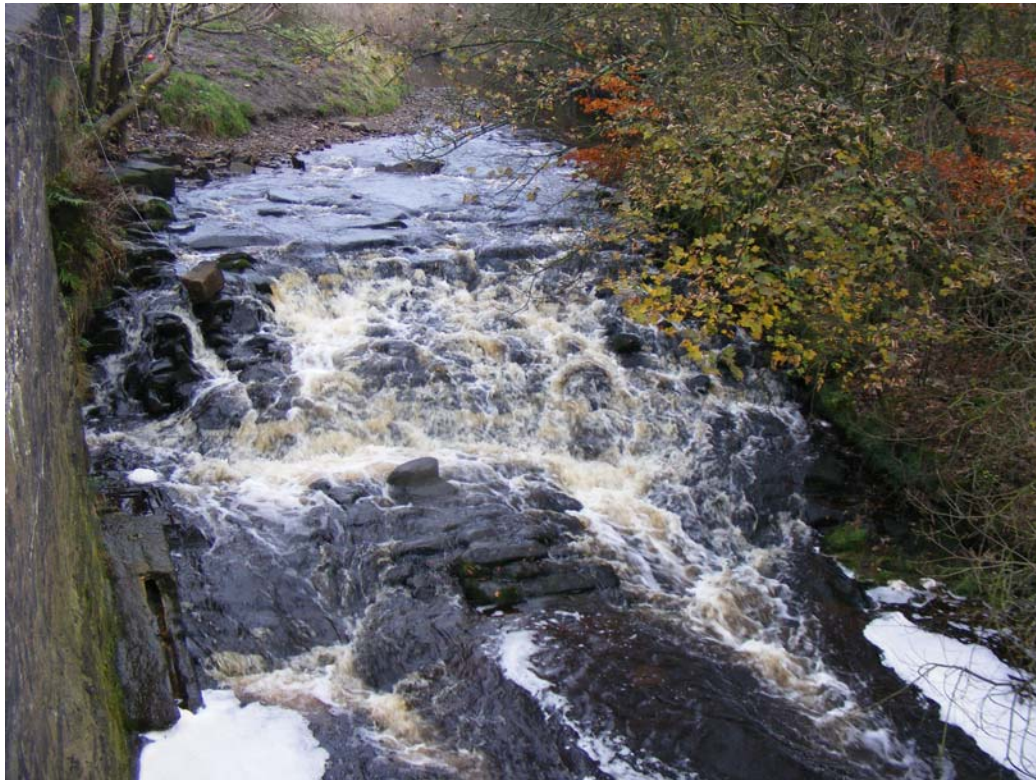
- 5.5.1 As described above the weir falls in four roughly defined phases for about 15 metres (measured horizontally) from the lip to its foot. The first and third phases are more or less level with the second and fourth descending more obviously (**see Fig 9**). The weir is constructed of large river pebbles with two 'islands' of more protruding adjacent to the right bank and in the centre of the stream (**see Plate 2**). There are also a number of isolated stones which stand proud of the weir.

Plate 2: Weir 1 looking upstream after removal of lip

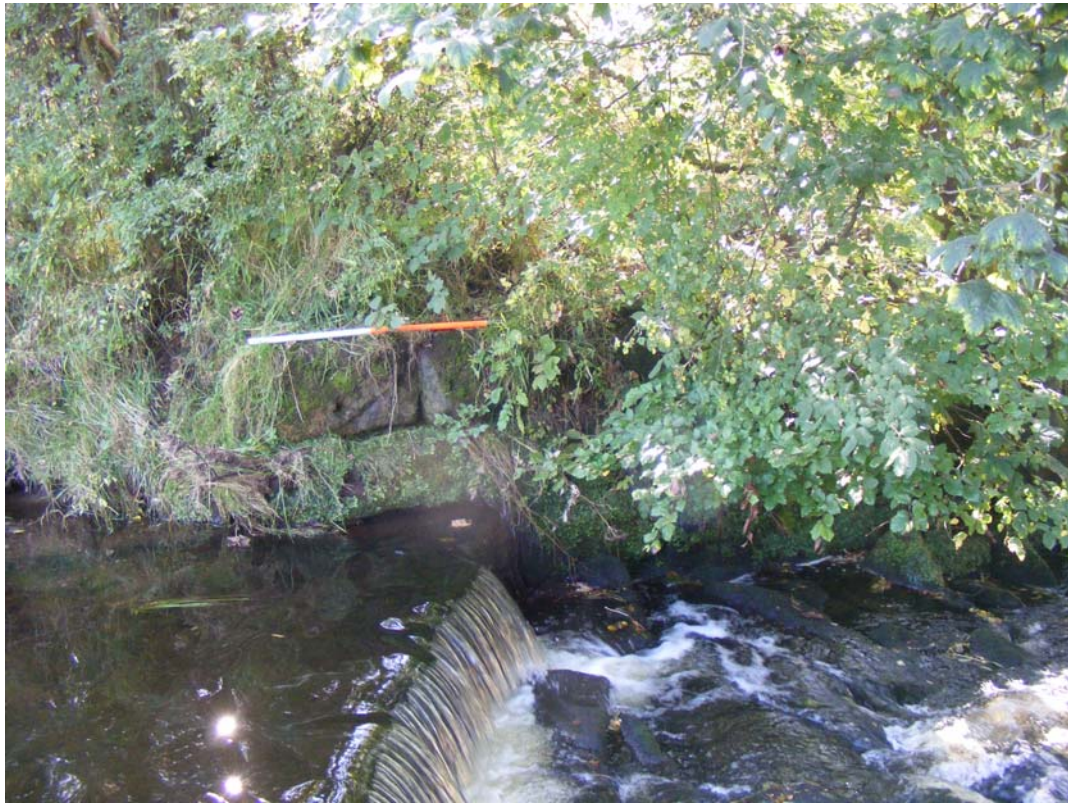
- 5.2.1 As outlined above the top (or lip) of the weir comprised a row of massive gritstone blocks (**Plates 5 to 9**) set out in a crescent shape with the horns of the crescent pointing downstream. It was some of the more central of these blocks which were to be removed in order to increase the hydraulic capacity of the watercourse. They varied in size but generally measured approx. 1mx 1.5m in plan and were approx. 0.5m deep. The blocks were not mortared but at the south end of the weir a layer of concrete had been deposited over the rear (east) surface of the blocks; presumably to improve their stability (**Plates 7**). Those blocks on the flanks had a regular rectangular shape and were laid longside to longside (**Plate 9**). The central blocks were wedge-shaped on their shorter sides (**Plate 10**) and were laid end to end. The blocks contained Lewis Holes (**Plates 6 & 10**) –small rectangles their surface which enable lifting pins (‘Lewises’) to be inserted as an aid to moving the blocks. These features along with their size and shape suggest that the blocks were specifically quarried to build the weir rather than being reused from elsewhere. The central blocks were removed by mechanical digger and re-sited on a grassed area at the north end of the lodge in approximately the same layout as in the river (**Plates 11 & 12**). However those adjacent to the river banks remained in place.

- 5.3.1 The retaining wall which comprised the left bank of the weir was substantially hidden by trees. However it could be seen to have been built from large rectangular shaped gritstone blocks which rose for approx one metre above the height of the weir lip and then sloped down from east to west in line with the weir’s descent (**Plates 5, 7 & 8**). Again these blocks were not mortared but laid dry.

Plate 5: lip of Weir 1 looking towards left bank

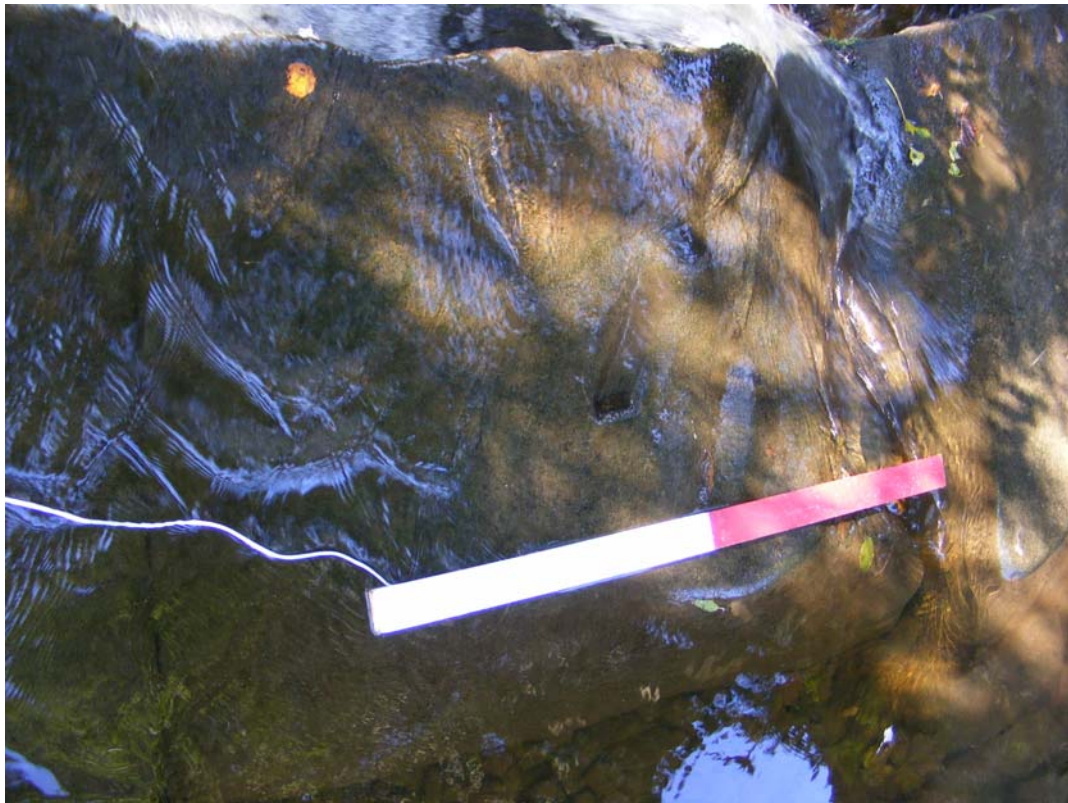
Plate 6: Block on lip in centre of Weir 1 looking downstream. NB Lewis Hole

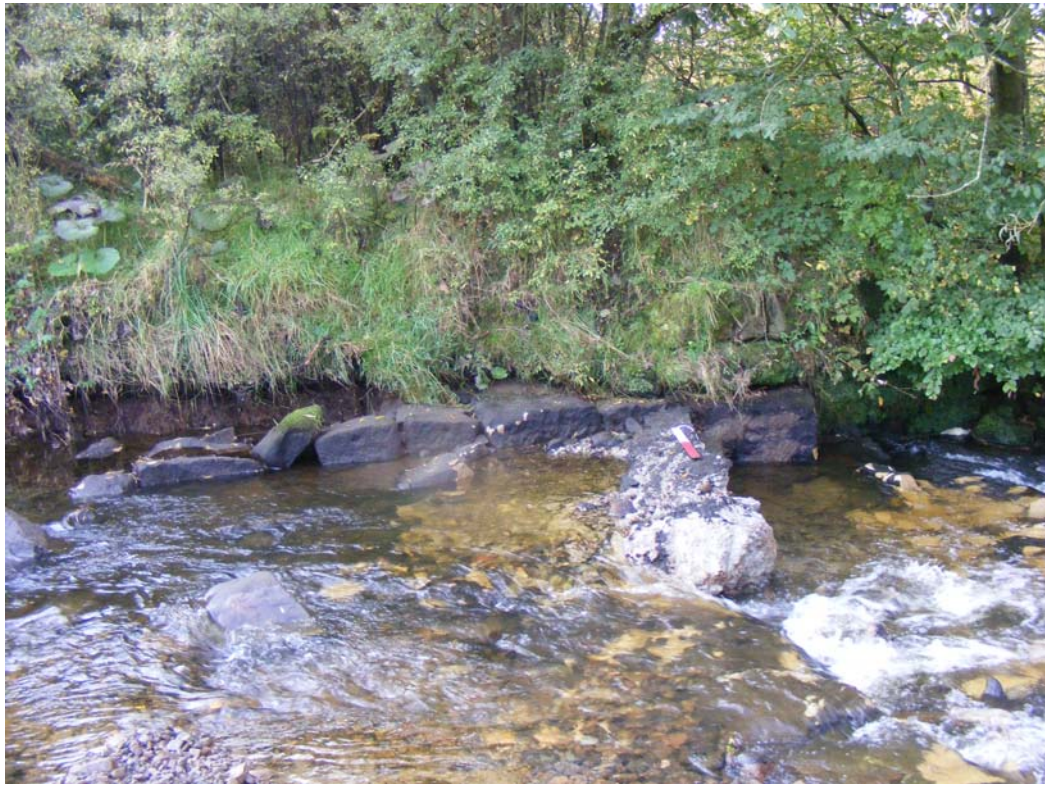
Plate 7: Layer of concrete over lip of Weir 1 looking towards left bank

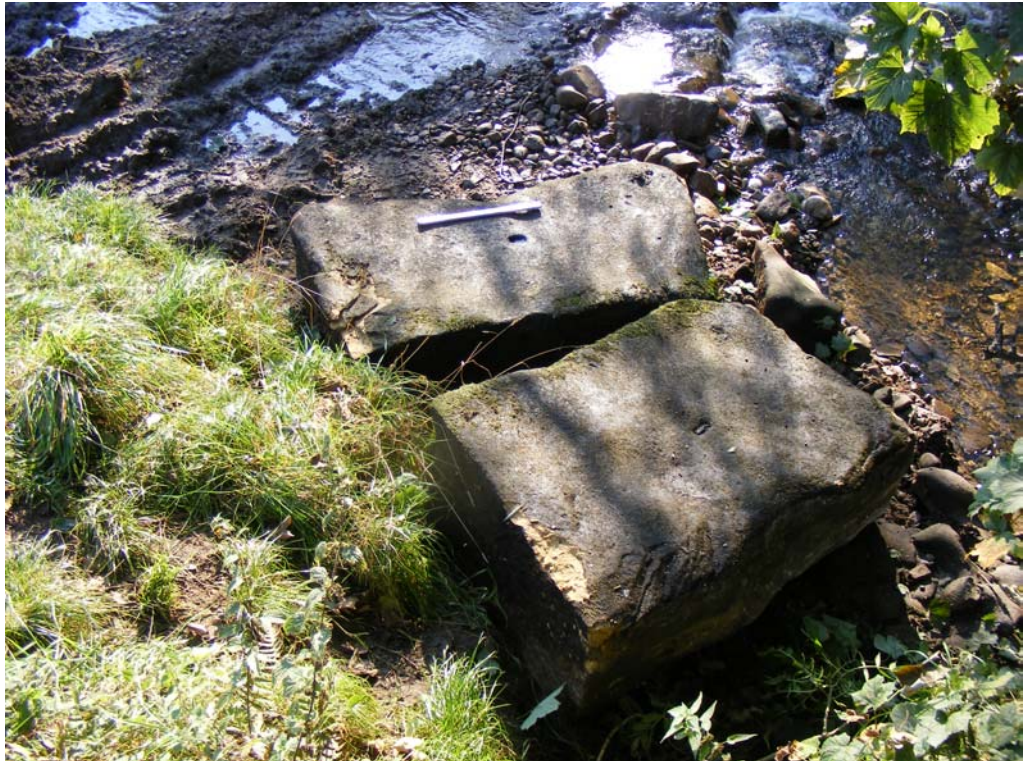
Plate 10: Central blocks after removal from Weir1. NB wedge shape and Lewis Holes

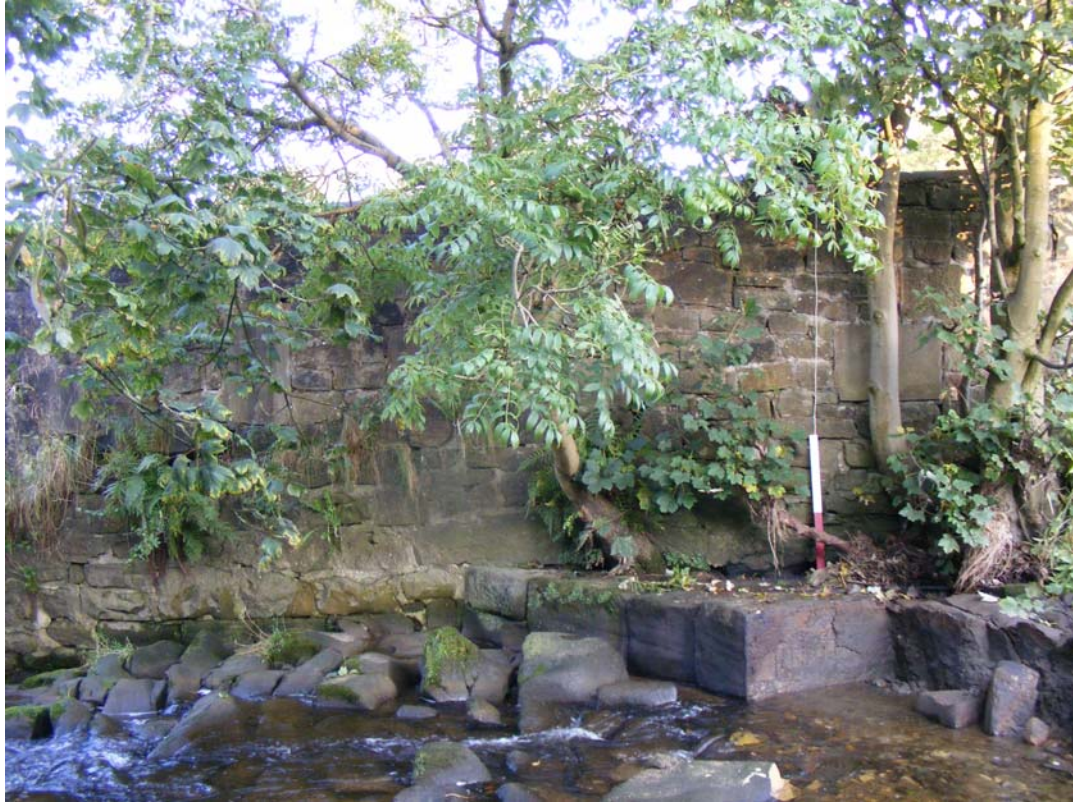
- 5.4.1 The retaining wall which comprised the right bank of the weir was partially hidden by trees at its northern end. At the lip of the weir it stood some 2.5m above the latter but at the foot of the weir it rose 5m above the latter. It was possible to discern at least three phases of building. The lower part of the wall, which rose approx. one metre from the lip of the weir and 3.5m from the foot was constructed of mortared uncoursed irregularly shaped gritstone blocks. However the top 1.5m was constructed of mortared rectangular and square blocks many of which were tooled (**Plates 13 & 14**).

Plate13: Right retaining wall above lip of Weir1. Stonework changes at the large block

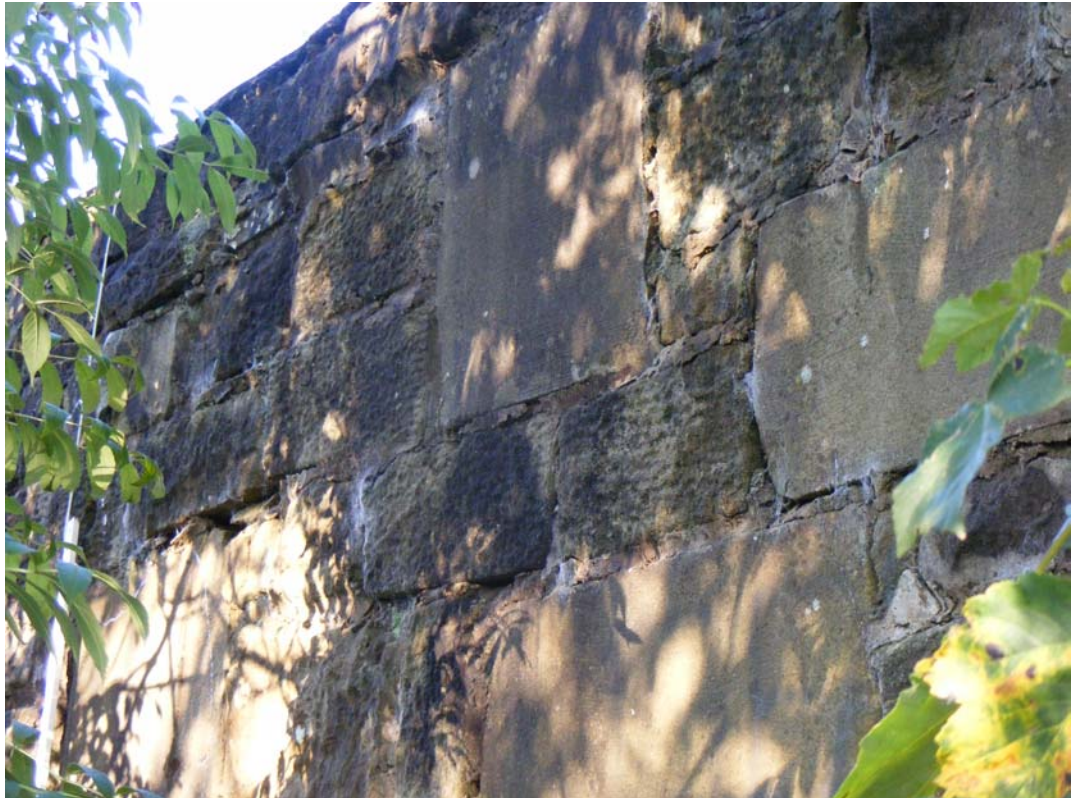
Plate14: Tooled stonework in upper part of right wall above lip of Weir 1.

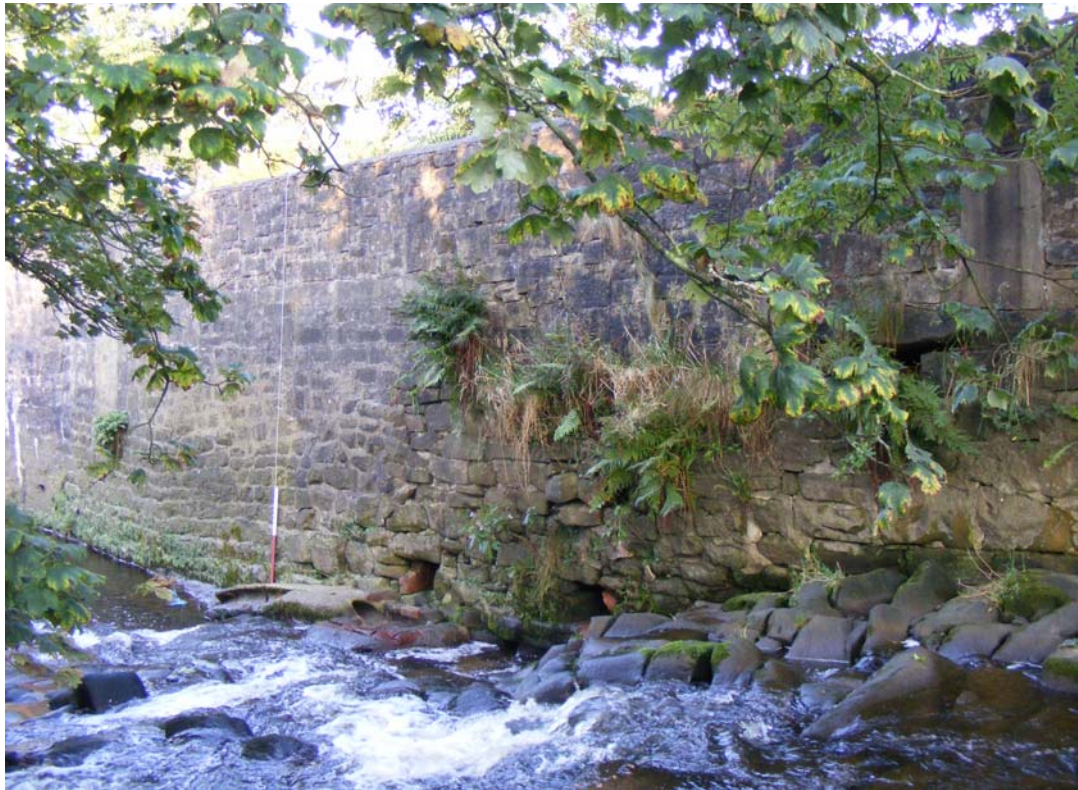
- 5.4.2 Beyond the end of the weir the wall was constructed of fairly regularly coursed stone blocks for the whole of its 5 metres plus height (**Plate 15**). It seems likely that the wall was raised in height at some time to protect pedestrians using the adjacent footpath rather than for water management purposes. It is also likely that the tooled masonry was a reuse of stone from one of the nearby mill buildings that went out of use. At the foot of the weir was a small rectangular outlet and a metre west of this was a similar one that debouched into an earthenware trap with a concrete cowl (now partially broken) (**Plate 16**). Both appear to be overflows from the adjacent lodge and leet. The wall is topped with a convex concrete haunching

Plate 15: Random and tooled stonework in right wall; coursed beyond foot of Weir 1

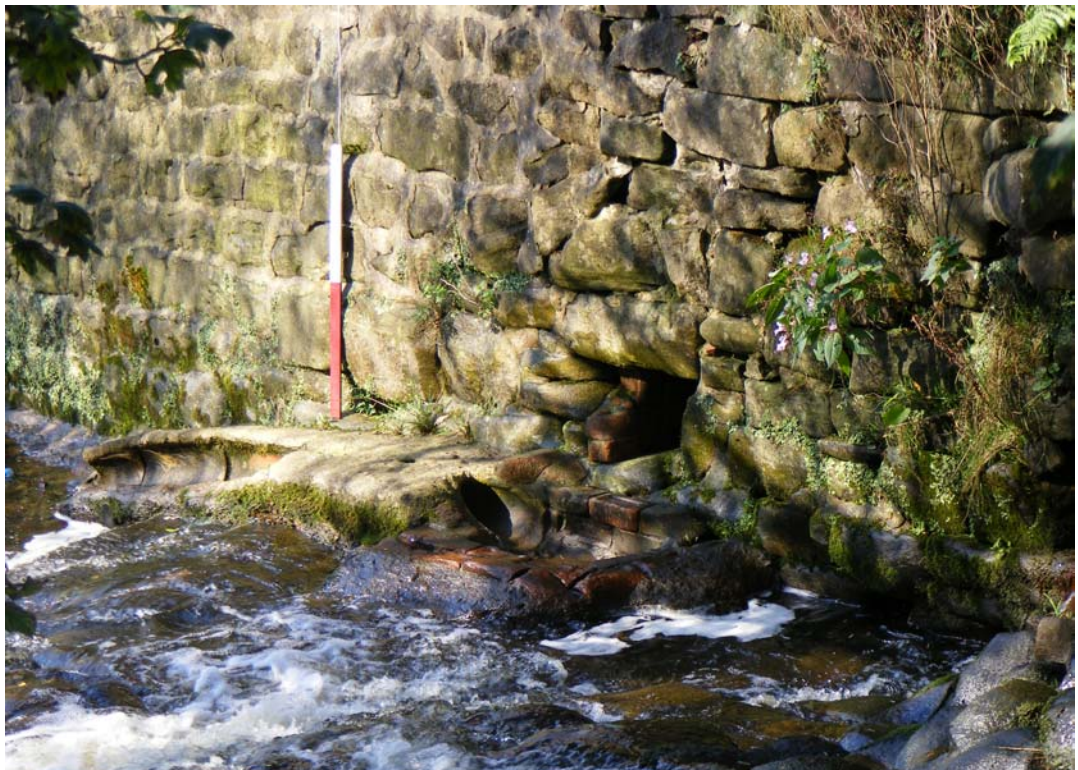
Plate 16: Western outlet in right wall just beyond foot of Weir 1

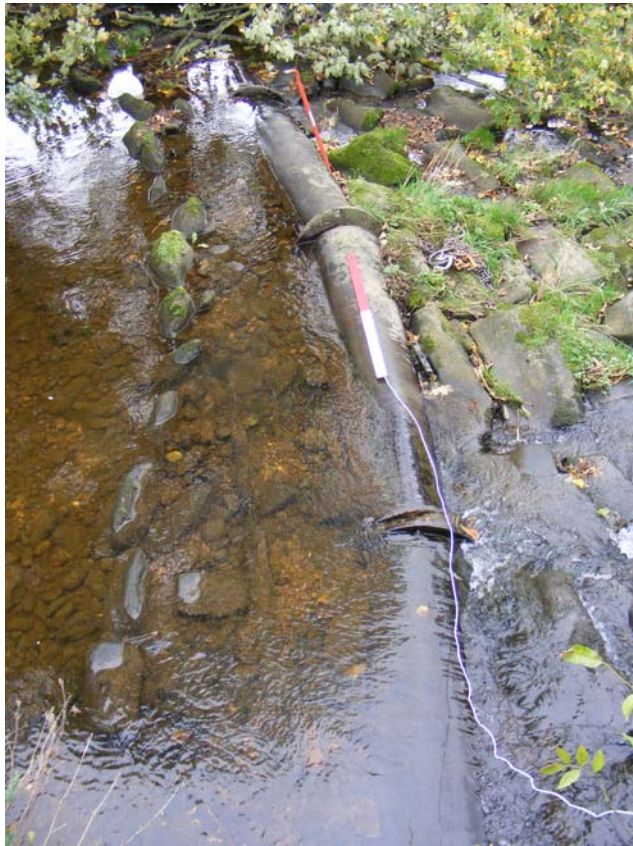
- 5.7.1 In this case the top (or lip) of the weir was formed by what appeared to comprise a substantial iron or steel pipe (or set of pipes) which straddled the weir (**Plate 21**). This was set out in a slightly segmental arrangement with the head of the segment projecting slightly downstream of the ends of the pipework. It was also slightly raised towards the centre. It was this pipework which were to be removed in order to increase the hydraulic capacity of the watercourse.

- 5.7.2 Upon removal the pipework was seen to comprise four hollow steel tubes each with a butt end and a flanged opening (**Plate 22**). The tubes were measured upon their removal and were found to be 2.35m long with the flange being 30mm thick. The external diameter was 375mm with the flange projecting some 60mm above the outside of the tube (**Plate 23**). There was a gap of some 930mm between the butt of the southernmost tube and the south retaining wall. The length of the string of the weir from wall to wall was some 10.2m whilst the actual distance along the length of the pipework including the southern gap was some 10.3m. About half the diameter of the pipework stood proud of the weir at its centre; rather less towards the ends. It seems clear that the stones on the downstream side of the weir butted up against the pipework suggesting that the latter had been part of the original design. On the upstream side there was a row of stones set back about some metre behind the head of the weir (**Plate 21**).

Plate 21: Pipework forming lip at head of Weir 2

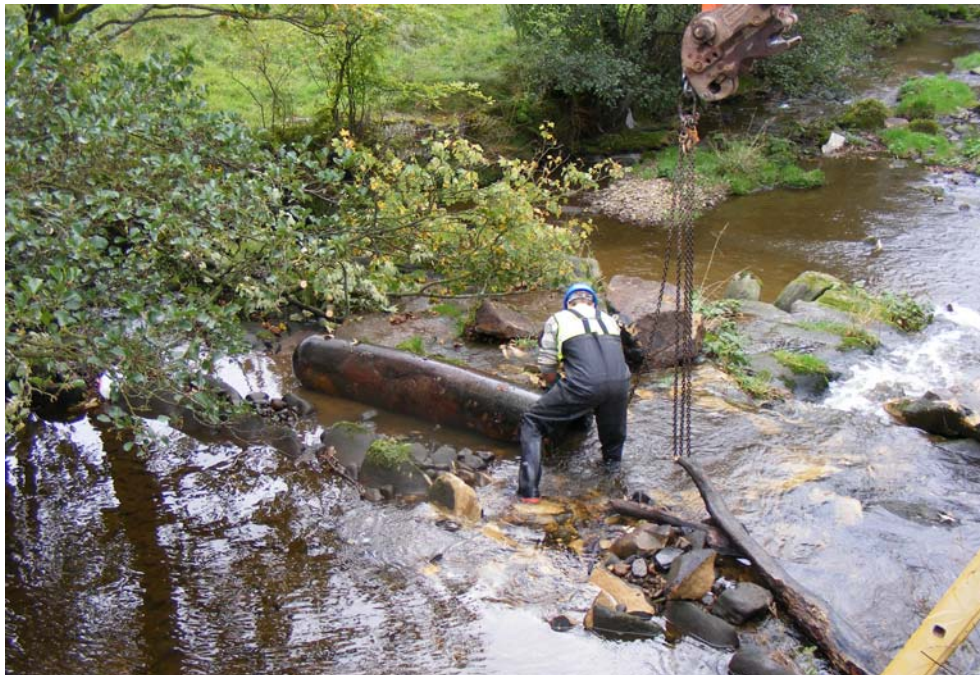
Plate 22: Pipes being removed from lip of Weir 2

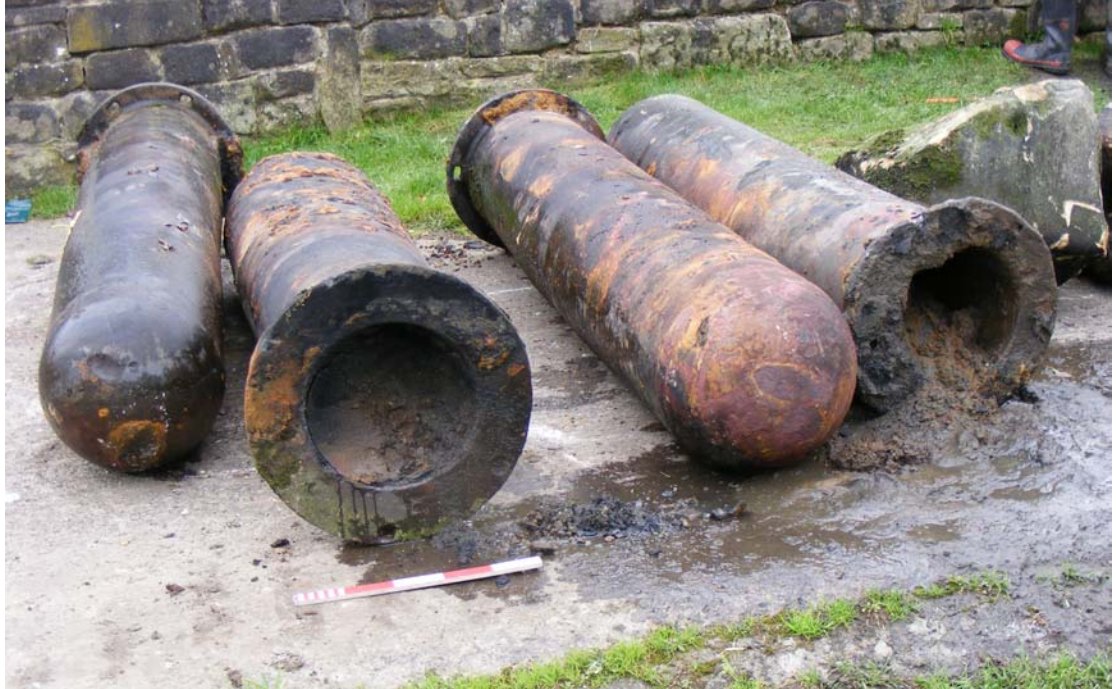
Plate 23: Pipes or tubes removed from lip of Weir 2

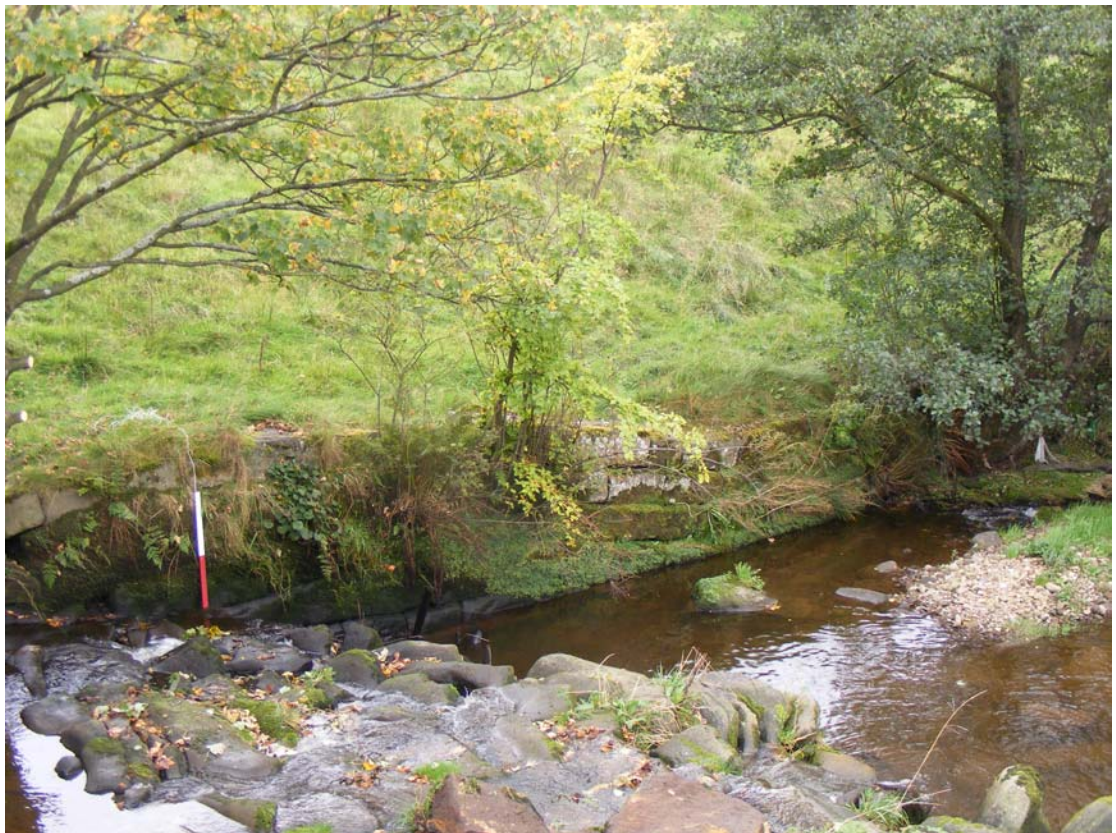
- 5.9.1 The retaining wall which comprised the left bank of the weir was built from large shaped gritstone blocks (**Plate 24**). These were substantially

overgrown with vegetation but appeared to curve upwards in a segmental shape towards the centre of the weir's edge. It appeared to be kerbed with regular gritstone blocks. As with Weir 1 these blocks were also not mortared but laid dry.

Plate 24: Left bank of Weir 2

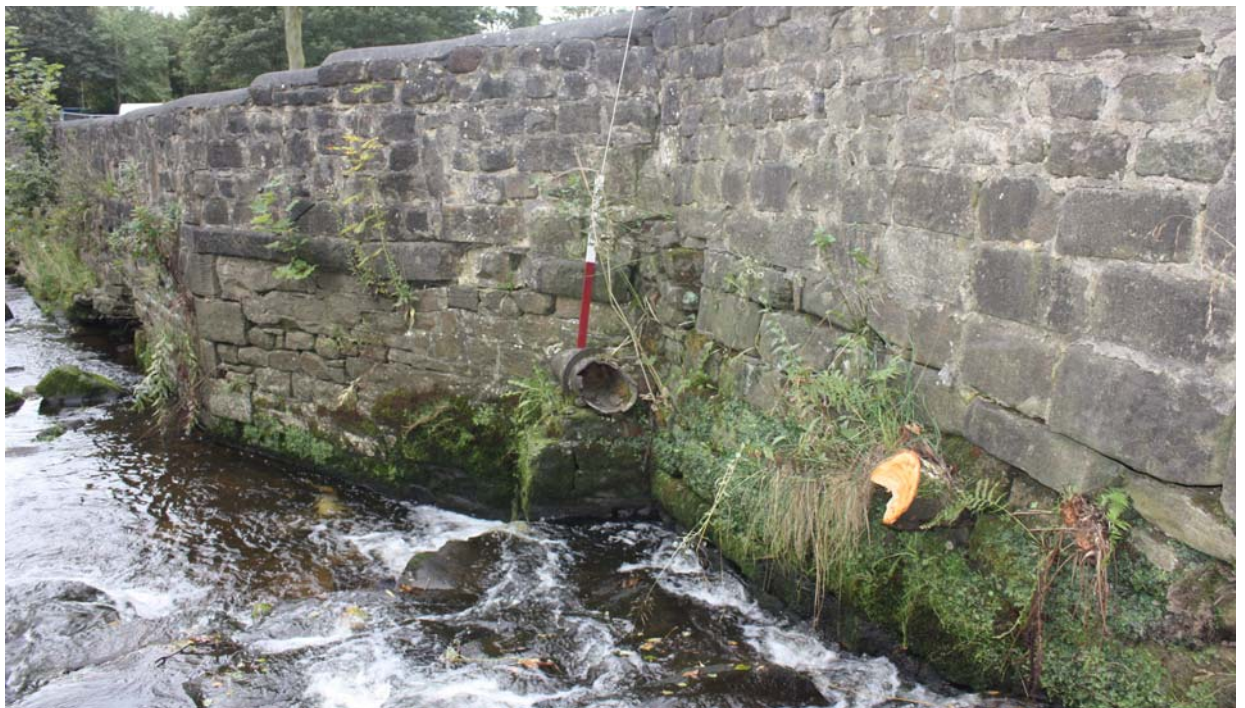
Plate 26: Right bank of Weir 2. Protruding iron pipe marks the foot of the weir

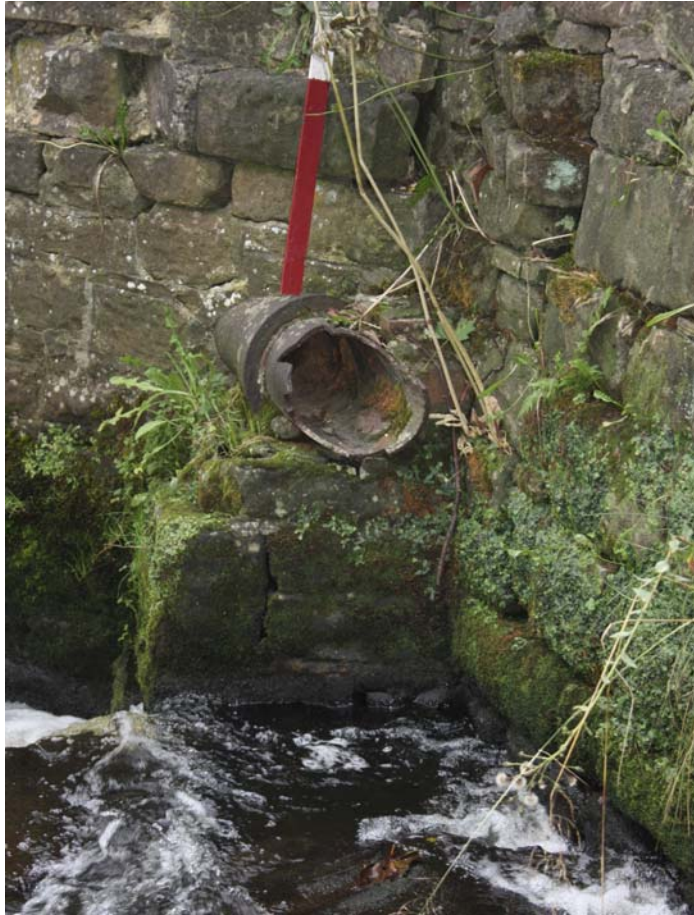
Plate 27: Detail of protruding iron pipe at foot of Weir 2.

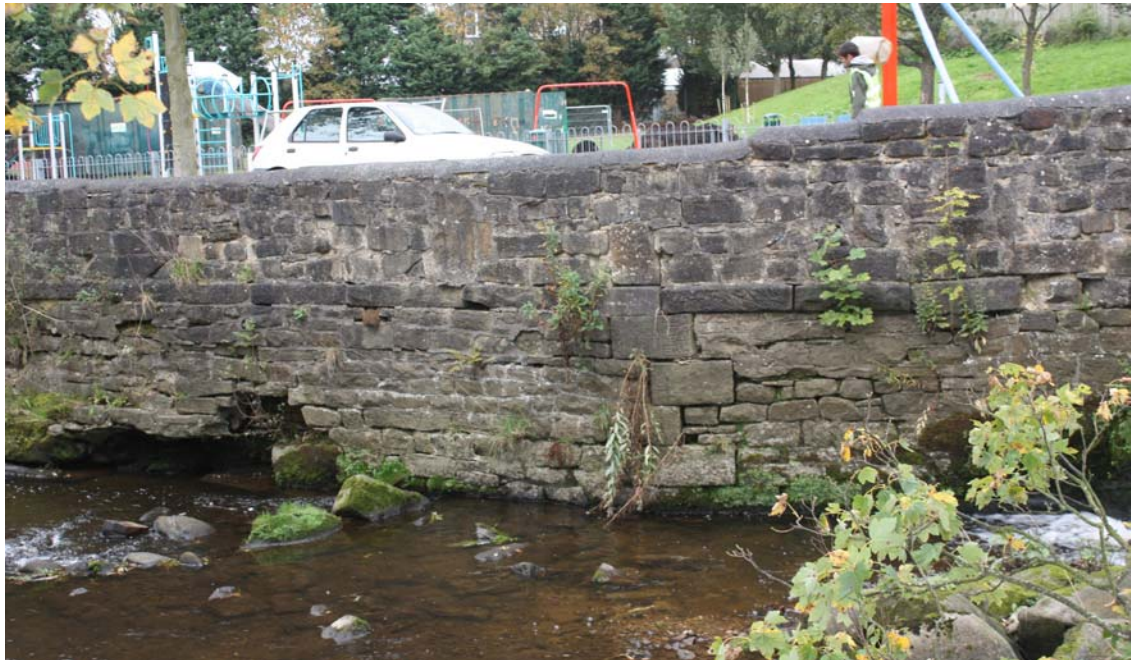
- 5.10.1 The retaining wall which comprised the right bank of the weir was inaccessible to the archaeological for health and safety reasons as agreed with the client. However we did have the benefit of photos taken from within the river by Tony Gibbon of Jacobs, the on-site supervisor. The wall was found to be of stone construction comprising in the main of roughly shaped gritstone blocks of various sizes but with the larger ones being towards the base of the wall. This was particularly noticeable in the area just downstream of the pipework which formed the lip of the weir (**Plate 25**). A row of large elongated blocks appeared to form a plinth which presumably marked the top of the original wall before it was extended upwards (**Plate 26**). The large blocks were laid unmortared but the smaller ones above were mortared. Conversely the large blocks were brought to courses whilst the smaller ones above were more random. Just beyond the foot of the weir was an angle in the wall where it turned southwards. At this point a stone block rose above the water level and supported a broken pipe which emerged from the wall itself (**Plate 27**). It was not possible to identify the purpose of this pipe but nothing was debouching and it appeared to be redundant. A little further downstream the wall was substantially undercut by a large rough-edged void (**Plate 28**).

Plate 28: Detail of undercut wall below foot of Weir 2.
