BUCKFAST METHODIST CHURCH ARCHAEOLOGICAL WATCHING BRIEF

**STEWART BROWN ASSOCIATES
FEBRUARY 2014**

METHODIST CHAPEL AT BUCKFAST ABBEY, DEVON ARCHAEOLOGICAL WATCHING BRIEF, DECEMBER 2013

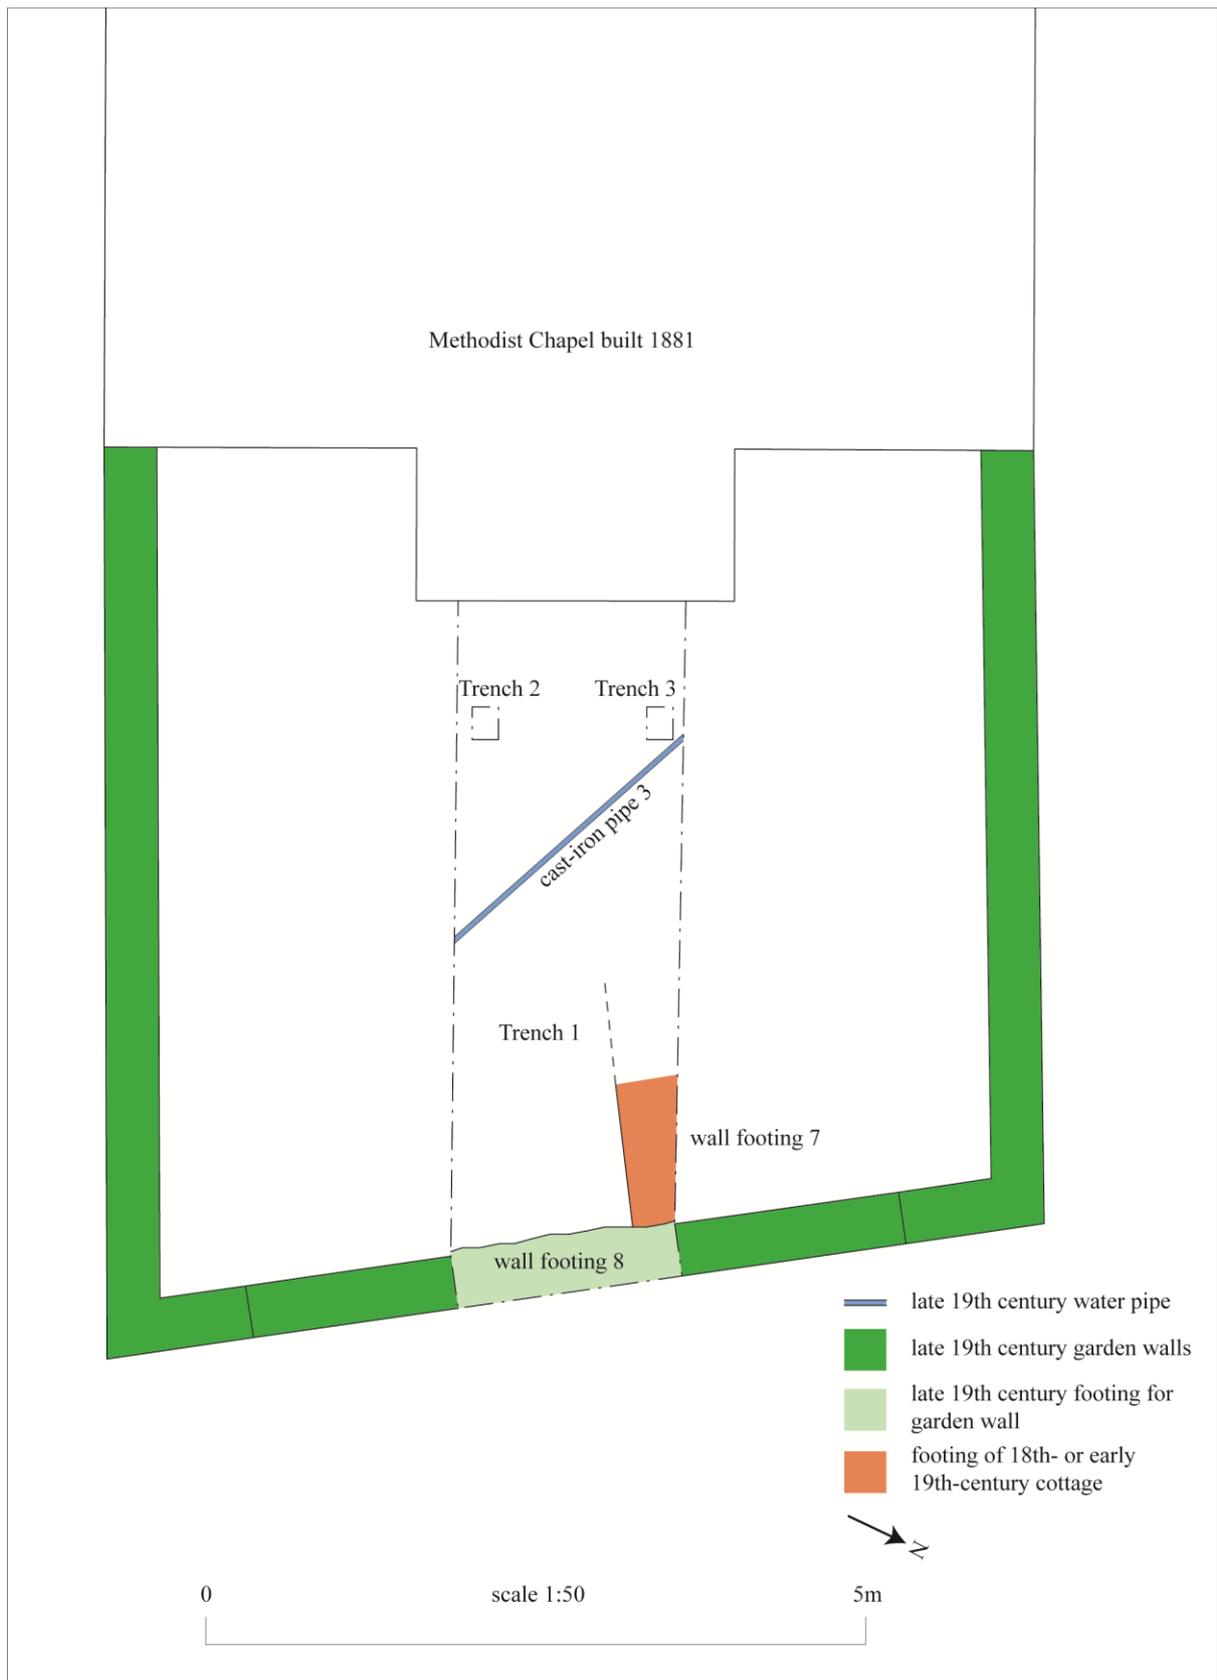
At the NE corner of the trench, part of a wall footing (7) protruded through the demolition deposit 6. The footing extended W-E and almost certainly belongs to the small building shown standing on this site on the tithe map of 1843, although which part of the building it represents is unclear. The footing was faced on its south side. Its north side lay beyond the limit of excavation.

Wall footing 7 is very likely to belong to the small building shown on the tithe map of 1843. Whether the footing was for an external wall or internal partition is uncertain. It is difficult to be certain about the precise position of the building since the tithe map was not surveyed to the same high degree of accuracy as modern surveys. The building may have been a cottage and is likely to date from the 18th or early 19th century, but might possibly be earlier. Its light brown mortar is much poorer in quality than the white lime mortar containing river gravel aggregate generally used for buildings in this vicinity in the medieval period.

Fig. 1 Plan showing excavation and wall footing of 18th- or early 19th-century cottage.

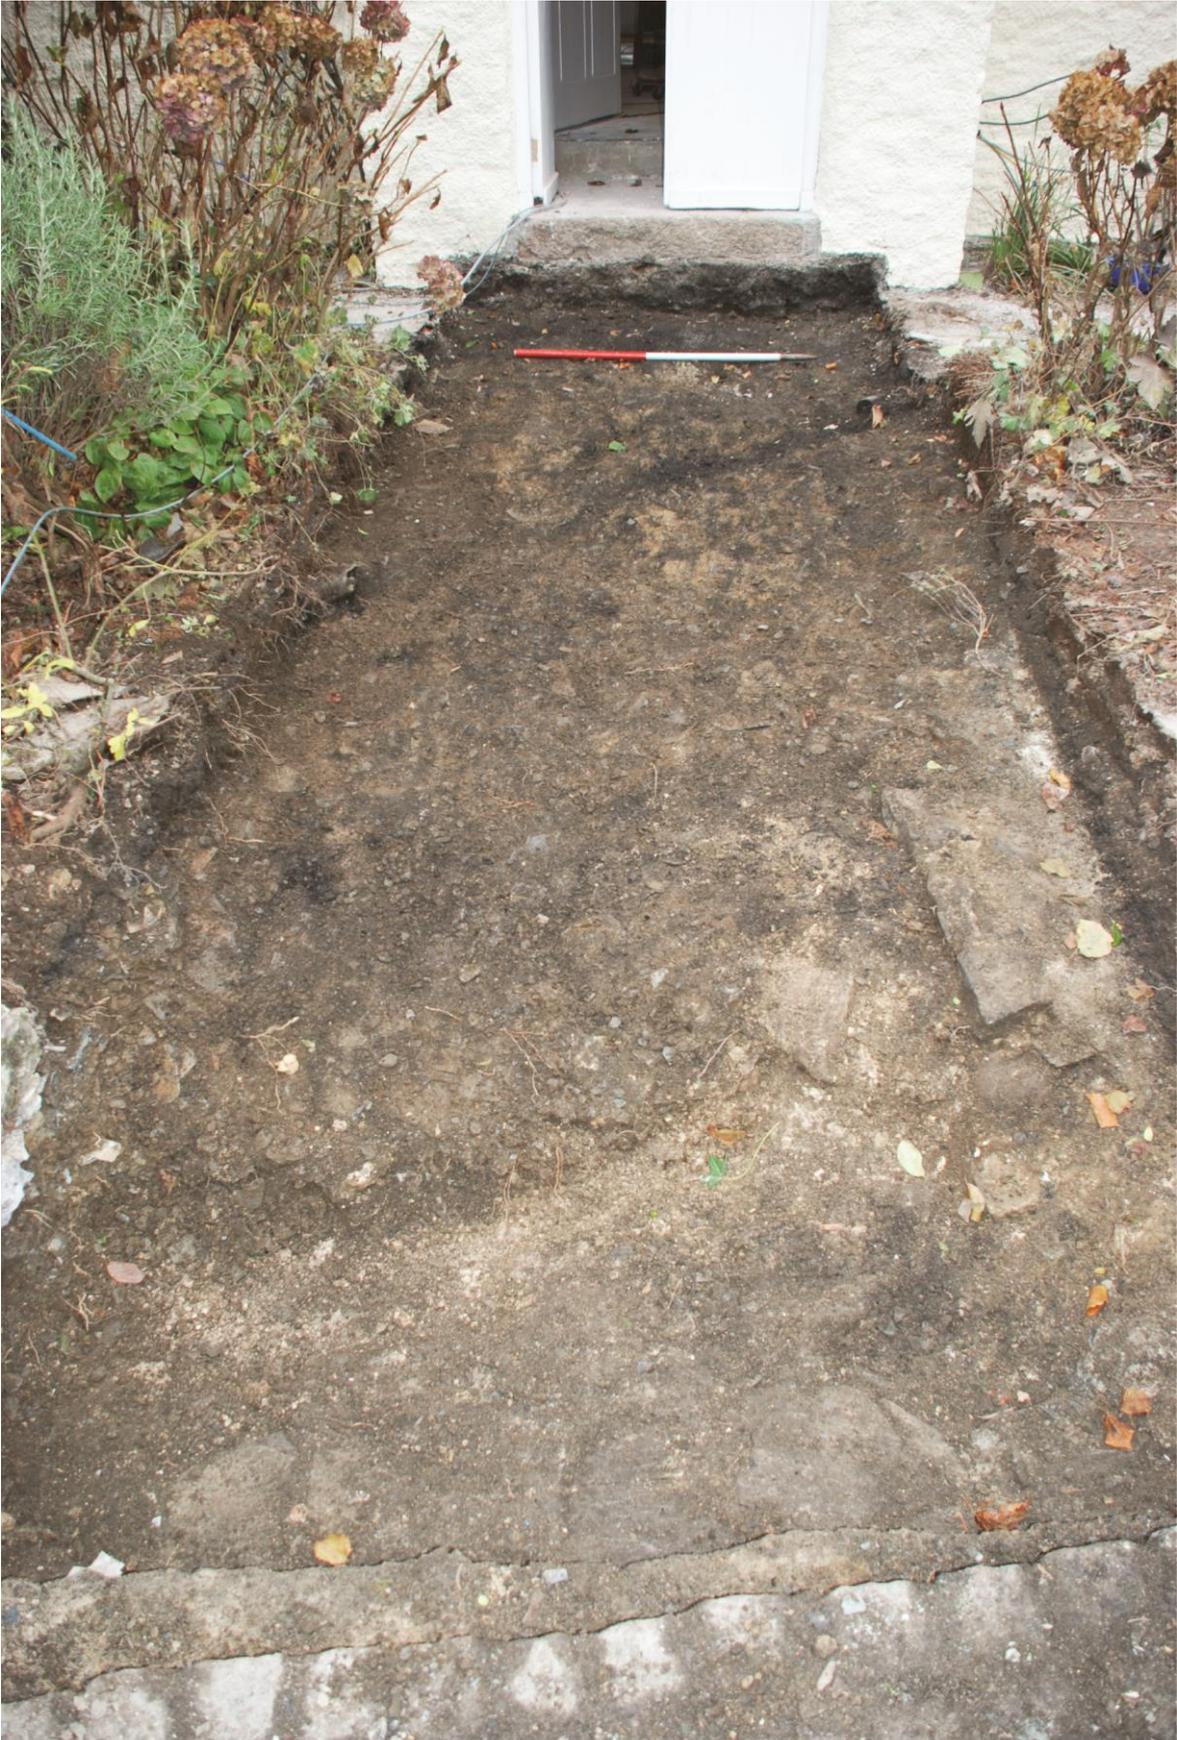
Fig. 2 The excavation showing wall footing 7 to right, looking southwest.

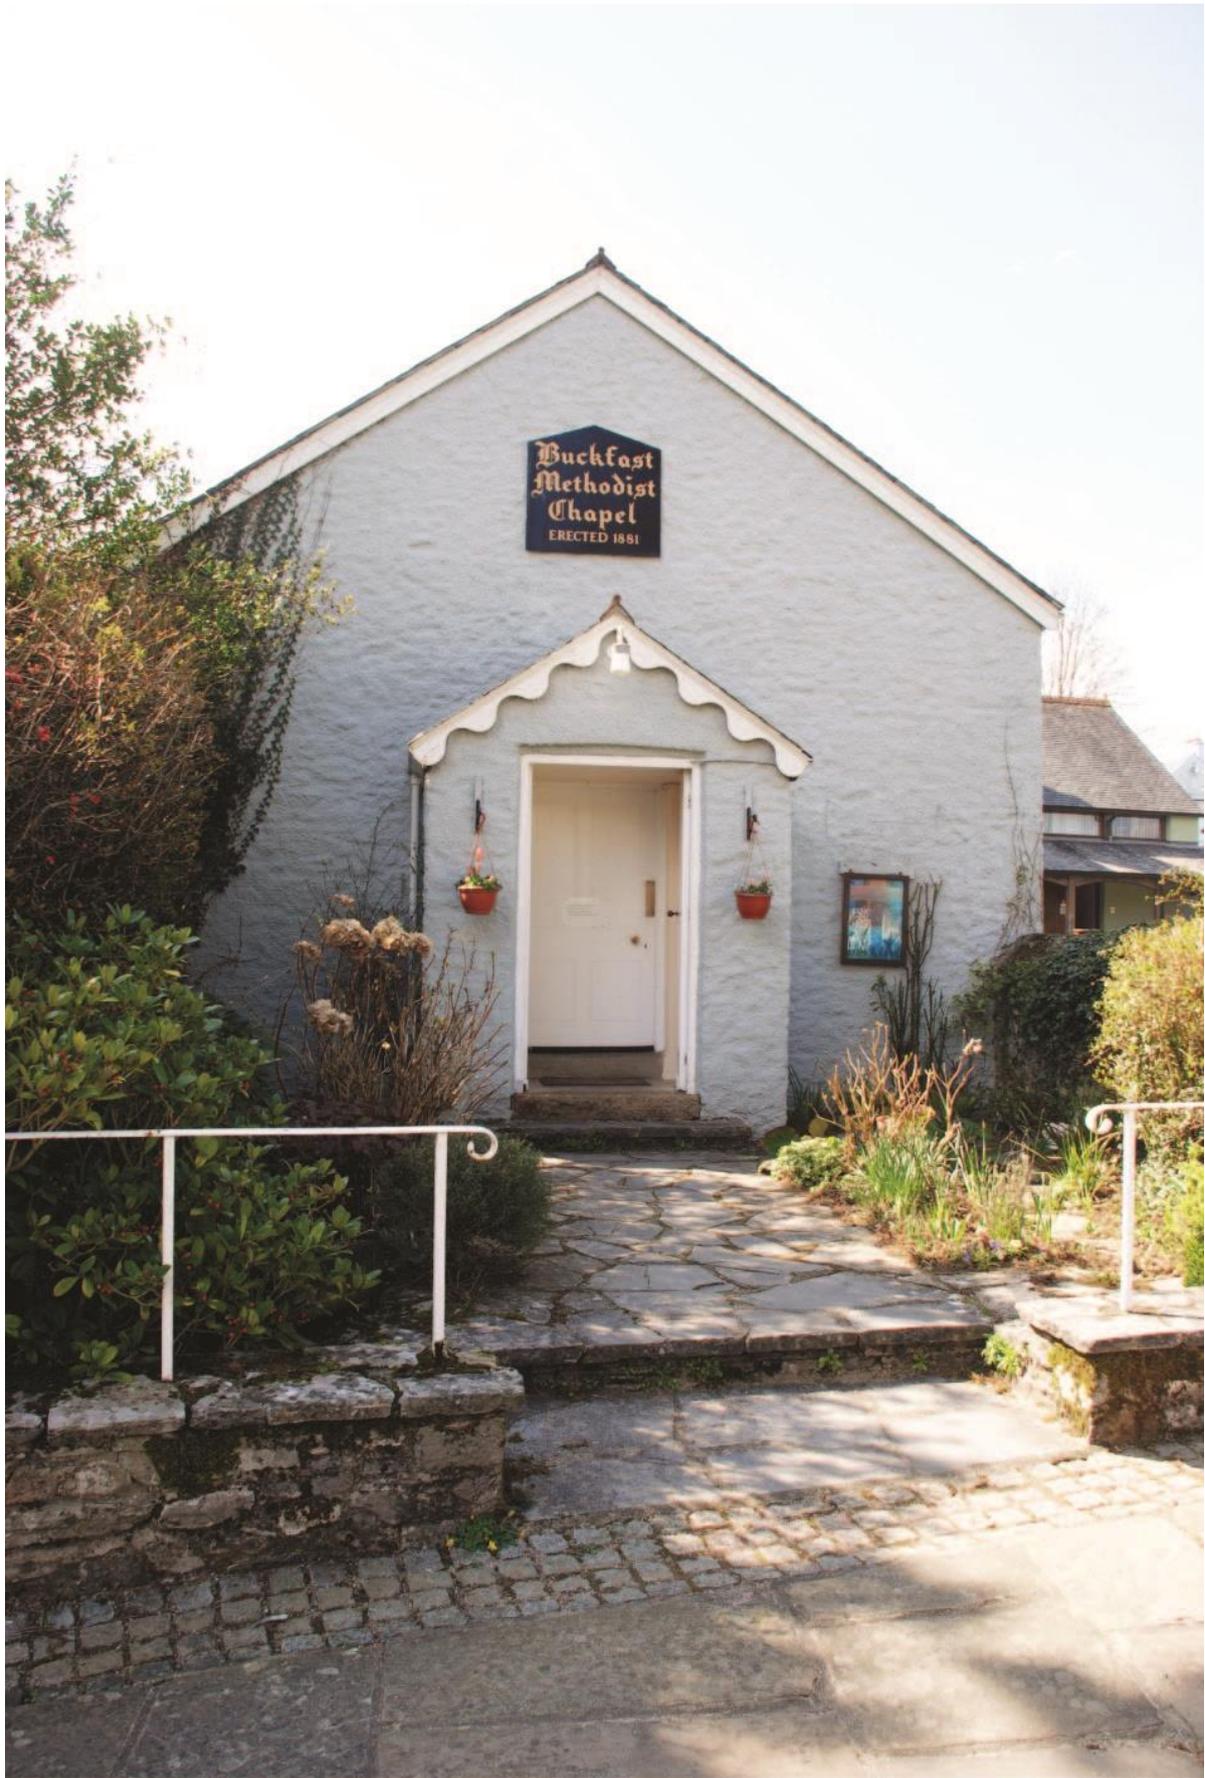
Fig. 3 The Methodist Chapel showing present paved path, looking west.

1.4 The proposed ground works which might uncover archaeological features and/or deposits are shown in drawings by Allen Van der Steen Hall Architects (Fig. 2). The present paving of the path leading to the porch (Fig. 3) is to be taken up and replaced with granite sets. The present step inside the porch is to be lifted and replaced at a higher level.
