**Building appraisal  
at The Sladd  
Kinver Road, Caunsall  
Kidderminster  
Worcestershire**

WSM 41860

10th September 2009

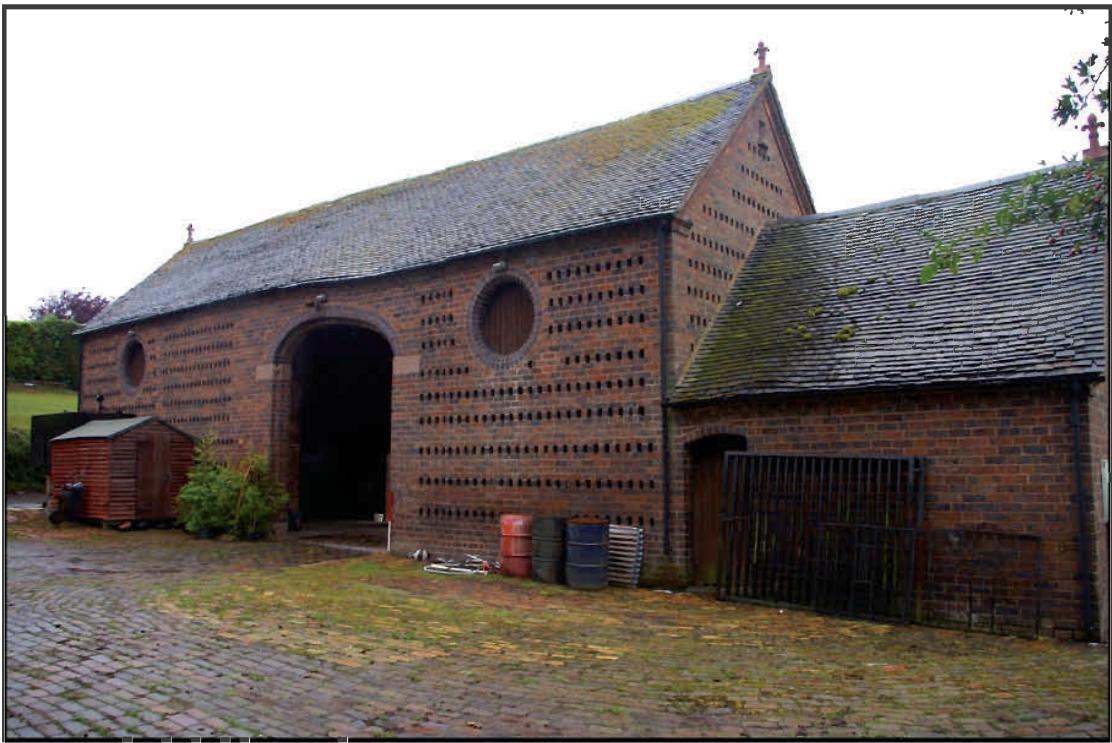
Fig 6: Phase 1 threshing barn; west elevation

The size of the doors opening onto the threshing floor was related to the way in which the barn was used. The example at The Sladd falls into Peters' Type I classification with high doors on both sides of the threshing floor (Figs 3.1, 3.2, 6 and 7). This style makes up nearly three-quarters of the examples, varying in date from the 16th century to 1880. They owed their popularity to their fitness for purpose and their adaptability. They not only permitted laden carts or wagons to enter from either side, but provided light for flail threshing and a flow of air for winnowing.

The buildings are in very good condition, having been substantially restored around 20 years ago (Figs 6, 7, 8, 9 and 10). Slight signs of structural movement still exist in a few places but this only to be expected in buildings of this age which were originally built with little or no foundation.

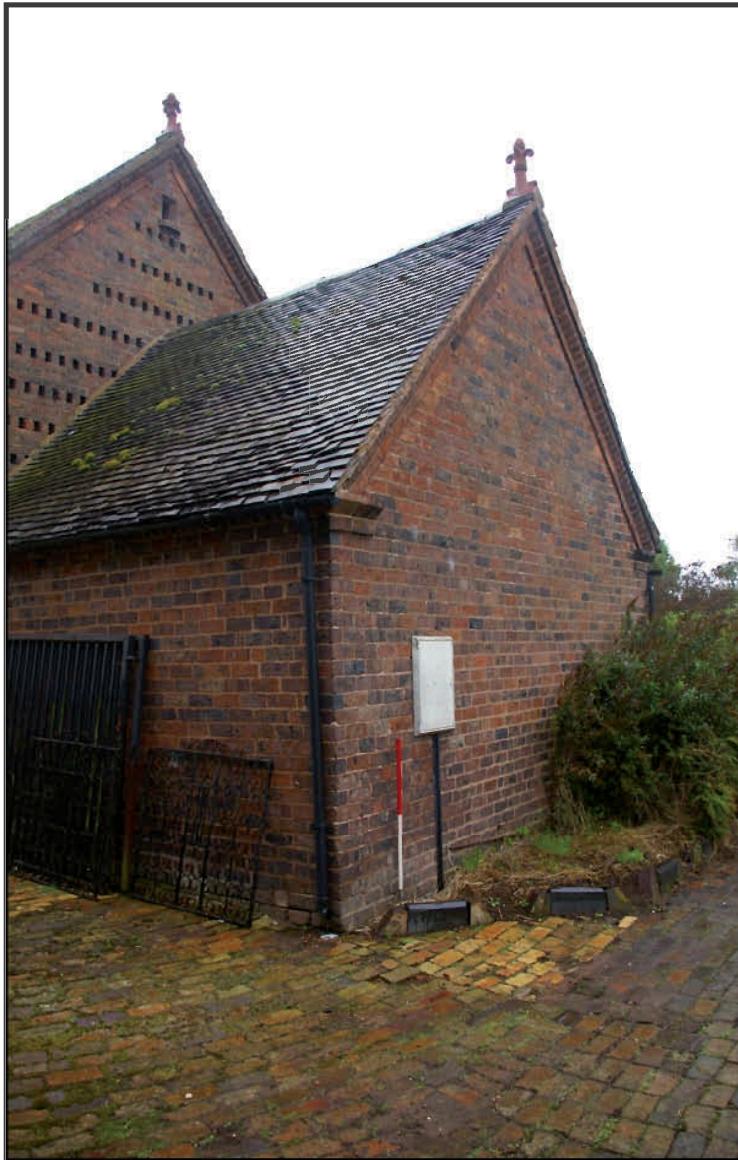
Fig 8: Phase 2 extension to south

The single storey building on the southern side of the barn was added. It is unknown what its original function was and was converted to a garage in the late 1970s and early 1980s.

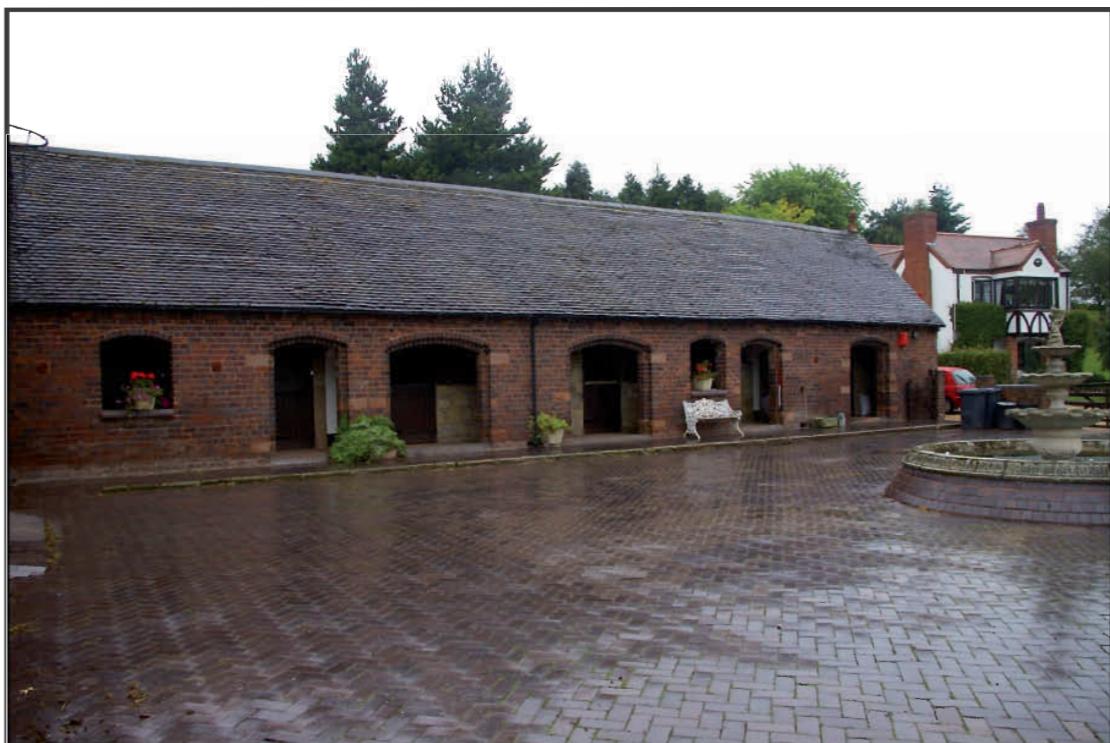
Fig 9: Phase 2 cattle shed; south elevation

The single storey building on the northern side of the fold yard (Figs 3.1, 3.2, 5, 9 and 10) has been identified as a cattle house, conforming to Peters' type 4b classification, the cattle being tied in a single row facing across the building, rather than a stable, for the following reasons:

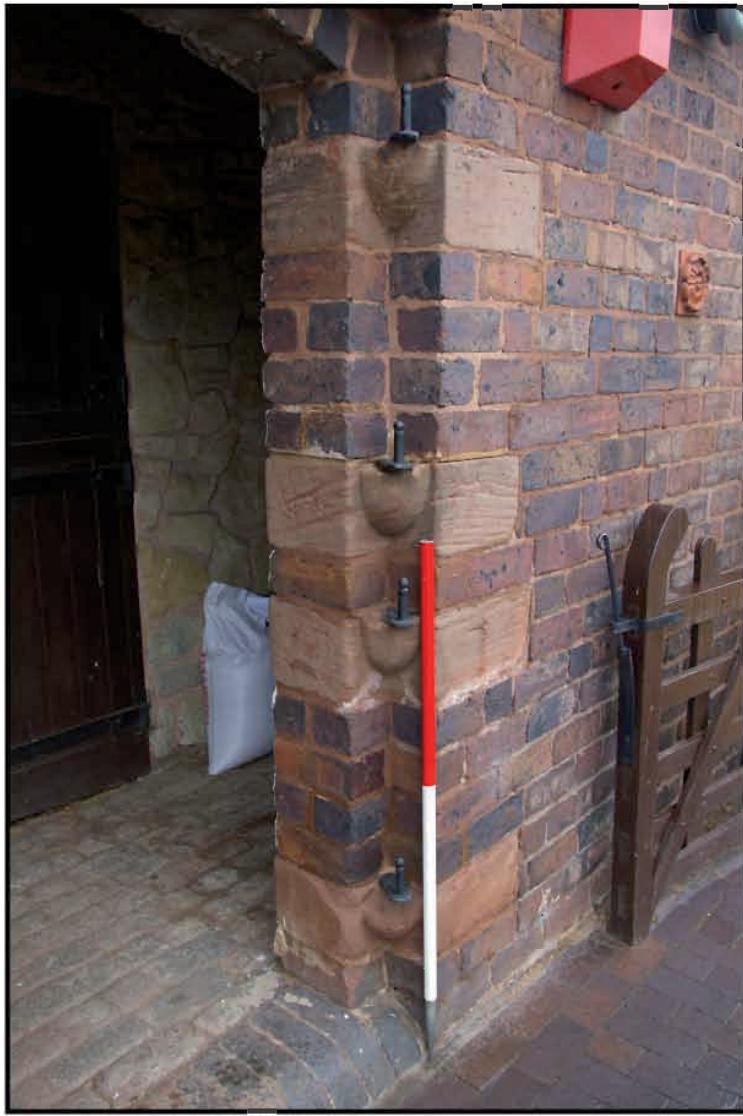
Fig 13: Phase 2 cattle shed; detail of doorway

The general external character of the buildings was retained by the use, reuse and retention of appropriate materials, particularly with regard to the brick and stonework (Figs 13 and 14). With regard to the interior of the cow house, the passage was created, most of the manger or trough was removed and the central part of the cow house was sub-divided. The metal, round-headed windows, which had been salvaged from a demolished building in Birmingham, were inserted. A photograph, taken by the client c 1979 (Fig 15), shows the original configuration of the windows on this side of the cow house. A photograph was taken during the course of this project from the same position (Fig 16), showing the inserted, round-headed windows.

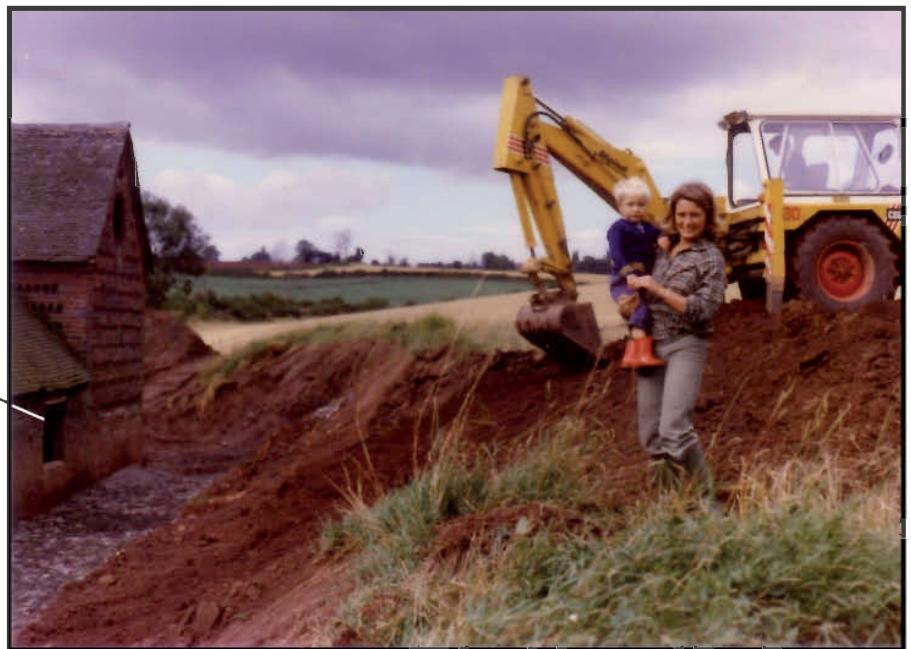
Fig 15: Client photograph (*c* 1979) showing original position and shape of window

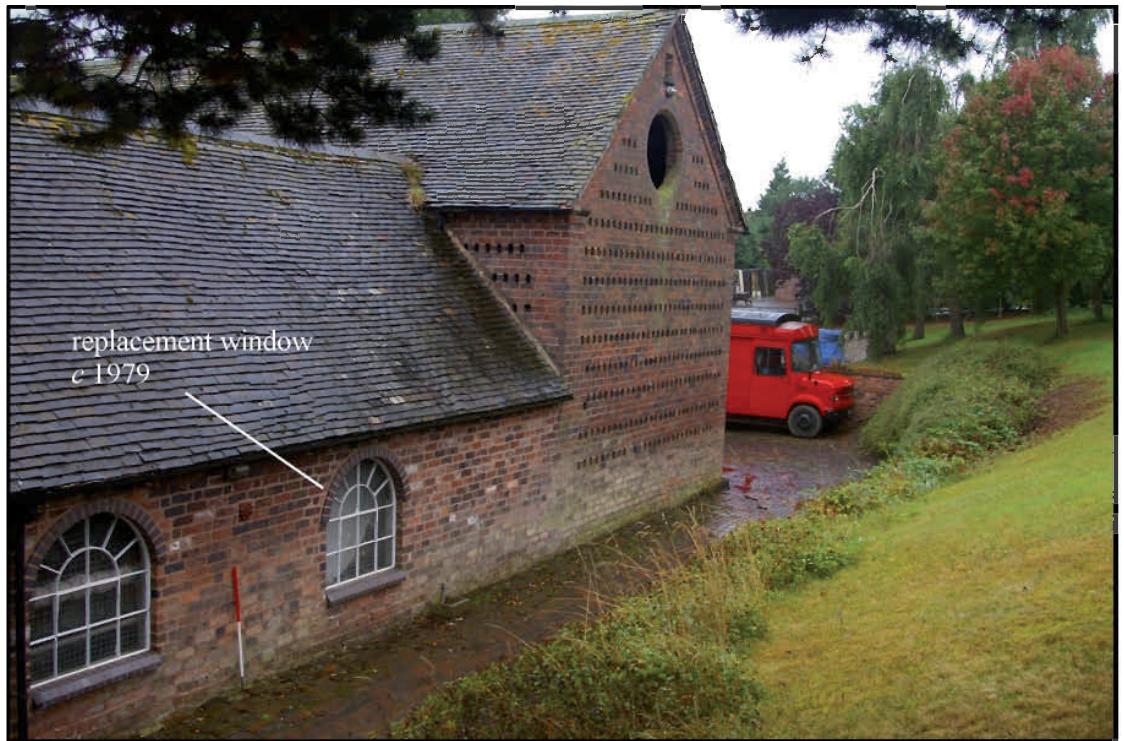
Fig 16: Photograph taken from same location as Fig 15 showing inserted window
