New electricity supply, Christchurch Priory, Dorset

Archaeological watching brief

**New Electricity Supply
CHRISTCHURCH PRIORY
Christchurch, Dorset
Scheduled Monument 22962**

**Archaeological Watching Brief
February 2014**

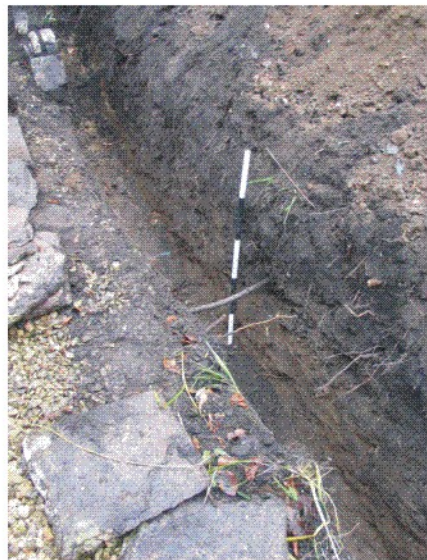
0 – 400mm Paving slabs and/or a very dark greyish brown sandy loam turfline and topsoil containing moderate quantities of slate, animal bone, hand-made brick and fragments of salt-glazed pipe. The topsoil was comprehensively disturbed by mature tree roots and numerous modern services. In the eastern c. 15m of the trench the ground level rose by c. 1m and the thickness of the topsoil reduced to c. 300mm, but without variation in its character.

1 Western end of the trench, viewed from the west

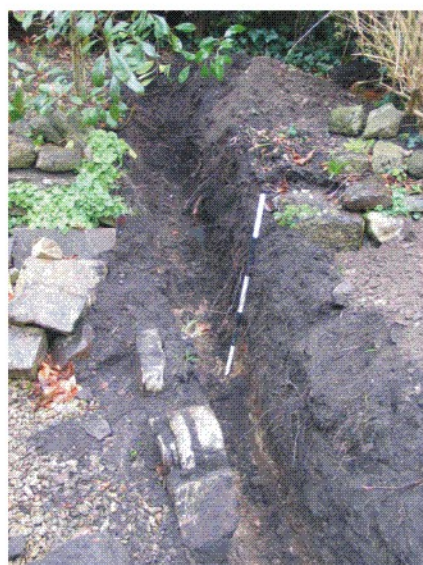
400-800mm In the eastern c. 15m of the trench, the topsoil lay on a 500mm thick layer of fine grade limestone and mortar rubble containing small quantities of roofing tile and oyster shell. This was at its thickest immediately south of the shop and thinned to the west, where it appeared to replace the natural subsoil there – i.e. it appeared to be filling a broad and poorly defined 'cut'. The base of this deposit was not encountered in the excavations. In the rest of the trench, running south of Priory Cottage, the topsoil lay over a dark yellowish brown sandy loam 'B' horizon subsoil containing moderate quantities of animal bone and oyster shell. The base of this deposit was not encountered in the excavation.

2 Central part of the trench at eastern boundary of Priory Cottage garden, showing 'made ground' deposit in base of trench

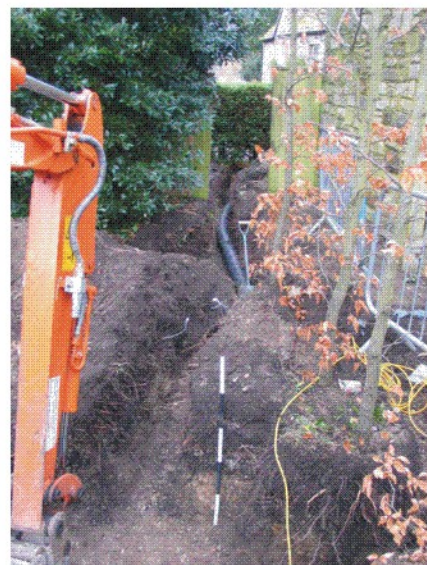
- 4.1.3 That along the south side of the shop is slightly more interesting. The layer of fine-grained limestone and mortar rubble replaces the upper c. 500mm of the subsoil but it is not clear if it is 'cut' into in the archaeological sense. Nonetheless, it corresponds exactly with the pronounced rise in ground level at the eastern edge of the Priory Cottage garden and the position of the large mound recorded by the 1871 Ordnance Survey map. It consists of demolition rubble and appears to contain no Modern materials such as machine-made brick or Portland cement, although only a relatively small exposure has been investigated, so it is highly likely that it is derived from the Priory church's fabric. Similar deposits have been revealed in the garden of the vicarage, filling deep amorphous quarry pits, where they also contained 18th and early 19th century pottery, fragments of human bone and large pieces of dressed stone of 12th century form⁷. The most likely interpretation is that this material was created during one or more of the many repair campaigns of the 19th century.

3 Eastern end of trench at shop, viewed from the east, showing 'made ground' deposit at base of trench

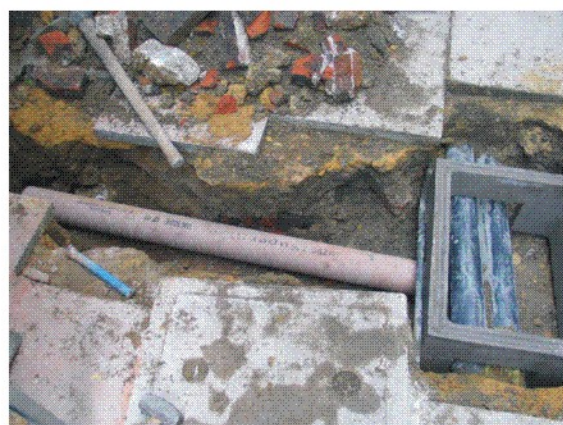
0-200mm Concrete paving slabs laid on yellow paving grit and a lean-mix concrete substrate.

200-300mm Homogenous greyish brown sandy loam containing large quantities of hand-made and machine-made brick, lumps of portland cement, and fragments of concrete. At the base of this deposit was a wall of hand-made stock bricks 750mm north of the wall and blocked basement window of Priory House and aligned parallel with it.

- 4.1.2 Two variations from that background sequence were observed. That at the eastern end of the trench, between the church and Priory House, is the anticipated result of repeated construction-related disturbances from the late 18th century onwards, and it is highly unlikely that any significant archaeological remains will survive in this zone within c. 1000mm of ground level.

4 Connection to Priory House, showing ground conditions

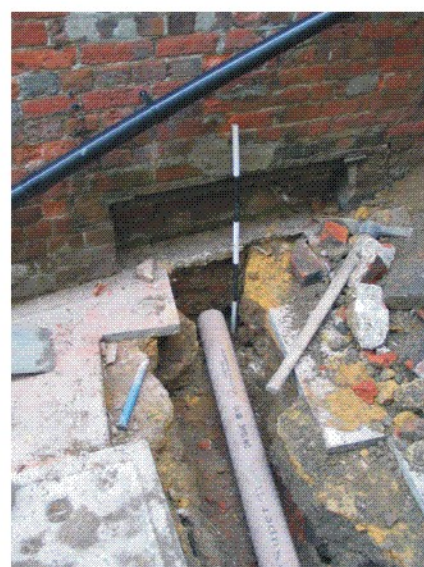
5 Connection to Priory House, showing new supply going through blocked basement window

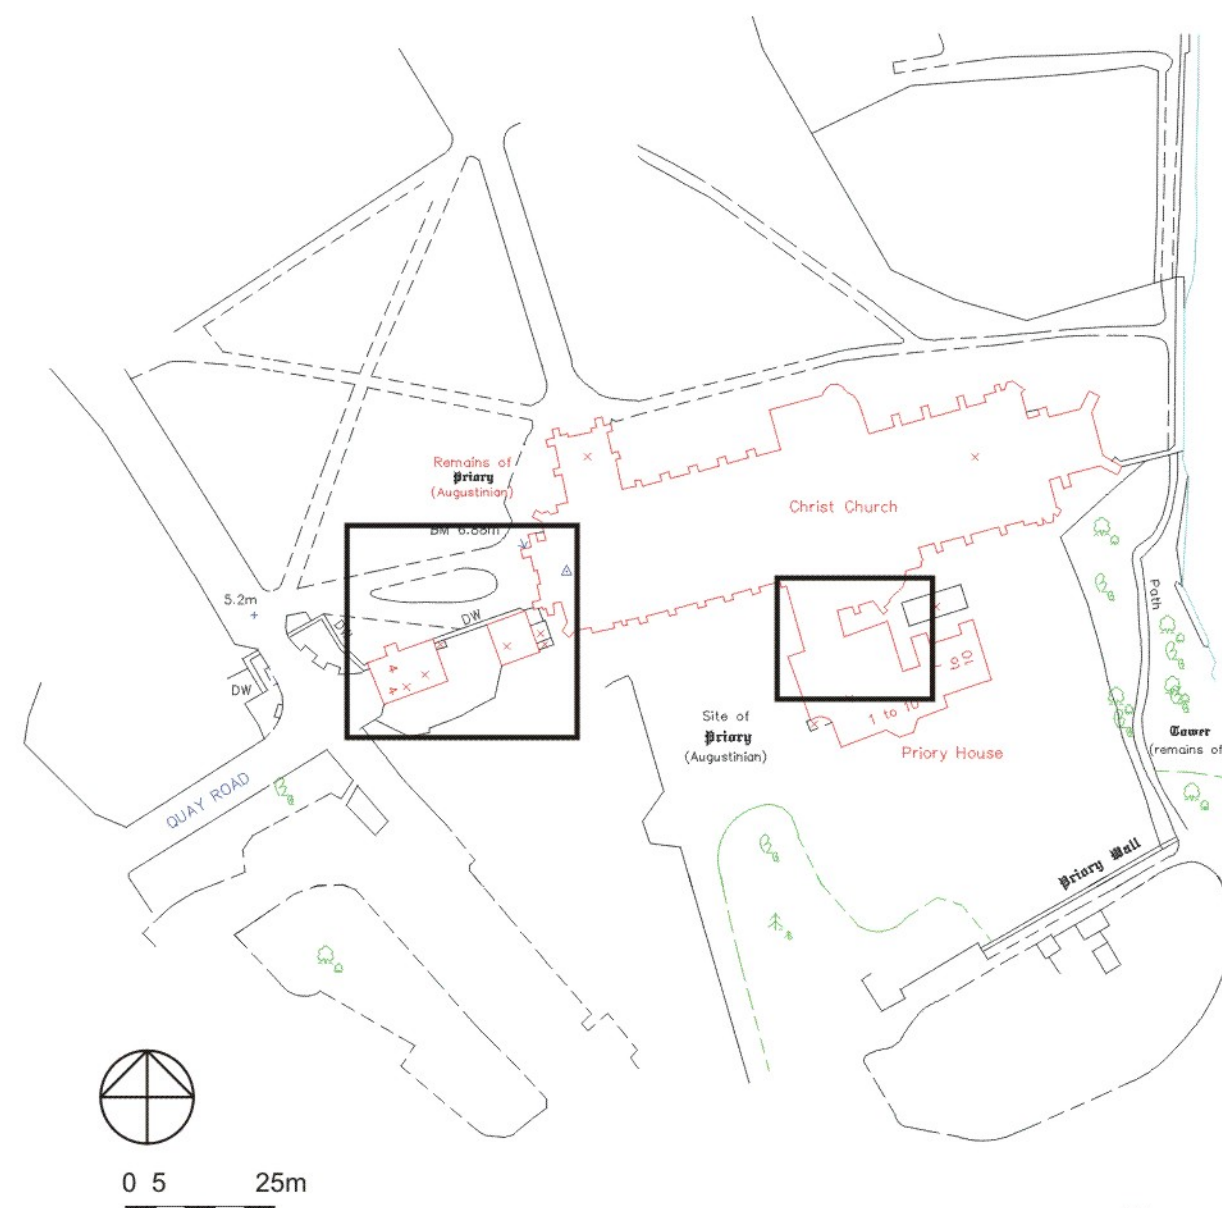
Figure 1

Figure 1. The Site and principal observations

1.2.2 The groundworks comprised removal of paving slabs and turf followed by mechanical and manual excavation of a discontinuous linear trench nominally 300mm wide x 450mm deep in the positions indicated on Figure 1, between the 17th and 24th of February 2014. The excavations were attended and observed intermittently, as determined by the progress of the excavations.
