**DUNSTER CASTLE
ROOF REPAIRS**

archaeological watching brief

2006-2008

Archaeological Watching Brief

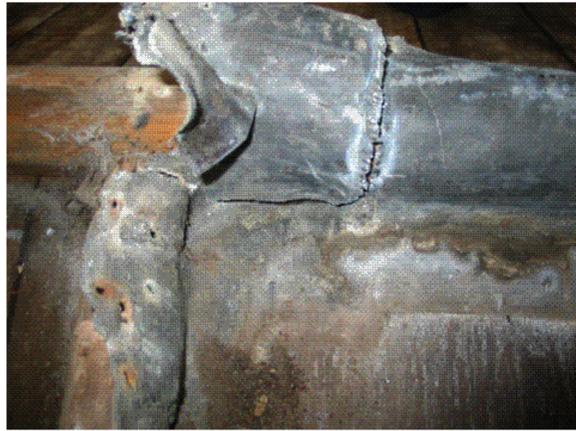
- 3.2.2 Most lead sheets open-cracked at the rolls, with multiple welded and tingled repairs (**Plate 1**). Merchants labels on underside of flashings around base of chimney in south-west corner of Roof 'E', dated 1998. Similarly un-corroded sheets forming most of the valleys, all of the covering of Roof 'D' and the upstands at the east ends of Roofs 'E' and 'F', suggest that most of the peripheral lead sheeting has been replaced relatively recently.

Plate 1. Example of failed lead sheeting at ridge

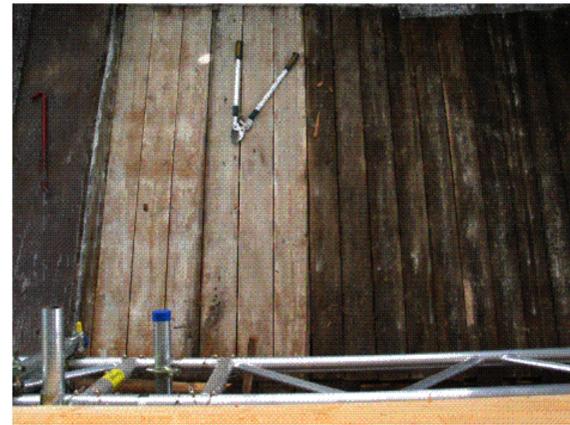
Plate 2. Example of the upper layer of counterboarding, probably of c. 1870

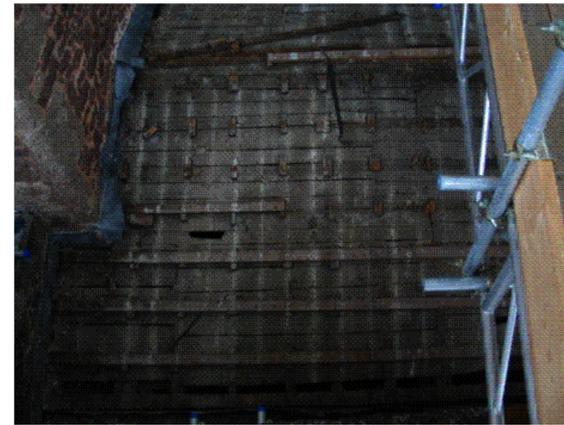
- 3.2.5 A lower layer of counterboarding survived across Bays 2 and 3 of Roof 'A', the interior of Roof 'C' and most of Roofs 'E' and 'F' (Archive references: 10-15, 18-23, 27-33, 41-44) (**Plate 3**). Extensively patch-repaired and, in places, almost completely decayed, it consisted of three forms of board: mixed width c. 145mm-260mm) 21mm thick pit-sawn softwood boards in lengths of c. 2.60m (mainly but not always determined by truss spacings) fixed by large cut brads; narrow (c. 130mm) pit-sawn and adzed 25mm thick oak boards in lengths of c. 2.6m – 3.5m (as above), bearing large, countersunk empty nail holes between the rafters, fixed by large cut brads and occasional large hand-wrought clout nails; and broad (c. 260mm) 25mm thick pit-sawn Elm boards fixed by large cut brads, generally forming short repairs at the verge abutments of Roofs 'A', 'E' and 'F'.

Plate 3. Example of the lower layer of counterboarding, on Roof 'E', with later firring pieces fixed to it.

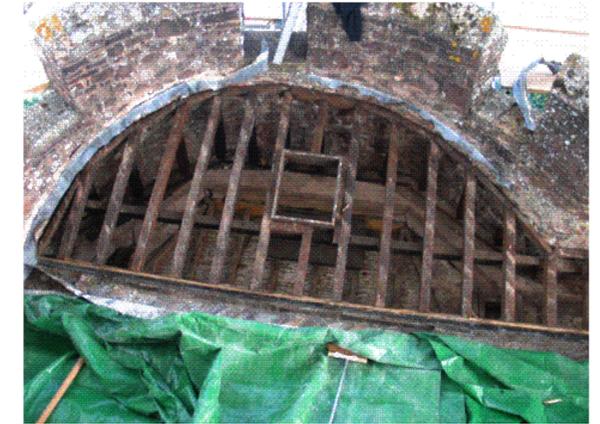
- a. The mono-pitches 'A1' (**Plate 4**) and 'B' are formed of 80mmx100mm band-sawn tanalised softwood rafters supported on a stud frame of similar scantling rising off an *in-situ* cast concrete ring beam that encloses the north, west and south sides of Roofs 'A' and 'B'. Roof 'B' is supported at mid span by a 'built up' 130mm x 180mm softwood purlin and at the valley by a 130mm x 300mm RSJ, whilst Roof 'A1' is supported mid span by a 75mm x 145mm softwood purlin and, at the valley, by a 'built up' 110mm x 230 softwood purlin.

Plate 4. Modern mono-pitch Roof 'A1'.

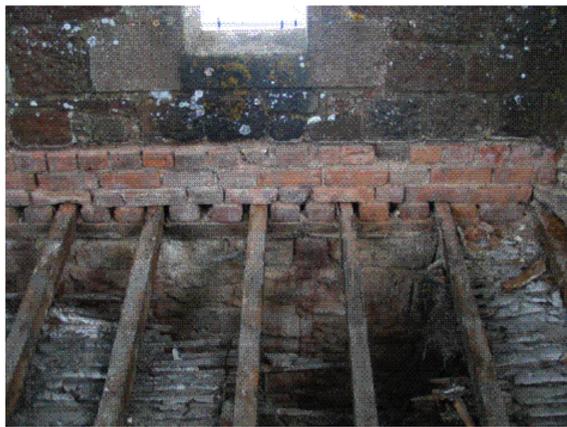
- 3.5.4 Brickwork was identified in the masonry of the walls at the east end of Roofs 'E' and 'F', in the chimney at the south west end of Roof 'E' and around the inner face of Roof 'R' below the roof line. The brickwork of the walls of Roof 'R' (**Plate 5**) is integral to

Plate 5. Primary structure of mono-pitch Roof 'R'.

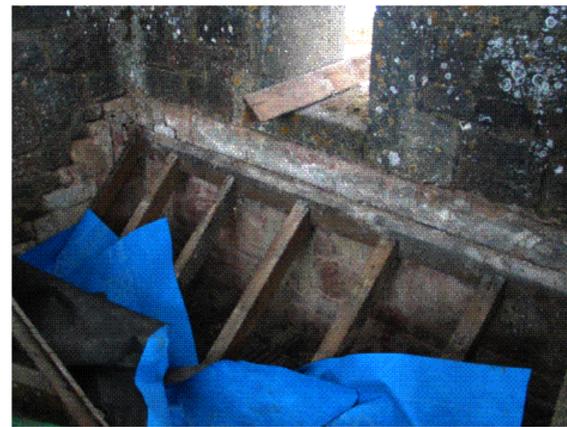
- c. The mono-pitch aprons along the south side of Roof 'R' are of two constructions, both utilising mechanically-cut softwood rafters: an 'original' form, at the west end, in which the common rafters are housed into the second of four courses of hand made stock brickwork (**Plate 5**); and an applied form in which the rafters are supported by a mural plate nailed to the rubble masonry behind (**Plate 6**).

Plate 6. Secondary form of mono-pitch Roof 'R'

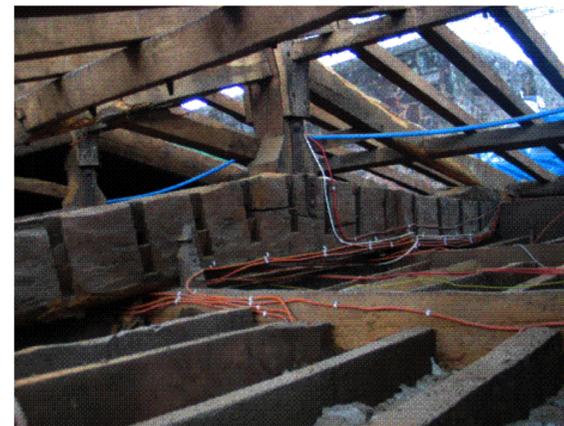
- d. The beams support king posts (**Plate 7**) and principal rafters of a similar form, but with minor variations. All are of pit-sawn oak, have shoulders and (except Truss 13) a joggle at the ridge into which the principals are tenoned. The trusses of Roof 'E', alone, have raking struts rising off the shoulders of the post to the principals and Trusses 9-11 have longitudinal struts rising off the top of the beam to the ridge purlin, to which they are half-lapped. The negligible pitch of the lateral struts (10°) makes it unlikely that they serve any structural function. The ridge purlins are all dovetailed into yokes spiked to the faces of the king post joggles. All the king posts, except those of Trusses 1, 13 and 19, are fixed to the beams by wrought iron straps secured by hand-wrought spikes and, to the posts, by forelock bolts. In the case of Truss 16, at the west end of Roof 'F', the strap covers and has been bent into one of the empty joist sockets.

Plate 7. Truss 6, from the north-west

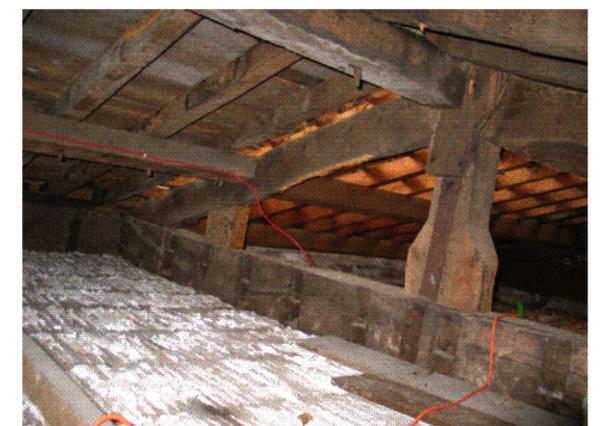
- e. The principal rafters of Roof 'A' are spiked onto the tie beams without, apparently, any form of tenon or key into the beam (**Plate 8**). The spikes are substantial hand-wrought iron items, and that at the south end of Truss 4 at the east end of Roof 'A', is loose. In all other cases except Trusses 10, 11 and 12, the principal rafters are spiked onto substantial horizontal timbers - referred to here as 'sprockets' - that are in turn spiked to the tie beams. (**Plate 9**, showing south end of Truss 6). Where principals are missing, shallow rebates are visible in the tops of the sprockets that would have restrained the outward thrust of the principals. The sprockets are of various forms and that at the south end of Truss 6, at least, is a re-used timber with a redundant forelock bolt in its west face. In the majority of cases, the sprocket outer ends correspond with those of the tie beams: those of Trusses 6, 8 and 9 in the western half of Roof 'E', and the principals carried by them, oversail the beam ends by up to 500mm. In all cases, the sprocket outer ends appear to support the valley sides.

Plate 8. Truss 2, from the north-east

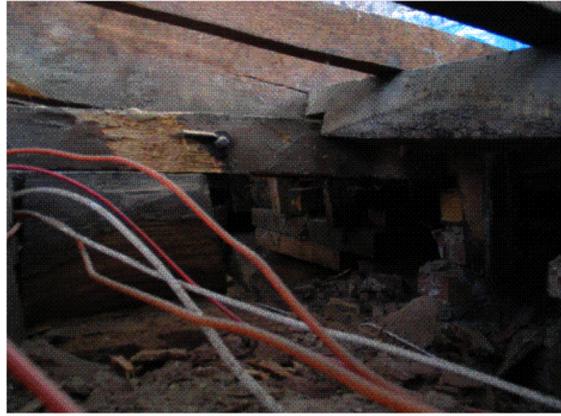
Plate 9. Re-used timber with forelock bolt used as sprocket at south end of Truss 6

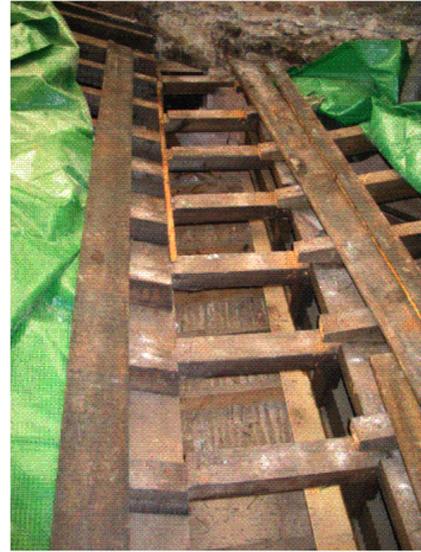
Plate 10. The west end of the valley between Roofs 'A' and 'B'.

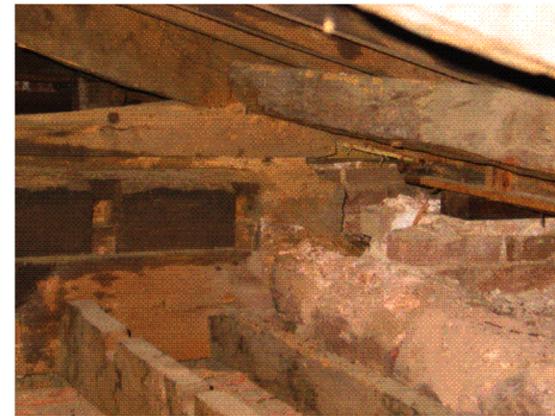
Plate 11. Brickwork piers carrying valley at north end of Truss 16,

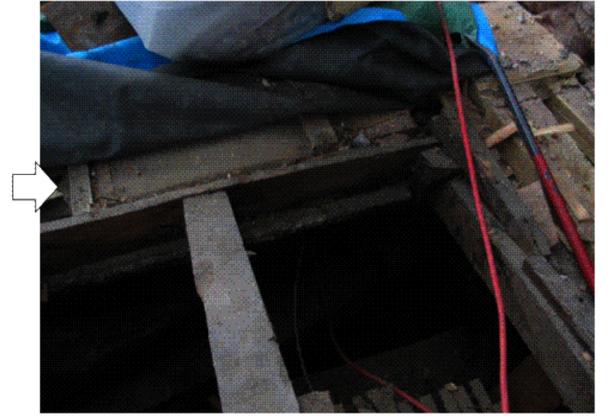
Plate 12. East end of valley between Roofs 'E' and 'F', showing middle of three phases of valley board with firing pieces on top.

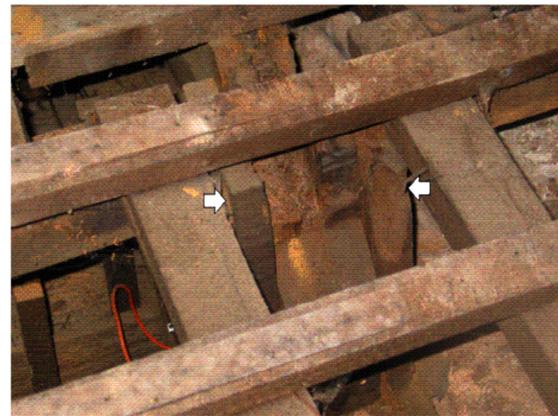
- d. Un-treated splints support the king post and ridge purlin of Truss 13 at the west end of Roof 'C' (**Plate 15**). This king post of this, the smallest and least complete of the trusses, lacks a joggle, the principals being tenoned into the edge of the post just above the shoulder. It has either lost its joggle to decay, or it didn't have one originally. The yokes differ from all others by bearing on the beam and in its simple rectangular form; that on the east face being a band-sawn timber, that on the west being pit-sawn. The form of the yokes may have been constrained by the diminutive proportions of the truss (king post is c. 600mm high), but equally they may allude to a different construction from the rest of the pitched roof.

Plate 15. Splints supporting king post of Truss 13.

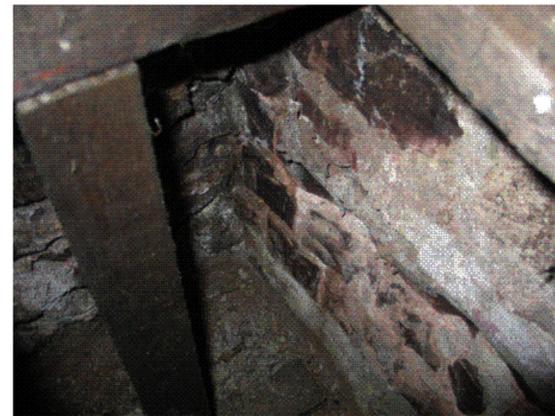
- 3.4.2 The latter (archive refs: 17 and 26) is the more easily described and interpreted (**Plate 16**, showing NW corner of Roof 'B'). It consisted of the hacked-off edge of a flashing of cast lead sheet c. 4-6mm thick, protruding from between the courses of the parapet masonry around the entire perimeter of the roof and its internal masonry surfaces, except the chimney at the south-west corner of Roof 'E', approximately 600mm above the wall head offset. For most of its circuit it has been cut-off close to the wall face, but in places it survived as a downward fold of c. 100mm depth. The flashing appears to be more-or-less level, except at the east end of Roof 'F' (Figure 3) where it follows a consistent inclination southwards of approximately 5° towards the ridge of the adjoining Roof 'E'. Along the northern edge of Roof 'B', the flashing (archive ref. 17) appears to have been dressed onto a protruding table course 150mm below the top of the flashing.

Plate 16. Relic lead flashing in wall face below Roof 'B'.

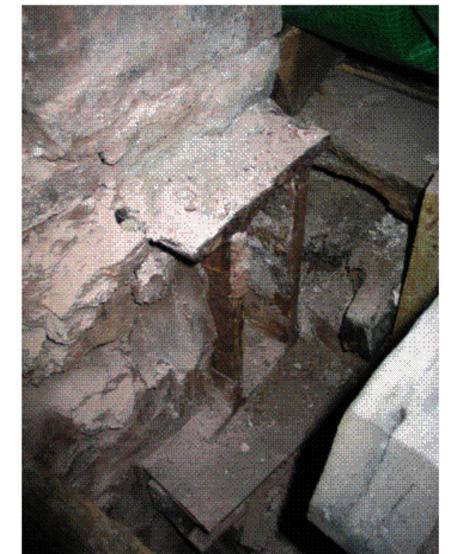
- 3.7.1 Richard Fewtrell's full report is held by The National Trust and TFT Cultural Heritage.
- 3.7.2 The majority of the structural metalwork is recently installed mild steel of metric dimensions.
- 3.7.3 The paired 'I' beams supporting the north ends of Trusses 11 and 12 of Roof 'E' and, apparently, the masonry of the turrets at the east end of that roof, are made of wrought iron. Each is c. 134mm x 470mm and c. 19mm thick, with slightly tapered flanges and with a well-defined 1mm thickening on each face of the top and bottom of the web. The profiles are illustrated on Figure 4 and a photograph is presented on Plate 17.

Plate 17. Wrought iron 'I' beams at south-east corner of Roof 'E', from the north-west.

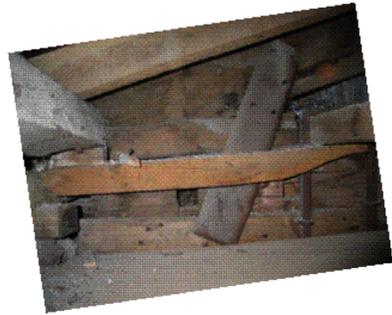
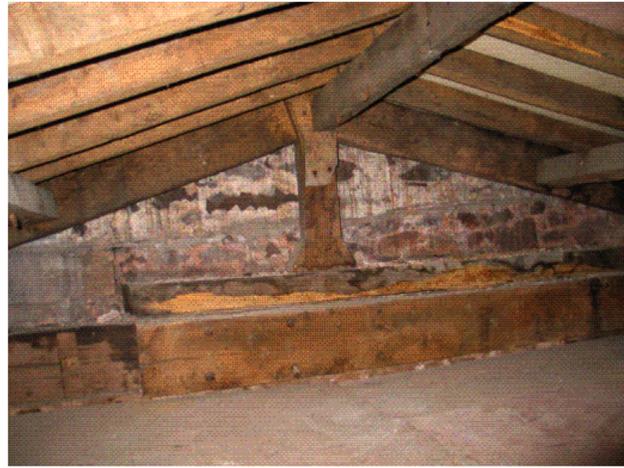
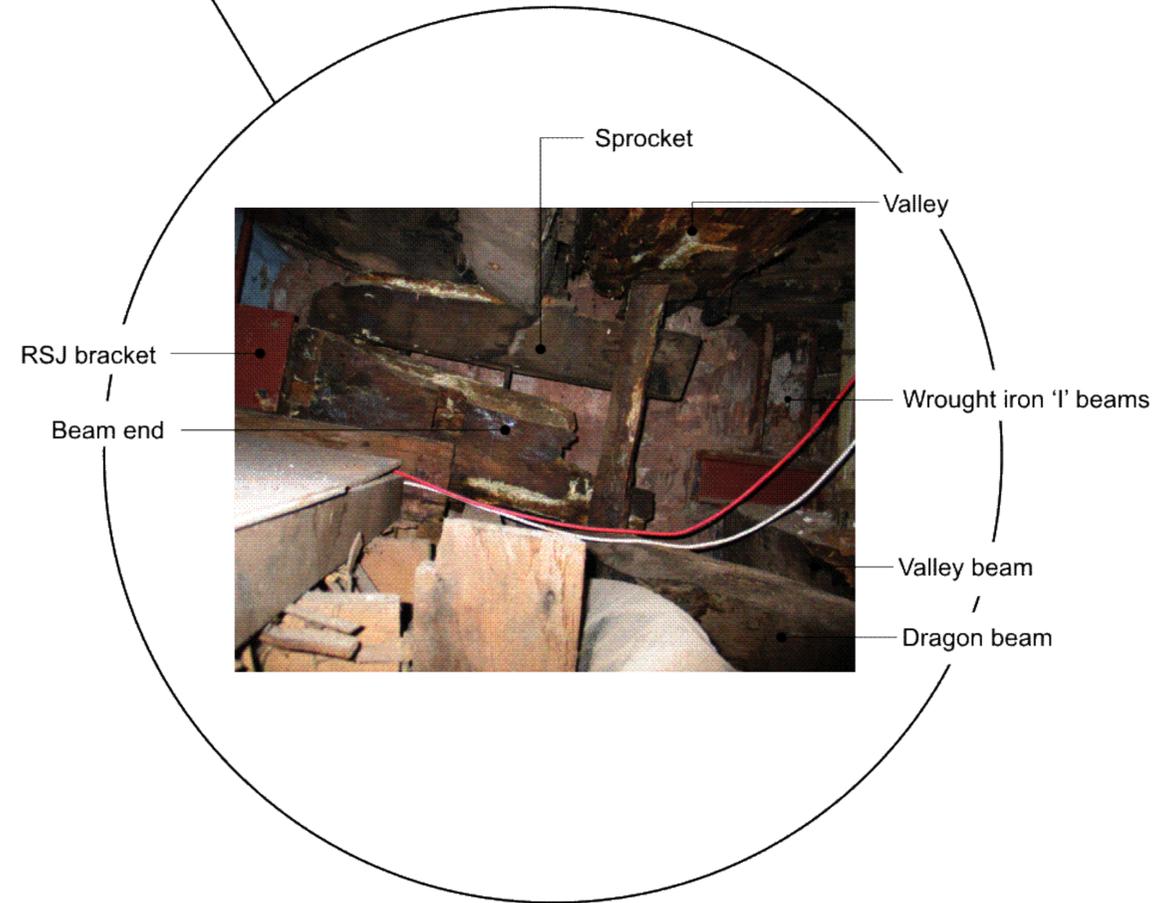
Figure 8. Plate 14

- c. Tanalised timber splints support the south end of Truss 3 and span between it and Truss 4 as an additional purlin. The most numerous and structural repairs affect Truss 19 (**Plate 14** and Figure 3): The beam - heavily decayed mid span - is splinted above and on its west face by c. 150mm thick oak beams spiked to it, the uppermost of which supports the king post. The north end, decayed to the extent that it does not bear on masonry, is supported by a salvaged 200mm x 90mm softwood beam/joist strapped to its upper side, which bears on Truss 18 and the adjacent wallhead offset. The principal/beam connection here is also braced by a pierced cast iron plate spiked to its west face. The east end bears, just, on a short dragon beam spanning between Valley Beam 2 and the adjacent wall face and is supported by two RSJs: one, 100mm x 205mm and galvanised, spans between Truss 18 and the eastern gable wall face with the beam suspended beneath it in a 20mm steel bracket; whilst the other - 80mm x 150mm - appears to run across the tops of the studs of the wall linings of the rooms below.

Truss 19, from the north-west
