JOHN MOORE HERITAGE SERVICES

HISTORIC BUILDING ASSESSMENT

CHILDWICKBURY MANOR WATER TOWER

SEPTEMBER 2013

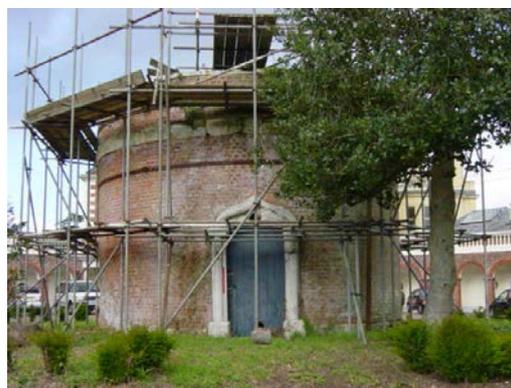
Plate 1: The Entrance to the Tower

Access to the tower is through a southeast facing doorway (Plate 1). The entrance is 1.06 m wide and provides access to persons for the maintenance of the machinery.

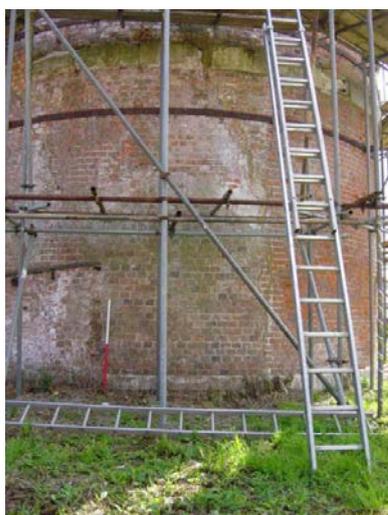
Plate 2: The Exterior View of the Blocked Doorway

A further entrance was situated opposite the current access and was much wider at c. 1.7 m. This doorway situated under a brick arch two rows deep, now infilled in header bond to match the rest of the structure, may have been to facilitate replacement of machinery held within the tower, or to assist in the general function of the structure. Some effort had been given to the infill of this wider doorway (Plates 2 and 3) including the establishment of a matching plinth, rendered in stucco at the base of the doorway, in keeping with the foot of the external detail of the main body of the tower.

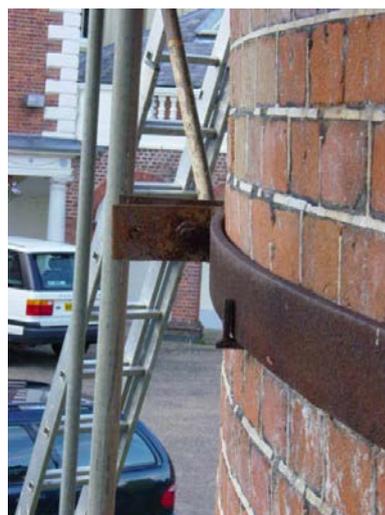
Plate 4: Detail of Iron Hoop

- 5.2 Header Bond was common in the south of England in the 18th Century. The bond is particularly suited to the construction of round walls and structures requiring additional strength, as is the case with the water tower. In addition to the enhanced strength provided by the bond, there are two iron bands/hoops, c. 0.08 m wide, fixed around the diameter of the tower to provide additional support. The bands are situated near the top of the tower, less than half a metre from the underside of the stone coping, with a further band some 1.12 m below the first. The true function of the iron hoops was to add support to the lead lined tank/cistern particularly when full to capacity.

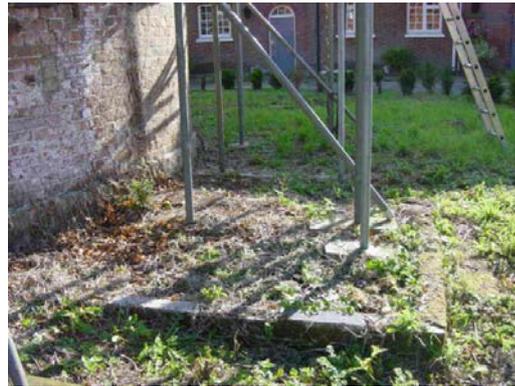
Plate 14: The footings of Demolished Additional Structure

There is a standpipe situated some 4.80 m from the blocked door of the tower (Plate 13). This pipe comprises early and recent metalwork. The date of origin for the pipe is unknown. A secondary structure, now demolished was situated adjacent to the blocked doorway on the western external face of the tower. The footings (Plate 14) are to the north of the doorway and measure c. 2.00 m by 1.55 m. Traces of the roof of this structure are still visible on the external face of the towers indicating a height of c. 1.3 m for the later build.

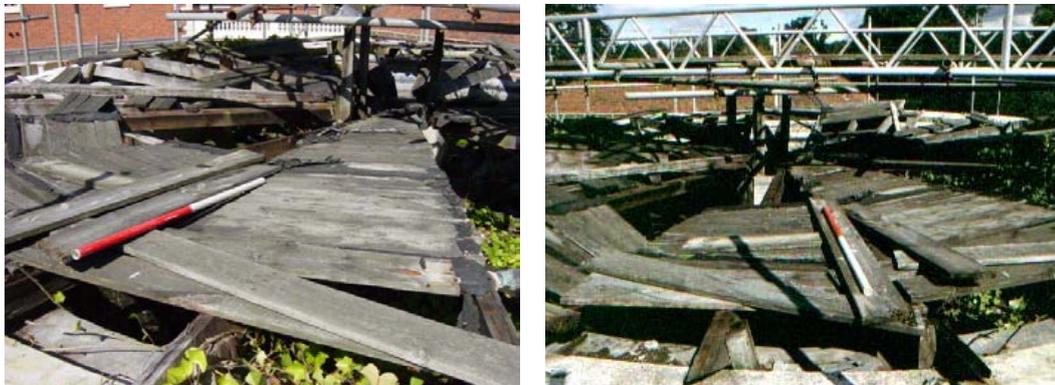
Plates 15 and 16: General Construction of Roof 'Segments'.

The roof is currently in a state of collapse and access was extremely limited. The roof was constructed in wedge shaped segments, each segment comprising two long timber members tapering towards the centre of the roof and overlain with lengths of board decreasing in length towards the centre (Plates 15 and 16). The timber segments rest on the coping at the top of the tower walls (Plates 17-18), and further support may have been provided by four vertical timber members situated at the corners of the hatch near the centre of the structure (Plates 19-20).

The almost centrally located hatch would allow access to the tank for maintenance and cleaning, that the timber infrastructure of the roof currently rests on this may suggest that the original position of the roof has failed, as access to the tank through the hatch would be inhibited.

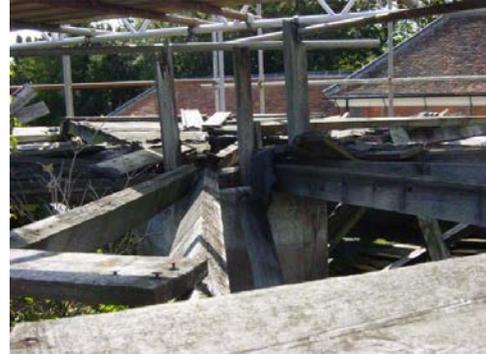
Plate 19: The Vertical Posts that would have Supported the Roof over the Hatch

The vertical timbers shown in Plate 19 may indicate the location of a sloping conical roofline. The original position of the roof structure would have been elevated at the centre to a height of c. 0.50 m above the level of the coping on the parapet. The nature of this roofing material suggests a 'lid' like function: prevention of bacterial contamination to the stored water supply, particularly from birds (Barry Barton, 2003).

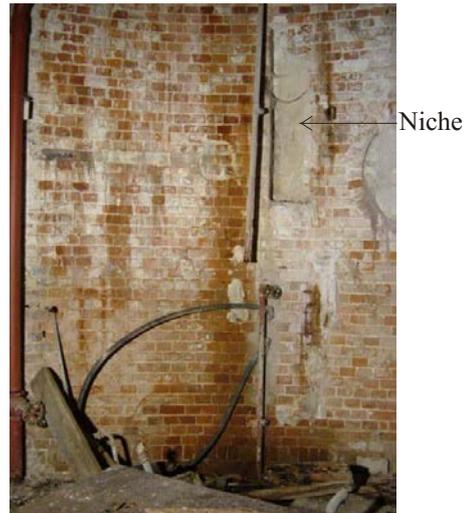
Plate 23: View of the Interior of the Tower Showing Location of Niche

The interior of the water tower has whitish discoloration on the walls reminiscent of mineral build up rather than the remnants of a decorative finish, additional discoloration may have been the result of staining from water leakage. The interior of the tower is further marred by cement patching and the addition of machinery due to the conversion of the tower to electrical supply. Several niches (Plate 23) are also let into the tower walls; the original function of these is unknown.

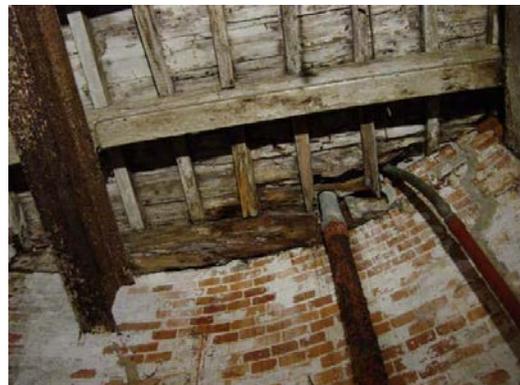
Plate 25: A Main Beam Recessed into Wall Later Iron Beam Re-inforcement Below

The ceiling supporting the underside of the cistern is an oak construction comprising main beams and joists; the hatch through to the tank is also clearly visible (Plate 24). The main beams include four that are recessed into the tower walls (Plate 25-26) and the joists are housed within the main beams. Later support was added in the form of iron I-beams in turn supported on vertical I-beams set into concrete footings. The iron supports are a much later addition to the tower: one is situated in front of the bricked up doorway, the other adjacent to a window.
