The structural development  
of  
**THE COTTAGE, FRIETH HILL**  
HAMBLEDEN  
BUCKINGHAMSHIRE

K A Rodwell  
for  
JOHN MOORE HERITAGE SERVICES

October 2009

**THE STRUCTURAL DEVELOPMENT**  
**of**  
**THE COTTAGE, FRIETH HILL, HAMBLEDEN, BUCKS**

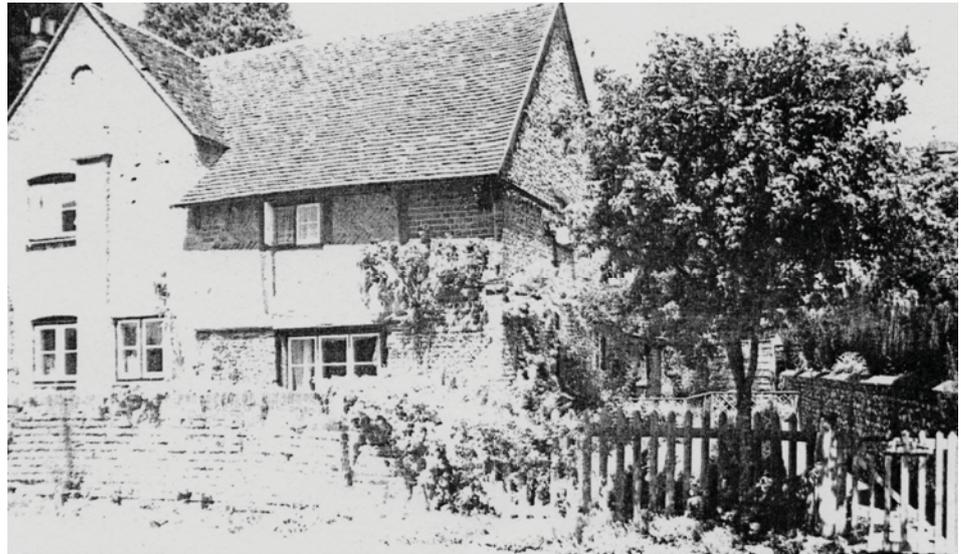
Old photograph of south elevation (undated; Frieth Village Society 1981)

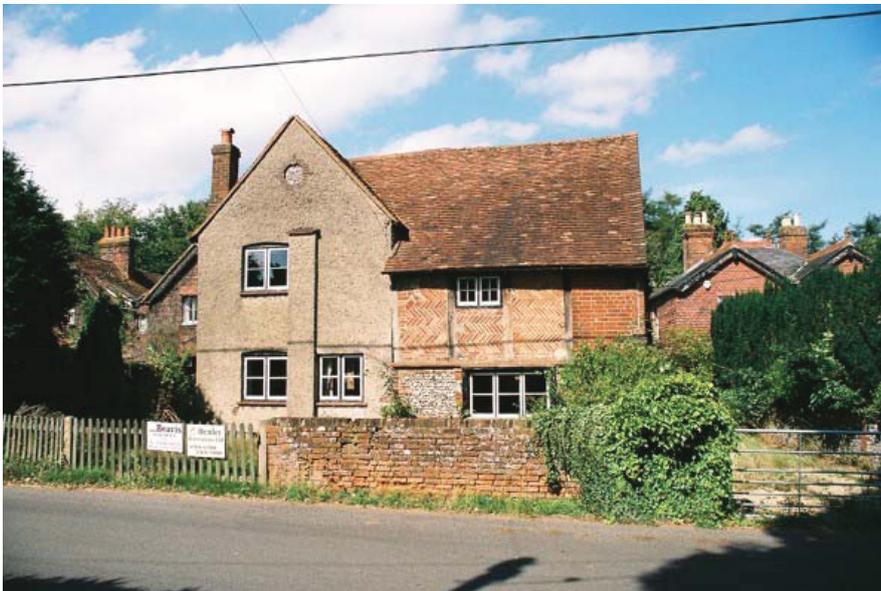
South elevation

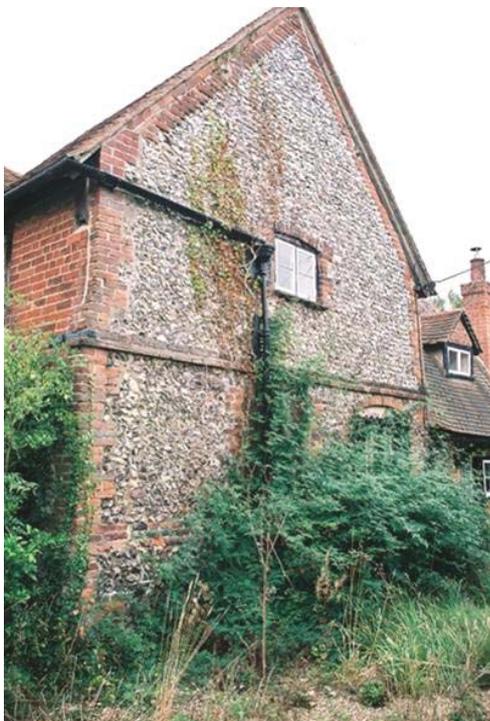
East elevation; blocked door behind vegetation

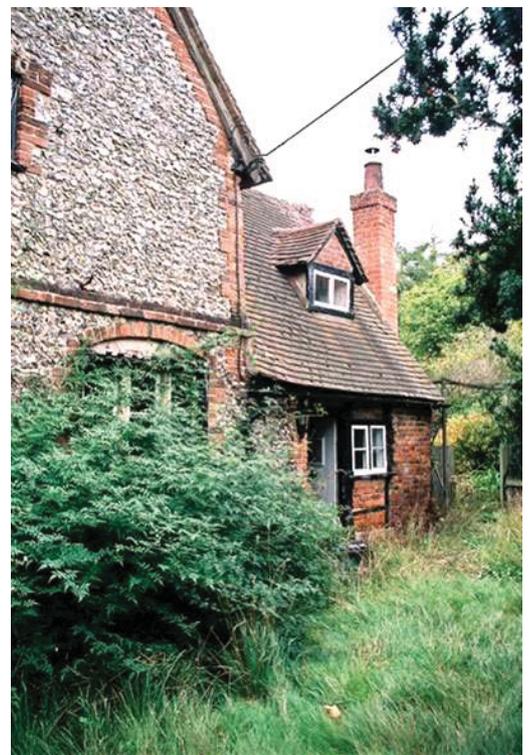
East elevation; timber-framed rear wing

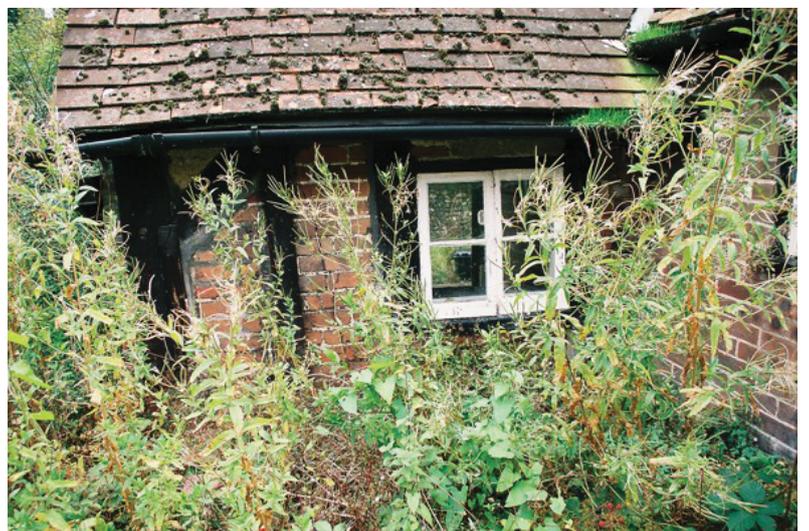
Lean-to at west end

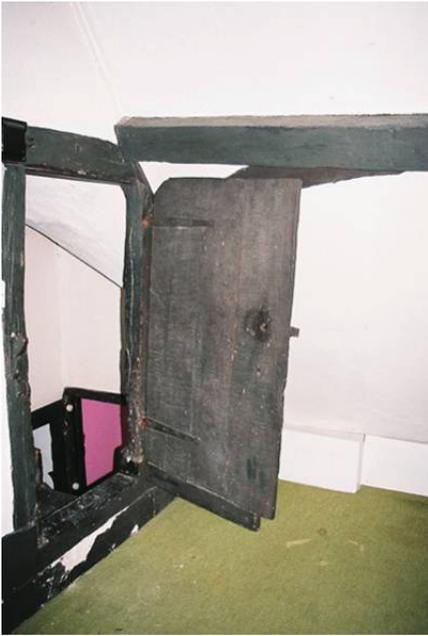
Door into first floor rear wing

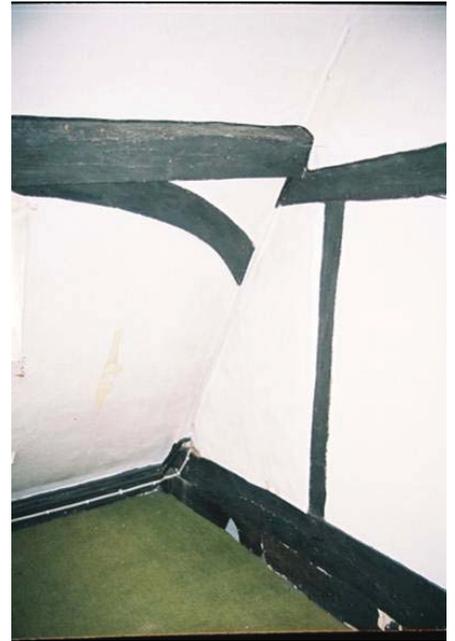
First floor rear wing, NE corner with curved windbrace & purlin

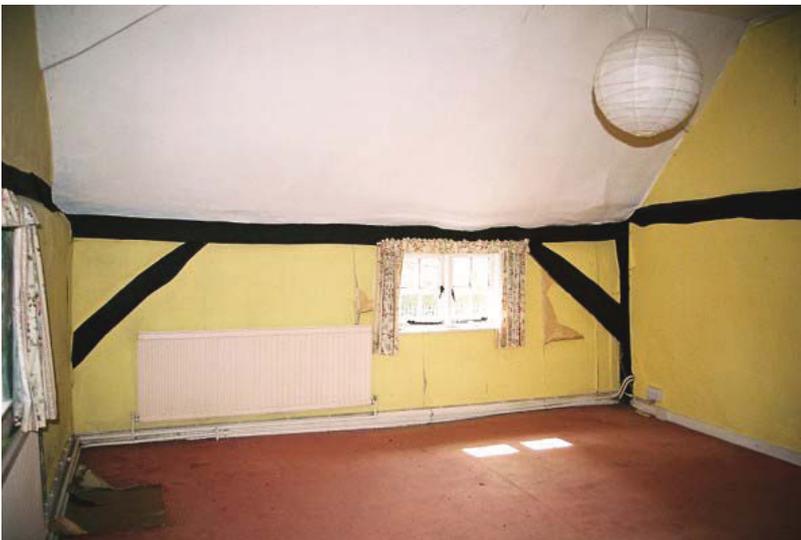
SE bedroom looking south
