Standing Building Survey
Ayton Farm mill cottage and mill system,
Aberargie, Perth and Kinross

Mill cottage/dam house looking South

24th January 2011

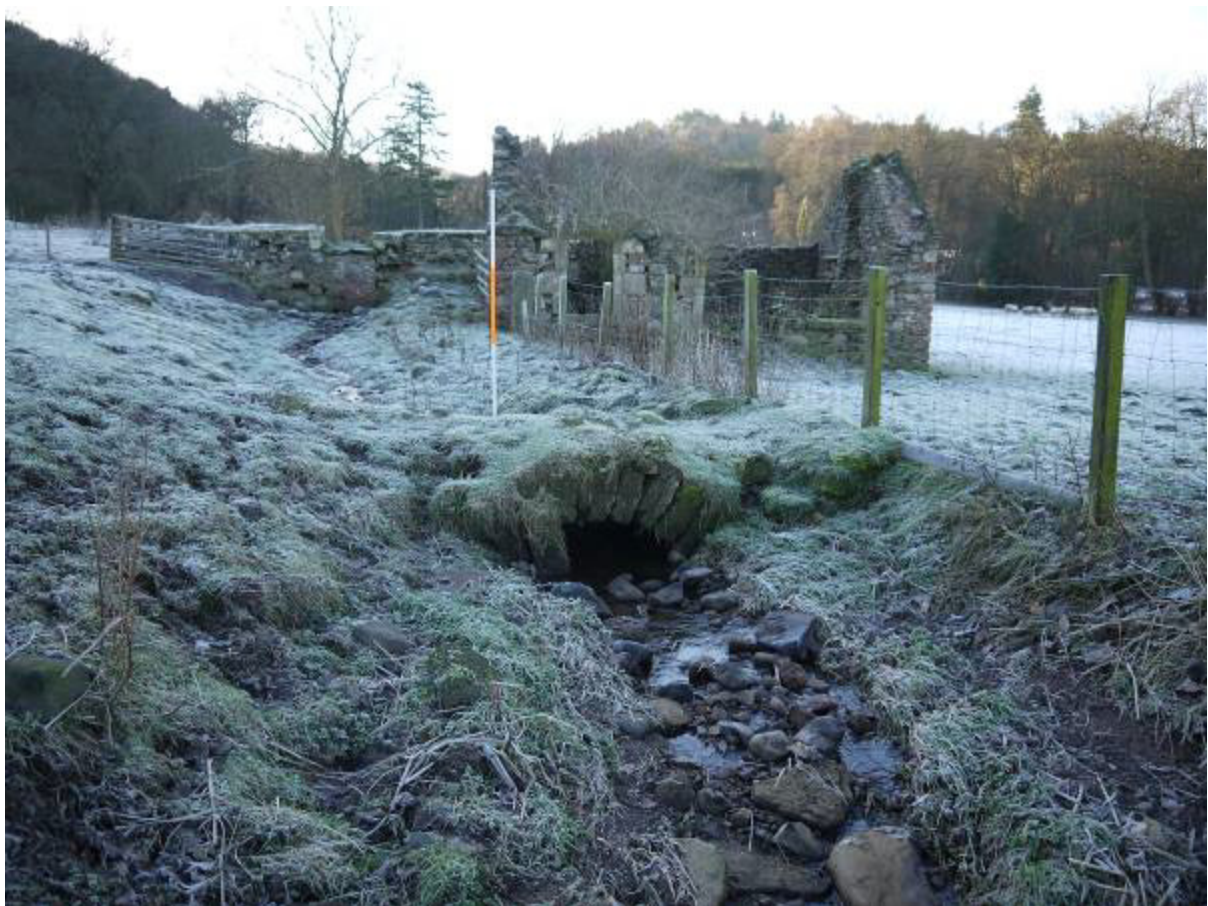
The roofless remains of a single storey building that represents the former mill cottage/dam house at Ayton Farm lie to the South of the farm at 22m OD. This building is aligned East to West and lies on the west side of the former mill lead, it is accessed by a small arched stone bridge (Illus 6).

Illustration 6 Small bridge over mill lead providing access to mill cottage/dam house looking South

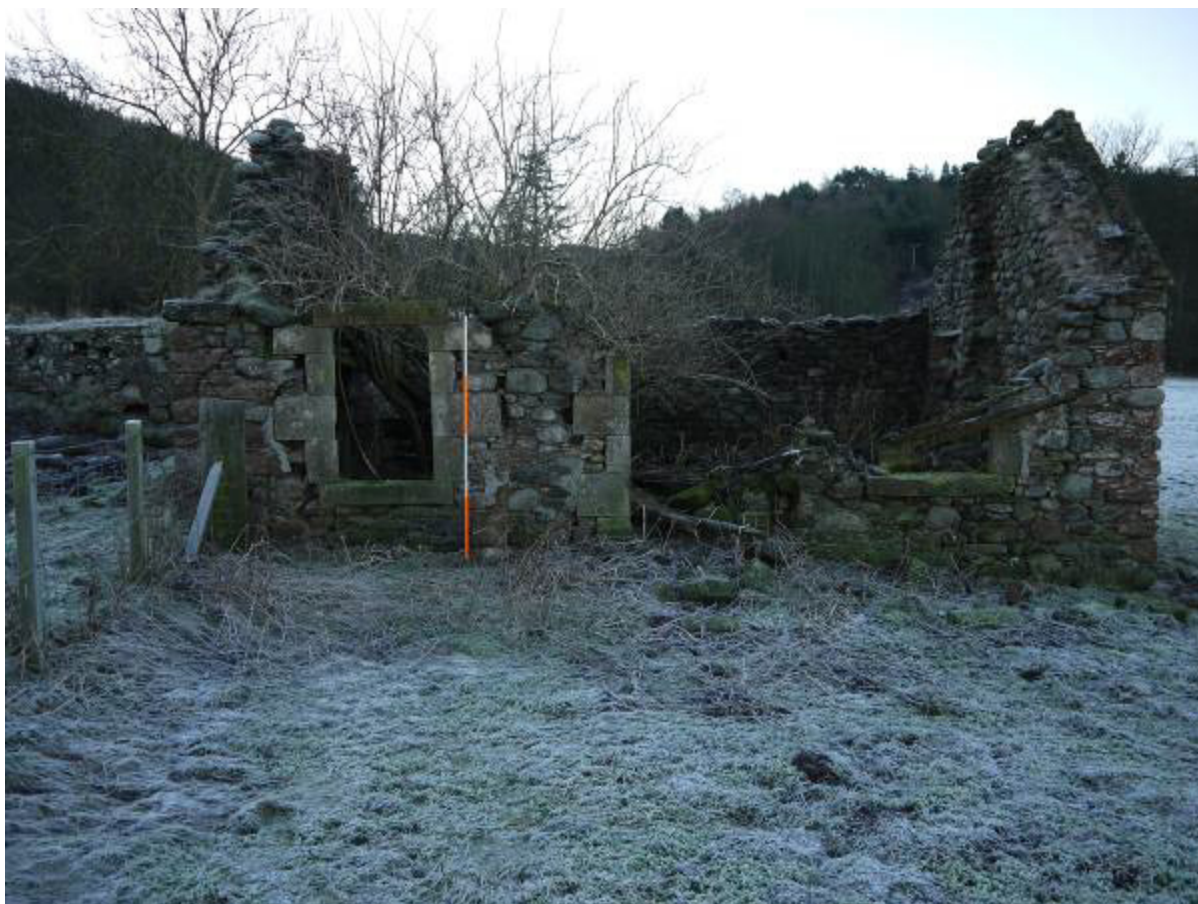
This elevation has a central doorway with a window on either side and is constructed of rough rubble (river cobbles and sandstones) bonded with lime mortar. The windows and doorway are defined by shaped sandstone blocks. The eastern end of this elevation survives to roof level whereas the western end has collapsed to a height of 1.6m. Its wall is 0.60m thick.

Illustration 7 Northern elevation of mill cottage/dam house looking South

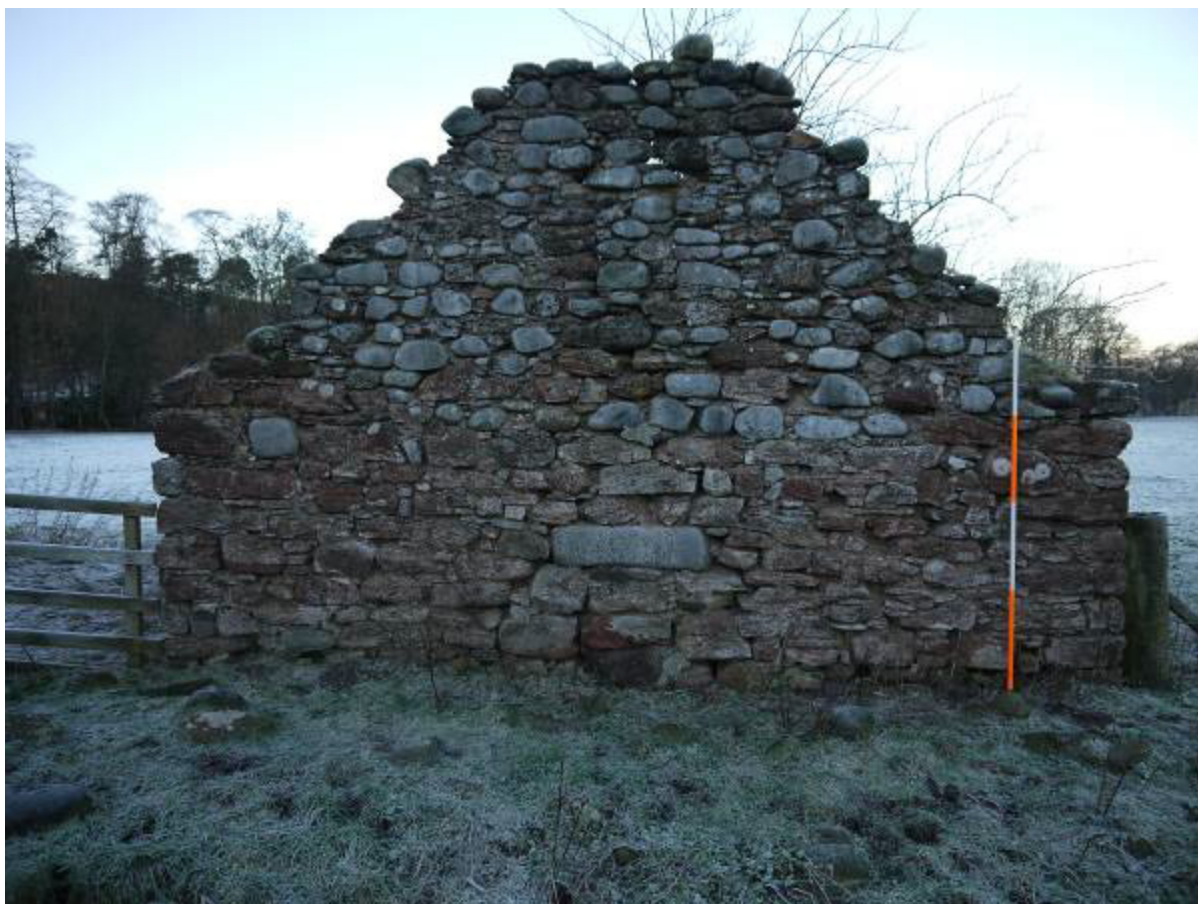
This elevation has a blocked small window just below the apex of the gable and a blocked narrow access point at ground floor level. It is constructed of rough rubble bonded with lime mortar.

Illustration 8 Eastern gable of mill cottage/dam house showing blocked window just below gable and access point at ground level looking West

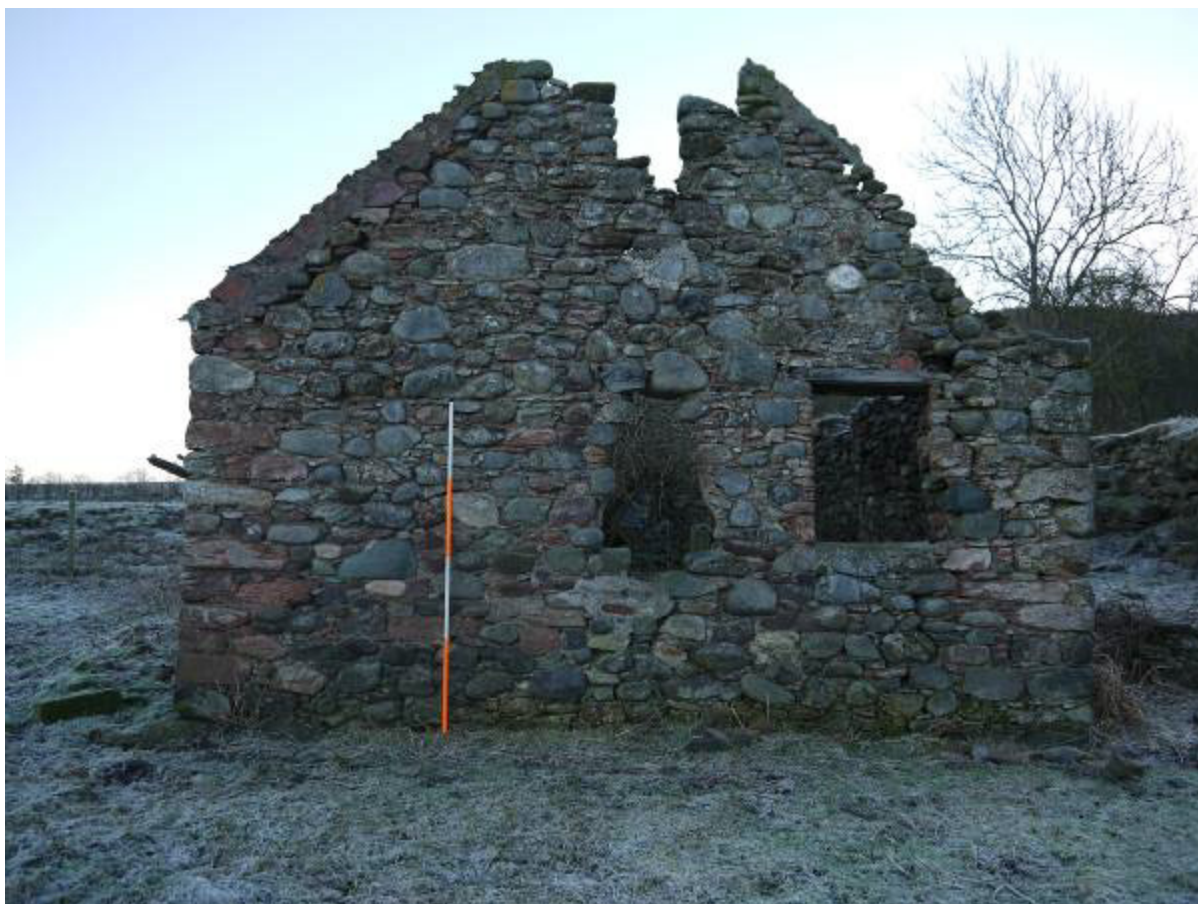
This elevation has a window at its southern end and a central hole through the wall behind the fireplace. It is constructed of rough rubble bonded with lime mortar. The window has a wooden lintel but is not defined in the same way as the windows in the front Northern elevation, its wall is 0.60m thick.

Illustration 9 Western gable of mill cottage/dam house looking East

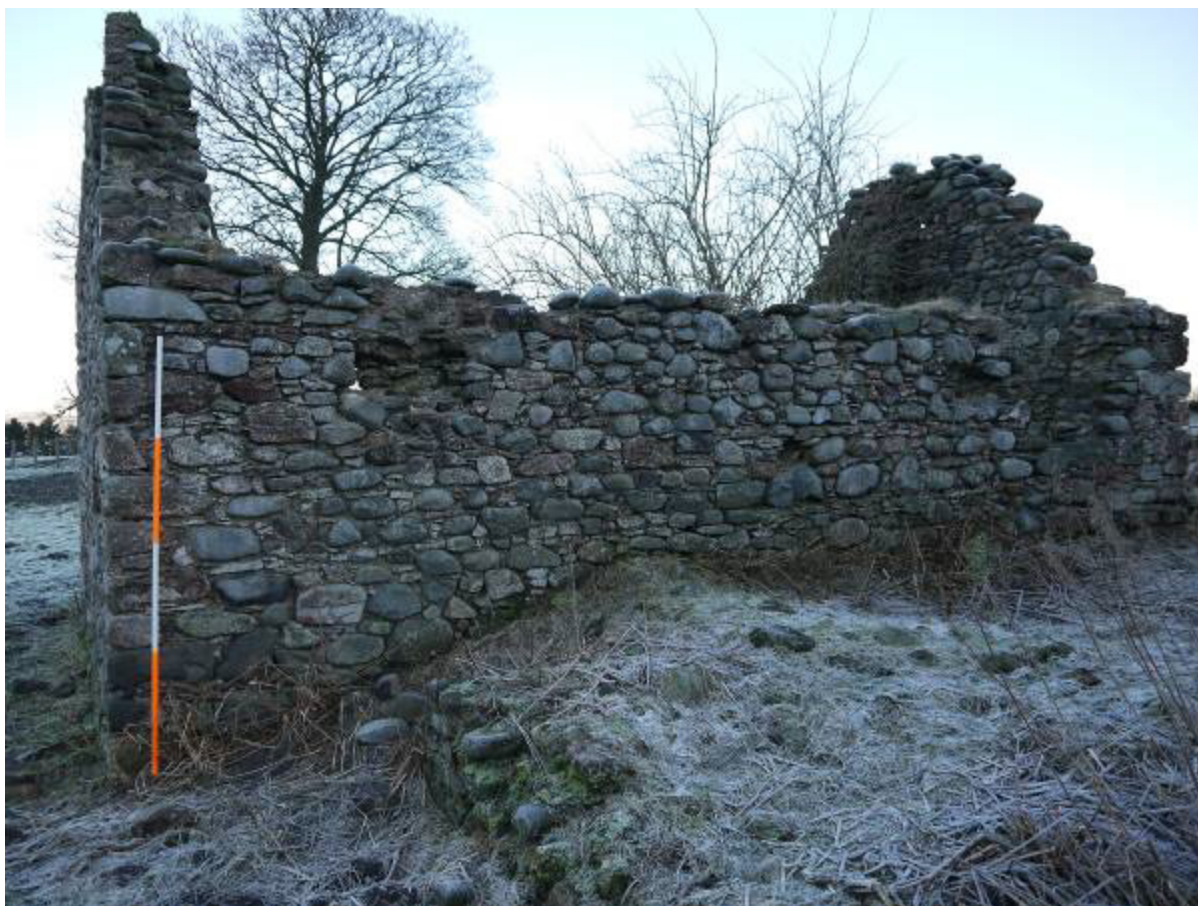
This elevation has a window at its eastern end and is constructed of rough rubble bonded with lime mortar.

Illustration 10 Southern elevation of mill cottage/dam house looking North

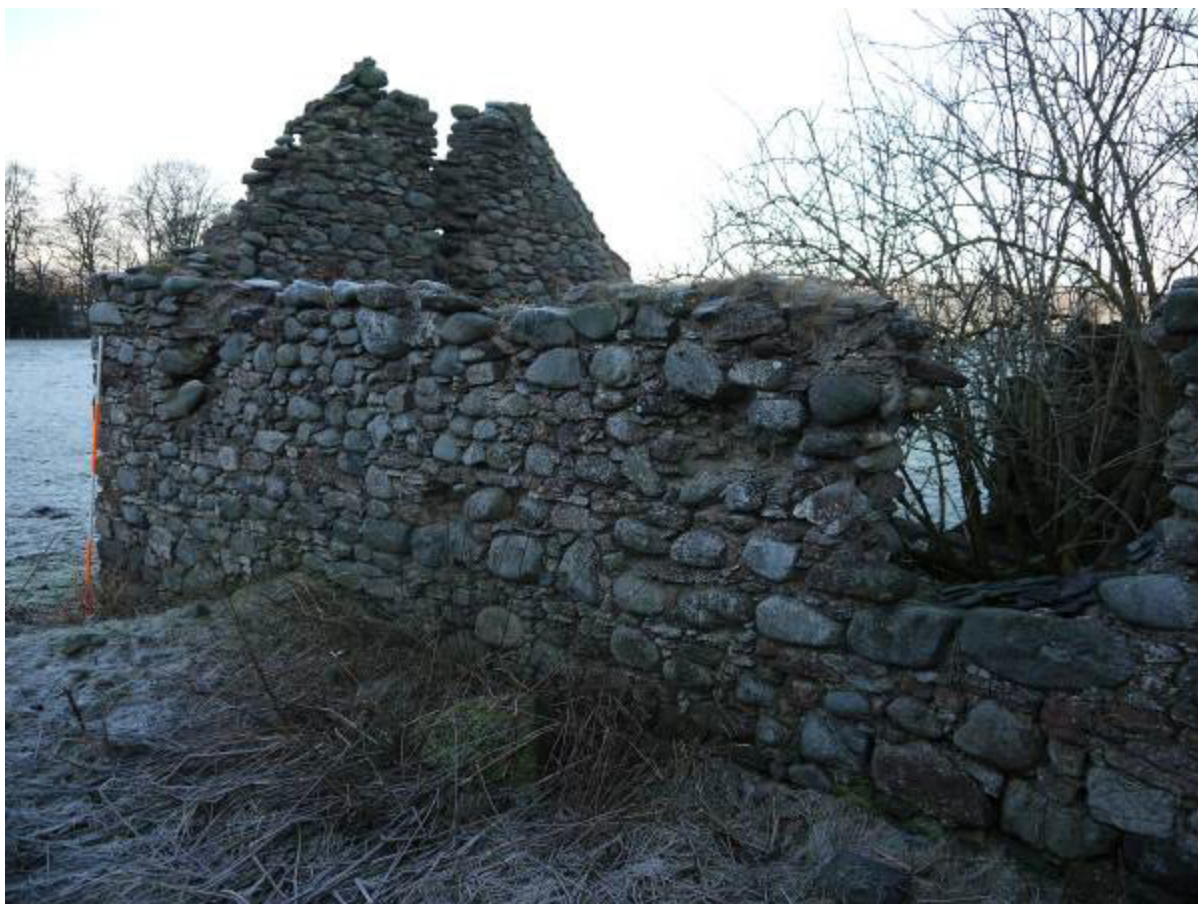
Illustration 11 Eastern end of Southern elevation of mill cottage/dam house showing possible window looking North West

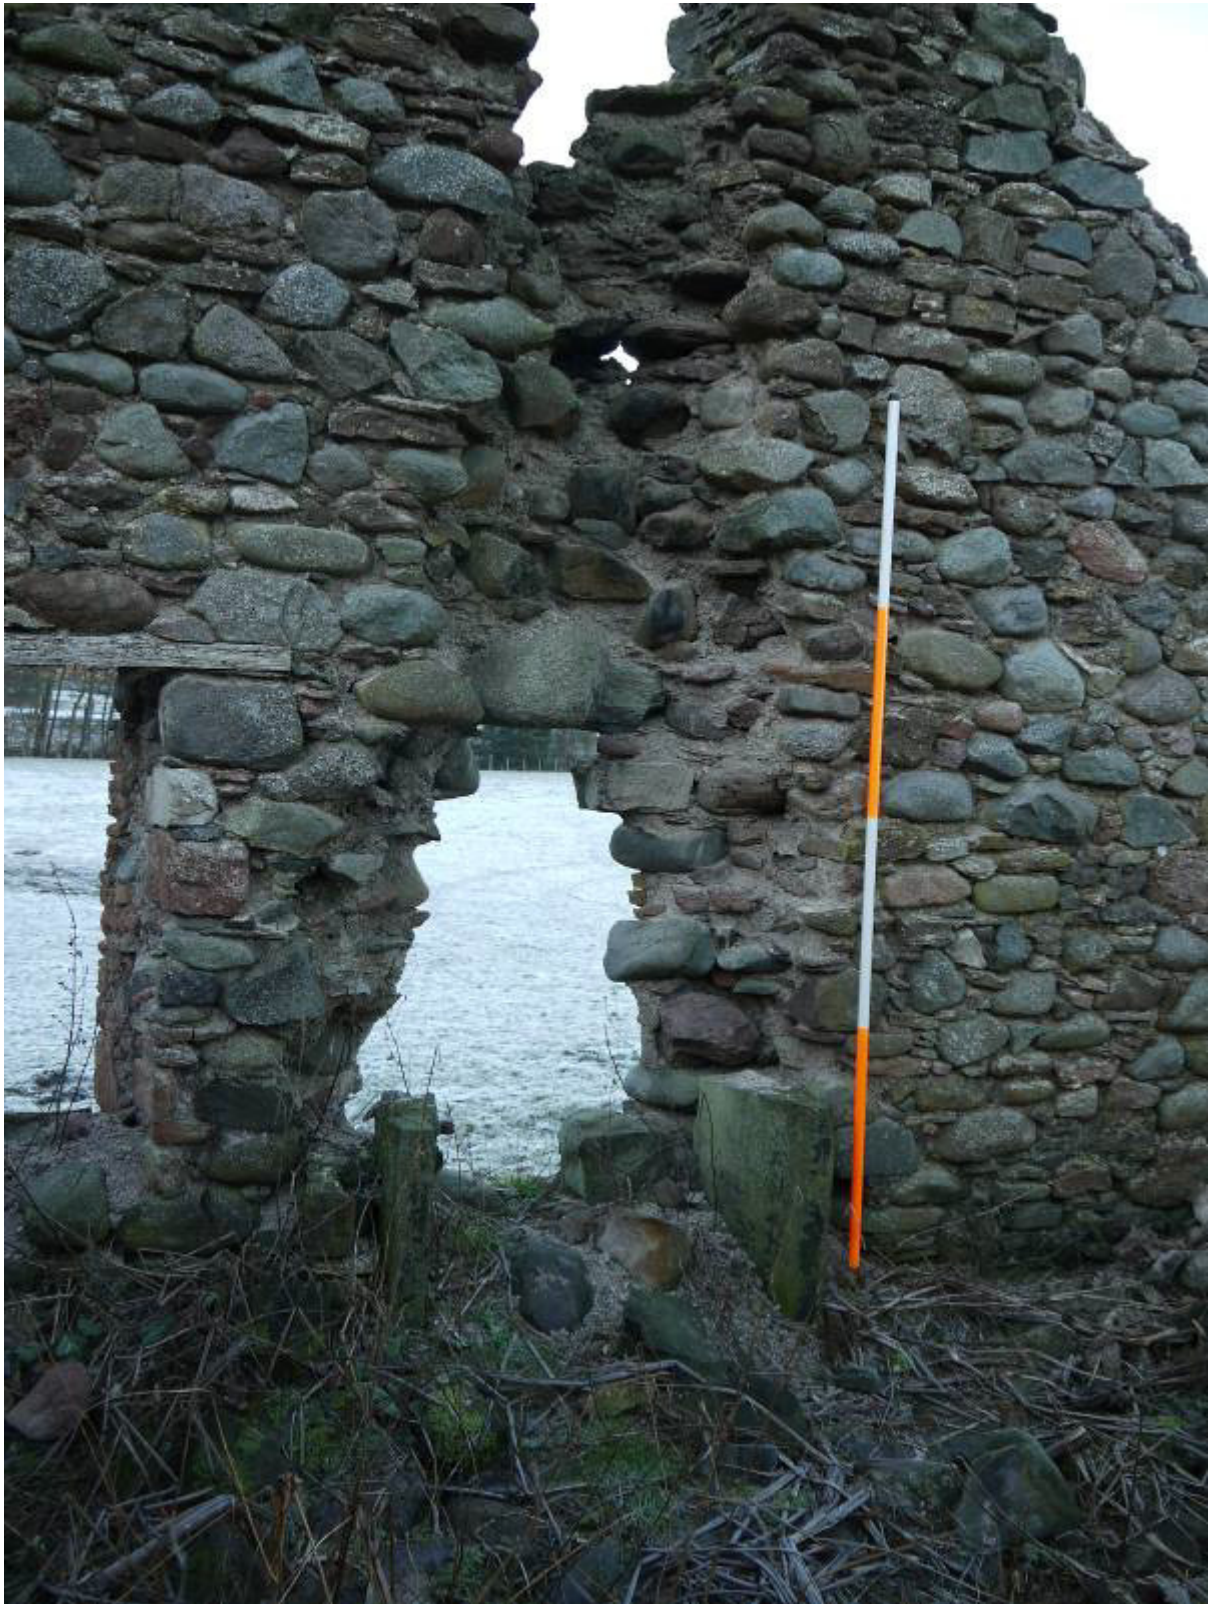
This building has a fireplace and chimney in each of its internal gable walls. There appears to be the remains of a stove in the western fireplace. The whole interior is full of a collapsed slate roof and associated timbers and it was not possible to locate either an original internal floor surface or remains of any internal subdivisions to the building.

Illustration 12 Fireplace and chimney at Western end of mill cottage/dam house looking West

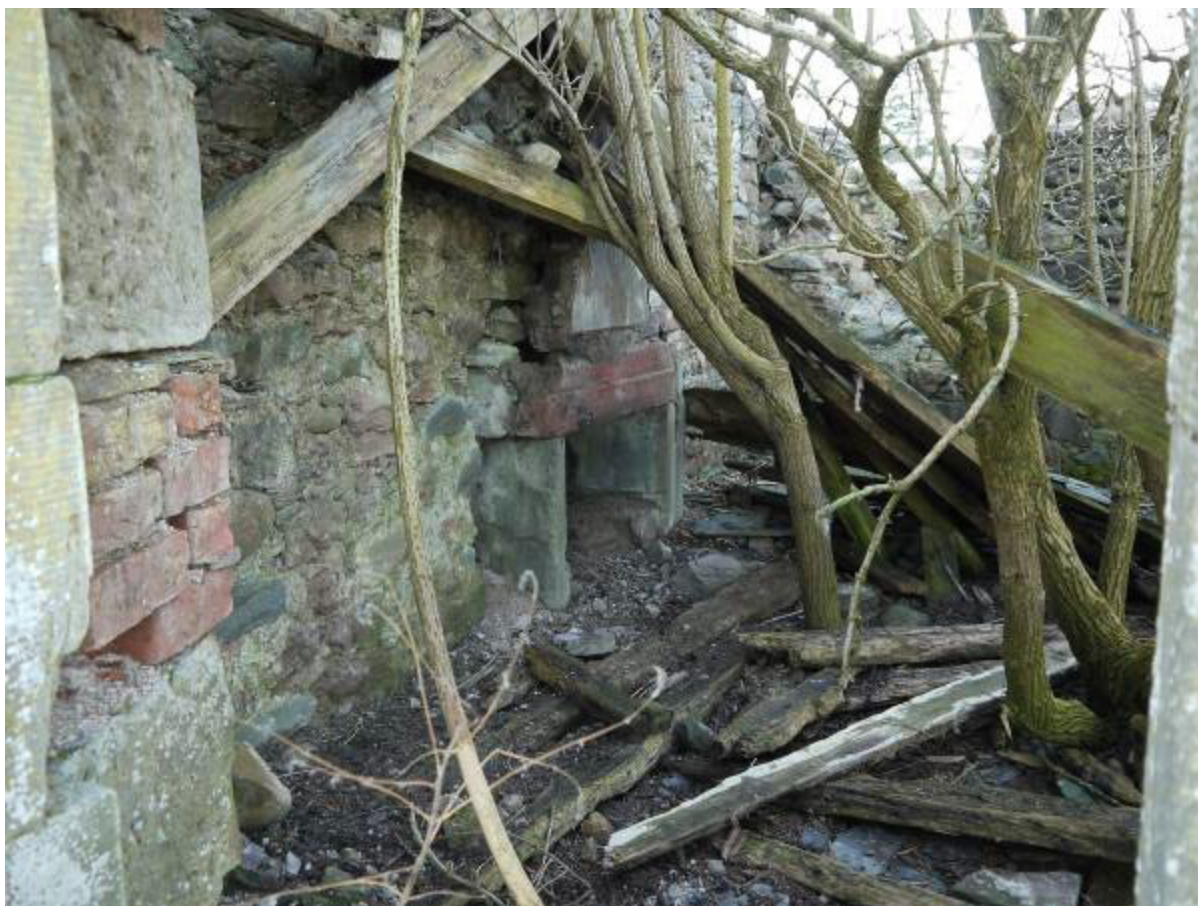
Illustration 13 Fireplace at Eastern end of mill cottage/dam house

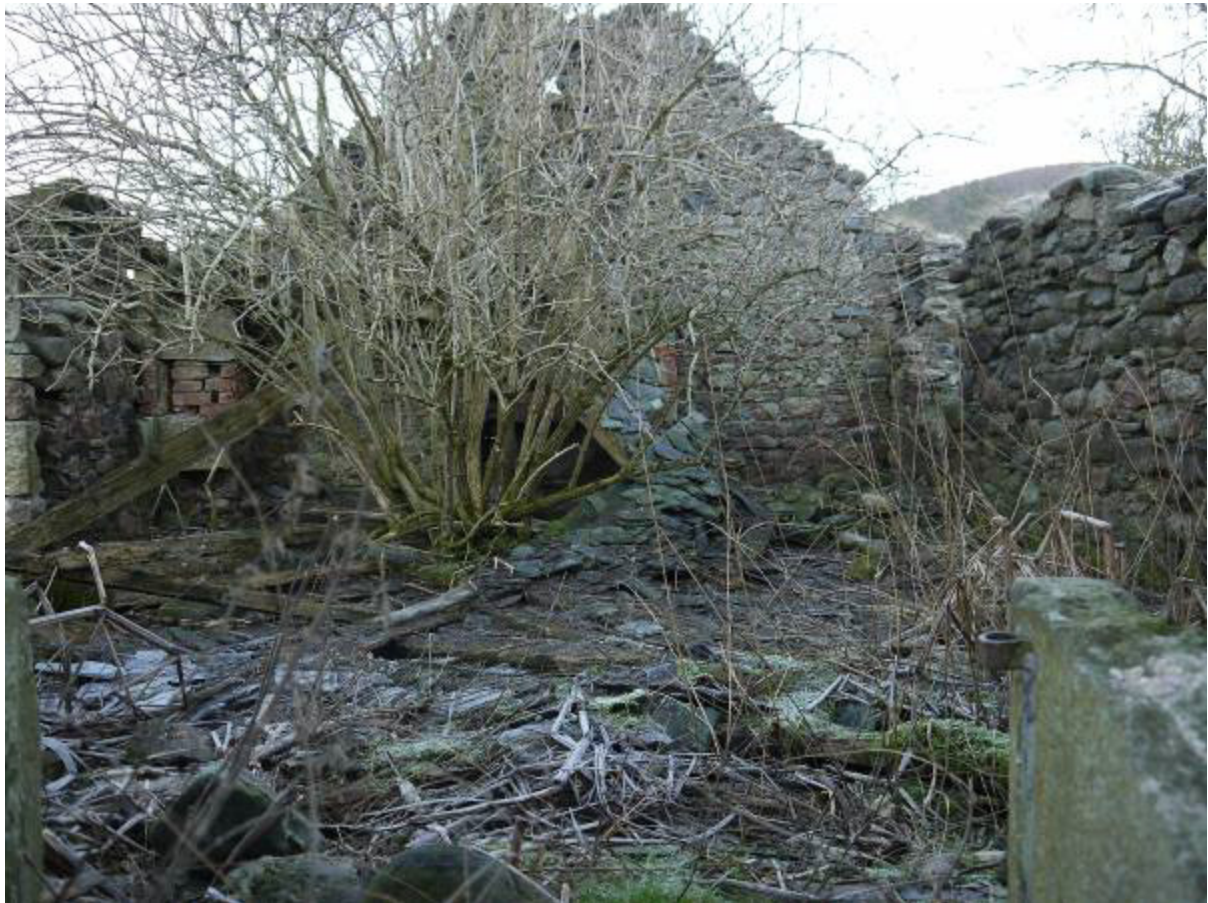
Illustration 14 Interior of mill cottage/dam house showing roof collapse looking East

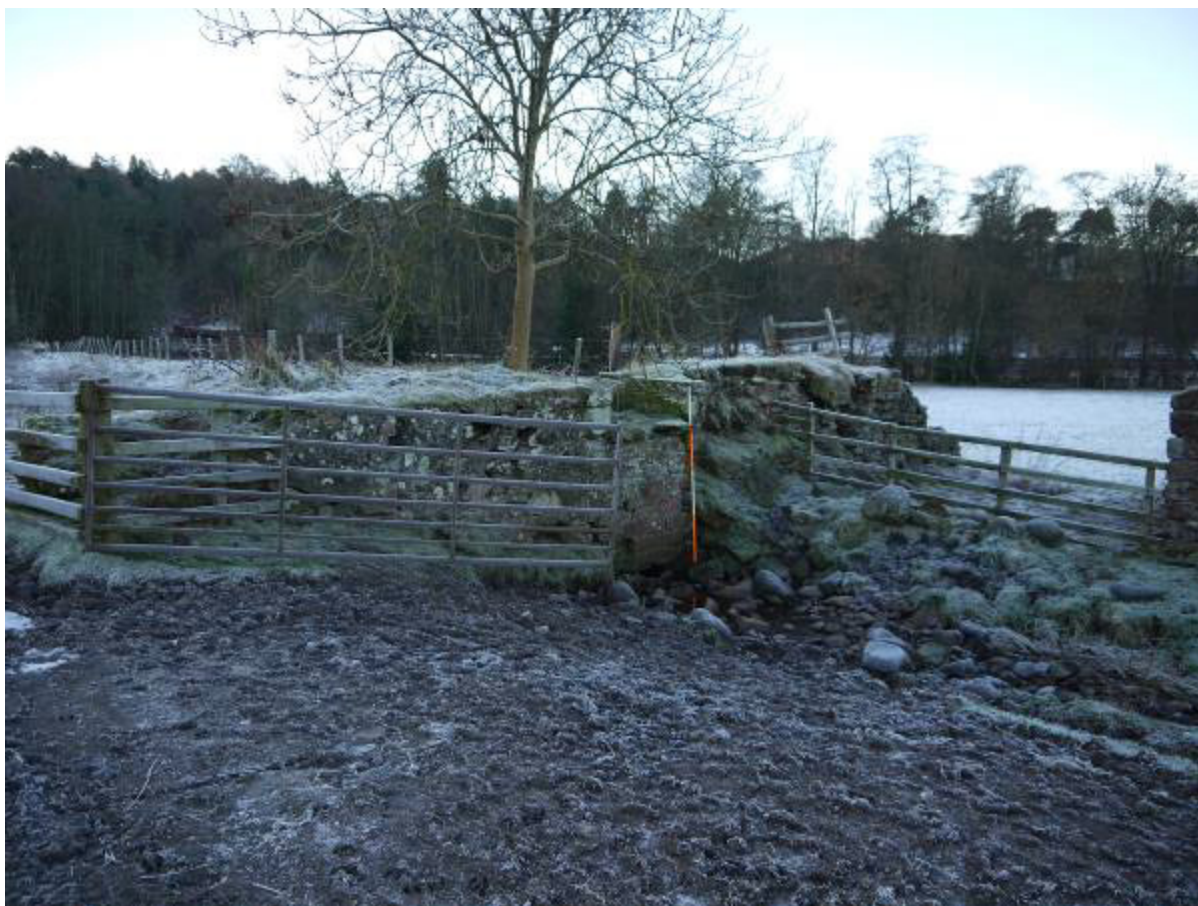
The dam wall is constructed of mortar bonded sandstone blocks and runs from East to West across the Northern end of the mill pond and stands 2.10m high at its highest point. The wall is 1.25m wide for just over 13.30m before it changes into a much narrower wall (0.42m wide) for another 8m and runs to the foot of the earthwork that forms the western side of the millpond. Almost half way across its length there is a gap 1.3m wide and 0.40m deep that presumably operated as its sluice, there is a visible culverted channel running under this gap through which water still flows.

Illustration 15 General view of North facing side of mill dam/sluice looking South West

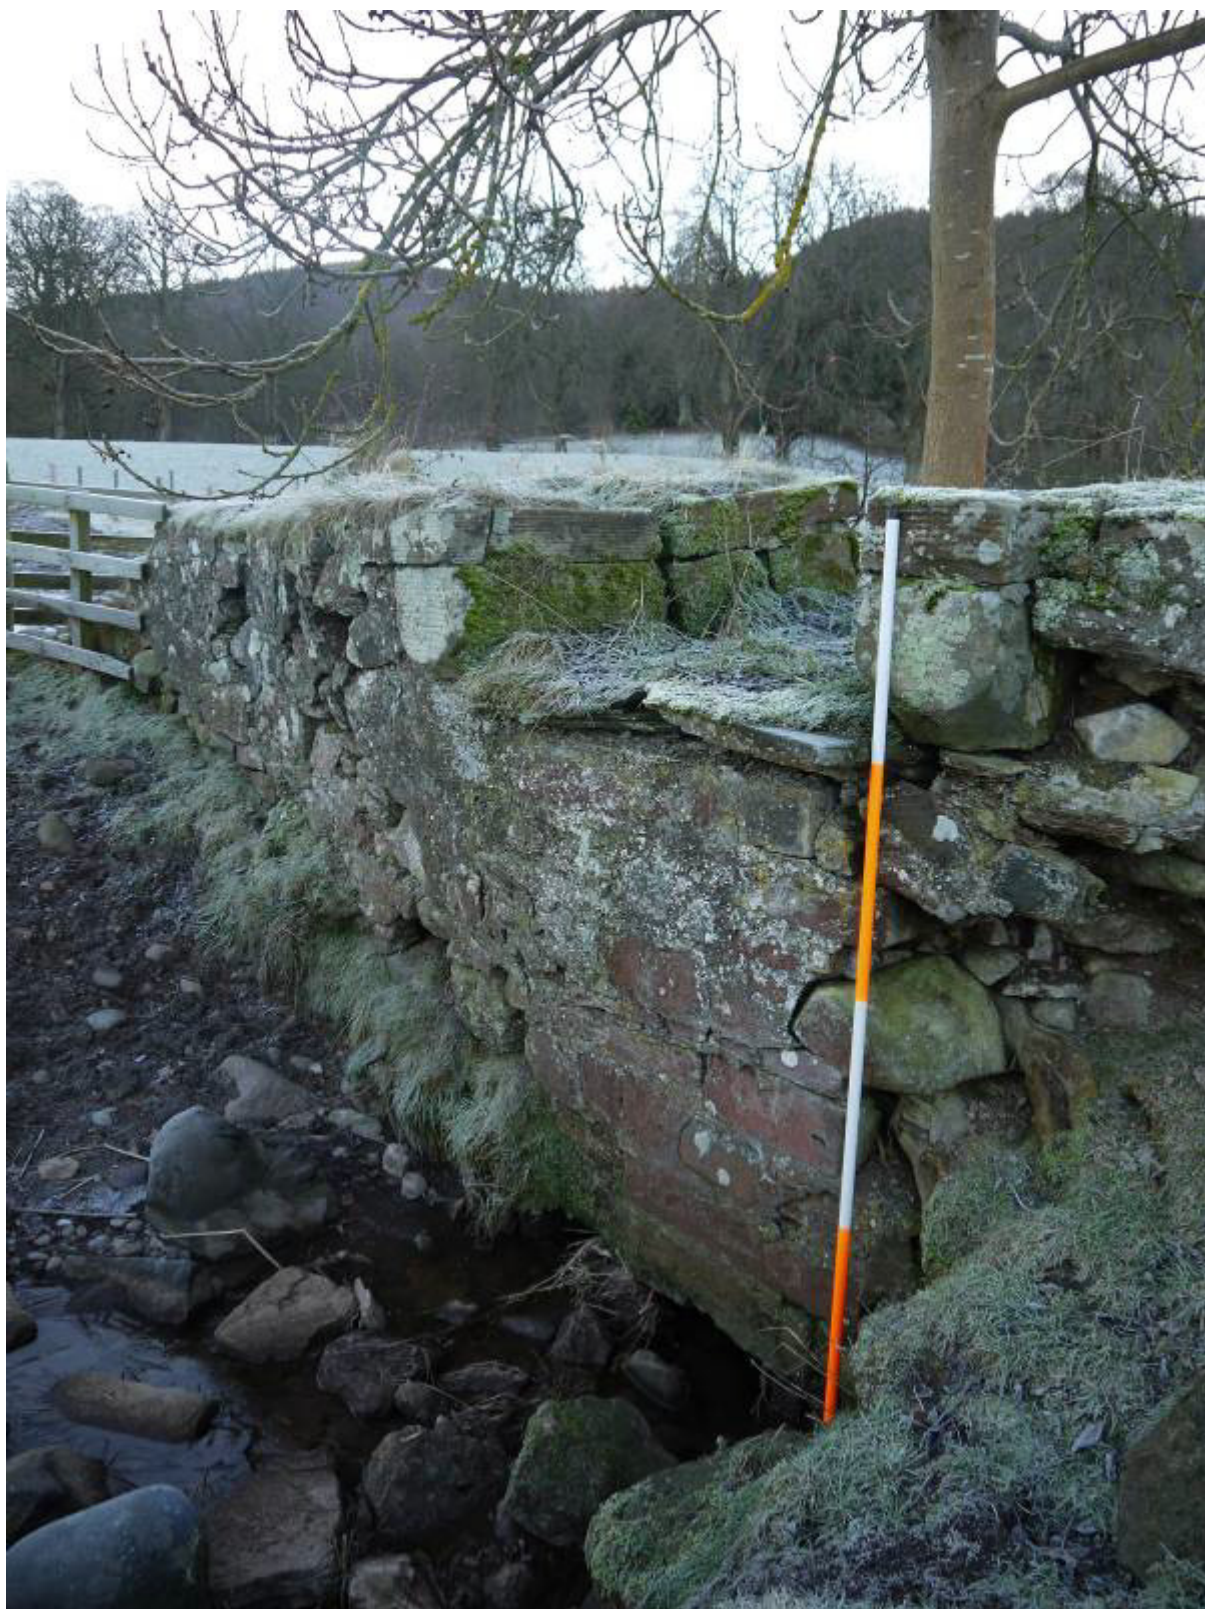
Illustration 16 Detail view of mill dam/sluice looking South East

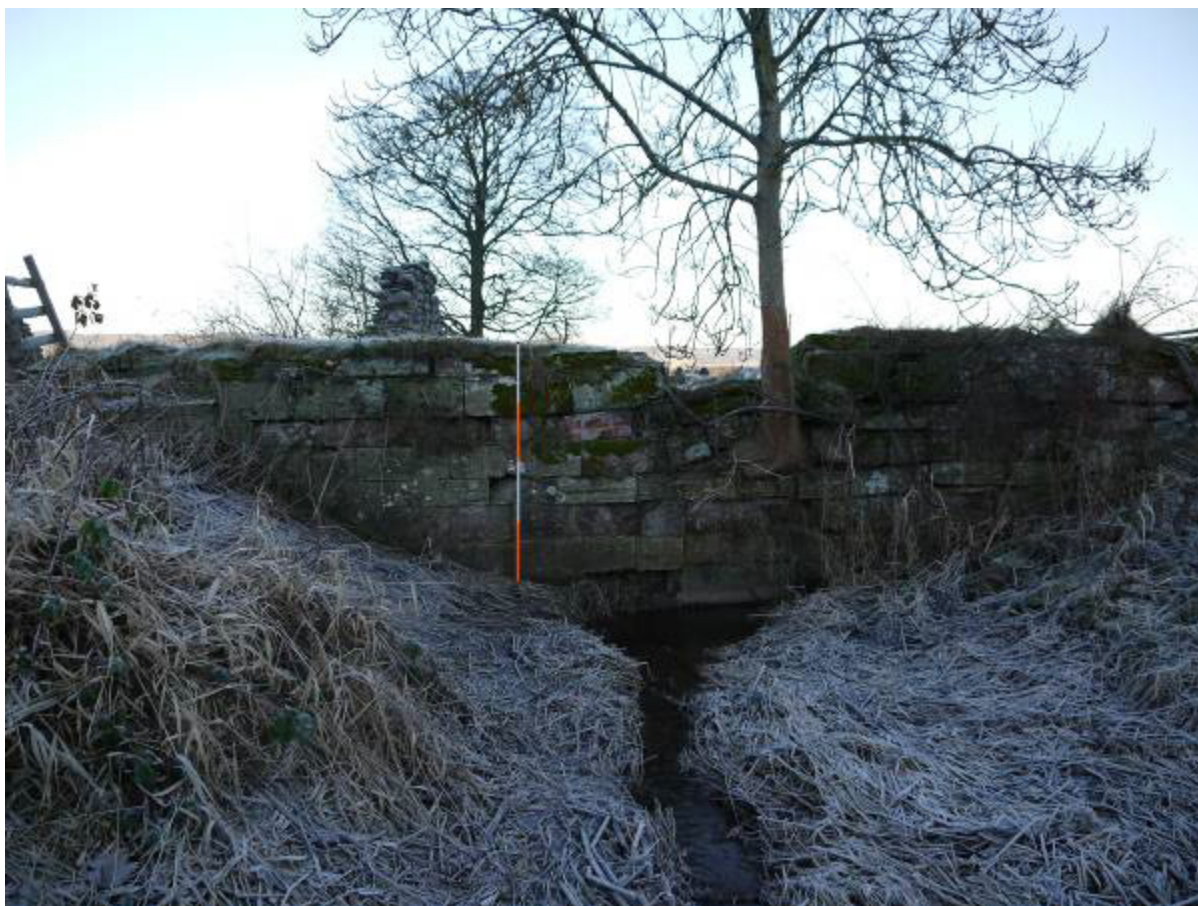
Illustration 17 General view of South side of mill dam/sluiice looking North

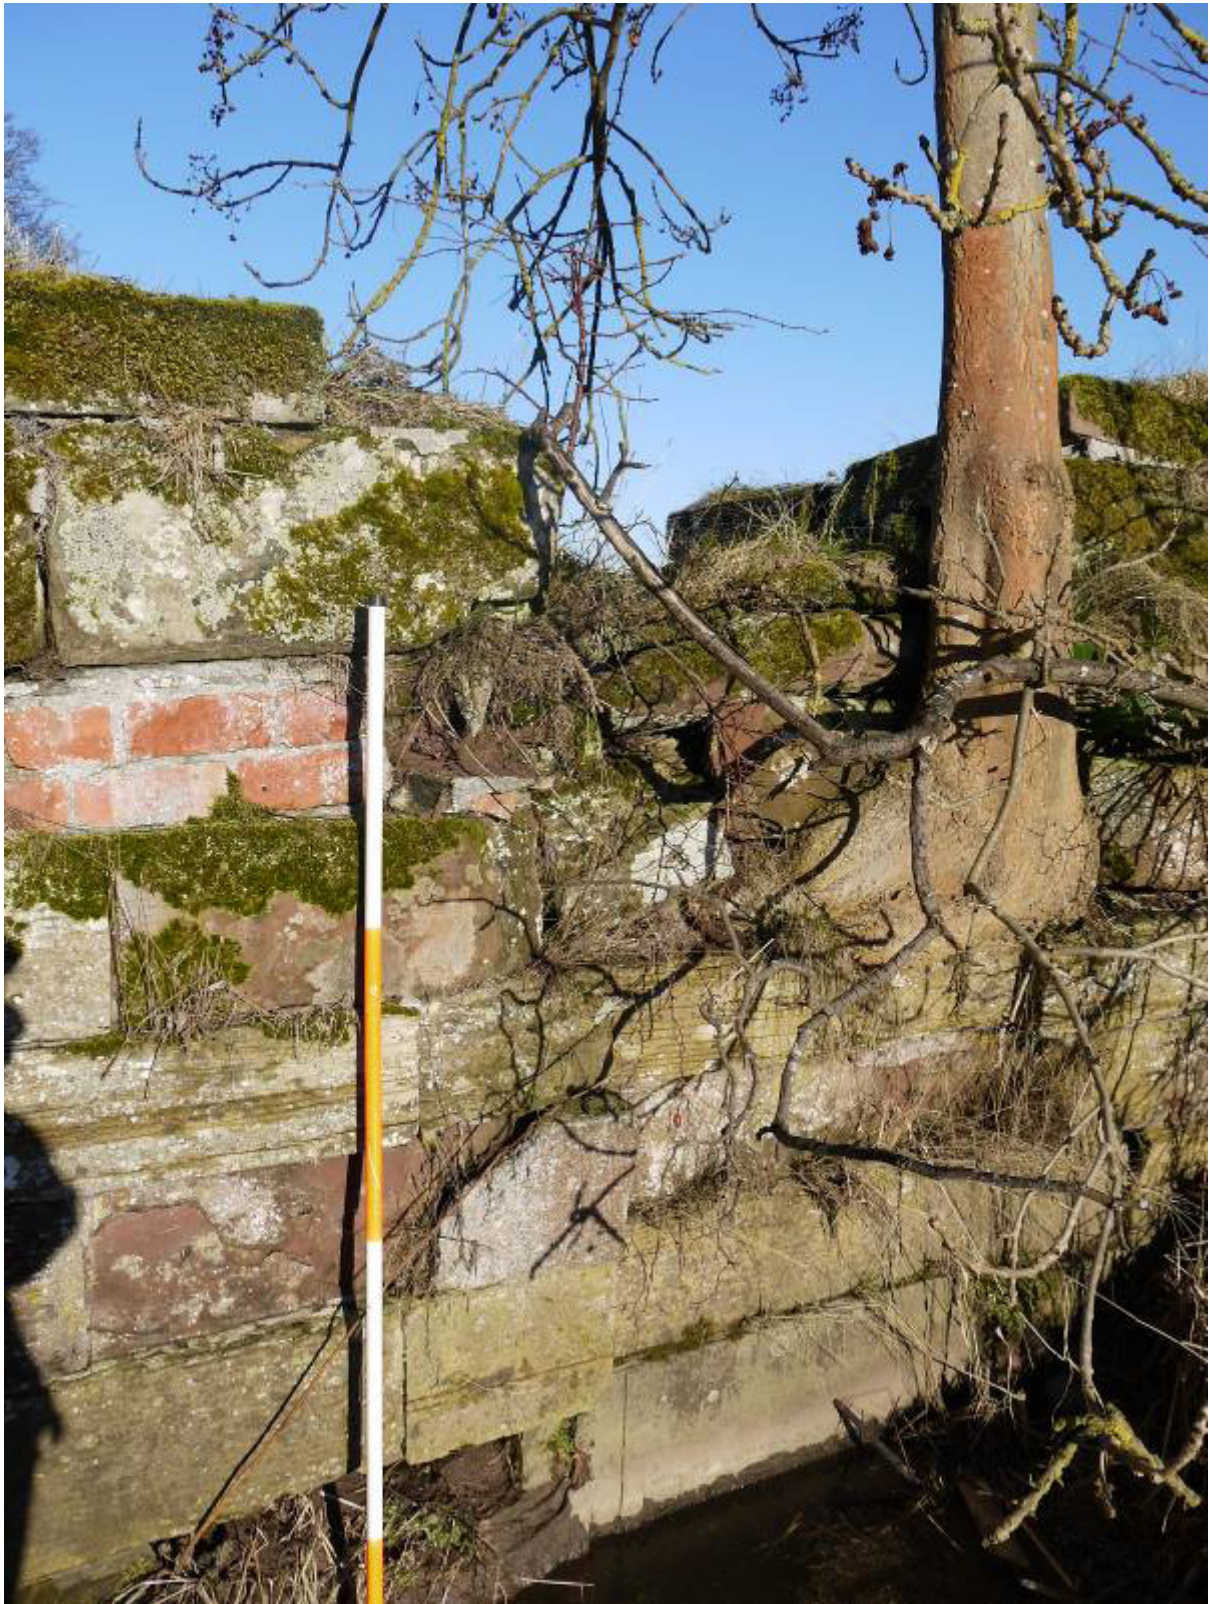
Illustration 18 Detail of central part of mill dam/sluice on its Southern side looking North East

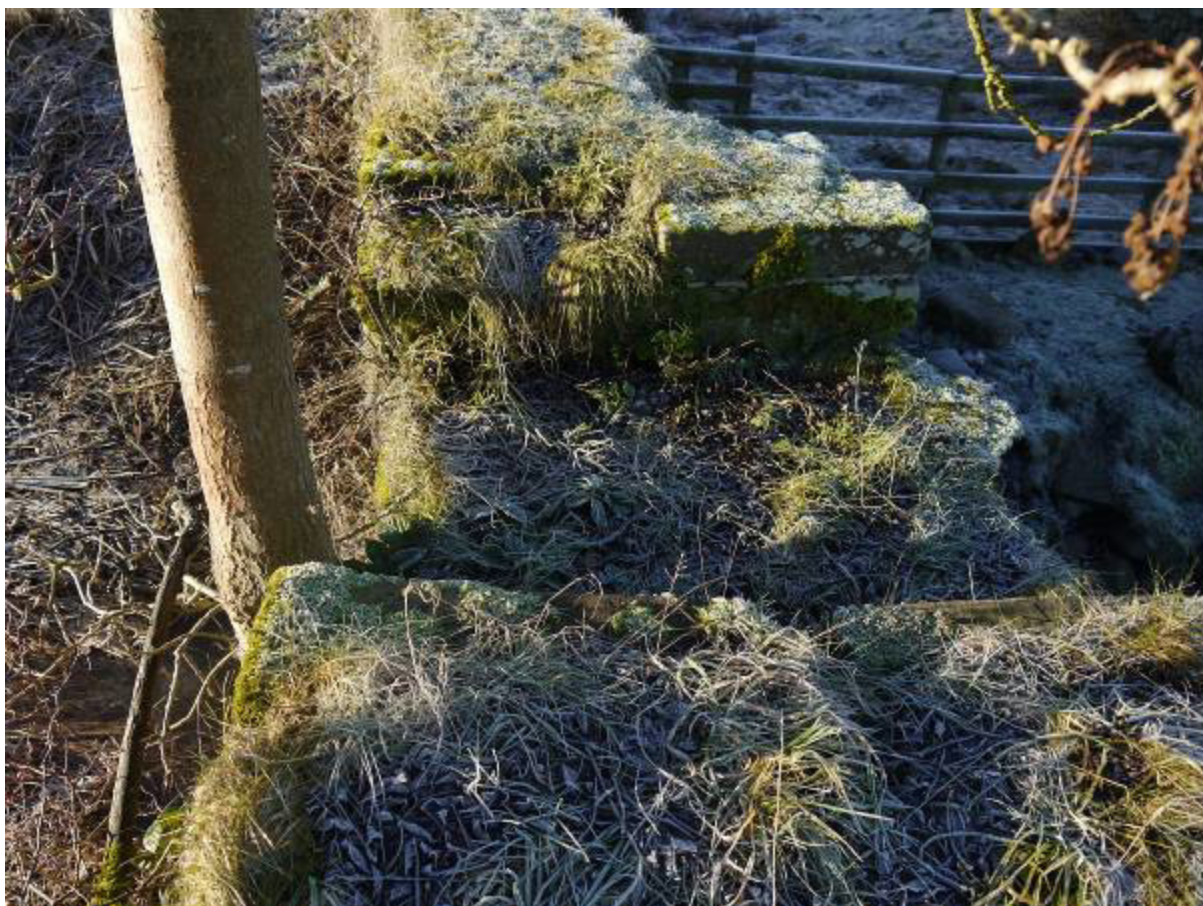
Illustration 19 Top of sluice on top of dam wall

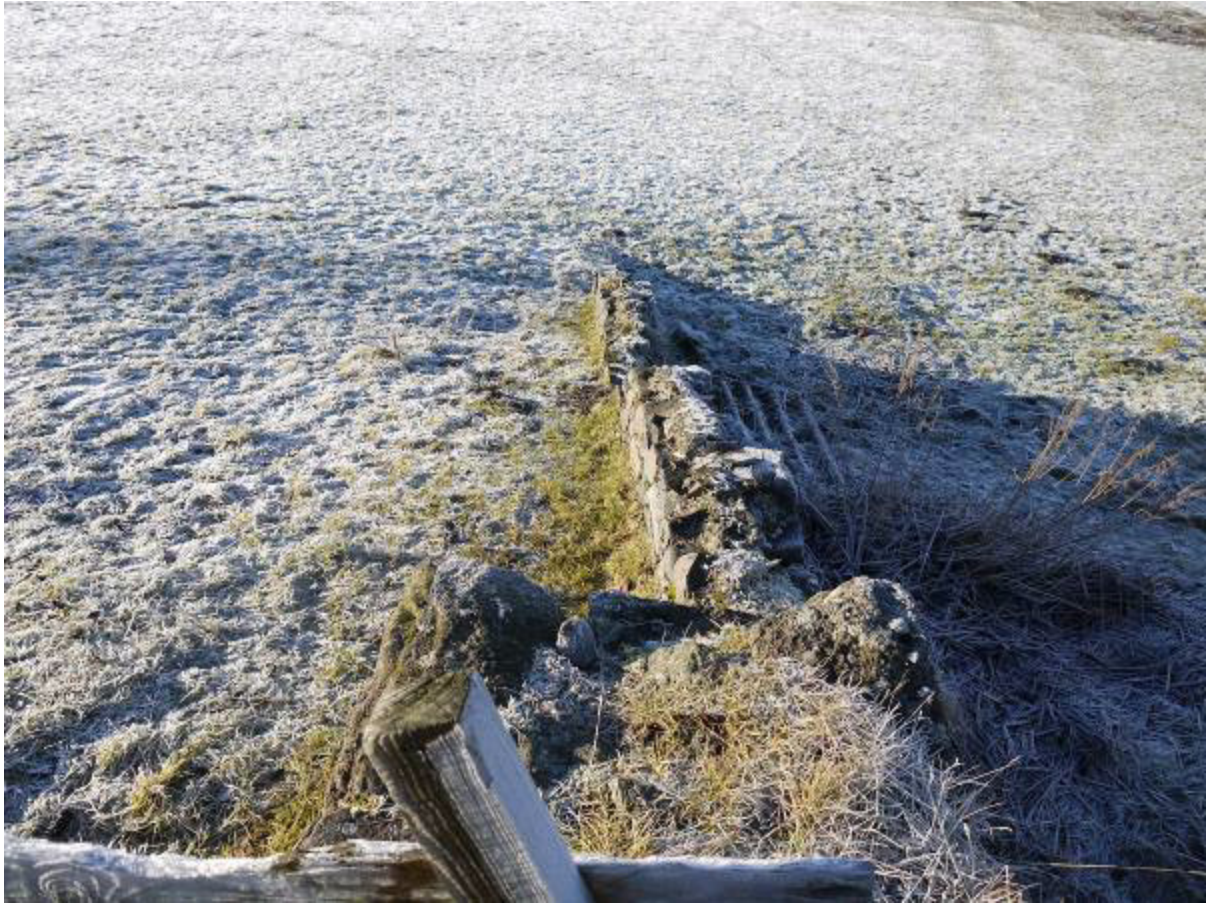
Illustration 20 Narrower piece of dam wall at its Western end

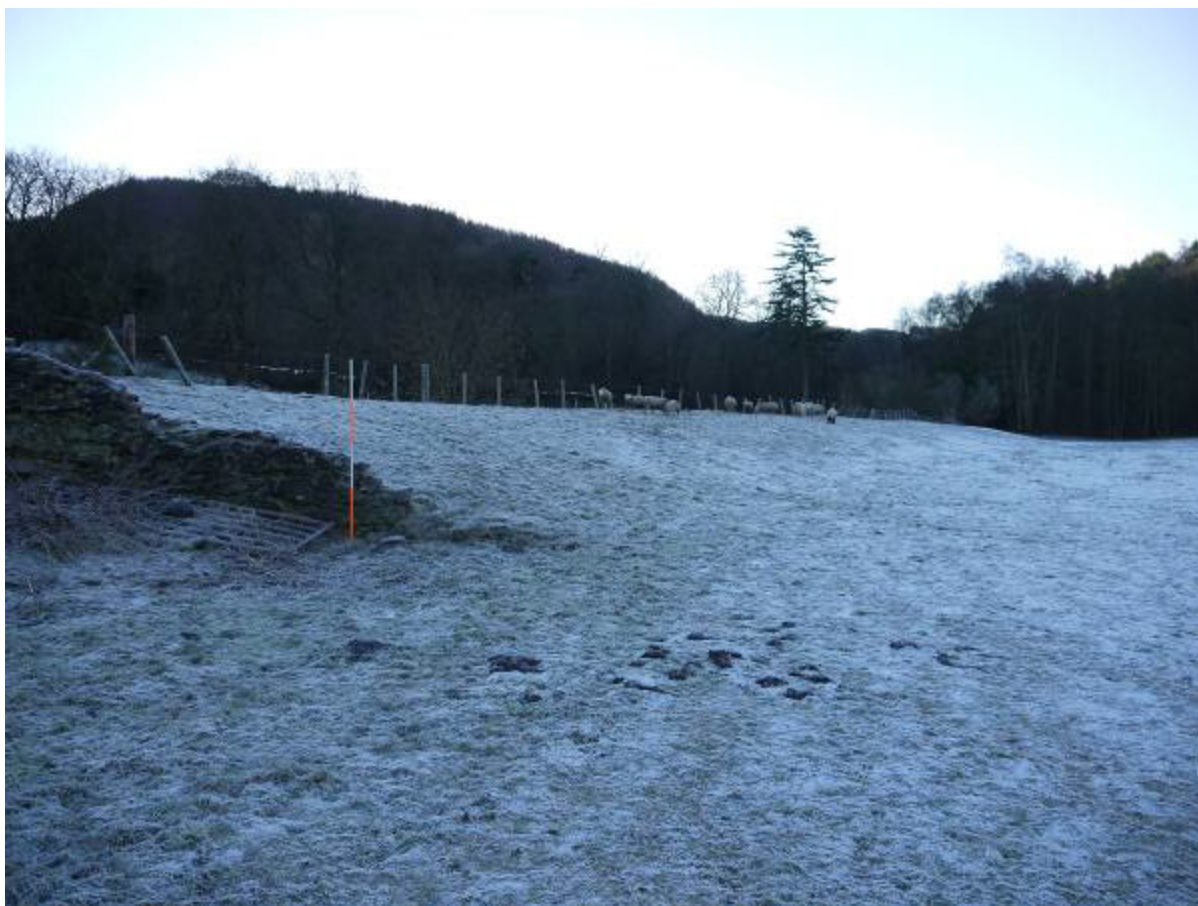
The most visible element of the mill pond is the substantial earthwork that formed its western boundary, this still runs up to the field boundary to the south. The eastern side of the pond is less well defined and a small stream still flows sluggishly through its entire length and feeds into the former mill lead to Ayton Farm.

Illustration 21 Earthwork forming Western side of mill pond looking South

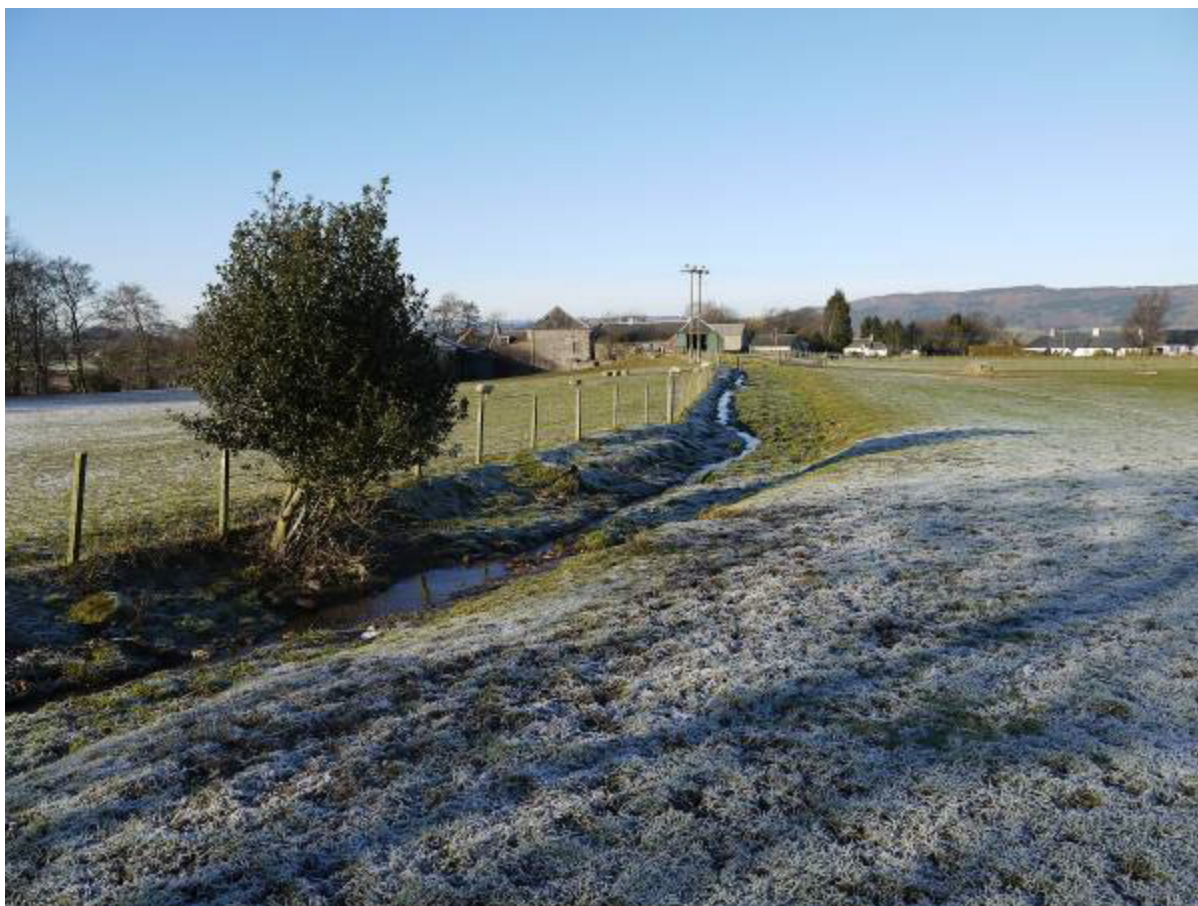
This is still visible running up to Ayton Farm where there is still a surviving stone built section just before a drop down to the former mill race and wheel housing of Farg's Mill. The lead can then be seen disappearing under the farm buildings in a culvert.

Illustration 24 Mill lead heading towards former mill at Ayton Farm looking North
