Standing Building Survey
Ayton Farm mill cottage and mill system,
Aberargie, Perth and Kinross

Mill cottage/dam house looking South

24th January 2011

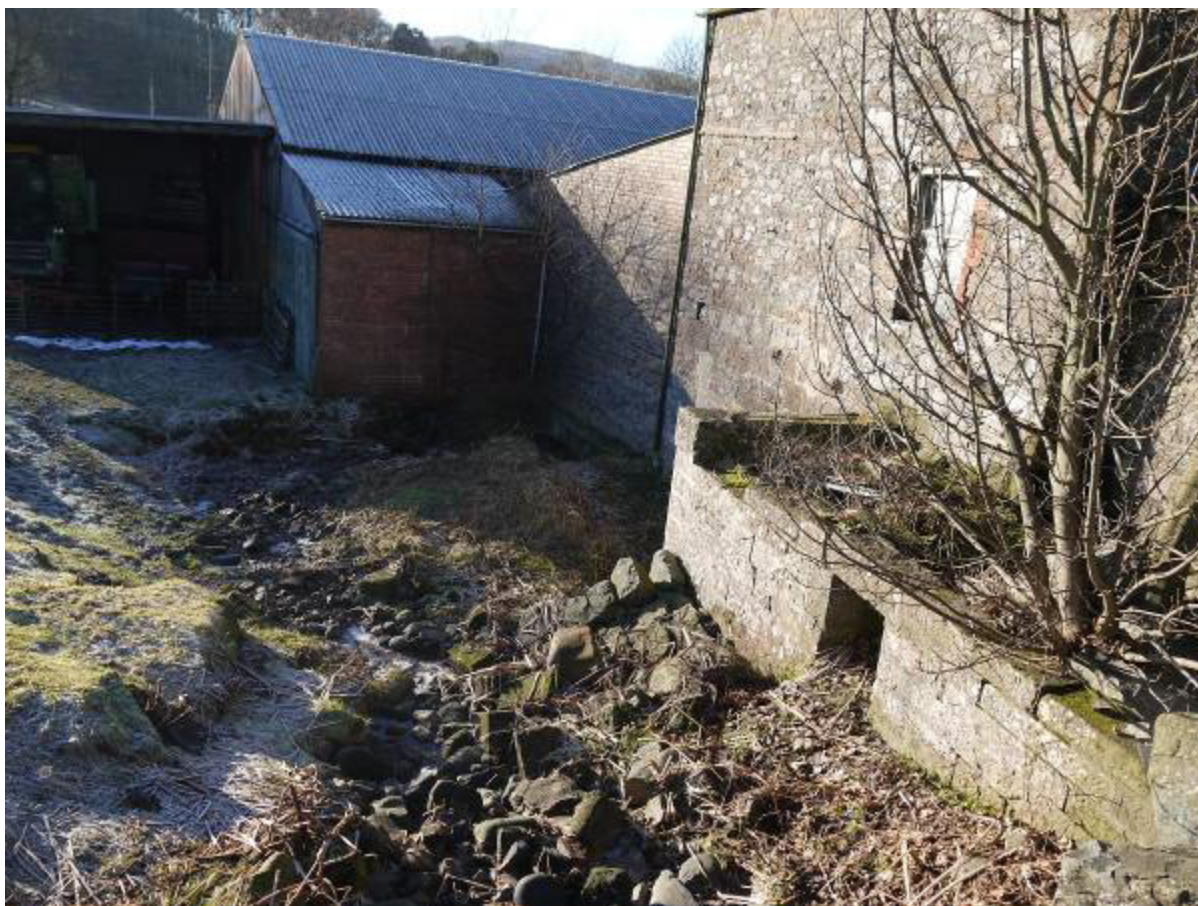
Illustration 25 Ayton Farm former Farg's Mill wheel pit and lead running under building looking East
