EAST LOGGIA ROOF

Hardwick Hall, Derbyshire

Historic Building Survey

August 2019

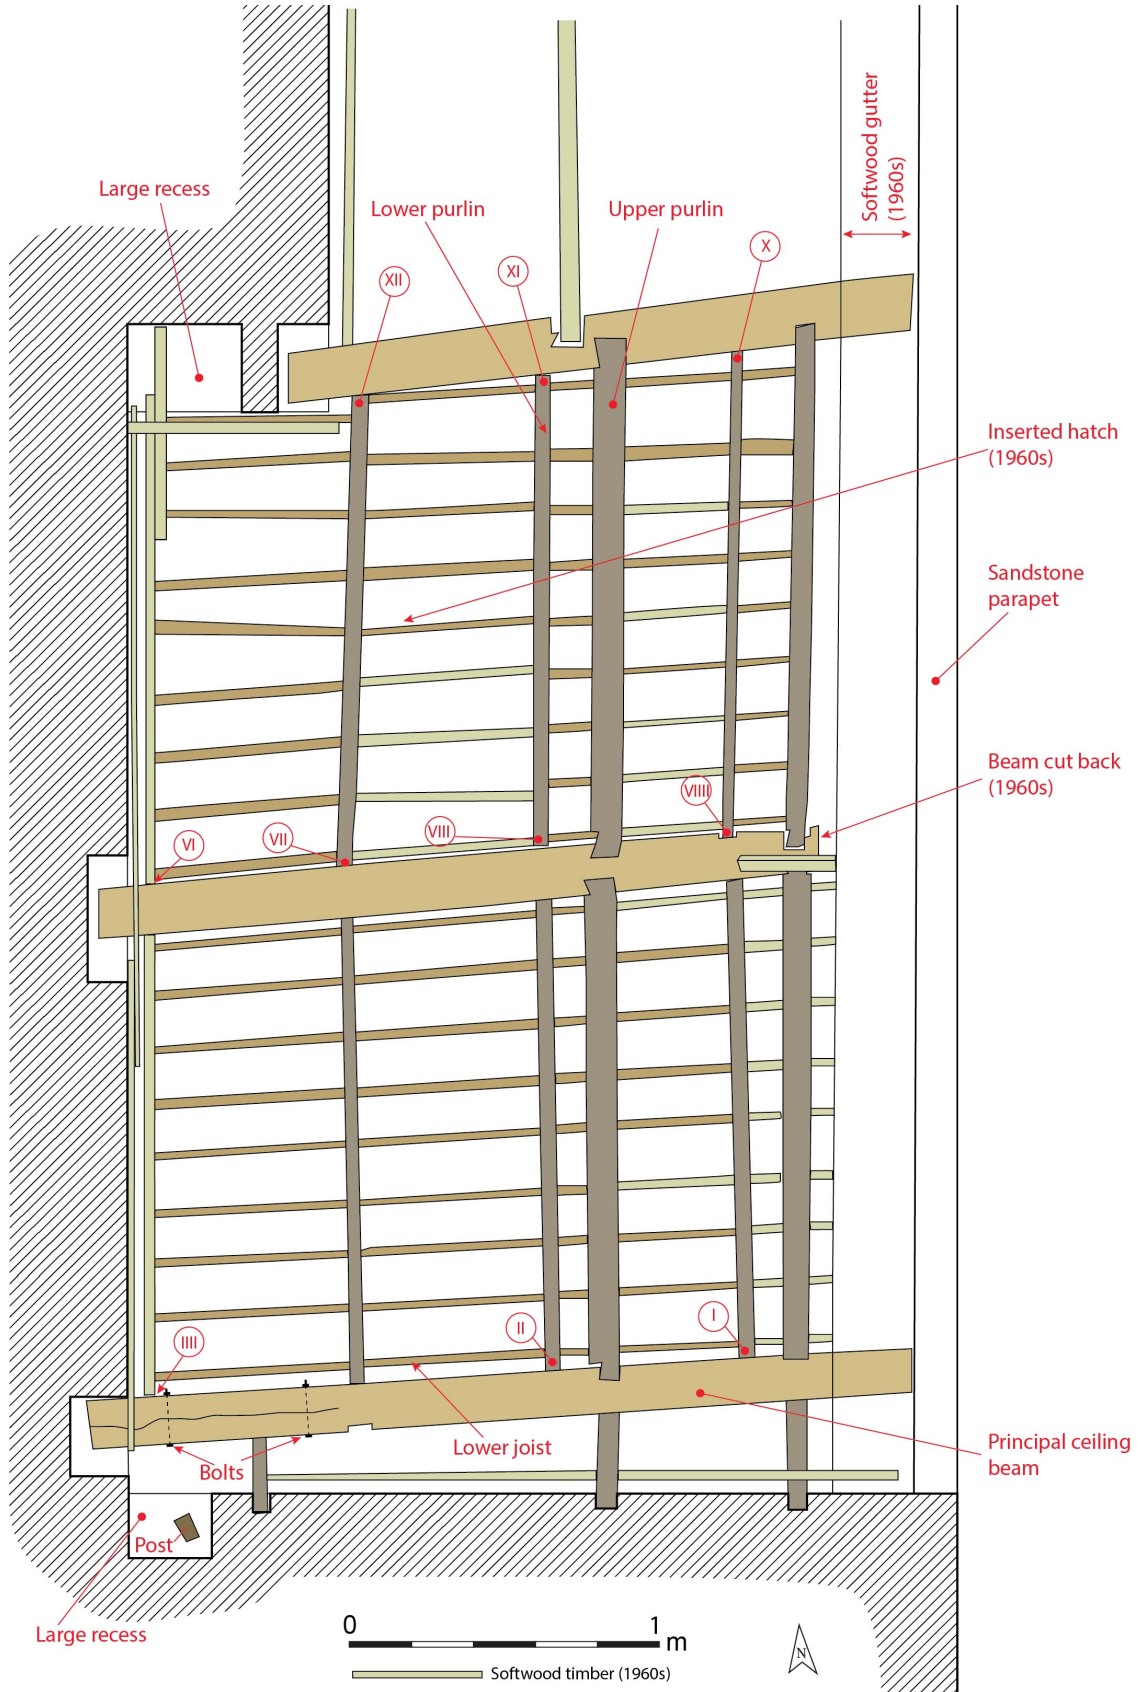
Figure 7: Arrangement of lower timbers within Section E

The roof of the east Loggia is supported upon seven large principal ceiling beams that are roughly orientated west-east (**Figure 7**). Although are slightly angled, presumably when being set within the existing stonework of the house and colonnade it was not possible to rotate them fully to a right-angled position. These beams are oak with dimensions of 33cm x 40cm and lengths of 5.10-5.2m. The central beam in Section E has been cut back (**Appendix 1.27**), presumably to remove a rotten piece of timber as part of the repairs undertaken in the 1960s. The eastern end of the principal ceiling beams are positioned on top of the stone columns of the colonnade below, whilst the opposite ends are housed within large sockets built within the stonework of the house.

The west end of the south principal ceiling beam (**Figure 7**) contains a large shake (split) in its upper face. This may have been due to water leakage from the downpipe immediately above (**Appendix I.23**). There are two large bolts with square heads (**Appendix I.33**) on either side of the shake and appear to represent a historic repair in this corner of the roof.

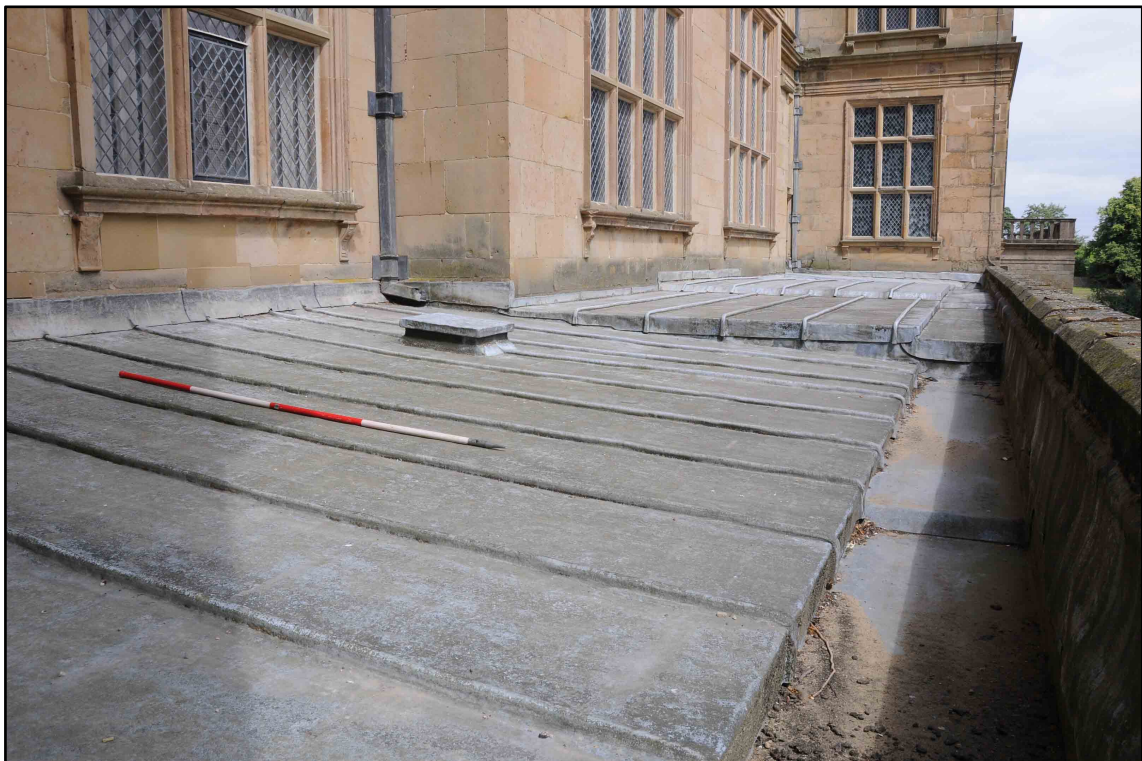
As part of the repairs undertaken in Phase 3 the central sections of the roof were raised (**Appendix I.8**). This involved the construction of a softwood super structure that sat above the existing rafters (**Appendix I.42**) being nailed together with round wire headed nails (**Appendix I.49**).

Appendix I.8: General view looking north of East Loggia roof before restoration (2m scale) (Photo D52)

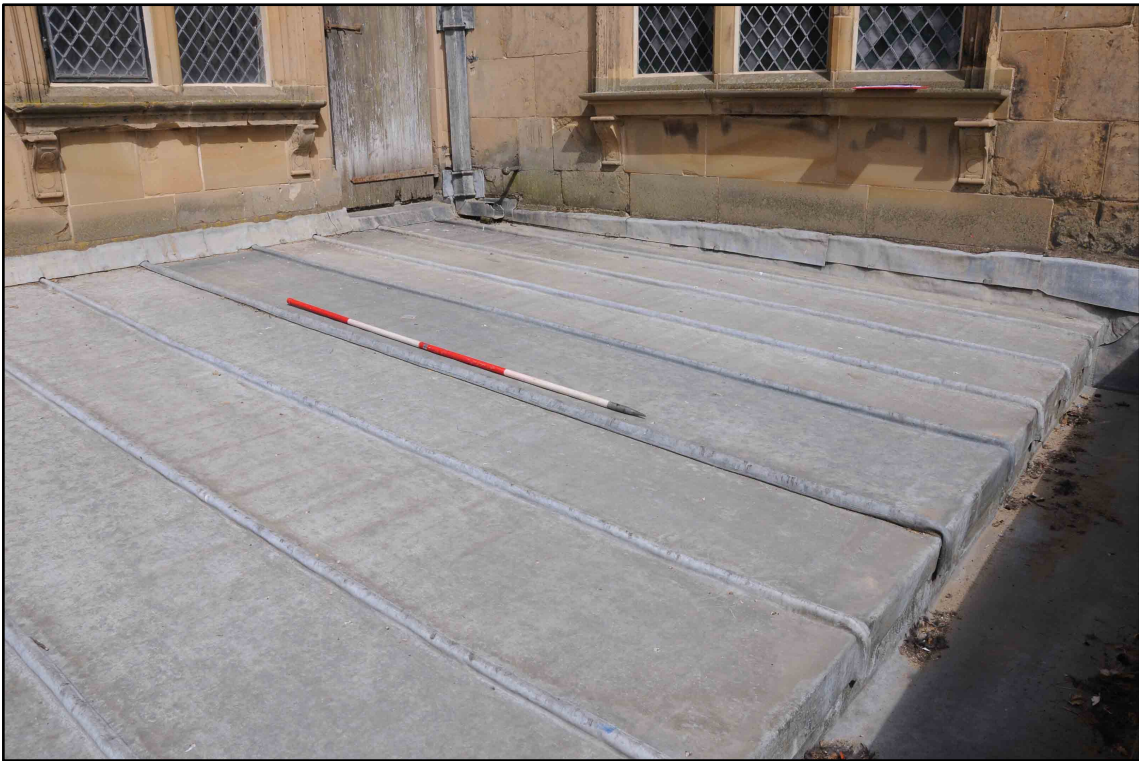
Minor patch repairs were undertaken to the lead sheet (**Appendix I.20**) and a single sheet was replaced in Section A in the northern part of the roof (**Appendix I.10**).

Appendix I.10: Detail of lead roof sheets in Section A, looking north-west (2m scale) (Photo D20)

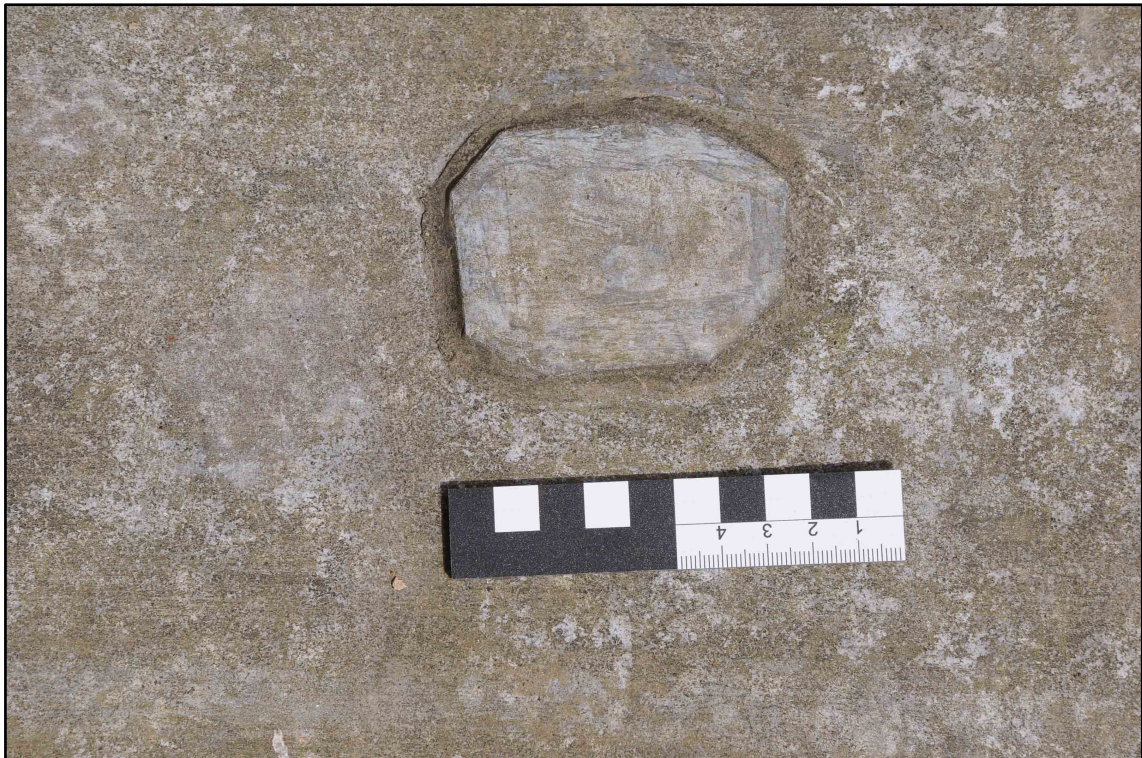
Appendix I.20: Detail of lead patch repair in Section C (10cm scale) (Photo D64)

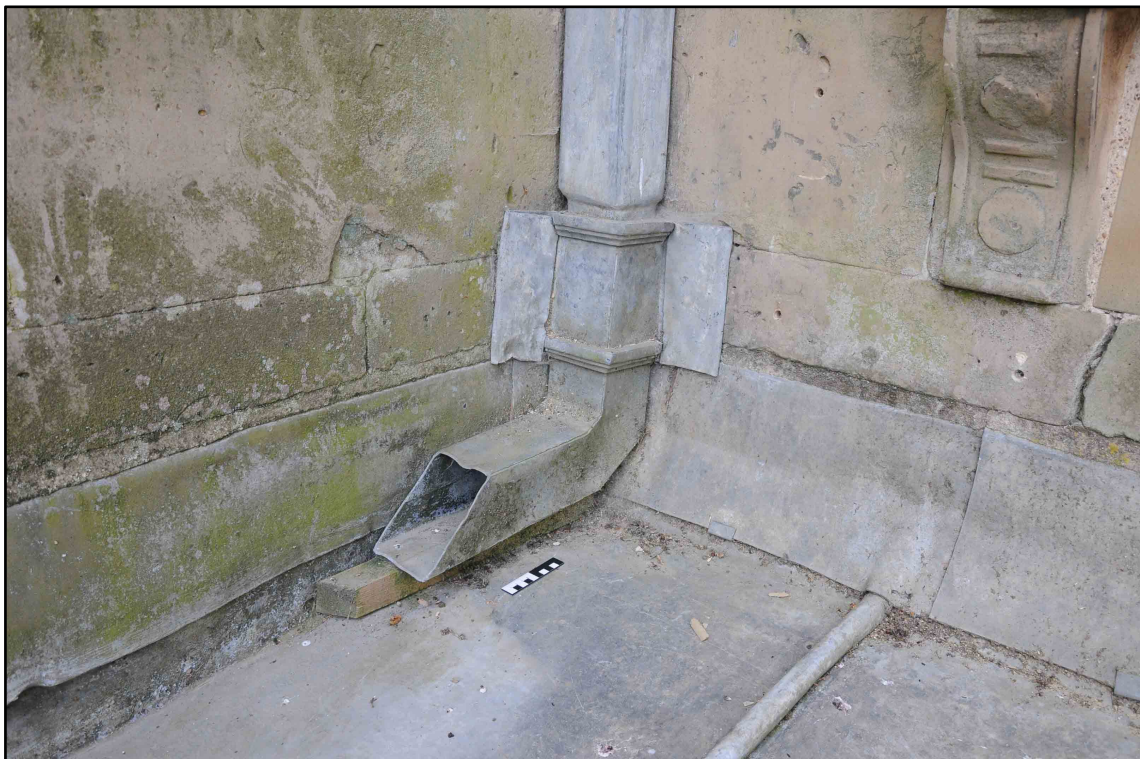
Appendix I.23: Detail of lead downpipe in southwest corner of Section E (10cm scale) (Photo D59)

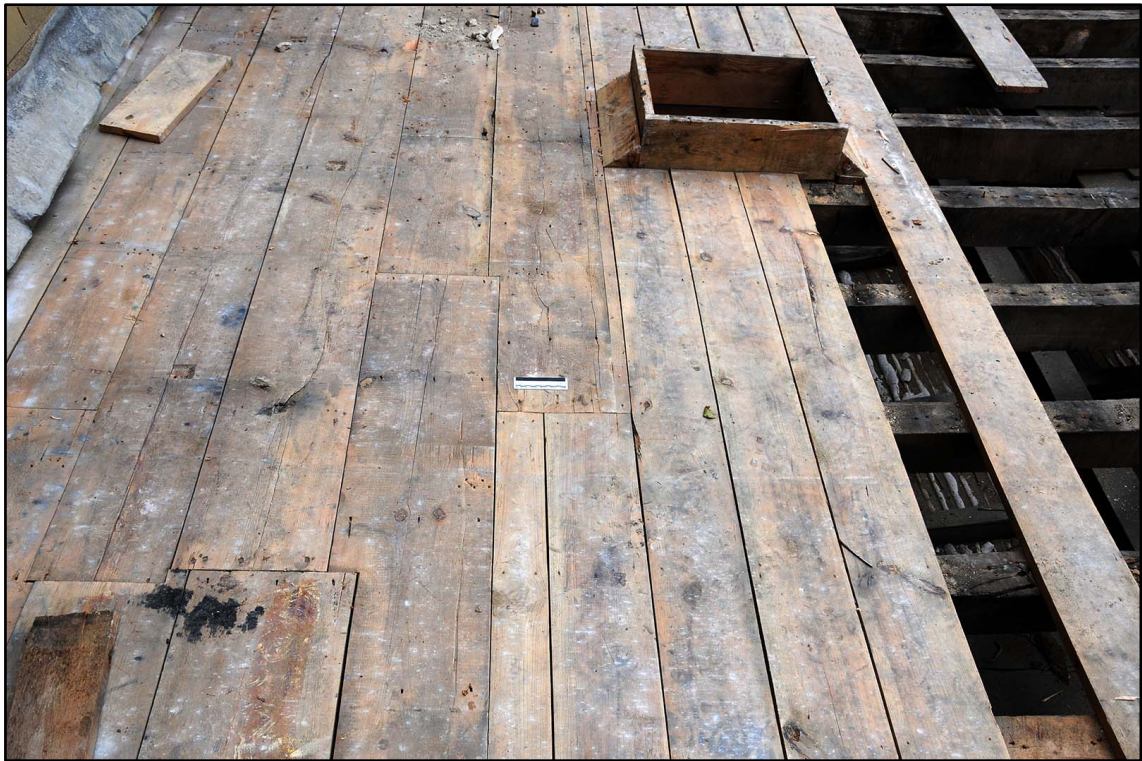
The timber boards were butt jointed and up to 4.32m in length, measuring 2.5cm x 17cm. Approximately 80% of the boards were replaced, although a section in the south-west corner may have been original (**Appendix 1.24**), being wider at 27cm, although shorter in length up to 3.4m. Two forms of nails were noted (**Appendix 1.49**), with the wider ones having hand-made nails.

Appendix I.24: Pine boards in Section E; note two different widths (10cm scale) (Photo D124)

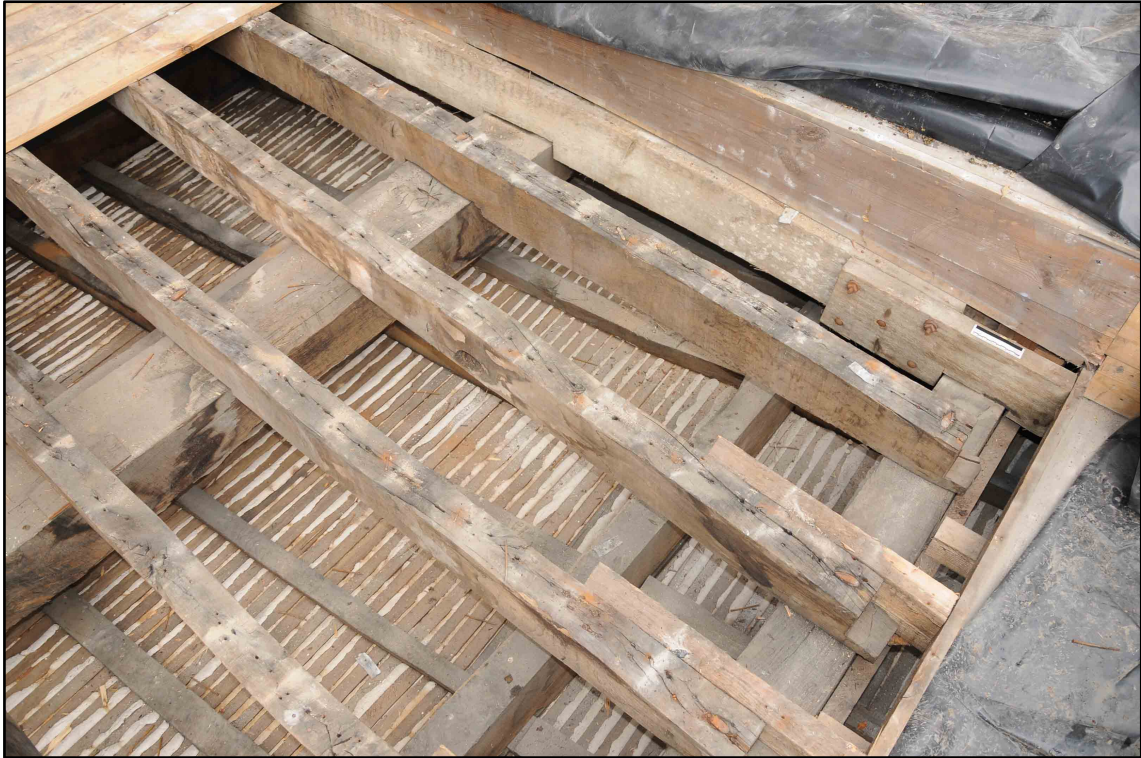
During the 1966-69 phase of repairs the ends of many of the rafters were strengthened by shorter sections of softwood (**Appendix I.28**), along with a complete bay in the south-west corner (**Appendix I.38**), where the original timbers were cut back to the edge of the upper purlin (**Appendix I.29**). These new timbers were noticeably narrower in section than the original oak purlins, as evidenced by the sockets within the east wall (**Appendix I.39**).

Appendix I.28: Detail of roof structure in Section E/D, looking north-west (10cm scale) (Photo D168)

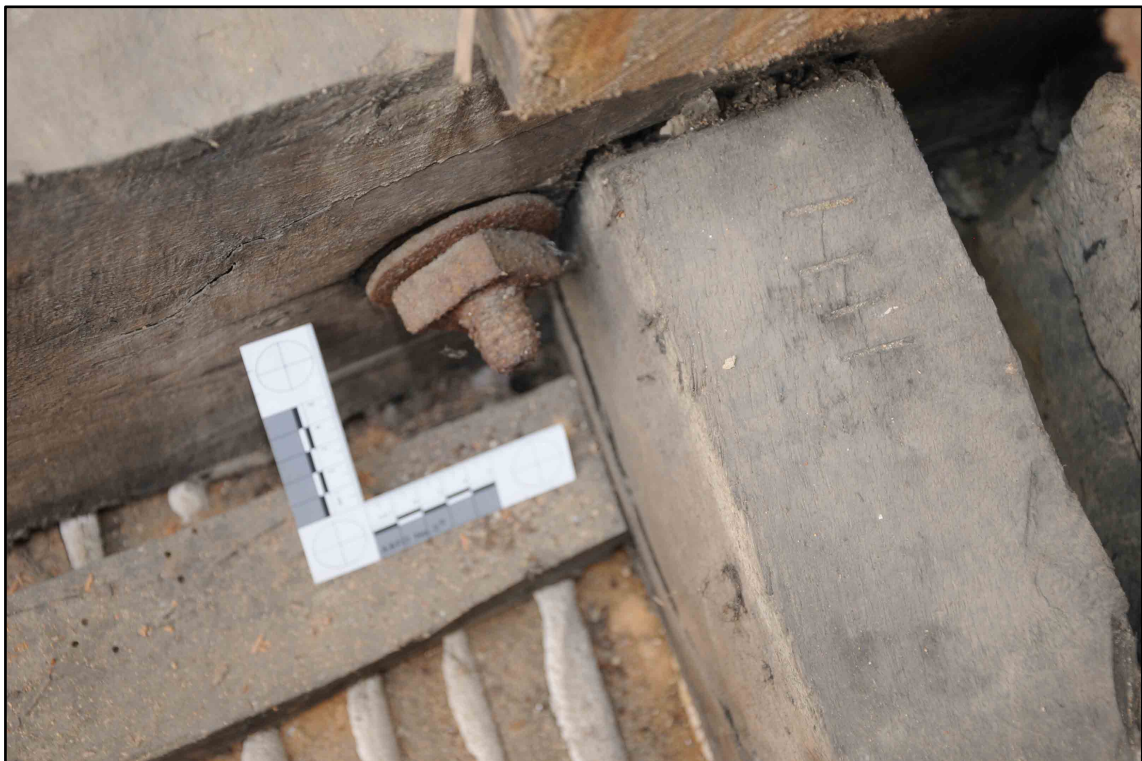
A single localised repair was observed in the south-west corner of the roof comprising of a pair of long wrought iron bolts with square heads (**Appendix I.33**) on either side of a large shake (split)

Appendix I.33: Detail of iron bolt (repair?) in south-west corner of Section E (5cm scale) (Photo D186)

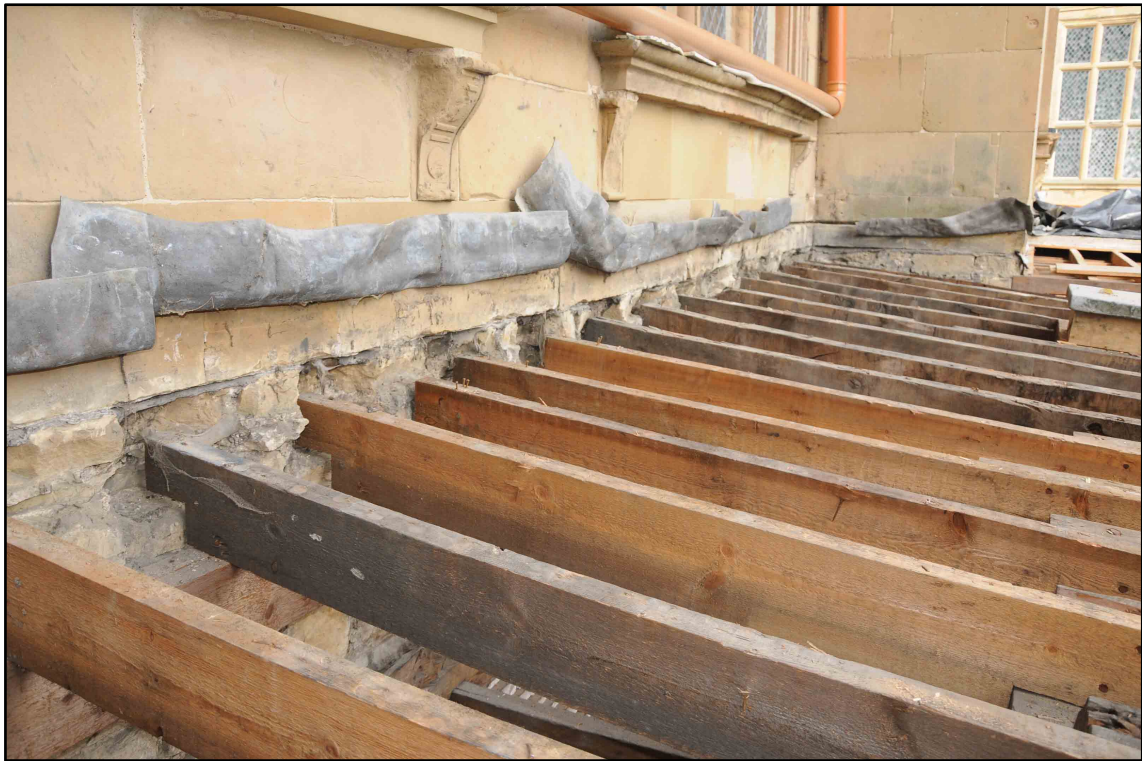
Appendix I.38: View looking north-west along replaced rafters in Section E (Photo D193)

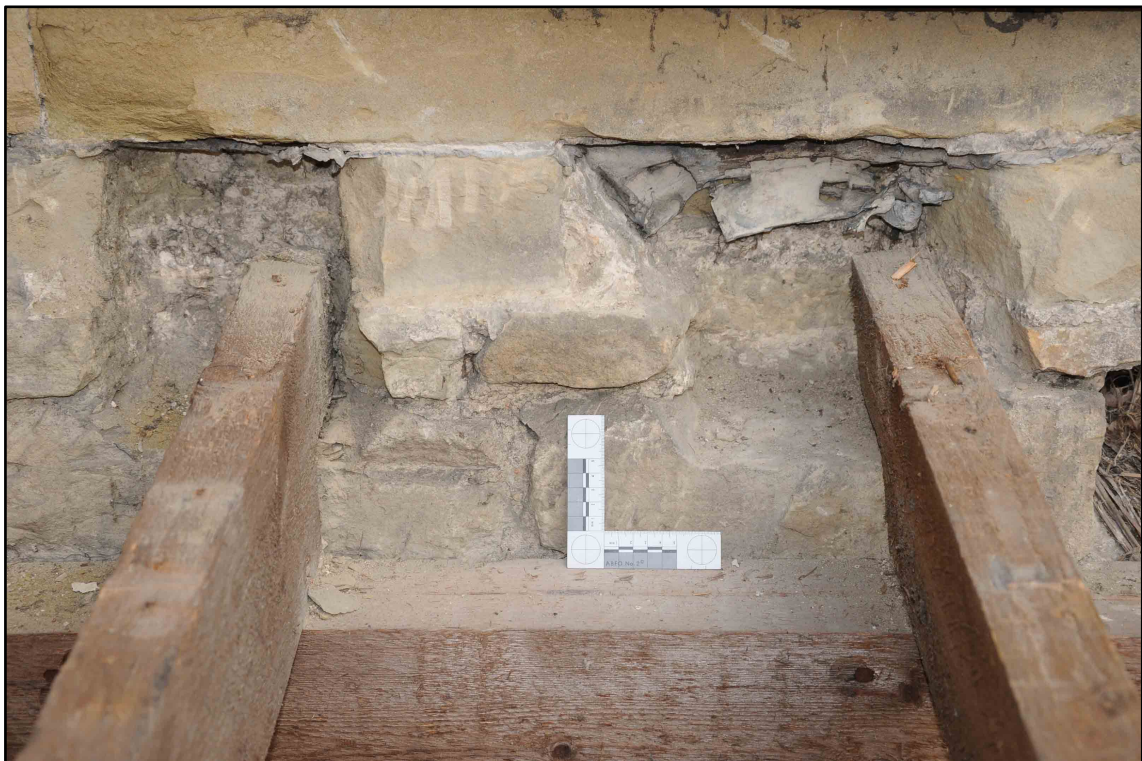
Appendix I.39: Detail of cut sockets for secondary rafters in Section E (5cm scale) (Photo D192)

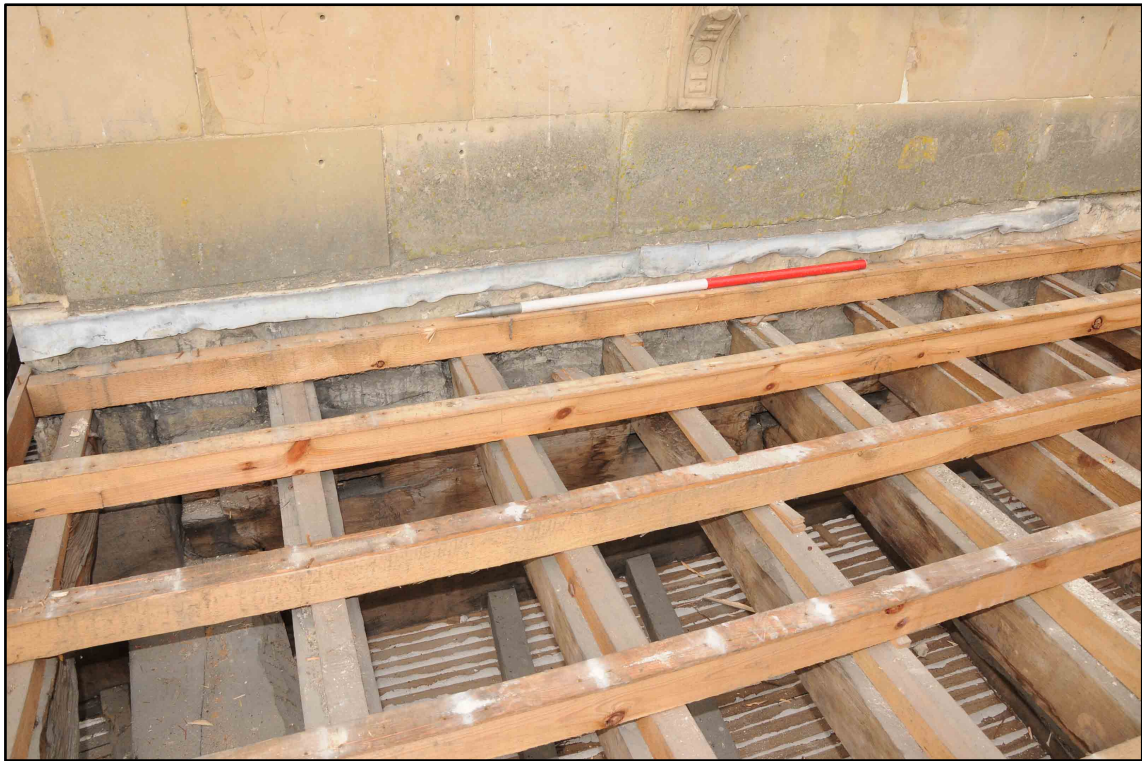
Appendix I.42: Inserted softwood timbers above oak beams in Section D (1m scale) (Photo D201)

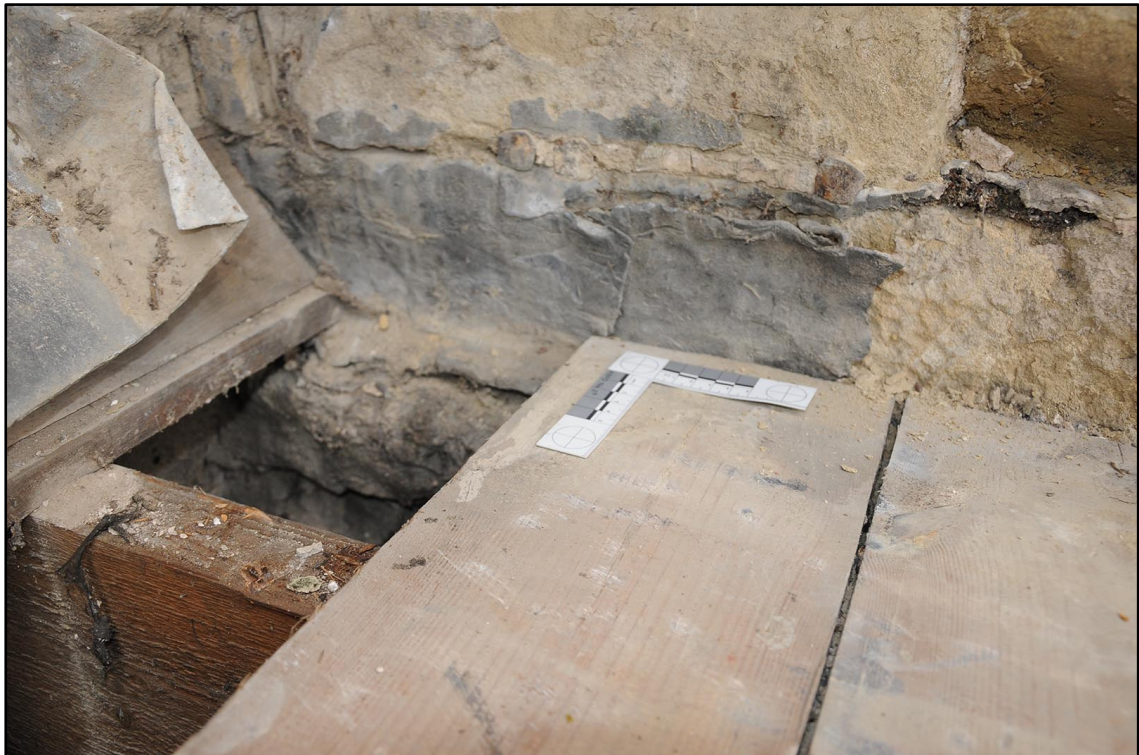
lead covering had been lifted and the boards removed a slight offset was noted in the vertical plain of the wall face which had trapped sections of an earlier flashing (**Appendices 1.38, 1.39, 1.47**) (**Figure 6**). This was set within the masonry joint of the course below the existing flashing with large flat headed iron nails/pegs (**Appendix 1.47**).

Appendix I.47: Detail of original lead flashing bent down below pine boards (5cm scale) (Photo D171)
