Ancient Monuments Laboratory
Report 46/97

WALL PAINTING CONDITION AUDIT,
DOVER CASTLE, KENT

J Davies
S Stewart

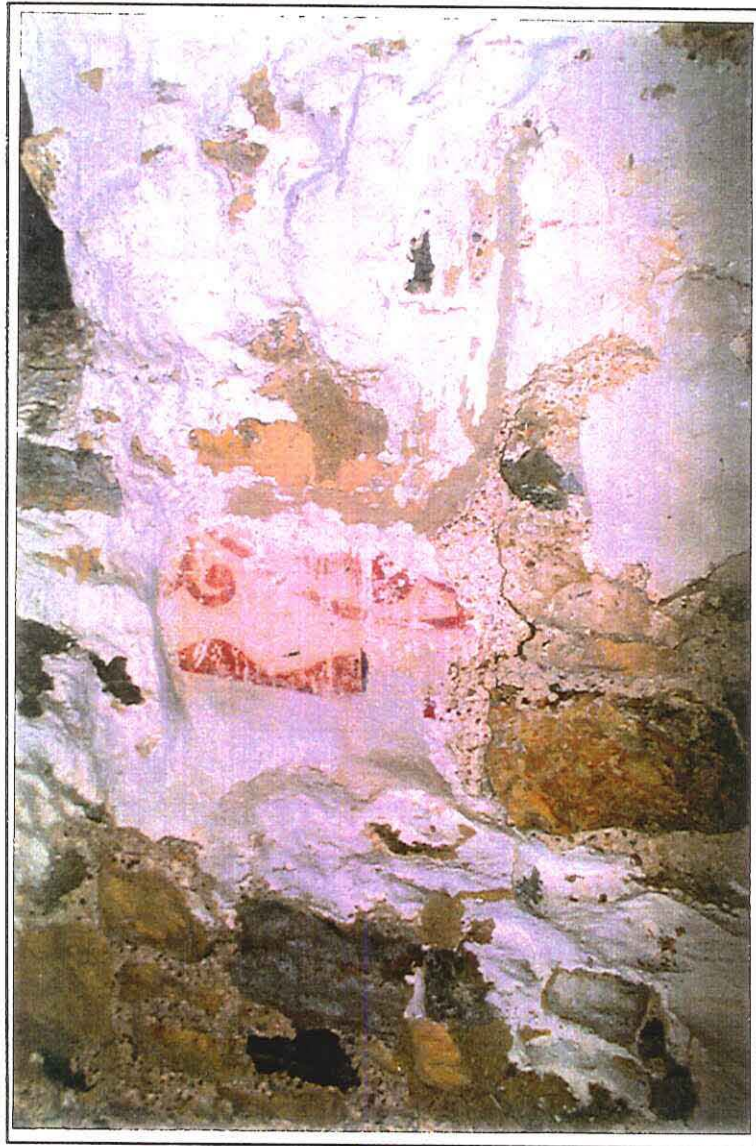
Great Hall, west wall, south end, detail painted plaster

This fragment is an important testimony to the original appearance of the room. However, its condition is poor and further loss appears to be occurring. Remedial treatment is therefore required. This should include minor grouting, edge repairs, removal of unsuitable repairs and flake fixing [Time scale: 2 conservators, 1 week, as soon as possible].

Comments Render layers are separating from the support and from each other.

Comments Render has become friable.

Comments Support is very obviously damp.

Comments Extensive loss of original. It appears that areas of the fragment have recently been lost as edge repairs are visible to areas where original plaster is no longer present. The render layers seem to be actively deteriorating.

Comments Powdering of the paint layer has occurred.

Comments Some limited flaking of the paint layer has occurred.

Comments Armour was previously hung in the room and some of the damage may have occurred during routine maintenance. Some smears of a black deposit (rubber from padded ladder ends?) appears to be associated with this damage.

Comments Further losses of the fragment appear to have occurred between 1982 and 1994.

Comments Possibly cement, very white, compact and hard, and appears to be associated with losses. Cement repairs seem to follow the form of original plaster which is lost, and the repairs now stand proud of the support. Traces of original render are present on the support.

Comments Consolidation of the friable paint layer is required.

Comments Repairs to render layer and edge repairs to support the original layers are urgently required.

Comments Removal of unsuitable repairs may assist in the stabilisation of the painting.

Type FLAKE FIXING **Date** 05/07/94
Person SS/JD
Comments Re-fixing of paint flakes is required.

Type GROUTING **Date** 05/07/94
Person SS/JD
Comments Grouting to consolidate the friable render layers and to readhere them to each other and the support is required.

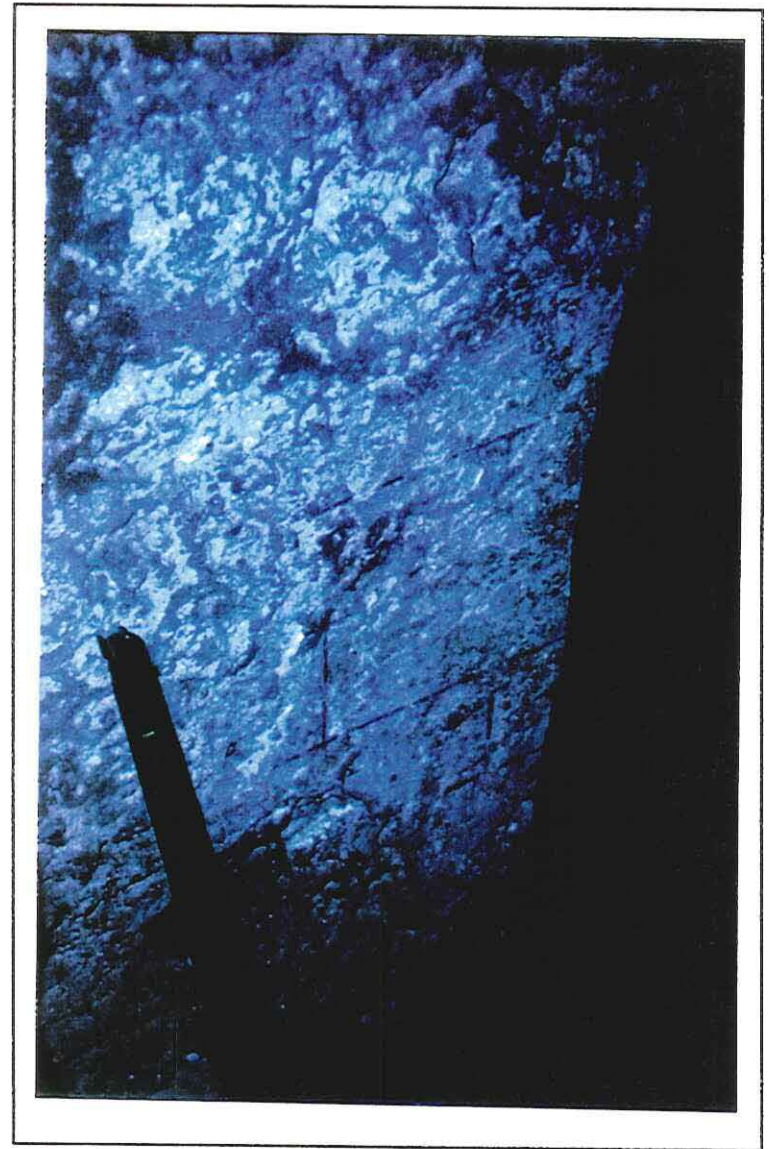
Regimental Museum, north wall, detail masonry pattern

The condition of the plaster and original decoration is poor. The render is severely delaminating and the surface is covered with dirt. This deterioration can be presumed to be active as the building as a whole is exceptionally damp. In addition all areas are at risk from mechanical damage due to the display which has been positioned extremely close to the wall surface.

Comments Render layer 1 is delaminating extensively from the support. Access was restricted and further investigation is required.

Comments Losses of paint, ground and plaster layers have occurred.

Comments The wall is very damp and according to the Curator spalling of plaster from the walls throughout the building is common. Microbiological growth was noted on the wall above and to the right of the painted area.

Comments Fine cracking has occurred throughout.

Type unidentified deposit
Location General
Comments Unidentified surface deposit, possibly alveolar deterioration. Dripmarks also visible.

Type plaster
Location General
Comments Hard lime/sand plaster, 0.5 cm thick, in poor condition, overlies original plaster in many areas. It may be possible to uncover more of the original scheme by removal of this layer, but this is not certain as it may have been applied to cover damages.

Type cement
Location Small patch, middle left.
Comments Possibly a white cement OR very dense lime rich mortar used as an edge repair, may be of the same type of white cement (?) noted in the Great Hall.

A programme of remedial conservation is therefore required in the very near future to stabilise the plaster as far as possible and to prevent further loss. This should include a preliminary recording phase (condition survey, photography, environmental survey) upon which an overall treatment strategy can be based. Treatment will probably include extensive readherence of the plaster layers to the support (grouting), insertion of repairs as necessary and surface cleaning. In addition a monitoring programme should be implemented. [Approximate timescale for treatment, 2 conservators, 2-3 weeks, as soon as possible].

Comments Surface cleaning to remove dirt, dust and cobwebs would significantly improve the appearance of the painting.

Comments Repairs are required.

Comments Removal of the hard white cement? repair is recommended.

Comments Grouting to re-attach the delaminating render to the support is urgent.

Comments Removal of overlying plaster may reveal more areas of design.
