Ancient Monuments Laboratory  
Report 1/90

ANALYSIS OF PLASTER SAMPLES FROM  
CLEEVE ABBEY, SOMERSET.

J G McDonnell BTech PhD MIFA

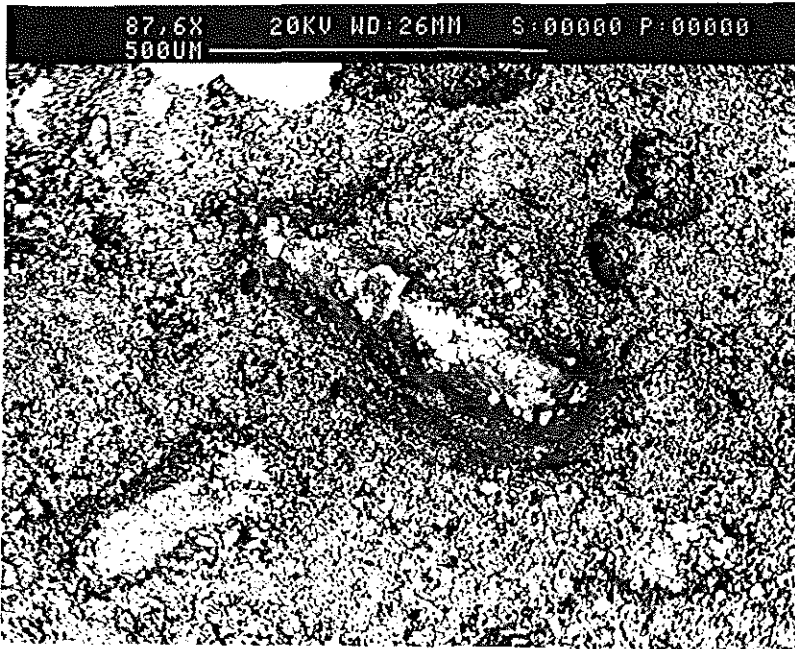
Further examination of the mortar showed the presence of cubic crystals (Plates 1-3). Spot analysis of the crystals identified them as sodium chloride (Figure 2).

The blistering of the mortar surface is probably due to the growth of sodium chloride crystals in the mortar, caused by fluctuating Relative Humidity (RH), and/or rising damp.

Plate 1  
SEM micrograph of  
mortar showing  
growth of crystals  
(white) in centre  
and lower left of  
field of view (x87.6).

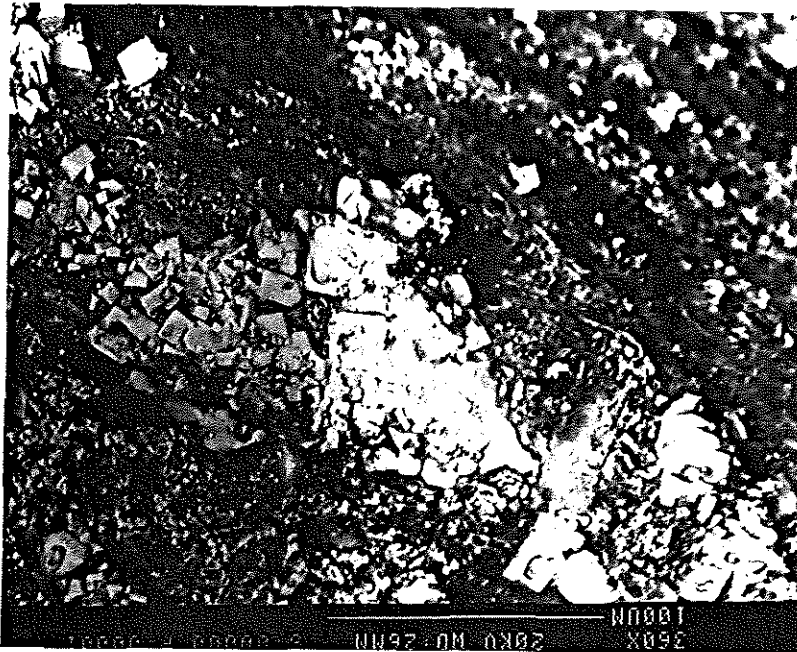
Plate 2  
Centre of plate 1 at  
increased magnification  
(x360)

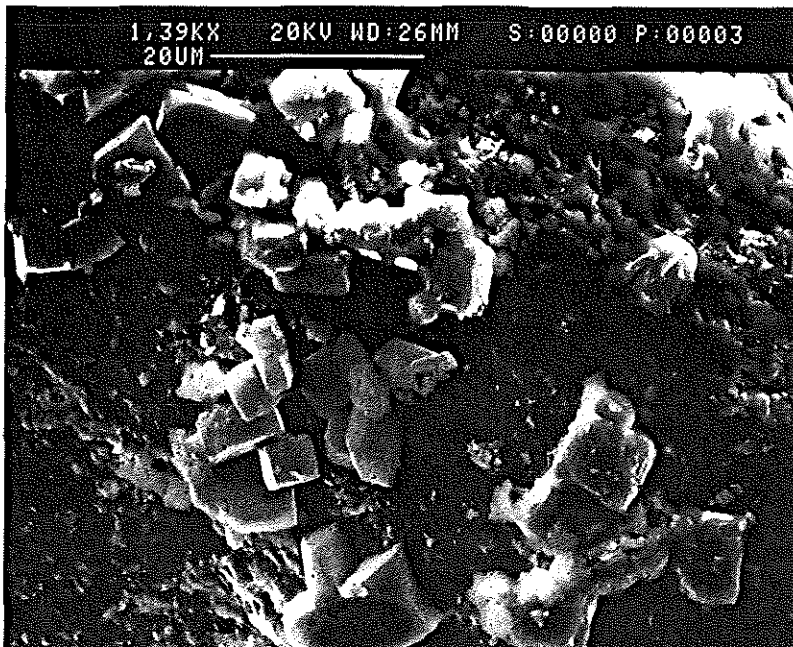
Plate 3  
Detail of crystals,  
note cubic form (x1390)

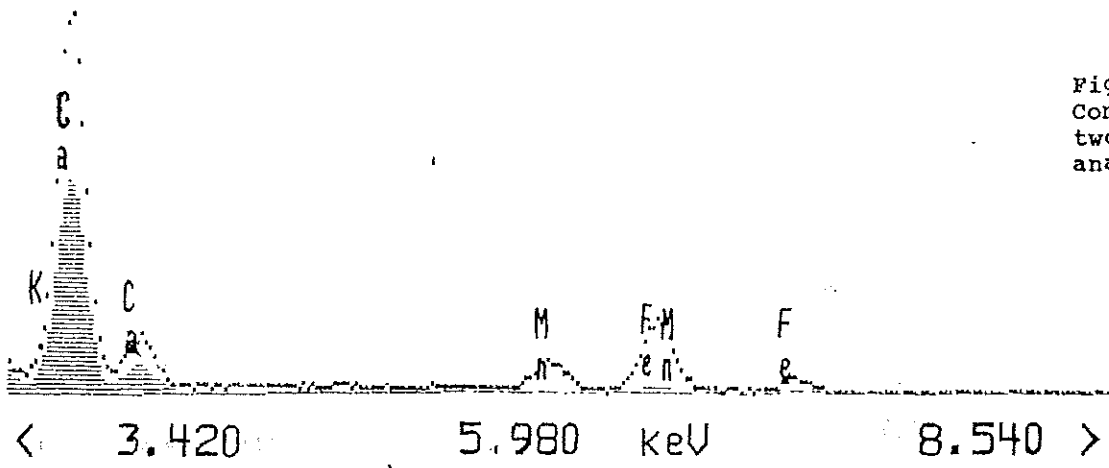
A sample of each mortar and a sample of local slate were mounted on stubs, coated with carbon (to make them conducting) and examined in the SEM. Energy dispersive X-ray analysis was used to qualitatively examine the chemical composition of the slate sample and the inclusions in the mortar. The texture of the mortar was also investigated. Analysis of the inclusions showed them to be similar to the local slate sample, but there was considerable variation in composition (Figure 1), particularly in the presence/absence of iron and manganese. Analysis of the local slate detected the presence of titanium, which was absent from the inclusions in the mortar, but given the variation already observed between inclusions, small variations in all elements must be expected. Therefore, no firm conclusion can be drawn about the source of the inclusions without further detailed analysis.

Examination of the inclusions and the mortar/inclusion interface showed that there was no evidence for chemical reactions, eg the growth of sulphides etc, that might cause the eruptions on the mortar surface.

Figure 1  
Comparison of  
two inclusion  
analyses

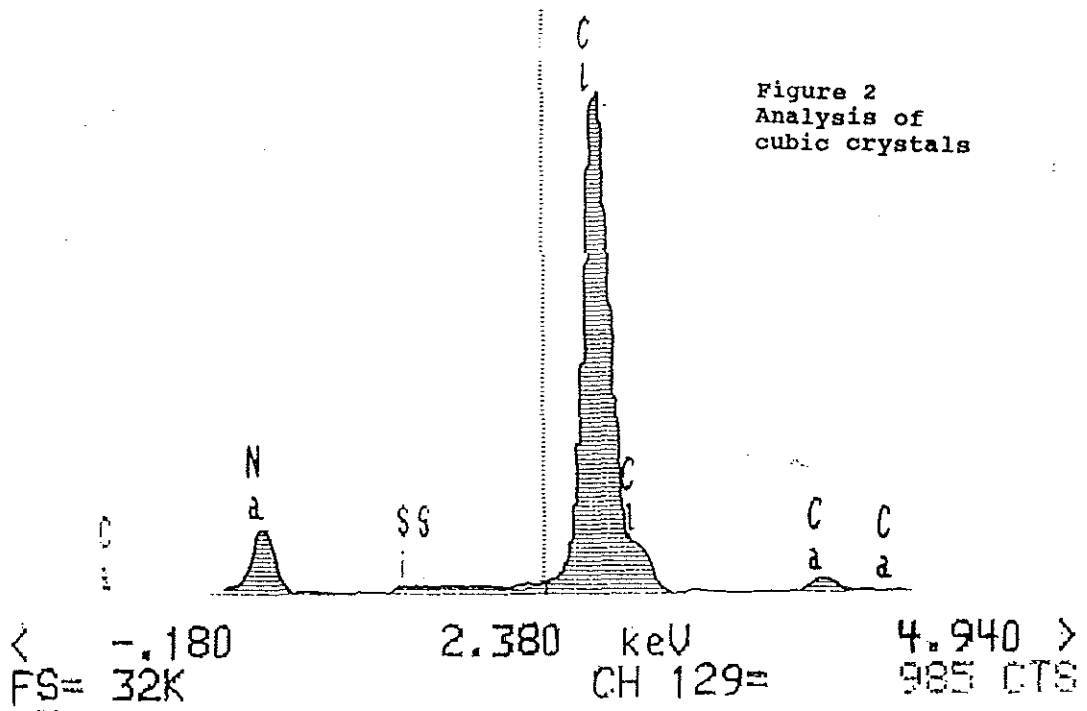
Figure 2  
Analysis of  
cubic crystals
