# Archaeological Investigation: Excavation and Recording

Fishpool Valley,  
Croft Castle,  
Yarpole,  
Herefordshire,  
HR6 9PW

Report by Stephen Wass MA, MCifA (7651)  
Polyolbion Archaeology  
For  
Imogen Sambrook, Project Manager,  
Janine Young, Archaeologist,  
The National Trust

October 2017

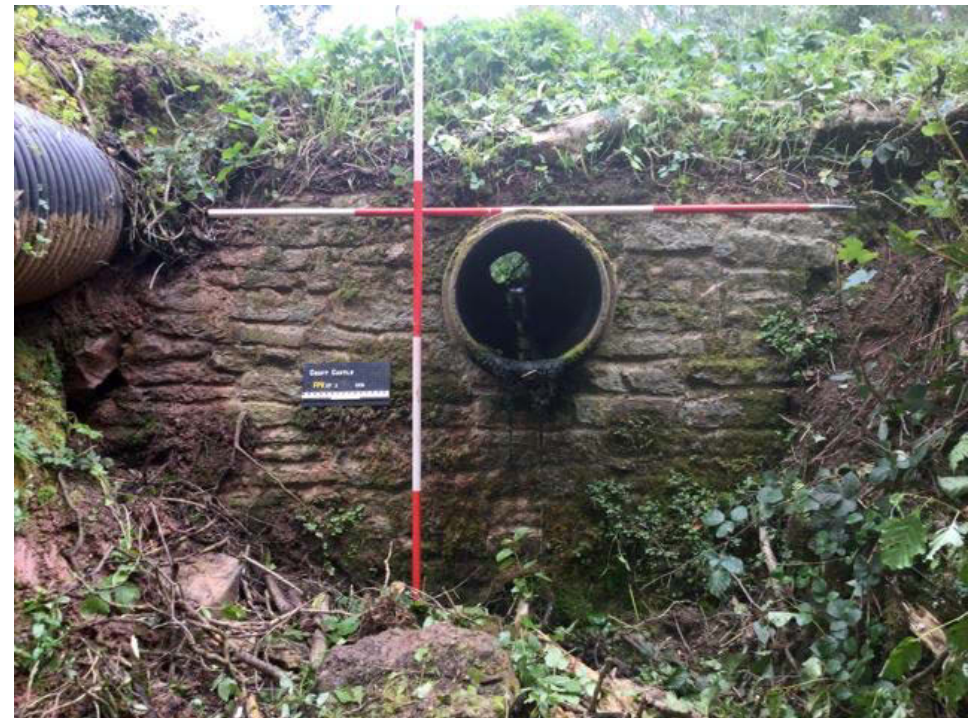
Access to IP1 was problematic with a large mass of loose stones and tangled branches making for an unstable footing. However after some initial clearing of vegetation a stone retaining wall supporting the outflow end of a large ceramic pipe (001) was revealed (Fig. 7). Although this appeared to be entirely recent in construction with Portland cement in use the possibility remains that this was a rebuild of an earlier wall. This feature is comparable with the wall in a similar position on dam 2 which was demonstrated not to be part of a cascade. The opportunity was taken to clean down a section of the near vertical face of the scour channel 5m to the east of the wall to examine the make up of the dam. Below a reddish grey clayey loam topsoil (004) was a capping of silty clay up to 0.5m thick (002) which was above a deep deposit of gravel in red silty clay (003).the friable nature of this deposit goes some way towards explaining the heavy erosive impact of the flooding events which have damaged the fabric of the dam.

Fig. 7 IP1 Retaining wall and pipe view looking west.

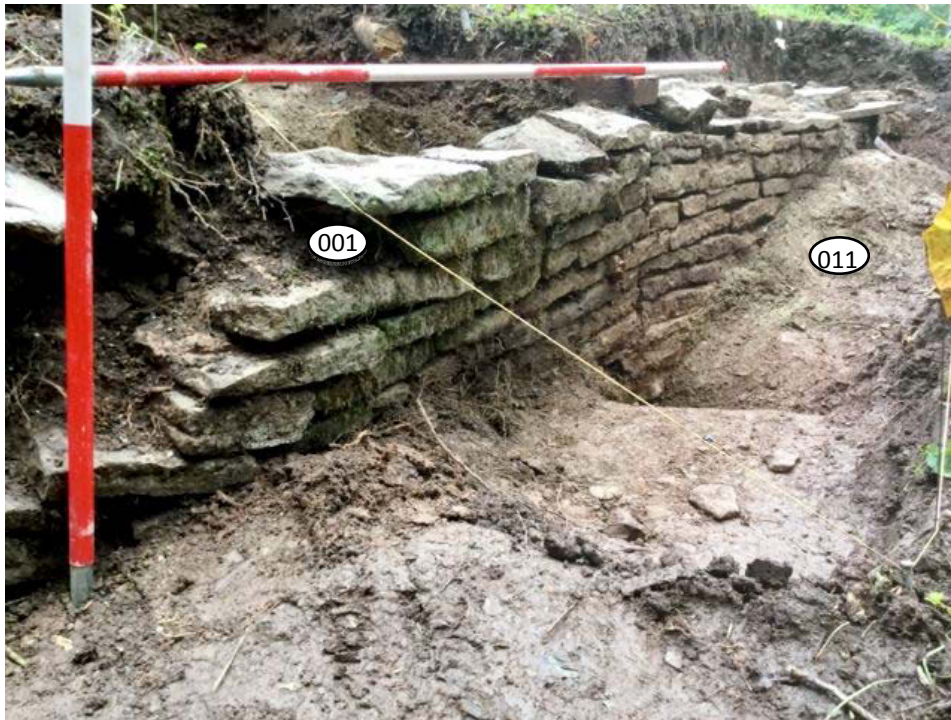
As the north face is well finished but the south face is rough and irregular the structure was clearly built partially as a revetment wall. Whilst appearing to be dry built removal of some stones revealed a hard gritty reddish mortar. In places the wall has been all but reduced to a scatter of rubble by the action of tree roots. Immediately adjacent to its northern face is a small area of pitched stone paving (004) roughly 1.2 x 0.8m (Fig. 13) and bedded in a light grayish brown clay (013). This is assumed to be a small surviving section of a water channel or spill way leading down from the crest of the dam, the rest having slipped into the scour channel to the north.

Fig. 10 IP2 wall 001 west end looking south west.

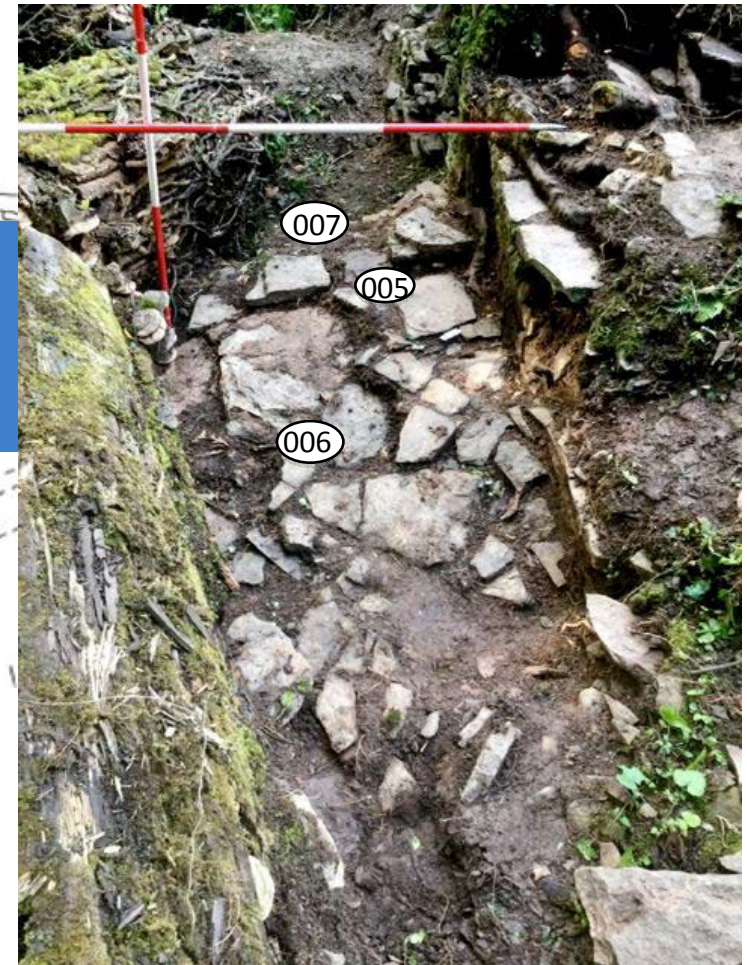
Fig. 12 IP2 Features associated with possible cascade, view looking north

Conclusions. Although badly damaged and largely eroded away enough remains to tentatively reconstruct the arrangement here for a long shallow spill way. The observations made in 2006 give us an idea of the possible width (Fig. 11) indicating that the whole structure was around 10m x 1.2m. The spill way terminated in a vertical plunge of around 0.7m and the water then flowed out along a gently sloping cascade made a several shallow steps. It is possible that at some point this arrangement failed catastrophically, this and the subsequent insertion of pipes and a drainage gully to the north has removed all traces of the northern retaining wall of the structure. The weak point in the dam left after the spill way was abandoned was made good with a dump of clay and gravel and later by the addition of a concrete beam.

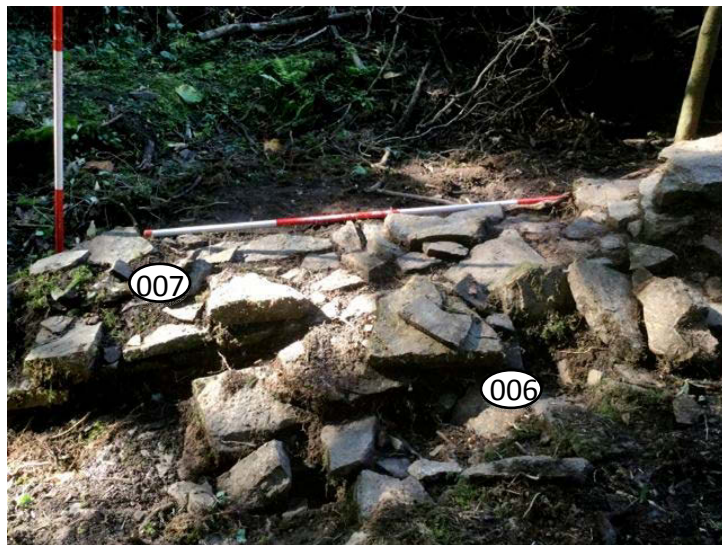
Fig 14 IP2 Extension of wall and cascade down slope looking south.

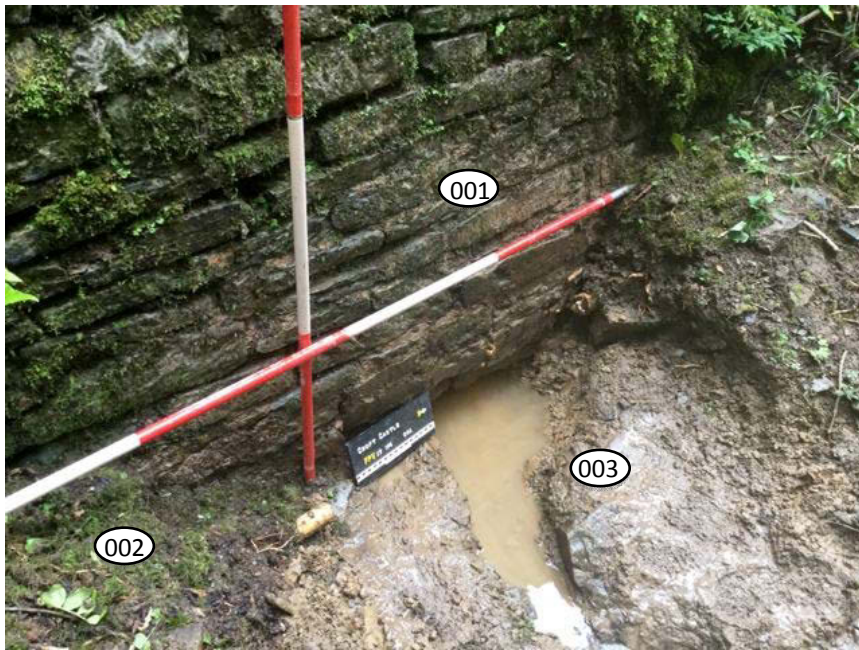
Fig. 22 IP4 recessed courses at foot of wall.

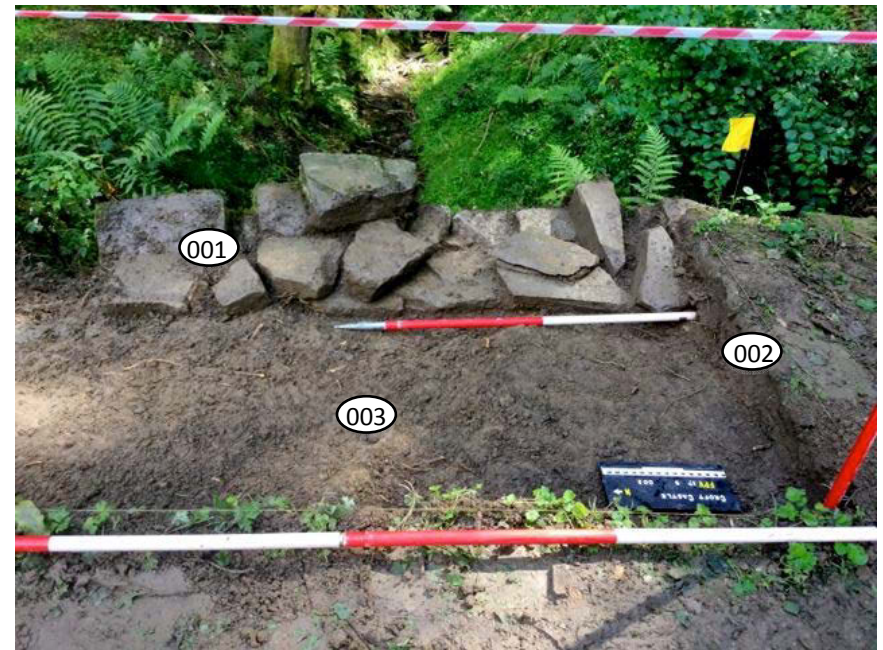
A trench 2.5m x 1m was laid out taking in, along its eastern margin, the top of the retaining wall (001). The wall was cleared of plant growth and turf and topsoil (002) removed to a depth of around 15cm. Below this was a deposit of brown silty clay (003) which was taken down by another 15cm to fully reveal the back of the retaining wall against which it had been packed (Fig. 23).

Fig. 23 IP5 Rear of retaining wall and clay make up looking east.

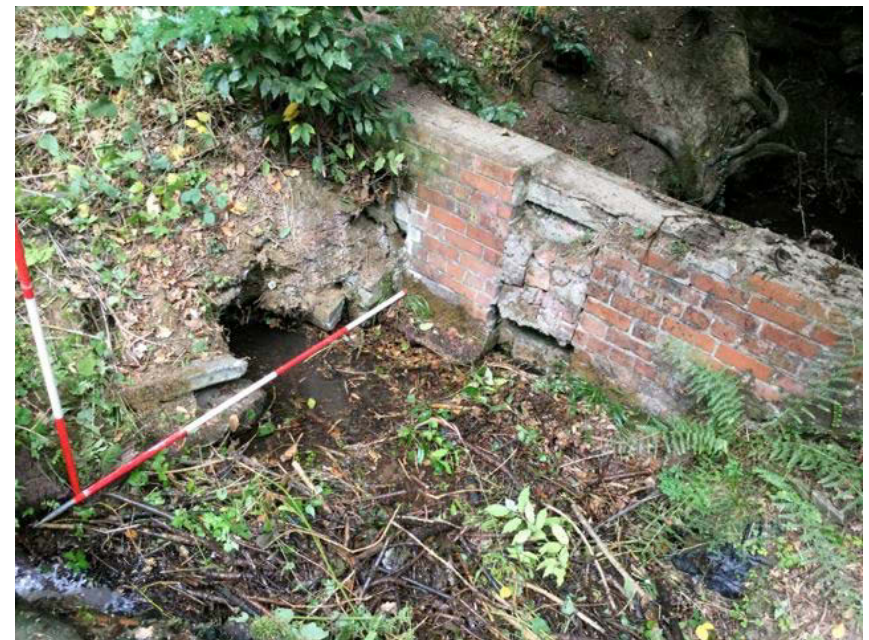
Fig. 43 IP10 Brick sluice looking north.

Conclusions. Although what could have been earlier stonework lining the channel to the north was noted the brick setting for the sluice itself, on account of the bricks used, the pointing and the concrete rendering on the east face has certainly been heavily repaired in recent times. There was no evidence of an earlier arrangement here although, of course an

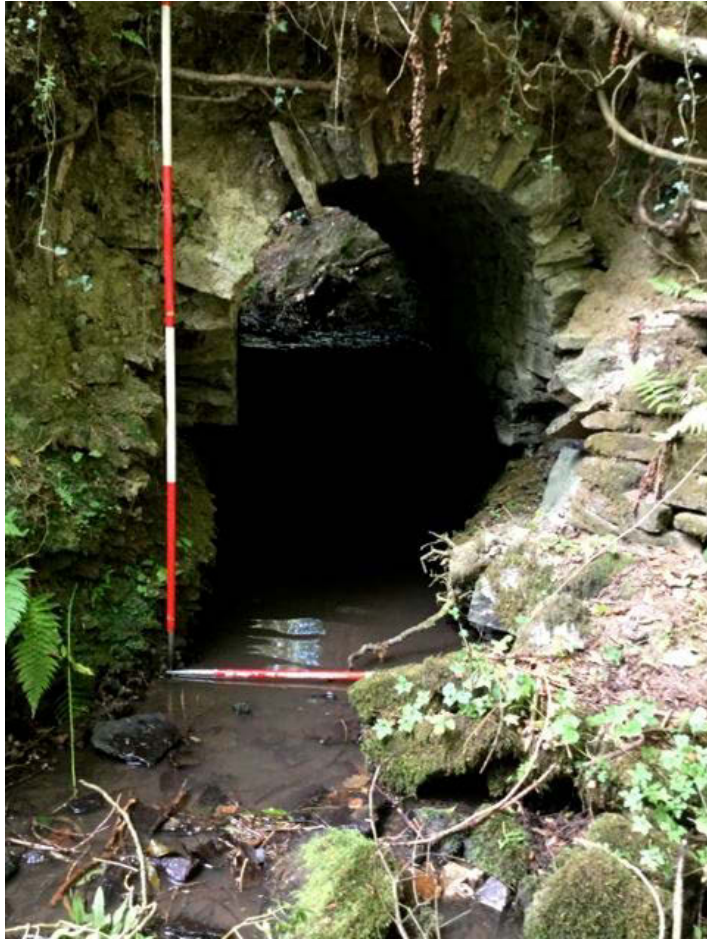
Fig. 46 IP10 Culvert looking west.

4.4.2 Discussion. Dam 5 is unique in that at present only a single exit from the pool via the sluice and culvert has been noted. The outgoing channel then cuts across the lower face of the dam in a southerly direction. If the erosive process continues at the same rate beneath the culvert it will be at increasing risk of collapse.

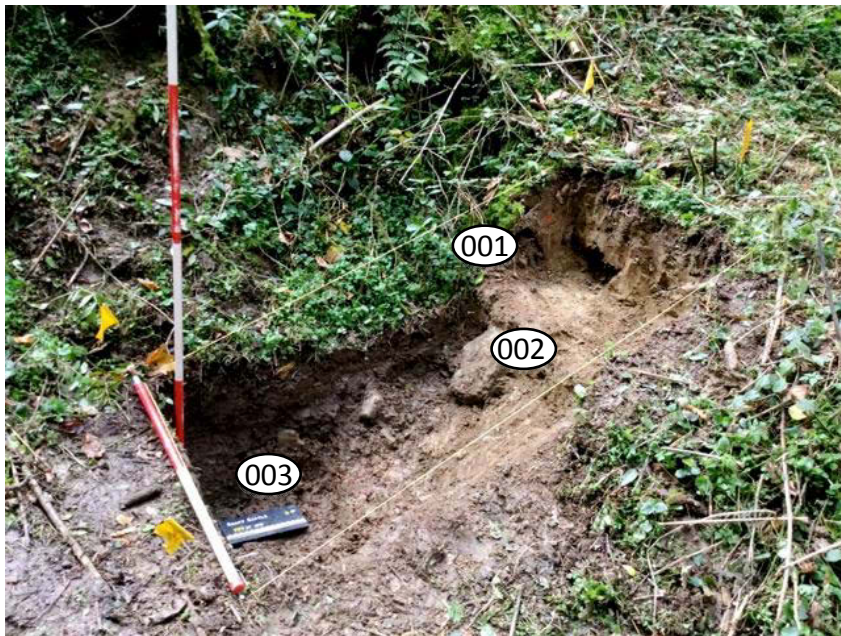
Fig. 47 IP11 looking north west.

represented the effects of water leaching through the dam at this point. Apart from a couple of loose slabs little stone was seen (Fig. 47).

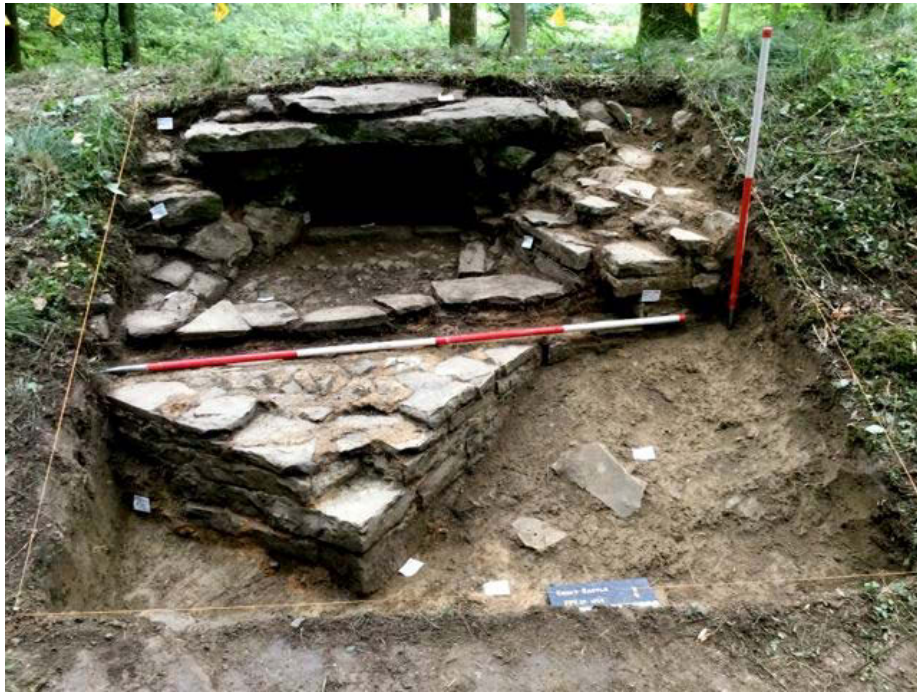
Fig. 57 IP14 Entry to culvert and base of debris catcher looking south.

011 (Fig. 57). The sequence of construction here can be followed in some detail (Fig. 58). The flanking wall (009) goes in first then the side of 011 is brought up against it. The front wall 010 is added and then continued across the top of 011 to establish a base for the slabs (023). It is likely that this is all part of one campaign of construction to insert the debris catcher and strengthen the approach to the culvert. Below the walling to the north is a compact light brown clay bank (012), part of the fabric of the dam and towards the base of its slope it is partially overlain by a deposit of fine grey silty clay (014) presumably some of the original pool bed silting. This in turn is above thin deposits of mortar (014 and 015) arising out of the construction of 011.

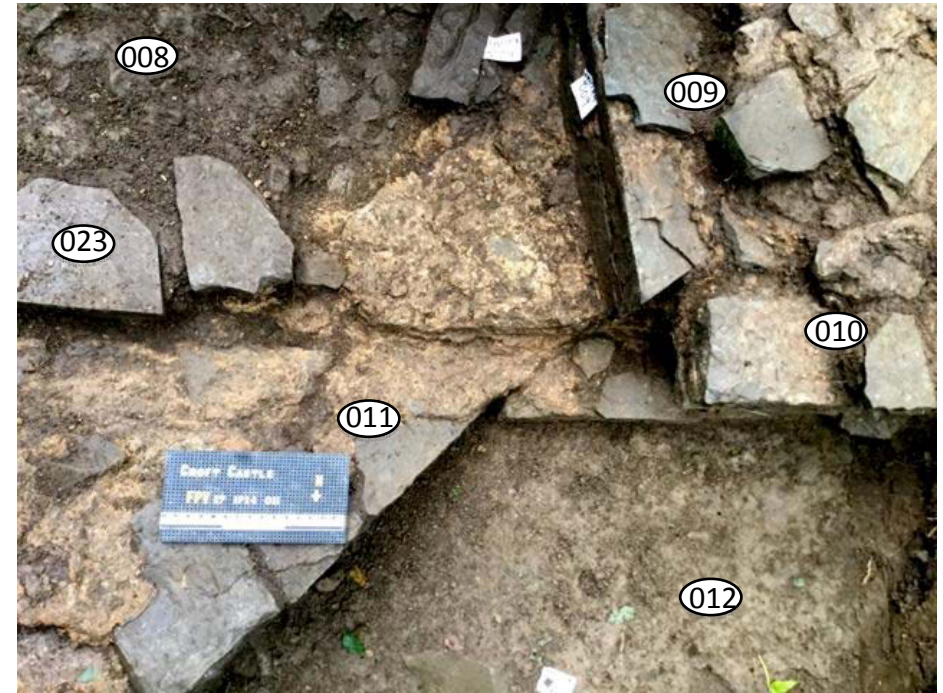
Fig. 58 IP14 Detail of junction between 009, 010 and 011.

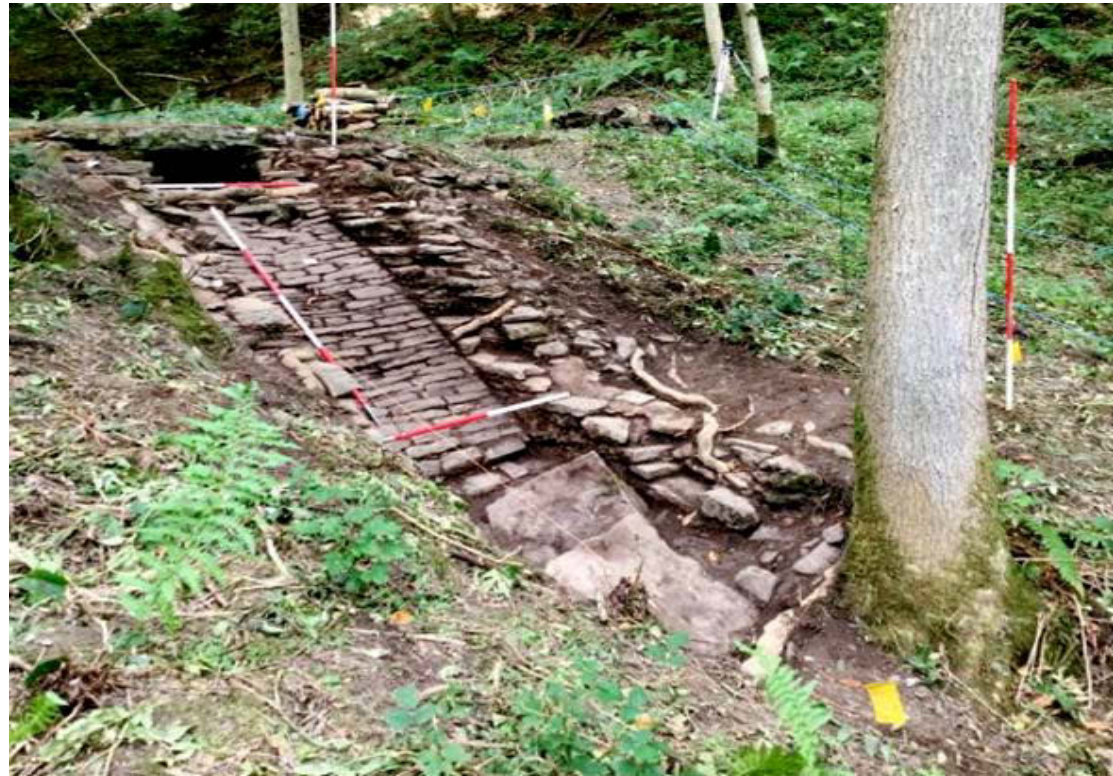
Fig. 60 IP14 cascade looking north east.

On the cascade side the situation was a little less complex (Fig. 60). The evenly sloping ( around 30 degrees from horizontal) pitched stone face of the cascade ( 021) has suffered some root displacement and there were a number of voids underneath where the substrate had been washed away but generally the condition was good. Roughly built walls edged the crest of the dam (017 to the east and 018 to the west) and may have partially supported the fallen capstone. The side wall to the cascade to the west (022) was particularly well preserved to the point where several examples of shaped stone blocks, cut to echo the line of the fall of the cascade, had survived. The eastern side wall was less well preserved (019). Beyond that a spread of rubble down the face of the dam (020 ) looked purposeful and may have been laid to enhance the rustic surroundings of the cascade. At the foot of the cascade the outgoing channel was lined with stone slabs (026) but much of it was filled by two large stone blocks (027) which on close examination proved to be the two broken halves of what appeared to be an additional capstone fallen down from above.

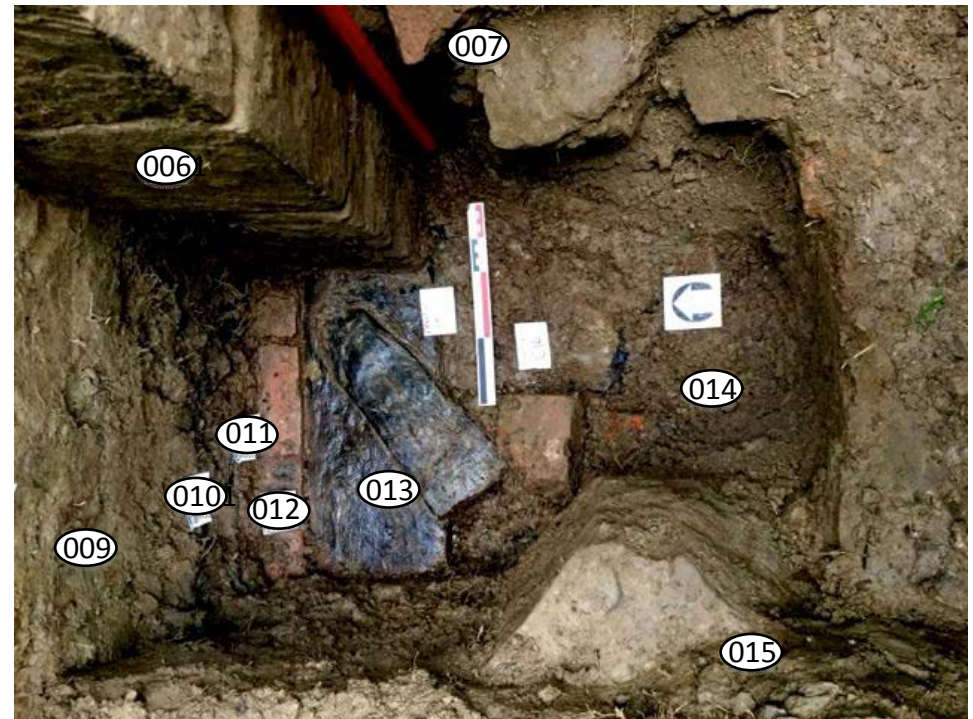
Fig. 64 IP15 vertical view of features at foot of arched opening.

jamb was a large timber beam roughly 30cm square, probably oak, which acted as a foundation for the walling but also as a sill for the brick bottom of the tunnel to the north (012). Lying on top of this timber was a loose piece of boarding which when lifted and cleaned bore some scribed markings (FPV17 IP 15 014/1). In front of the beam was an area of silt with rubble fragments (014) and below that a further deposit and grey clayey silt (016) which appeared to seal further brick work, although these could have been bricks simply discarded within the silting. At this depth the excavation was being carried out at arm's length within what was in effect a keyhole so no further progress was possible (Fig. 64).

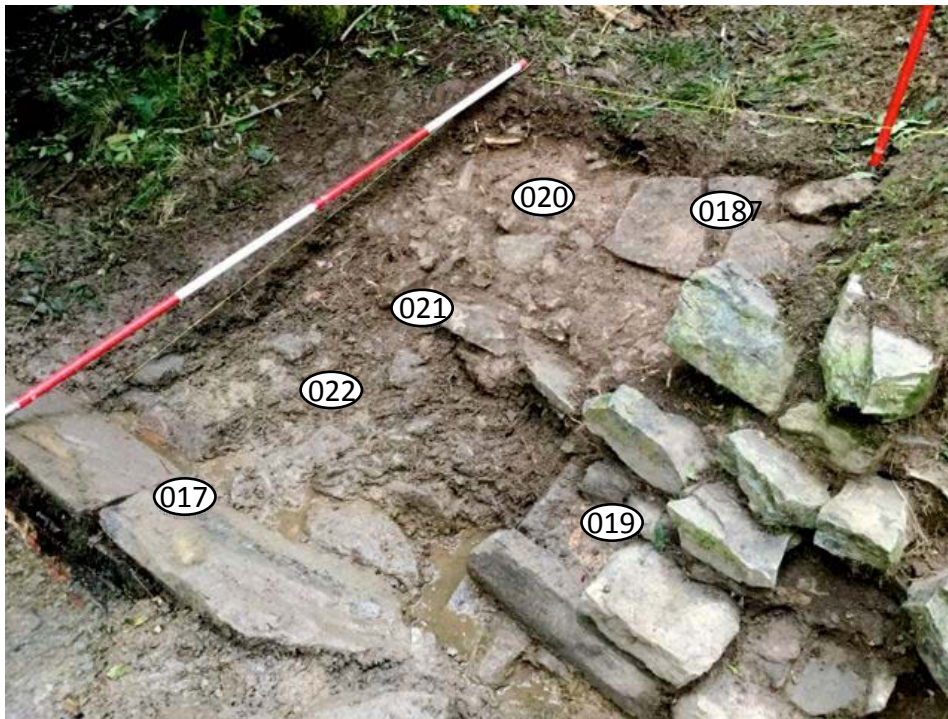
Fig. 68 IP15 Site of spill way and weir looking north west.

To the west the stream was partly bounded by a low brick wall of three courses capped by some large stone slabs (017). This construction steeply sloped backwards, an arrangement which could not have been sustainable without the water rapidly under-mining the bricks. Rather it appears that material, possibly a wall, behind the front edge of the weir was dug out leaving a loose area of sandy loam and rubble (022) causing the leading edge of the weir to subside backwards. Up stream from this was a sloping ramp of mortar and stone fragments (020) edged with some larger pieces of rubble (021). A few surviving slabs along the east side (018) indicates that this ramp could have been paved with flat slabs to create a smooth spill way above the low weir to the south. The existing stream may have eroded away the flanking wall to the west but the eastern wall (019) of random rubble was preserved partly revetting the dam and clearly inserted over the top of the jamb for the arched opening (Fig. 68).
