A Historic Building Survey at the Britannia Works, Coleshill Road, Atherstone, Warwickshire

ULAS Report No. 2019-006 ©2019 A Historic Building Survey at the

For: Hazleton Homes

ULAS Report Number 2019-006 ©2019 Accession Number pending

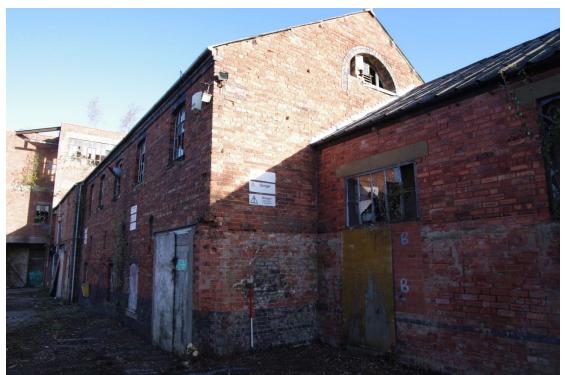
Figure 20 Building C south-east facing gable end Looking north. 1m scale. Note chamfered corner. Building A/B on right

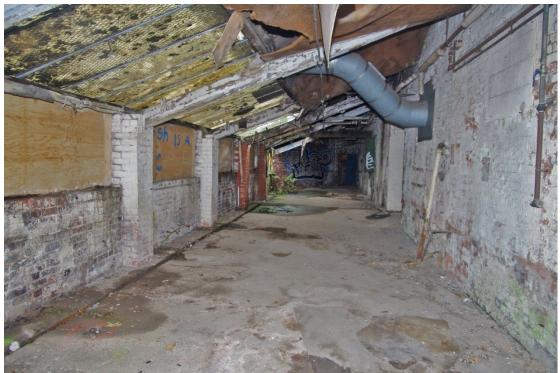
The interior of Building D appears to be a rather makeshift space created when the wharf was covered over (Fig. 25). The roof appears to be present when the 1889 OS map was published. The eastern wall alongside the canal does not have any access to the canal suggesting that direct loading from the factory to the canal ceased when this addition was made. Two more triangular machine bases are located towards the southern end of this room (Fig. 26).

Figure 25 Building D ground floor Looking south-east. 1m scale

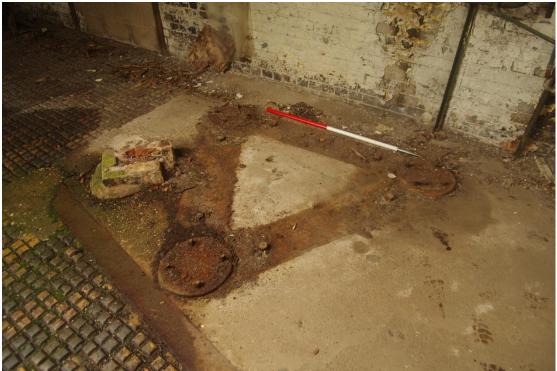
Figure 26 Building D possible machine base at southern end of room 1m scale

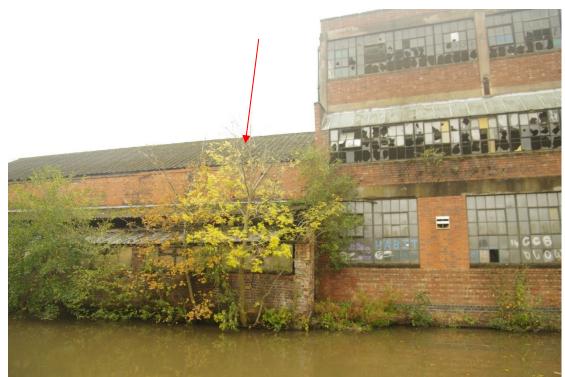
Figure 27 North-east facing elevation of Building E Joint between Building C and Building E is arrowed. Building F-L on right

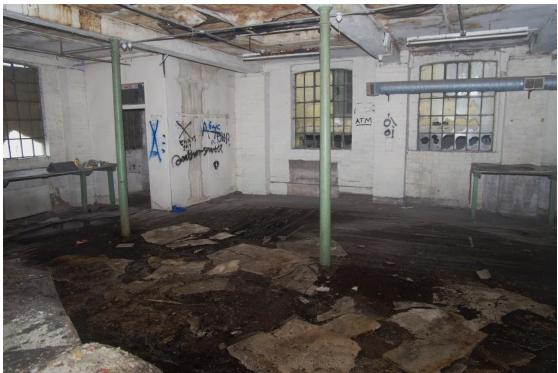
The first floor has an unsafe floor and ceiling and was only inspected from the doorway of Building R1 which has a set of concrete stairs ascending alongside this building (Fig. 59). Transverse stop-chamfered beams are supported by cast-iron columns. Doors also lead into the first floor of Building N – also unsafe. The second floor could not be entered following the collapse of the roof (Fig. 60). Once again this room can be seen from the concrete stairs of Building R1. Debris covers most of the space but it appears that the room was open to the full height of the hipped roof.

Figure 59 Building Q first floor Looking north from Building R1 doorway

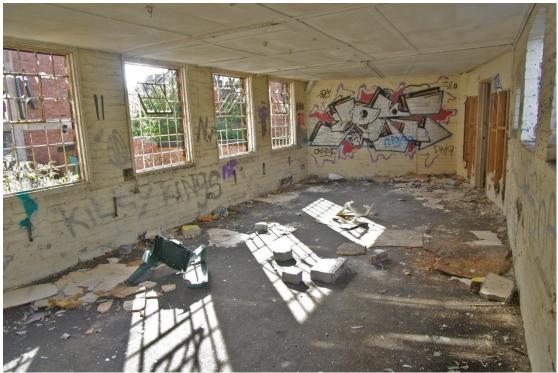
Figure 70 Rear wing R1 second floor Looking north-east from stairs of Building F-L. Plasterboard partition to rest of R1 on right.

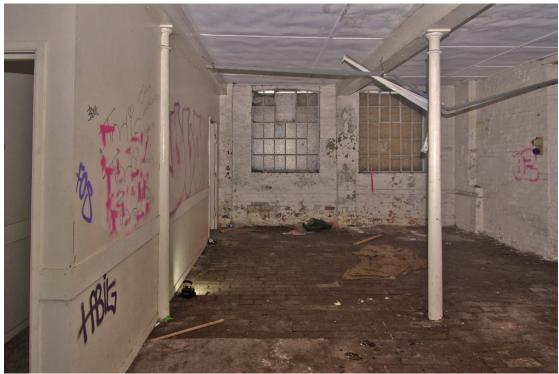
Inside Building U, the ground floor forms a single open space very similar in form to the adjacent room in Building T. The two rooms, as discussed above are separated by a brick wall which has had two large openings broken through (Fig. 82 and see Fig. 77). Two cast-iron columns support substantial transverse stop-chamfered timber beams. The tops of the columns in are different in each room. A modern stud wall partition on the western wall houses a wooden chute down from the first floor. This was presumably for sending down finished goods into the dispatch area but may have begun life as the original staircase.

Figure 82 Building U ground floor Looking north-west. 1m scale

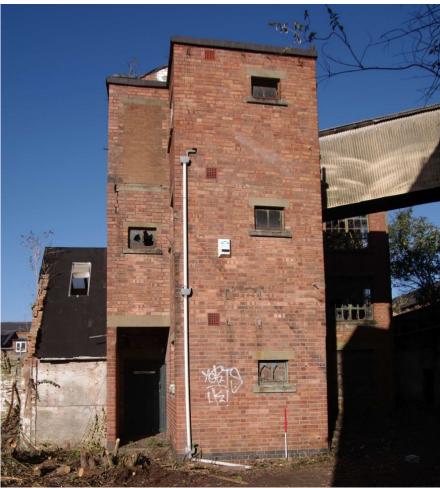
Figure 84 Building V south-east facing elevation Looking north-west. 1m scale. Note stairs and building remnant on left

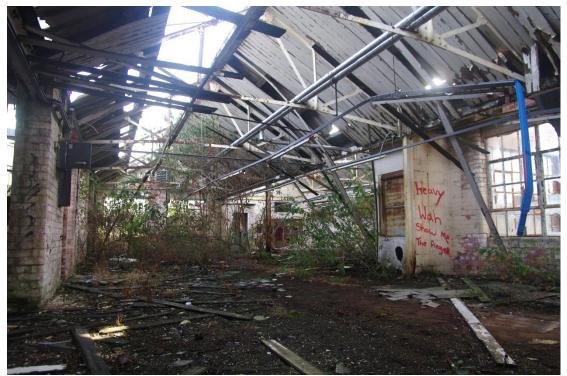
The second floor of Building V has a long pitched roof supported by lightweight angleiron trusses (Fig. 90). This roof has collapsed and a large amount of vegetation has grown over the floor. This appeared unsafe so the room was not entered.

Figure 90 Building V second floor Looking north-west from southern staircase
