LOCK COTTAGE, CANAL FOOT, ULVERSTON, CUMBRIA

Archaeological Building Recording

Client: Mr and Mrs White

October 2011

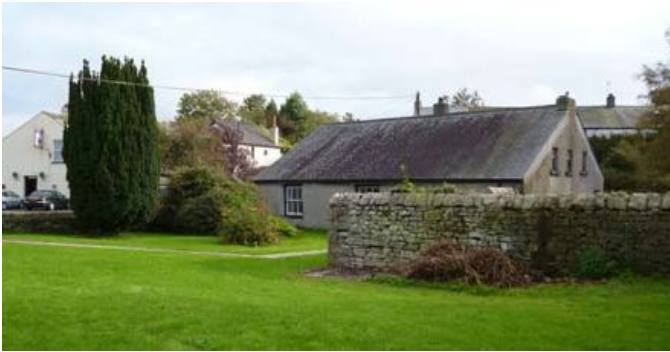
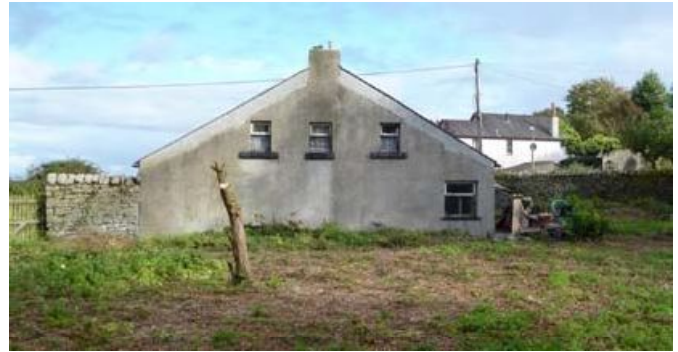
4.1.1 The building is roughly square in plan (see Figure 4 and Figure 5) and is orientated approximately north-west/south-east (although in order to simplify descriptions it will be considered to be orientated east/west in this report). The north elevation overlooks a large expanse of lawn adjoining the canal and the front door is approached via a concrete slab path (Plate 11). The east elevation faces towards the road, there is a large garden to the west, and there is a concrete yard to the south (rear) (Plate 12). There is a small chimney at the west end of the building and another one to the west of the centre.

Plate 11 (left): View of the Cottage from the north

Plate 12 (right): View of the Cottage from the west

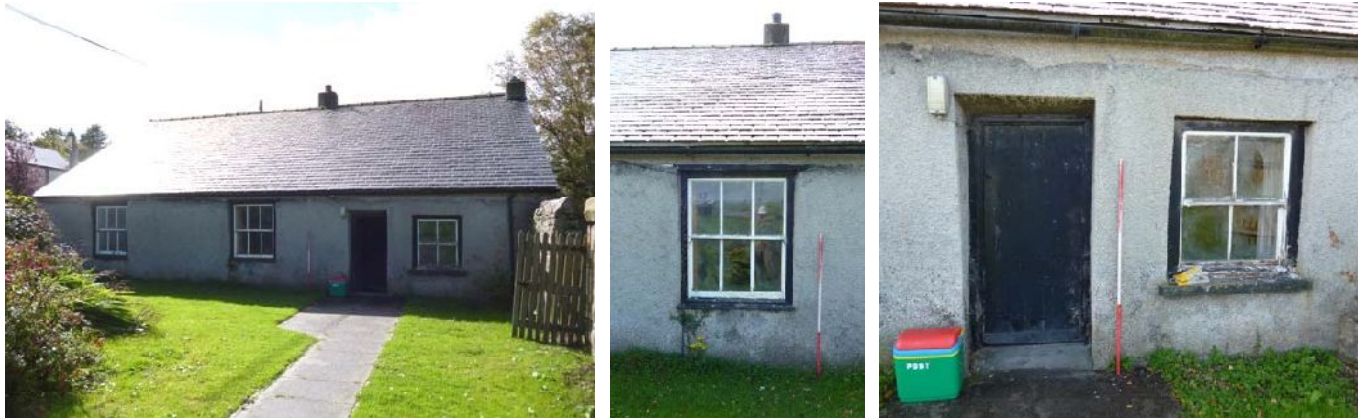
Plate 13 (left): North external elevation

4.2.1 **North elevation:** the north external elevation is very low and finished with roughcast concrete render. It is butted by boundary walls at its east and west ends (Figure 2; Plate 13). There is a line in the render immediately below the eaves, presumably relating to the replacement of the roof, and there are plastic rainwater goods. There are two large six-light sash windows, with horns, stone lintels, and timber sills, to the east side of the elevation. The west window (Plate 14) has a thinner sill and the lintel is possibly re-used as it has peg holes. The doorway is located slightly to the east of centre and has a beaded plank and batten door and an early latch plate, with a fairly plain surround with a beaded top (Plate 15). There is a similar window to the other two to the east side of the door, except that it is a four-light sash window with horns and a concrete sill. There is a low concrete block wall around a drain at the east end of the elevation.

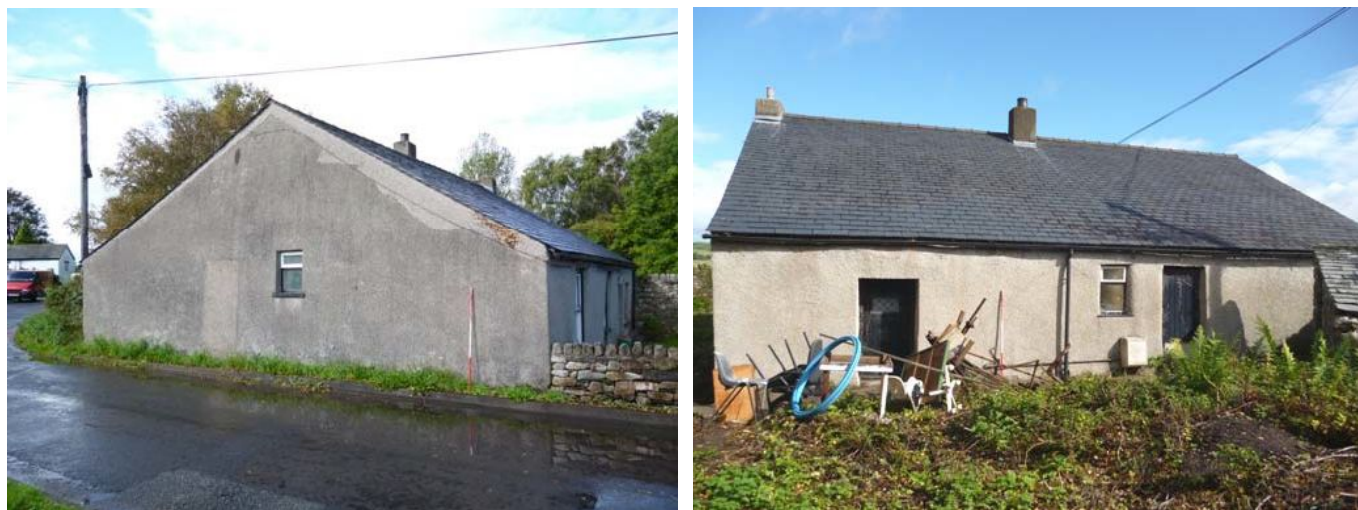
Plate 16 (left): East external elevation

4.2.2 **East elevation:** again there is a scar visible where the wall has been re-rendered after the roof was replaced; the wall having evidently been raised slightly in height, although it is apparently not raised as much on the south side (Figure 2; Plate 16). There is a blocked doorway evident as a scar in the render to the south of centre and to the north of this there is a small two-light hinged casement window with a concrete sill.

4.2.3 **South elevation:** this elevation (Figure 3; Plate 17) has a doorway on the west side and has plastic rainwater goods. There is a scar where it has been re-rendered below the eaves. The door is a tongue and groove plank and batten construction with a single light window and a chamfered surround. It also has an original lock plate. There is a small two-light hinged casement window to the east, with a thin slate sill. There is a second door to the east with a very basic tongue and groove and plank and batten construction in a plain surround. The lower part is filled with concrete, presumably as a flood defence, and there is a copper pipe and gas meter box attached to the wall to the west of this.

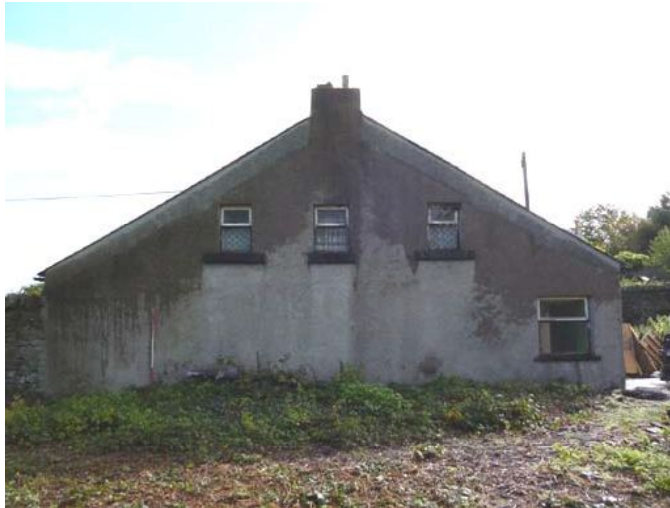
Plate 18 (left): West external elevation

4.2.4 **West elevation:** there is scar in the render along the wall top, up to the chimney, which shows where the roof has been raised (Figure 3; Plate 18). There are three windows on the first floor, all of which are two-light hinged casements with thick concrete sills. The ground floor window on the south side is a two-light hinged casement and has a thin stone (slate) sill. A hole had been dug at the south-east corner of the building, which showed the large limestone block footings of the building (Plate 19).

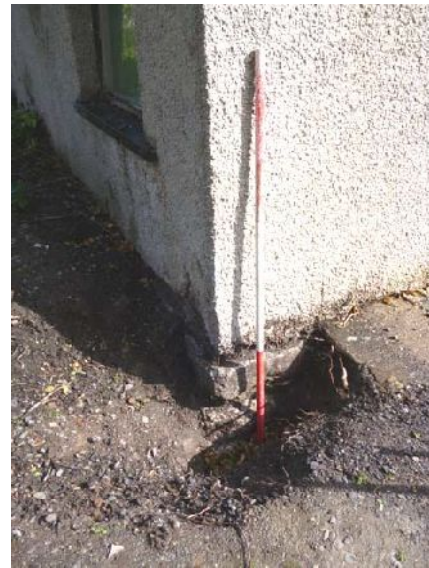
Plate 19 (right): Footings exposed at the south-east corner of the building

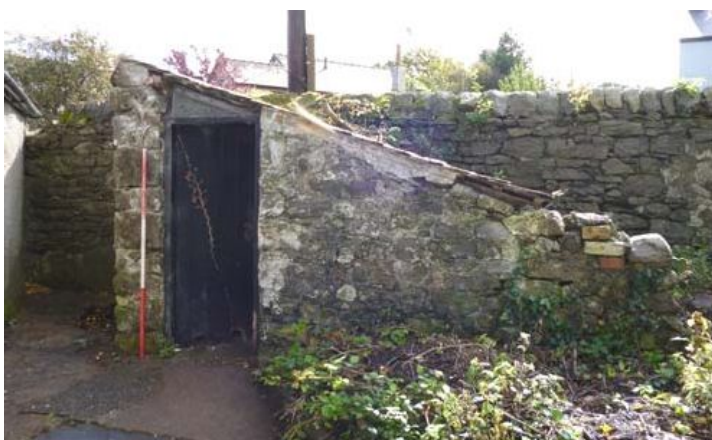
Plate 20 (left): Mono-pitch outshut

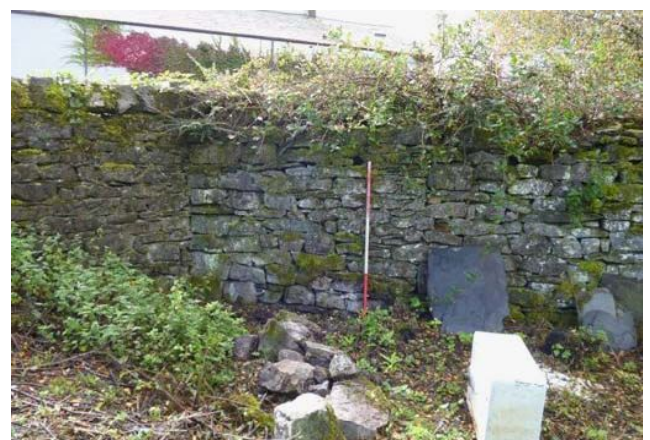
Plate 21 (right): Blocked opening in the boundary wall

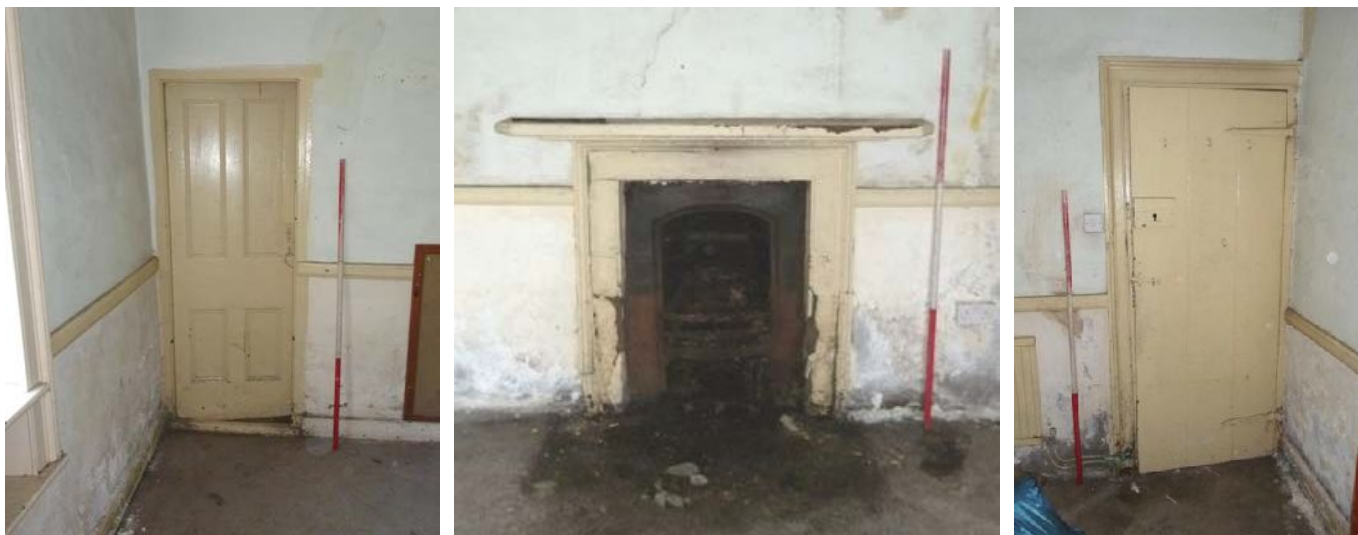
Plate 28 (left): Door in the east elevation of Ground Floor Room 2

4.3.2 **Ground Floor Room 2:** this room has a concrete floor and possibly the original plaster ceiling. The walls are plastered and painted and have a moulded dado rail. There is a plain chamfered skirting throughout. The north elevation has a six-light sash window with a moulded surround. There is a lower window sill (forming a window seat) constructed from timber but there is a further sill above this, which is also timber. The dado rail continues to the west side of the window, but is lower. There is a doorway to Ground Floor Room 1 in the east elevation with a plain surround and a beaded edge (Plate 28). This houses a door with four moulded panels, which has the original latch. The south elevation is plain except for the original central fireplace, which has a moulded stone surround and a timber lintel (Plate 29). Within this there is an iron insert and grate and a brick-backed hearth. The lower part of the moulded stone surround is in poor condition and so too is the corresponding hearth stone in the floor. The west elevation is plain and has no skirting board. There is a doorway on the north side, which has an original beaded plank and batten door (Plate 30), with the original large timber lock, strap hinges on pintles, and latch.

Plate 29 (centre): Fireplace in Ground Floor Room 2

5.3.1 As much of the original and early fabric as possible should be retained during any renovation work, in particular the early doors, the fireplace in G2, and decorative details such as the dado rail in G2 and panelling in G1 and G3. The sash windows in the front elevation, although later additions, are the most historically appropriate of all of the windows in the building and should be retained or replaced with something matching. The concrete block walls forming Room G8 should be removed and the large doorway in the east elevation of G7 could be opened up, although it would be practically difficult to make use of because of its position next to the road. The concrete floor and stalls in G7 could be justifiably removed as they are almost certainly a later addition and of poor quality. The roof trusses are almost certainly original, however, and should also be retained if at all possible. Adding a second floor above Rooms G1, G2 and G7 could conceivably be done as there is evidence that one did formerly exist, at least on the west side, although altering the roof level further to accommodate this would be detrimental.

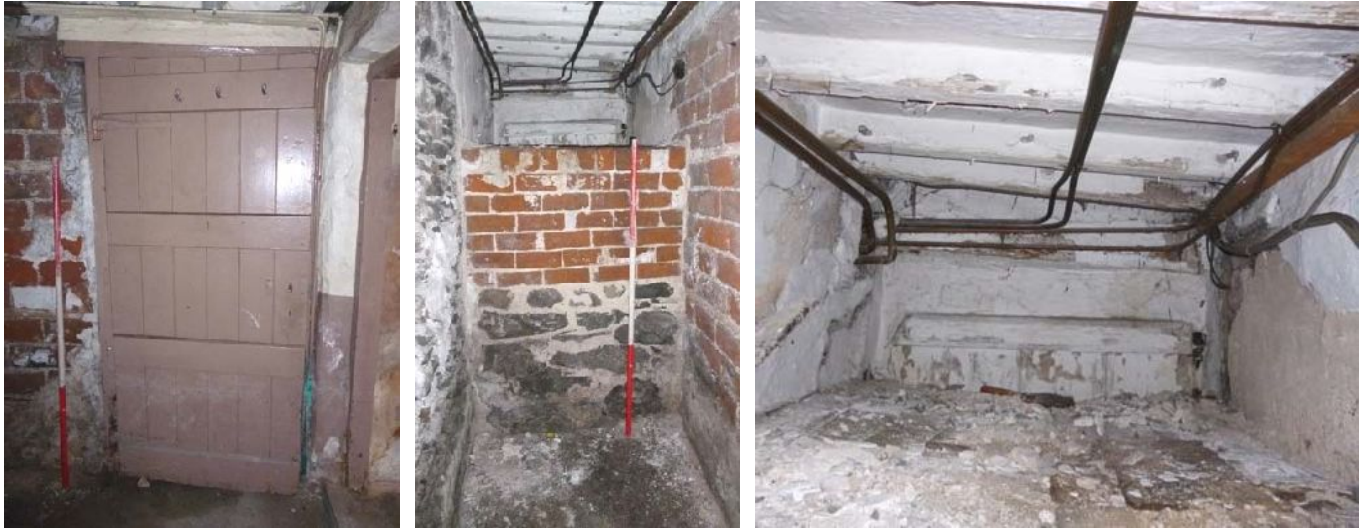
a large block of bricks like those in the north elevation (Plate 37). These bricks are piled and mortared seven courses high and six bricks deep on a stone plinth corresponding with that in the north wall. The bricks are not evidently bonded to the walls although whitewash to the south side does come down onto them. The west side of the south elevation is constructed from slate, with remnants of plaster on the west side with a diagonal line of some form of fitting(?) including piece of iron visible. The doorway to the west on the south elevation has a plain surround and no door and there is a slight step up to the east and a further doorway in an angled modern plasterboard stud wall on earlier frames. The door has a plain chamfered surround, but is an early plank and batten type hung on strap hinges with an early latch. There are two concrete steps up to the door on the north side of the east elevation, which has a modern surround and a modern panel door (Plate 39). There is plain skirting extending to the south wall, which is modern stud plasterboard.

Plate 37 (centre): Brick in-fill at the west end of the east/west section of Ground Floor Room 3

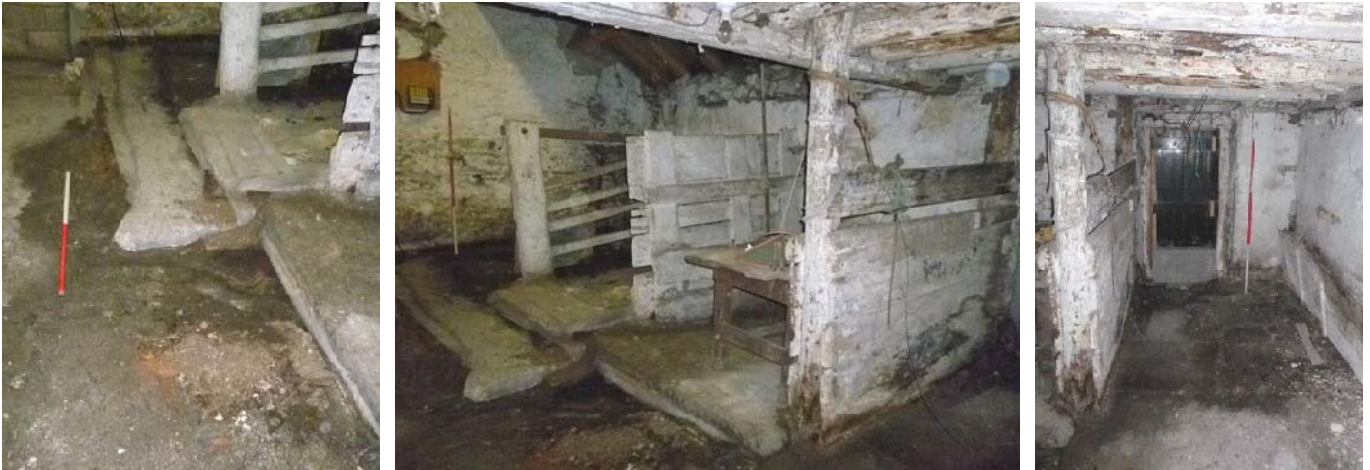
Plate 51 (left): Uneven concrete floor and drain in Ground Floor Room 7

Plate 52 (centre): Stalls to the south side of Ground Floor Room 7

Plate 53 (right): Flagged area in the south-west corner of Ground Floor Room 7

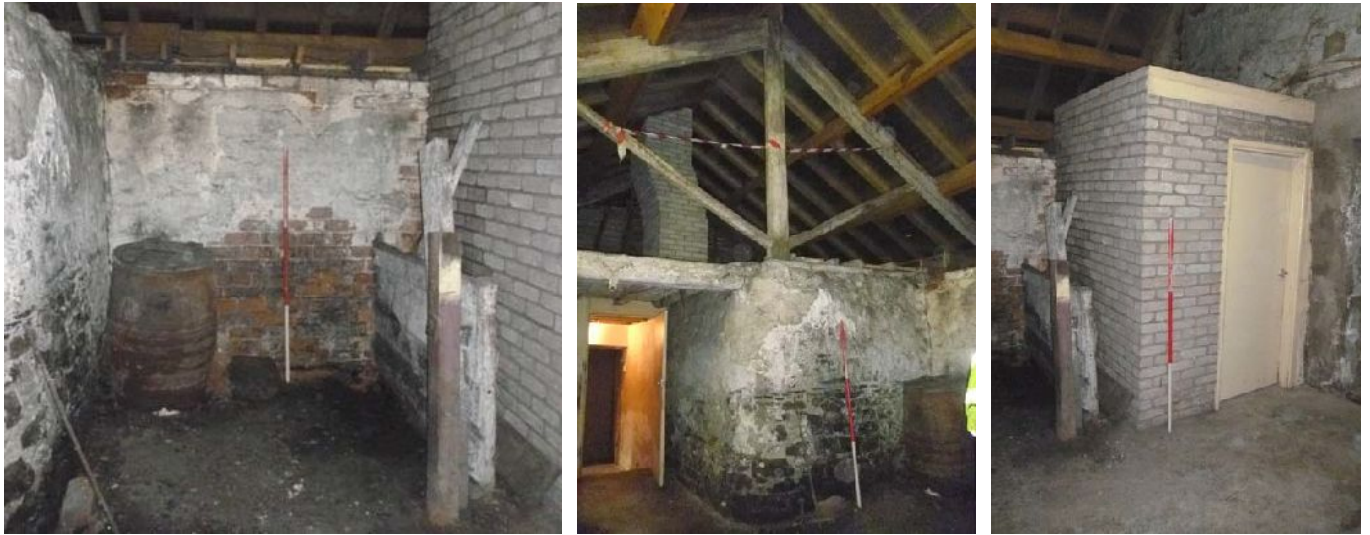
Plate 54 (left): Red brick-built section of the north elevation of Ground Floor Room 7

Plate 55 (centre): North-west corner of Ground Floor Room 7

Plate 56 (right): Modern concrete block walls partitioning the north-east corner of Ground Floor Room 7

5.1.5 Phase 3 (late 20th century): a variety of modifications have evidently been carried out more recently some of which were quite damaging to the original fabric. The insertion of concrete block walls within Room G7 to form a toilet (Room G8), with the small window in the east elevation perhaps also created at the same time is a relatively minor alteration. By contrast, the complete replacement of the roof, which included raising and levelling it, especially at the west end, led to a number of damaging alterations. These included the loss of all the original purlins, the artificial building up of the west end, disguising the original height of the chimney, extensive re-plastering of Rooms F1 and F3, the rebuilding of the central chimney in concrete blocks, and probably the loss of any room or rooms to the east of Rooms F1-F3. Other modernisation has also occurred such as the installation of kitchen units in G5 and bathroom fittings in G1, neither of which are of great consequence. The fire surround in G4 was also added during this period, presumably removing an earlier, perhaps original one. In addition, the partial blocking in concrete was added to the base of the door in the east side of the south elevation, presumably as a flood defence, and electrical cabling and water pipes were added throughout.

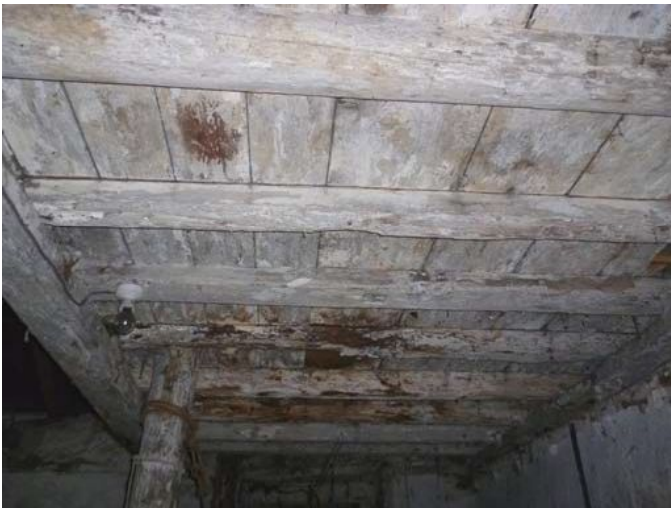
4.3.10 The ceiling on the west side of the room above Ground Floor Room 7 had the original rougher timbers (Plate 62); some were $\frac{1}{2}$ and $\frac{1}{4}$ round, one had Baltic marks (Plate 63). The floorboards on top were covered by modern chipboard. All of the flooring and timbers visible in the ceiling were whitewashed and rest on the top rail of the stud wall to the west and carry on above Ground Floor Room 6 to the west and onto the beam and slightly later joists which were added to form a lower ceiling over that room.

Plate 62 (left): Timber in the ceiling on the west side of the room above Ground Floor Room 7
