MOOR HOUSE FARM, BROUGHTON BECK, ULVERSTON, CUMBRIA

Archaeological Building Recording

Client: Neil Price Ltd

June 2012

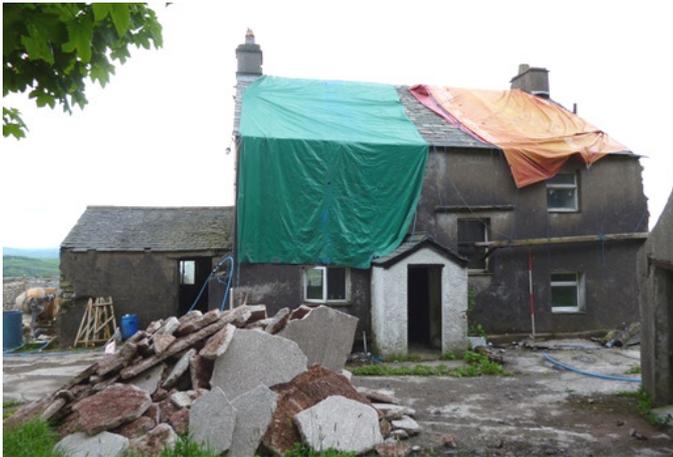
4.2.1 **North-west elevation:** this forms the side elevation (Plate 5; Figure 2). The main elevation has two ground floor windows, both with modern UPVC two-light casements and stone sills and lintels. These are positioned either side of a gabled porch, which is of red brick construction finished with roughcast render painted white and has a slate roof finished with ceramic ridge tiles and a timber barge board. Internally the underside of the roof is constructed from machine cut rafters and backed with tongue and groove boards and the walls are whitewashed. The doorway within the porch has a tongue and groove plank and batten door with what is probably a glazed upper panel, although this is covered with a plywood sheet, and it has a plain timber surround. To the south-west of the porch, situated between ground and first floor level, is a tall stair window. This has a single-light UPVC casement, a slate sill and slate drip course above (Plate 6). On the first floor there are two windows, one on either side, both with a two-light UPVC casement and slate sill. The north-east end is extended by a single-storey outshut finished with concrete render as per the rest (although some of the rough stone masonry is exposed at the north-east end where the render has come away). There is a doorway on the south-west side with a slate lintel; some of its plain surround survives but it has no door.

Plate 5 (left): North-west external elevation

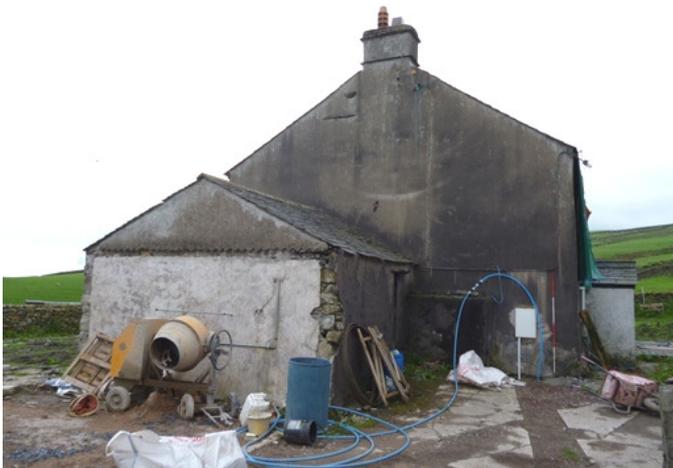
4.2.2 North-east elevation: this forms the gable end of the main building (Plate 7; Figure 2). The ground floor on the south-east side is covered by the low outshut, the gable end of which in effect forms part of this elevation. The upper part of this is finished with concrete render and the lower with an internal concrete plaster, and dividing the two types is the concrete scar of a former corrugated roof for the now demolished additional extension to the north-east, which was evidently monopitch. To the north-west, on the main elevation proper, there is a large projecting section of masonry at ground floor level filling the remaining space, evidently corresponding to some form of oven or fireplace internally. To the north-west of this is a modern electricity or gas meter box set into the wall. The first floor level is relatively plain, with a lintel projecting through the render on the south-east side at attic level. The gable is topped by a rectangular section chimney, also finished with concrete render, with a slate drip course near the base and a coping at the top and two ceramic chimney pots.

Plate 7 (left): North-east external elevation

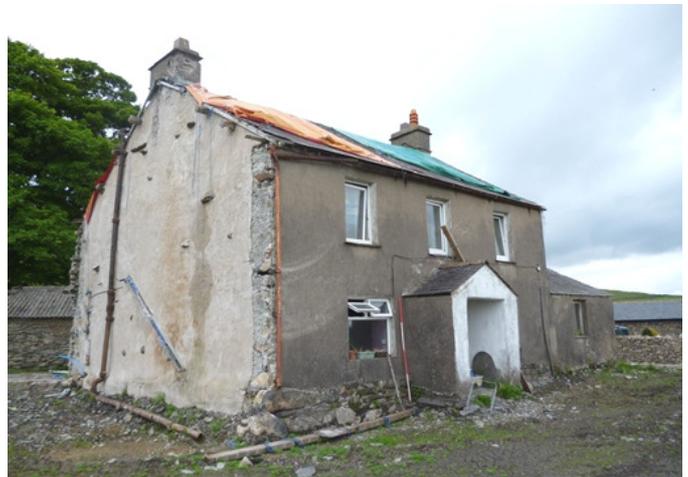
Plate 8 (right): South-east external elevation, south-west end

4.2.3 South-east elevation: this forms the opposing side elevation (Plate 8; Figure 2) is entirely finished with smooth concrete render, apart from the plinth, which consists of courses of local slate, including large boulders at the south corner (Plate 9), and has two iron grates on the north-east side. There are two windows on the ground floor, both of which are relatively wide and have three-light UPVC hinged casements and slate sills. These windows are positioned either side of a central porch, which has a gabled roof finished with slate and finished with red sandstone v-shaped ridge tiles. Internally this is finished with timber boarding. The porch is also finished with concrete render externally and plaster and white paint internally (the paint continues onto the front elevation), and within it is a doorway leading into the building with a modern timber door with two solid panels and four glazed. The first floor has three

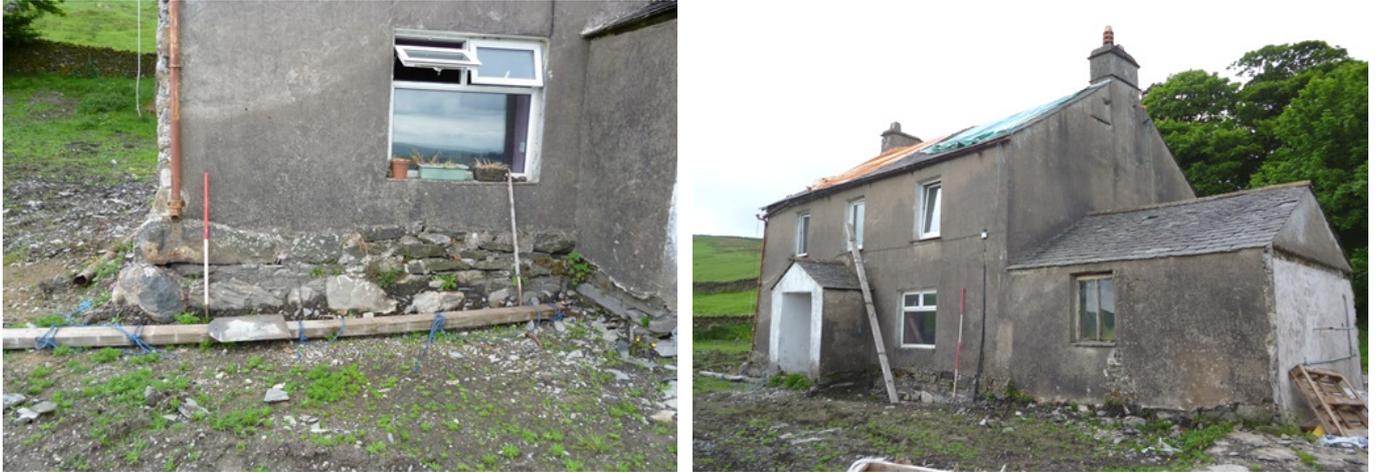
windows, all with thin slate sills and modern single-light UPVC casements. The elevation is extended at the north-east end by the single storey extension (Plate 10), which also has a slate roof, finished with red sandstone v-shaped ridge tiles and a single-light skylight consisting of just a sheet of glass. The wall is also finished with concrete render and has a single window with a timber two-light casement.

Plate 9 (left): Plinth exposed at the south-west end of the south-east external elevation

Plate 10 (right): North-east end of the south-east external elevation

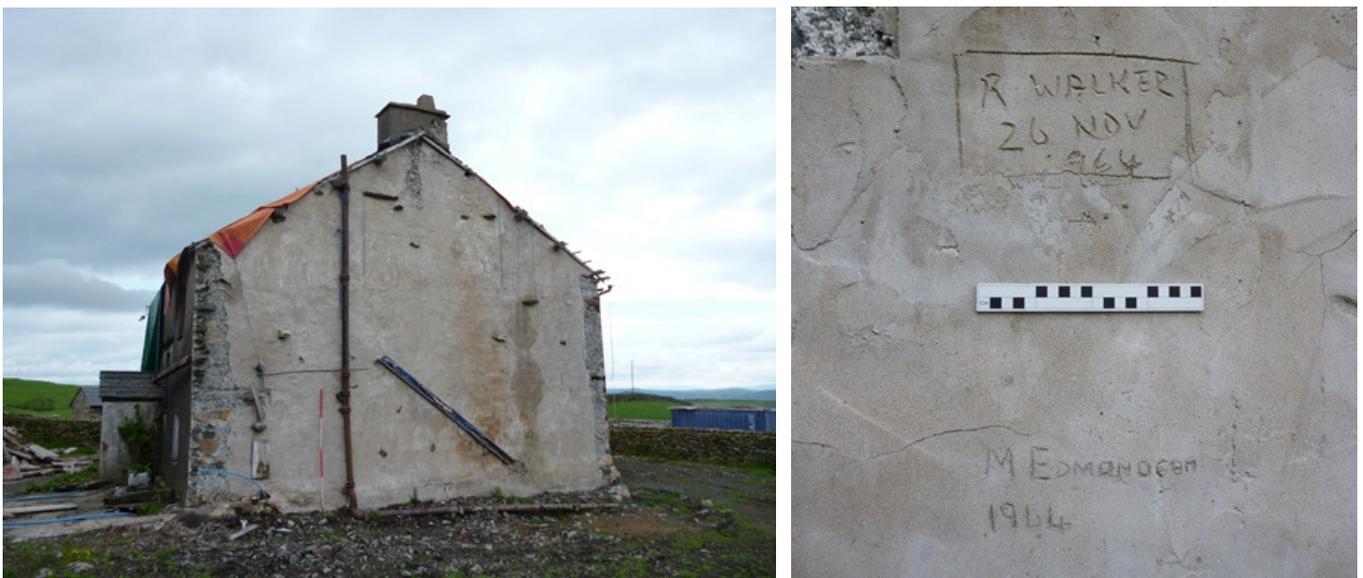
4.2.4 **South-west elevation:** this forms the gable end of the building (Plate 11; Figure 2), and is mostly covered by a fairly rough skim of concrete, into which, on the north-west side at ground floor level has been scored 'R WALKER 26 NOV 1964' and 'M EDMONDSON 1964' (Plate 12). The plinth is visible below what would have been the floor level of the former extension to this end of the building, and comprises large boulders at either corner with roughly coursed local slate between. The scars for the former external walls are also visible at either side, and where they were attached traces of the original roughcast render and stone walling are exposed. Some through stones project through the render at first floor level and there is also what is evidently a lintel projecting on the north-west side at attic level. Various water pipes are attached across the elevation and the gable is topped by a rectangular section chimney of stone construction finished with concrete render, with slate coping and a single ceramic square-section pot. Below the eaves the ends of the purlins are exposed as is the end rafter below the roof.

Plate 11 (left): South-west external elevation

Plate 12 (right): Graffiti scratched into the render on the south-west external elevation

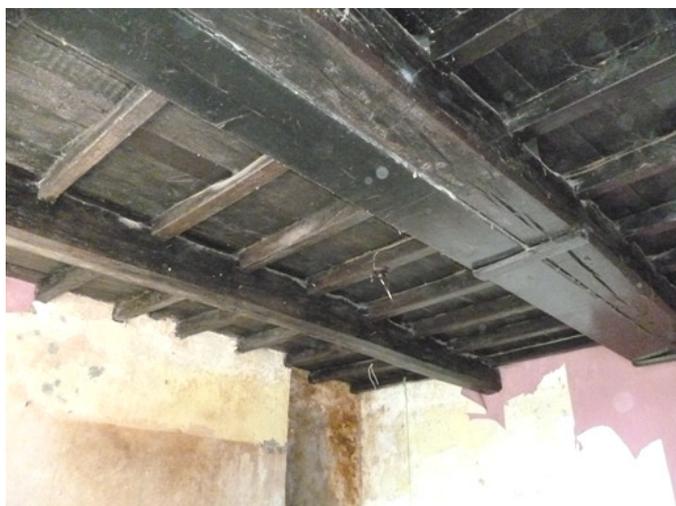
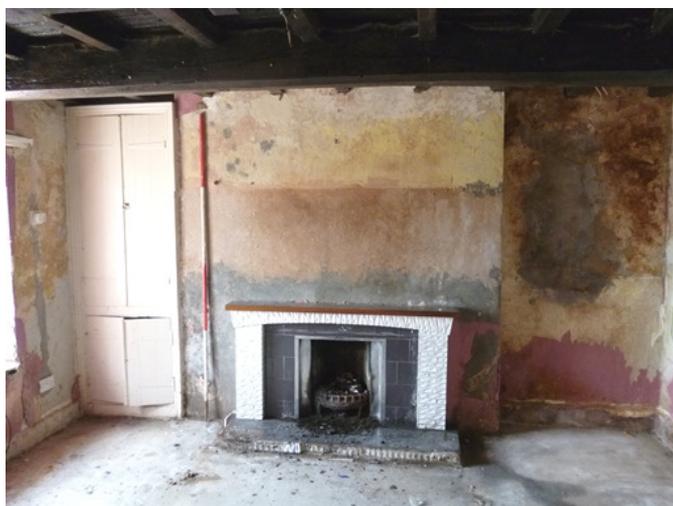
4.3.1 **Ground Floor Room 1:** this has a concrete floor, perhaps covering earlier stone flags, and the ceiling is supported by two beams orientated north-west/south-east, which are hand-finished and chamfered. The north-east beam has a more recent timber shelf attached to it and the joists are evidently sawn and support the floor boards of the floor above, which are exposed (Plate 13). All of the timber has been stained or varnished a dark gloss brown. All of the walls are finished with plaster, much of which has been replaced by a modern concrete skim, and wallpaper and all are of solid masonry construction. The north-east elevation is plain, the south-east has a doorway on the north-east side with a modern door with two panels and four glazed sections and a timber lintel. To the south-west of this is a window, which is relatively wide and has splayed jambs and a two-light UPVC casement. The south-west elevation has a central chimney breast with a 20th century tiled fireplace surround and hearth, and a cupboard built into the alcove to the south-west with a perhaps early moulded surround but seemingly later tongue and groove plank and batten doors with strap hinges (Plate 14). The north-west elevation is relatively plain, with a doorway at the north-east end with a tongue and groove plank and batten door in a plain surround.

Plate 13 (left): Beams and joists in Room G1

Plate 14 (right): Fireplace, south-west end of Room G1

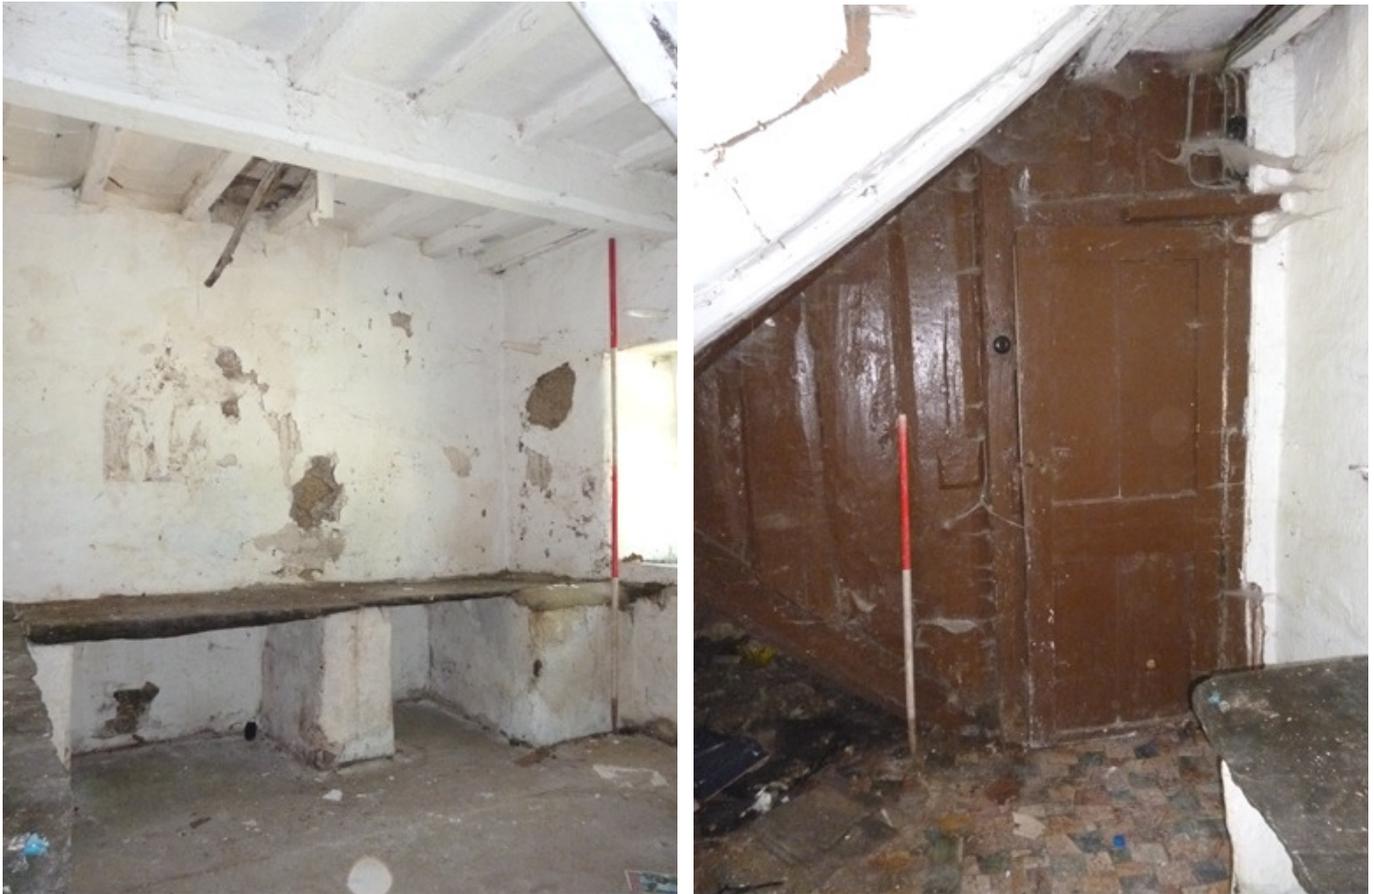
4.3.2 **Ground Floor Room 2:** this too has a concrete floor, still partially covered by lino on the north-east side. There are slate benches along the south-east and south-west walls, supported on masonry pillars. The ceiling is supported by two beams orientated north-west/south-east, which are chamfered but whitewashed, as are the joists and the plaster ceiling. The north-east beam supports the structure of the adjoining staircase, which forms part of the north-east elevation and the space beneath its angled north-west end forms part of the room, and is also supported by two upright posts both of which are hand-finished. The walls are finished with plaster and whitewash. The north-east elevation has a doorway on the south-west side with a two-panel doorway with relatively early strap hinges and early latch plate. To the north-west of this the wall is constructed from thick hand-finished boards, which continue below the stairs. All of the timber work in the doorway, wall, and stairs is of pegged construction and the underside of the stairs is finished with lath and plaster. The south-west and south-east elevation are plain apart from having slate benches set against them. The north-west elevation has a central window with relatively splayed jambs, below which is the scar of a timber shelf and there are further timber brackets above for another shelf.

Plate 15 (left): Slate benches against the south-west elevation of Room G2

Plate 16 (right): Door and panelled wall, north-east elevation of Room G2

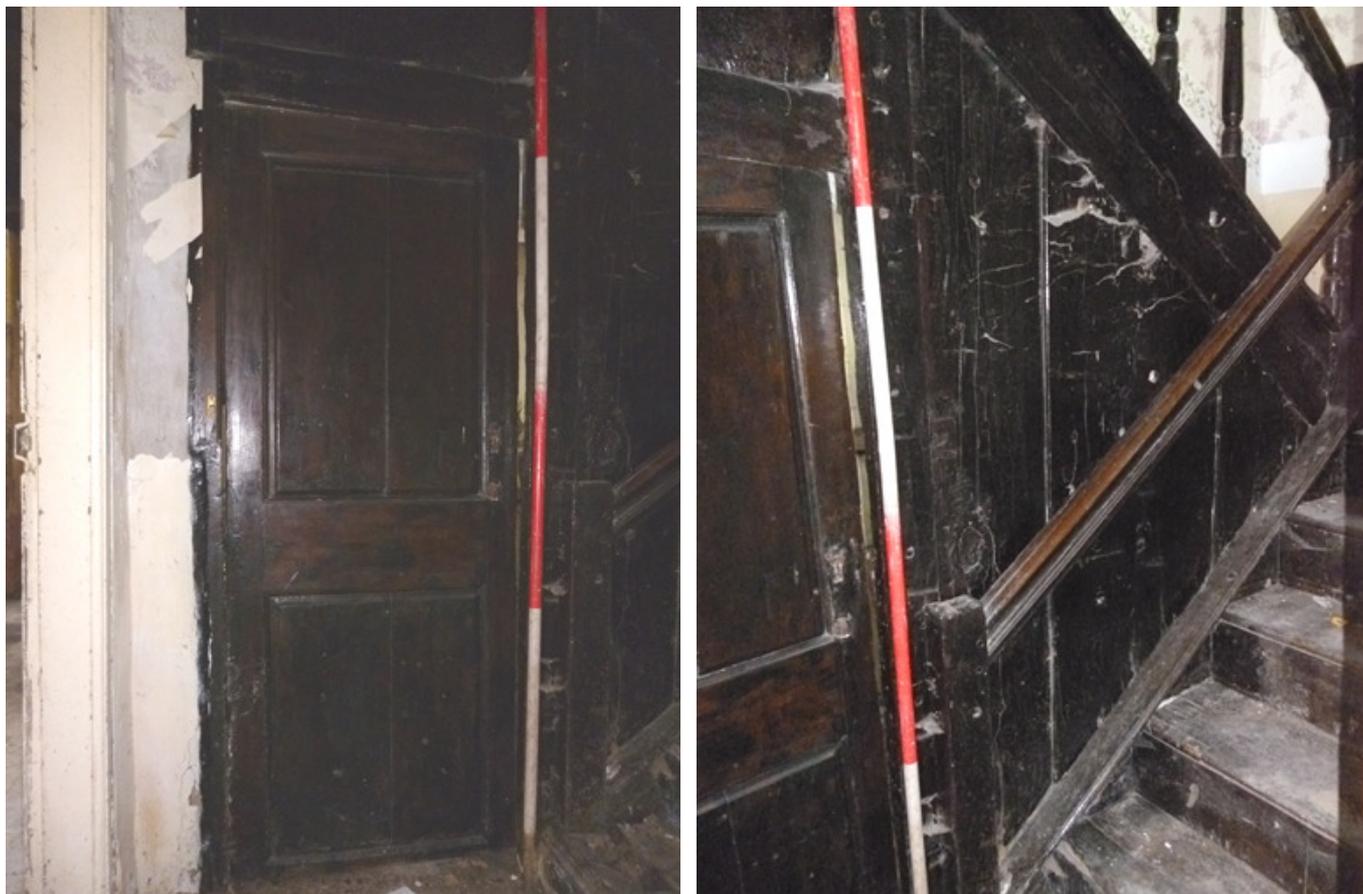
4.3.3 Ground Floor Room 3: this room also has a concrete floor on the south-east side but is continued by timber steps forming the main staircase on the north-west side. The staircase is clearly very early but in relatively poor condition. A moulded handrail and square section newel post is all that survives, apart from the steps, at ground floor level although turned balusters remain *in situ* on the first floor (see *Section 4.3.9* below). All of the elevations apart from the south-west are finished with plaster or a concrete skim and wallpaper. The north-east elevation has a doorway on the south-east side with a plain modern surround and door. The south-east elevation has a doorway with an ovolo-moulded surround and beaded tongue and groove plank and batten door. The south-west elevation is constructed from thick timber planks forming the side of the staircase and on the south-east side these incorporate a doorway with an ovolo-moulded surround and door with two bevel-raised and fielded panels with an ovolo-moulded border. The north-west elevation is at landing level and is described as part of the first floor (see *Section 4.3.9* below).

Plate 17 (left): Early panel door, south-west side of Room G3

Plate 18 (right): Lower part of the stair case, Room G3

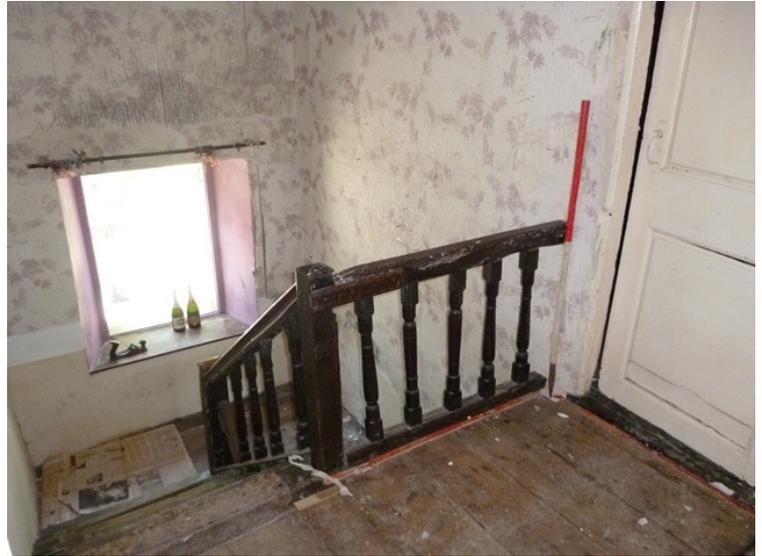
Plate 30 (right): Handrail and turned balusters in Room F3

4.3.9 **First Floor Room 3:** this is the upper level of the stairs and the landing. The steps are probably original and in poor condition, but the moulded hand-rail, square newel posts (capped with domed tops), and turned balusters are almost all present at this level (Plate 30; Figure 4). The early wide floorboards also survive throughout, although some have been replaced with later tongue and groove type. All of the walls are stud partitions, apart from the north-west. There are two doorways to the north-east, one with an early two-panel door the constructed from three wide beaded planks (Plate 31), and there are two doorways to the south-west, both with early two-panel doors with bevel raised and fielded panels and ovolo-moulded surrounds (Plate 32), with a beam along the elevation at ceiling level. The south-east elevation is constructed from wide beaded tongue and groove planks with a door of similar construction on the south-west side (Plate 33). The north-west elevation has a tall window at landing level, with splayed jambs and a single-light UPVC casement.

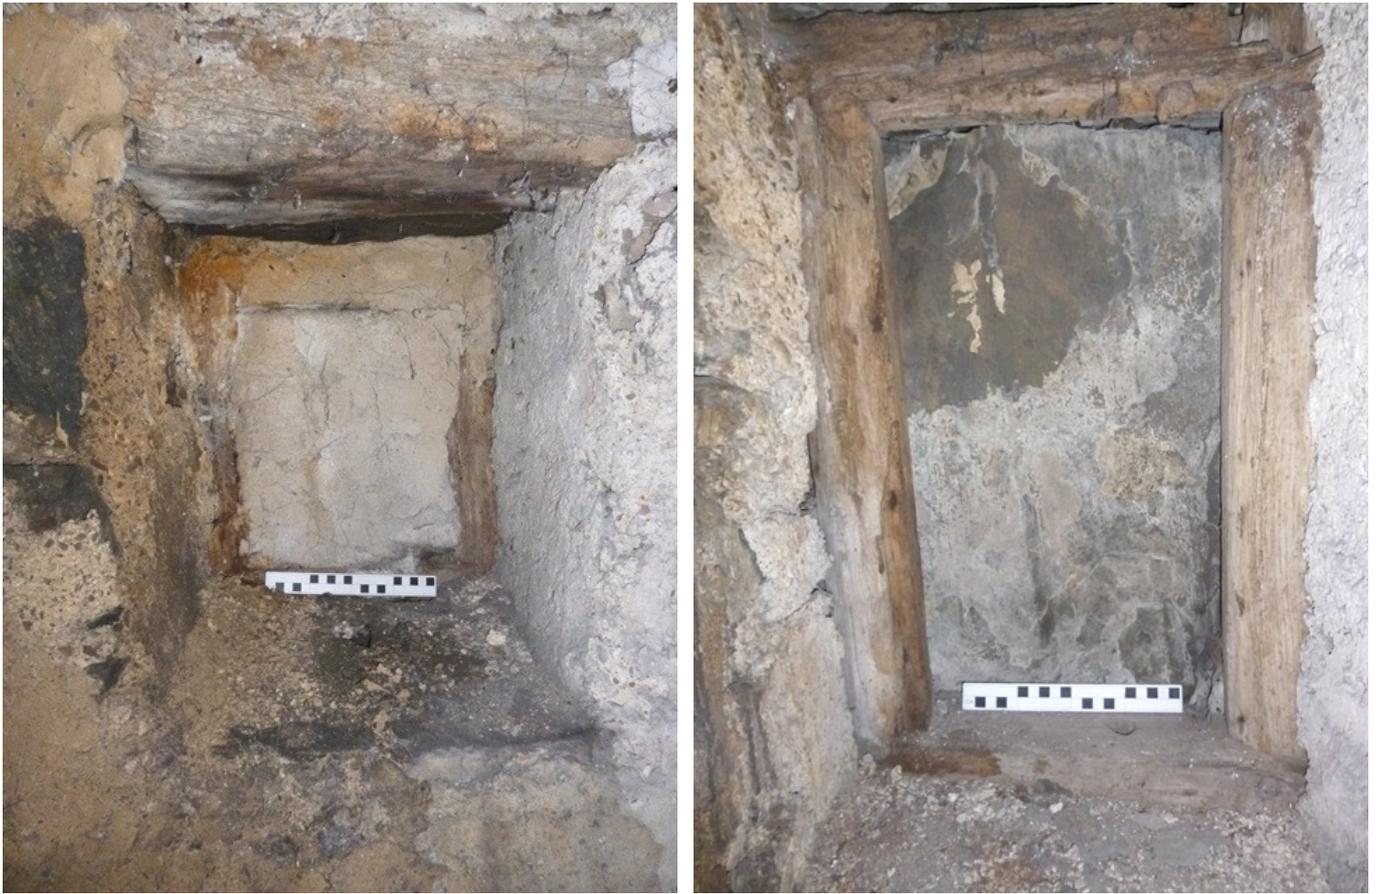
4.3.14 The north-west and south-east elevations comprise the two pitches of the roof; the rafters are evidently later than the other timber, and the underside of the slates is plastered. The north-east elevation has rough lime mortar exposed throughout, which covers much of the stonework. There is a small window on the south-east side with a timber lintel and slate sill, which has been blocked externally leaving an alcove. It has splayed jambs and the remains of a timber mullion surround are just visible, although largely obscured by mortar used in blocking the window (Plate 43). The south-west elevation is essentially the same as the north-east, with another small window on the north-west side. This has an overlong timber lintel, the north-west side has been covered with a large amount of thick lime plaster, and it has splayed jambs and a stone lintel. Again the window has been blocked externally leaving an internal alcove (a large slate slab has evidently been inserted into the opening), and the timber mullion surrounds are more visible. These are five sided in the jambs and square in the sill and lintel, with holes for diagonally-set central bars (Figure 4; Plate 44), only remnants of one now surviving.

Plate 43 (left): Mullion window, north-east elevation, attic

Plate 44 (right): Mullion window, south-west elevation, attic
