BARN ON LAND TO REAR OF ROSE COTTAGE, STANK LANE, STANK, CUMBRIA

Archaeological Building Recording

Client:
David and Kate Hornby

October 2012

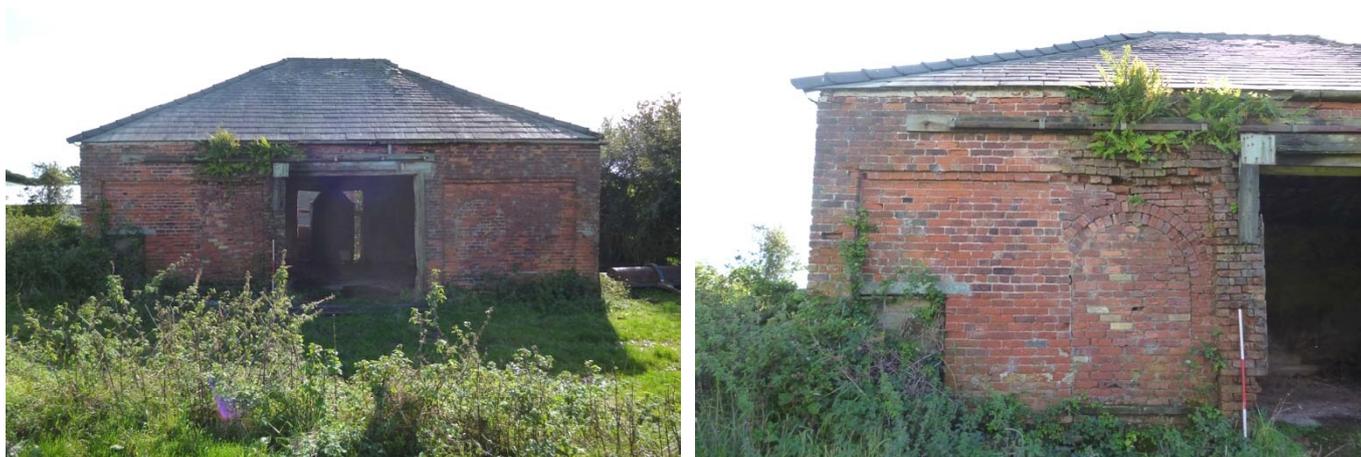
4.2.1 **North-west elevation** (Figure 2): this has two recessed panels either side of a central wagon doorway (Plate 11). The north-east of these panels, and probably the rest of the associated wall, has evidently been rebuilt in a similar type of brick to the original build, and this area includes a small doorway with a slate lintel. This has been blocked with concrete blocks, leaving a recess. To the south-west of the rebuild is a window with a round header arch and red sandstone sill, although this has been cut through on the north-east side by the line of rebuild, and the whole window has been blocked with brick, including some re-used yellow fire brick (Plate 12). The wagon doorway has the remains of a timber sliding door in front of it, with a long timber rail and iron fixture attached above. The doorway has a timber lintel, and there is apparent rebuild around the south-west end, evident as concrete patching. The jambs are also finished with concrete and it is apparent that this doorway is wider and differently arranged to that in the south-east elevation, suggesting that it has been inserted or widened. To the south-east of the doorway there is another recessed panel, also with a blocked window with a round header arch and red sandstone sill. A short distance to the south-east of this is a short timber lintel at low level below which is a small aperture, which cuts through the moulded plinth but is blocked with brick (Plate 13).

Plate 11 (left): The north-west external elevation

Plate 12 (right): Blocked doorway, rebuild, and window, north-east side of north-west external elevation

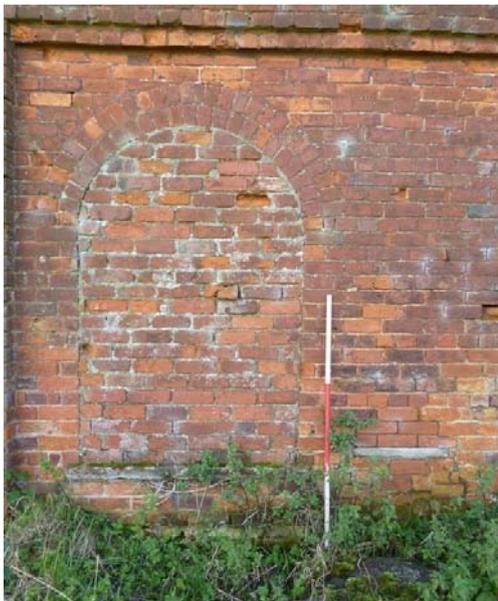
Plate 13 (left): Blocked window and aperture with timber lintel, south-west side of north-west external elevation

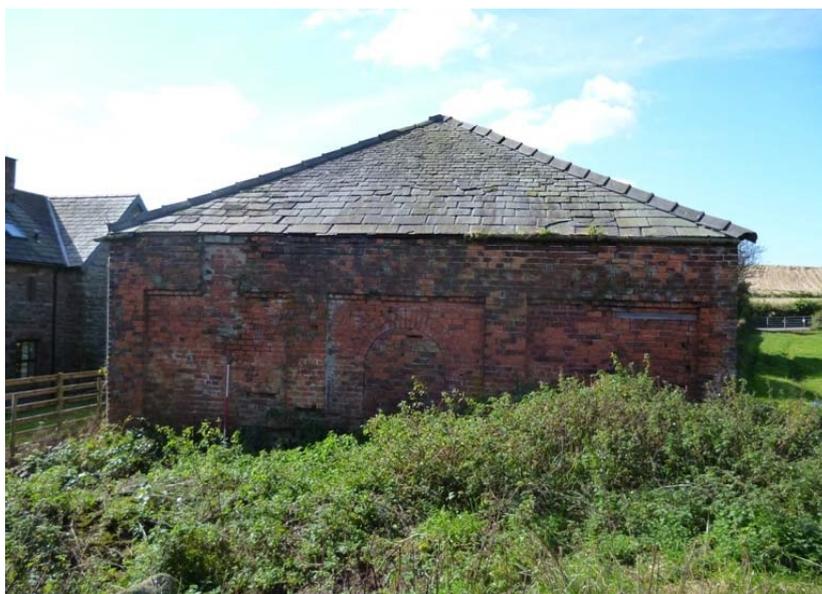
Plate 14 (right): North-east external elevation

4.2.2 **North-east elevation** (Figure 2): as per the other elevations there are three recessed areas across the elevation, situated between a pair of columns either side of the centre and one at either end (Plate 14). The plinth has largely collapsed and is in places unrecognisable and the lower part of the south-east central column has also collapsed. In addition, there is a rectangular section cut out of the area above the south-east recessed area, which is topped with loose concrete blocks (Plate 15). The central recess has a window with a round header arch and red sandstone sill, which is blocked with bricks. The north-west recess has a horizontal piece of timber built in on the north-west side, which appears to be a lintel it does not correspond to any obvious opening. There are traces of limewash on the south-east side of the central recess and in the south-east recess.

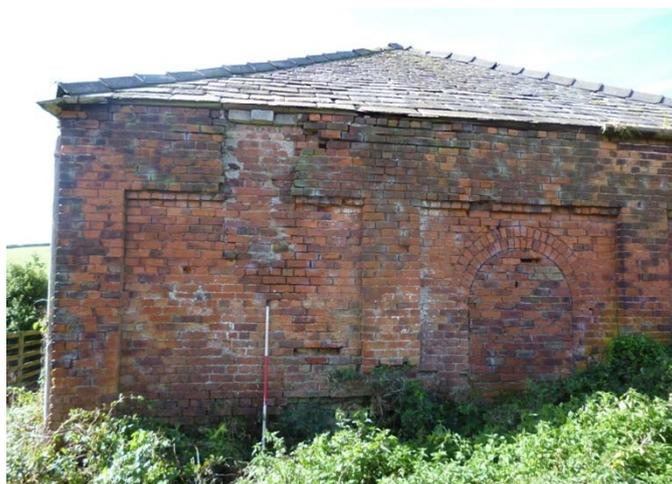
Plate 15: Detail of the south-east side of the north-east external elevation

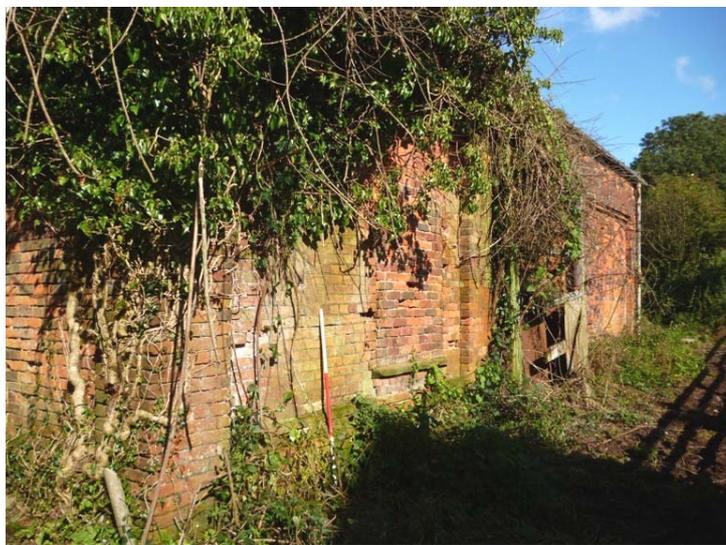
4.2.3 **South-east elevation** (Figure 3): this is broadly the same as the north-west elevation, although it is partially obscured by vegetation (Plate 16). There is a recessed area either side of a central doorway, although the doorway is different in style to that to the north-west, with recessed areas on both sides and a lower timber lintel with projecting brickwork above. The remains of a timber plank and batten sliding door are positioned in front of the doorway and they are fixed to a timber rail above (Plate 17). In the recesses to either side there is a single window with a round header arch, blocked with brick (the north-east including some re-used yellow fire bricks) and with a red sandstone sill.

Plate 16 (left): South-east external elevation, south-west end

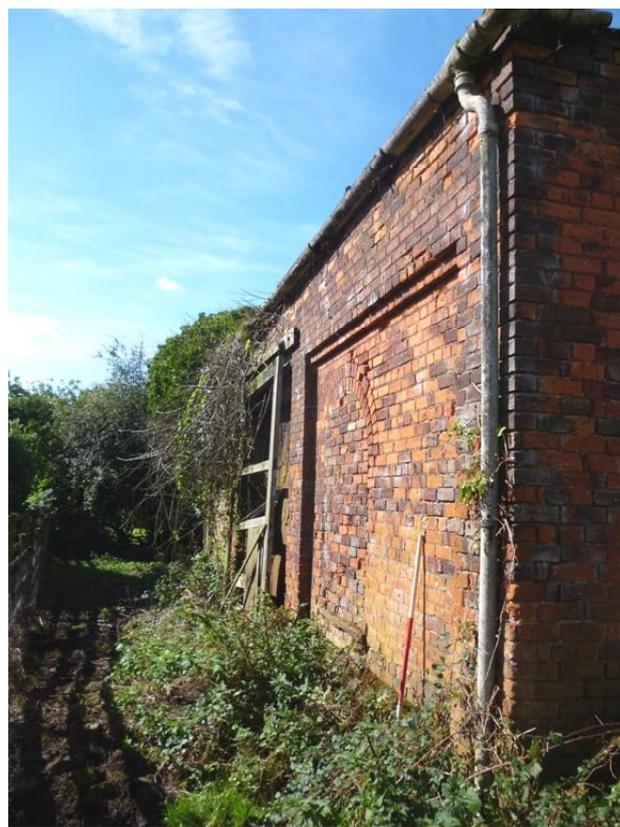
Plate 17 (right): South-east external elevation, north-east end

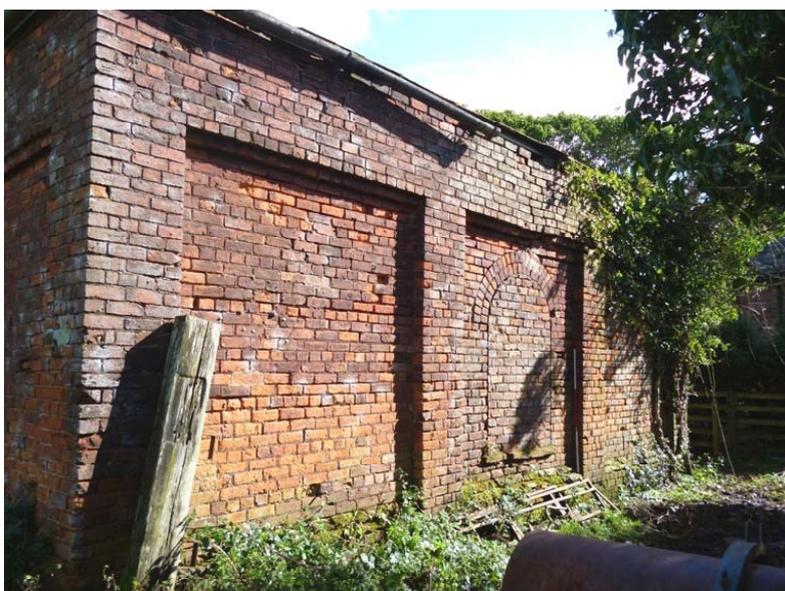
4.2.4 **South-west elevation** (Figure 3): this is essentially the same as the north-east, although the plinth is better preserved. There are three recessed areas divided by projecting columns. The north-west is plain, while the central one has a window with a round header arch and red sandstone sill, which is blocked with brick (Plate 19). The south-east recess has a small low aperture with no lintel on the north-west side, which cuts through the plinth and is blocked with brick (Plate 20).

Plate 18: General view of the south-west external elevation

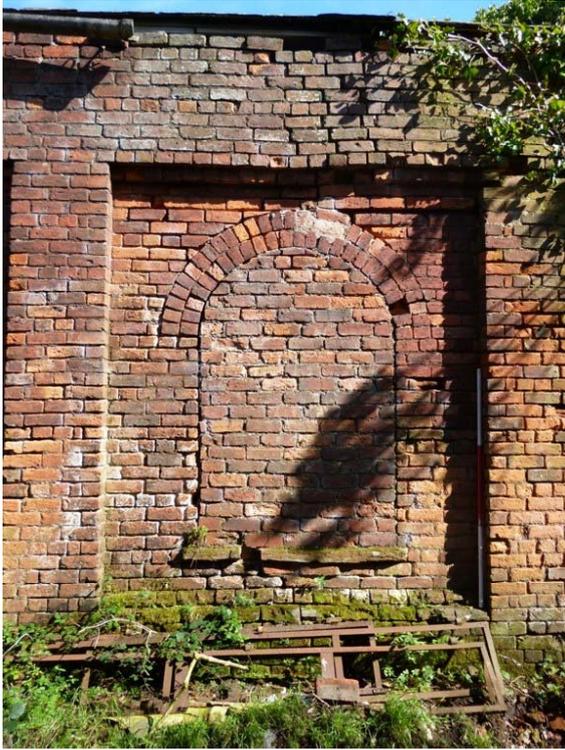
Plate 19 (left): Central blocked window, south-west external elevation

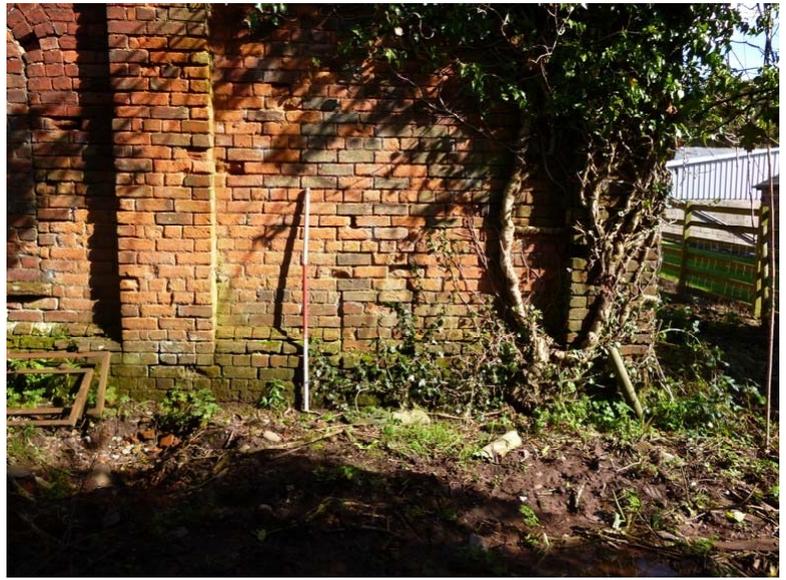
Plate 20 (right): Blocked aperture, south-west external elevation

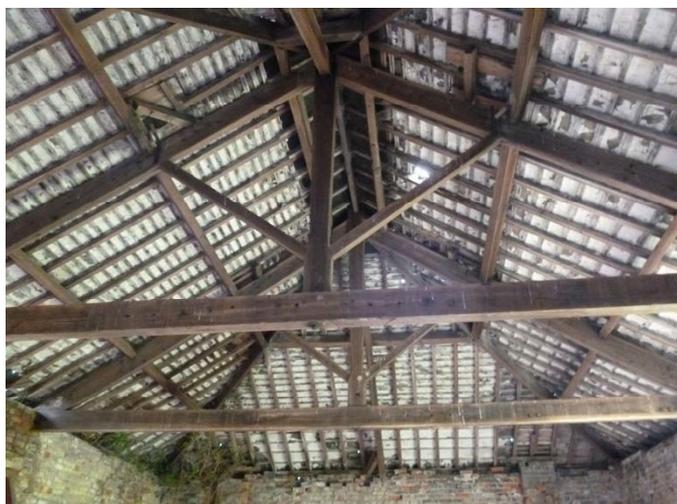
4.3.1 **Ground Floor Room 1:** the interior of the building comprises only a single room, although it is open to the roof structure, which extends well above ground floor level. The floor is covered with gravel, but there is a poured concrete section against the north-west doorway and a plinth made of concrete blocks around the interior and either side of a passageway running between the opposing central doorways in the north-west and south-east elevations (Figure 4). Slots within this plinth along the north-east and south-west elevations denote the position of joists that originally supported a raised floor. The roof structure is supported by two king post trusses orientated north-west south-east (Plate 21). Each truss has a pair of angled braces running between the joggled end of the king post and a flat joint with the principal rafters (Figure 5). The king post too forms a flat joint with the principals and is fixed with a bolt through the underside of the tie beam. There is a long iron bracket bolted to the south-west face of the north-west end of the south-west tie beam (Plate 22), and there are numerous other bolt holes across both tie beams, most of which are empty. The trusses support two purlins on all four sides and a ridge plank orientated north-east/south-west. There are additional timbers around the apex and this, plus the fact that the slates are not plastered in this area, suggests that there was originally a louvred opening (Figure 5). In addition there are two similar patches within the slates in each pitch, indicative of flues or skylights and similar patches above the pairs of former flues against the north-east and south-west elevations (see Sections 4.3.2 and 4.3.3 below). All of the timber in the roof is machine sawn.

Plate 21 (left): Trusses

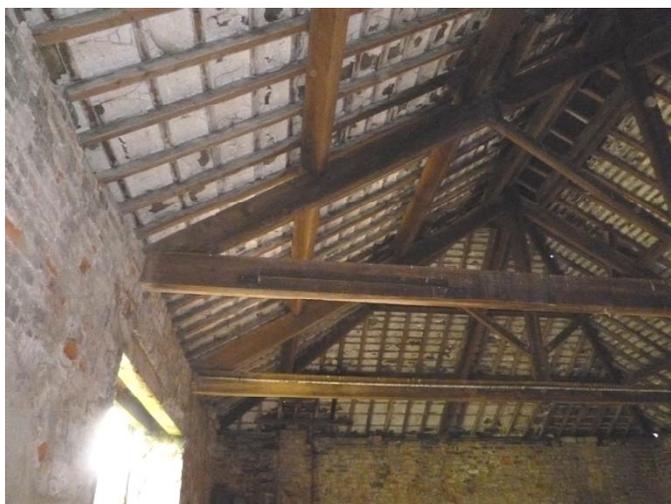
Plate 22 (right): Bracket at the north-west end of the south-west truss

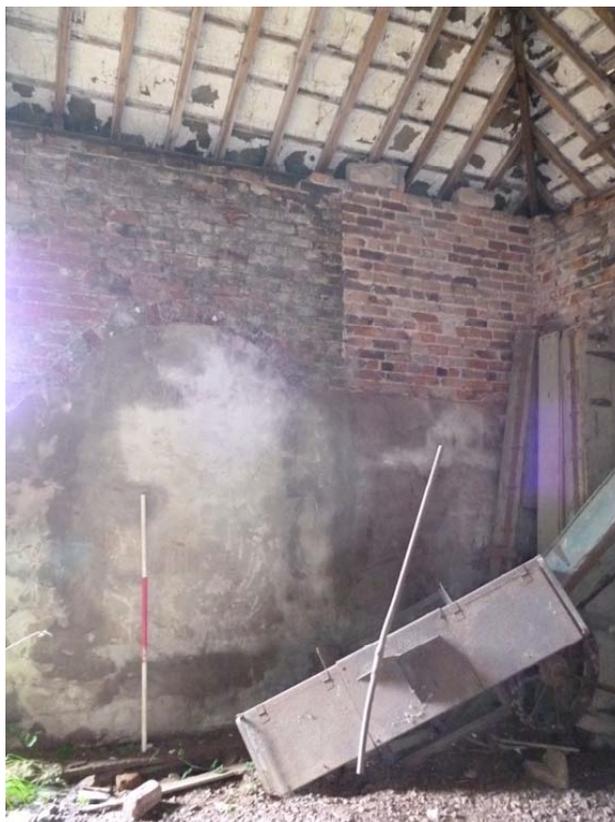
4.3.2 The walls are all constructed from brick laid in English Garden Wall bond at a ratio of four rows of stretchers to one row of headers. The lower part is finished with a thin skim of concrete, which obscures all of the blocked openings visible from the outside, with the exception of the tops of the windows. It is apparent from holes in the external blocking that internally the windows are blocked with concrete blocks, leaving a central void. The brickwork exposed above this skim has the remains of a limewash finish over it. The north-west elevation has the round arches of the windows exposed either side of the central wagon doorway, which has a timber lintel with a shallow slot cut out of the underside on the south-west end. The north-east end has a clear, essentially vertical, line of rebuild north-east of the centre (Plate 23).

Plate 23: Blocked window and rebuild line, north-east end of north-west internal elevation

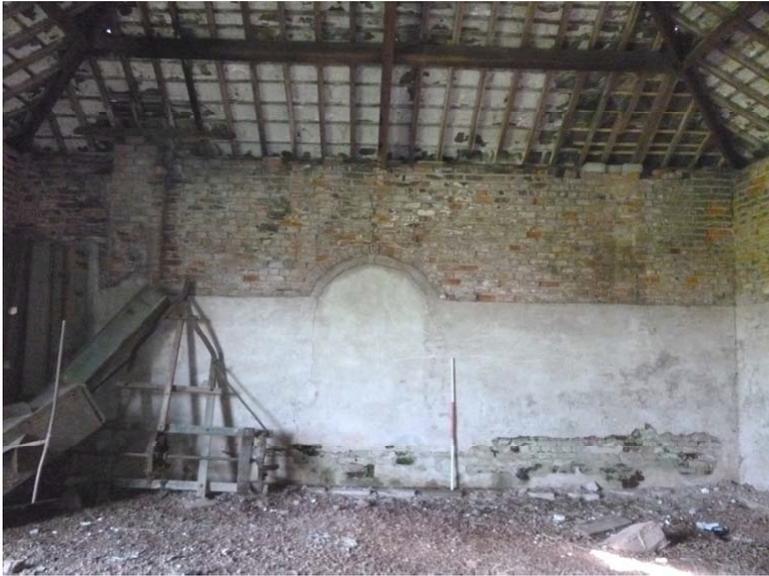
4.3.3 The north-east elevation has a central window, only the arched head of which is visible, the rest covered by the concrete skim (Plate 24). At a high level on the north-west side there is a projecting block of brickwork, evidently the truncated remains of a flue, extending between the roof and the concrete skim (Plate 25). The centre of the south-west face has an area of rebuild or perhaps rough blocking of a small aperture evident as a patch of concrete pointing. On the south-east side of the wall there is a scar at a similar level, again evident as a patch of concrete pointing, but also some broken brick, presumably denoting the original position of another flue, which is topped by loose concrete blocks (Plate 26). The south-east elevation has a pair of windows either side of a central wagon doorway, again only visible due to their round arches remaining uncovered (Plate 27). The doorway has a machine cut timber lintel, lower than that evident externally and there are rectangular patches of the concrete skim missing either side of the door jambs, presumably denoting the former position of a low wall or similar. The south-west elevation has a central blocked window, again only the top of which is visible (Plate 28). Either side, at high level, are the truncated remains of further flues, again extending between the concrete skim and the roof line and with patches of concrete pointing apparently denoting blocked apertures in the centre of the north-east face (Plate 29 and Plate 30).

Plate 24 (left): North-east internal elevation

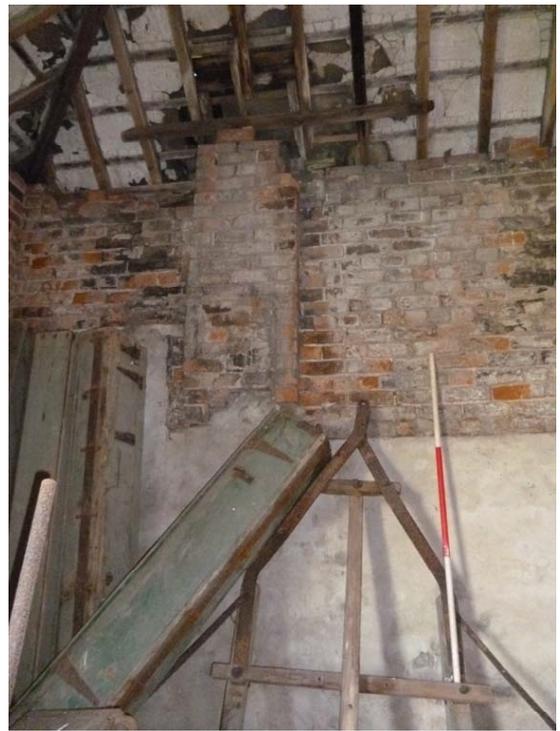
Plate 25 (right): Detail of flue on north-west side of north-east internal elevation

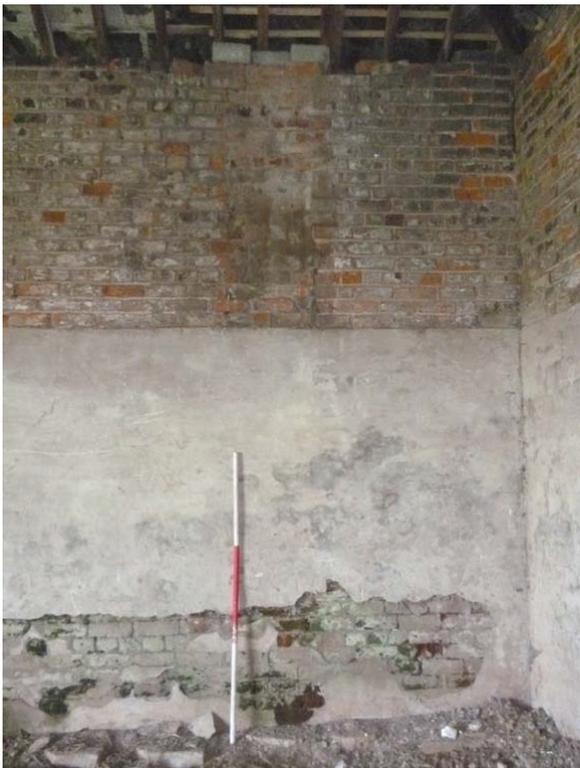
Plate 26 (left): Scar of flue, south-east side of north-east internal elevation

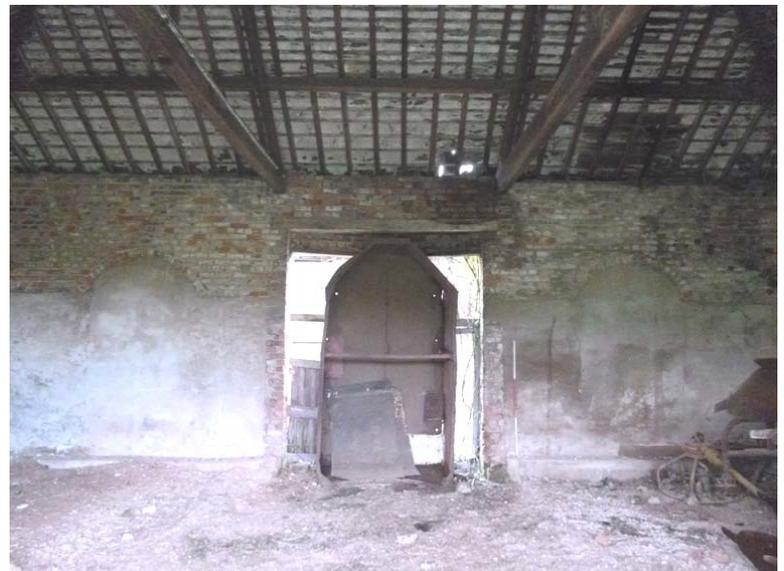
Plate 27 (right): South-east internal elevation

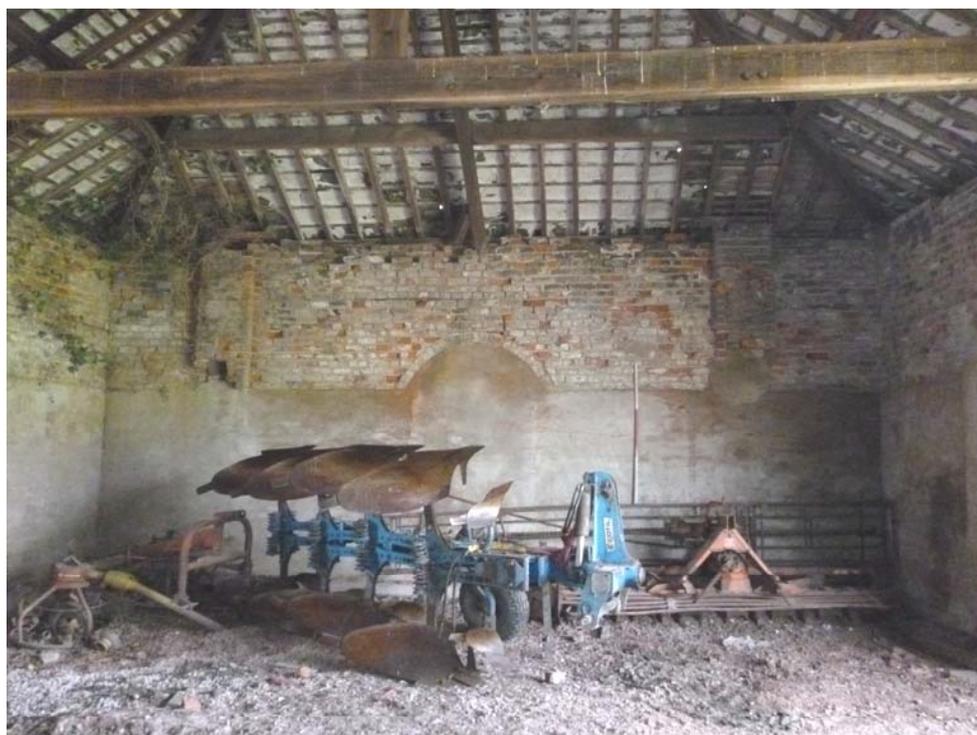
Plate 28: South-west internal elevation

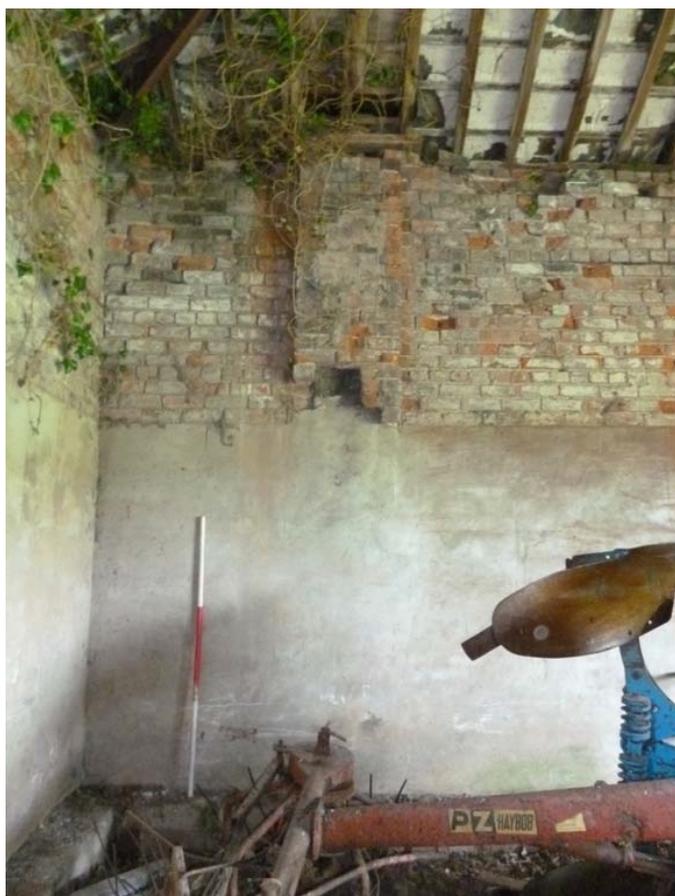
Plate 29 (left): South-east flue, south-west internal elevation

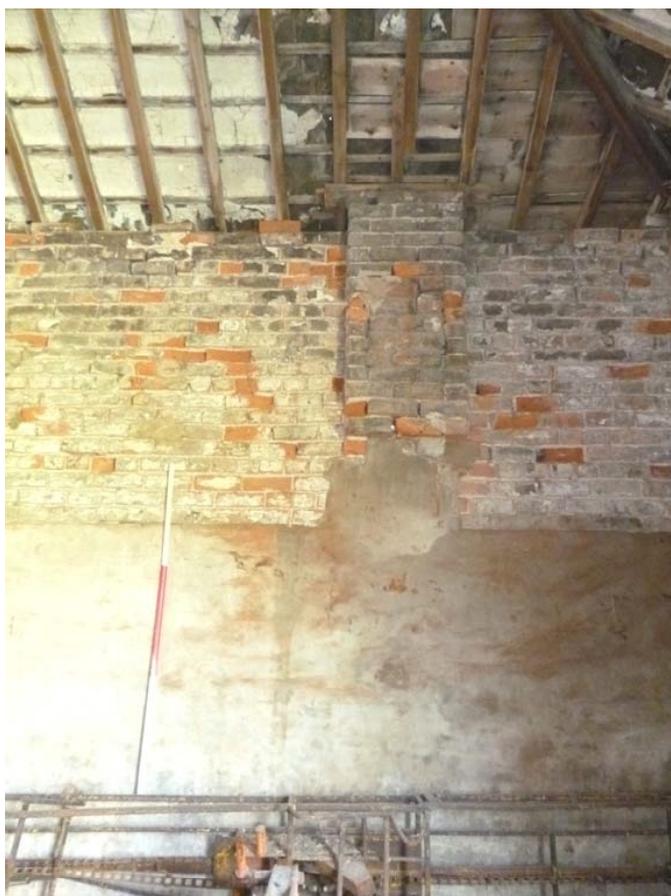
Plate 30 (right): North-west flue, south-west internal elevation
