# FORMER METHODIST CHURCH, QUEEN STREET, MILLOM, CUMBRIA

Archaeological Building Recording

Client: Mark Tohill  
Planning Ap. Ref.: 4/06/2352  
NGR: SD 17593 80057

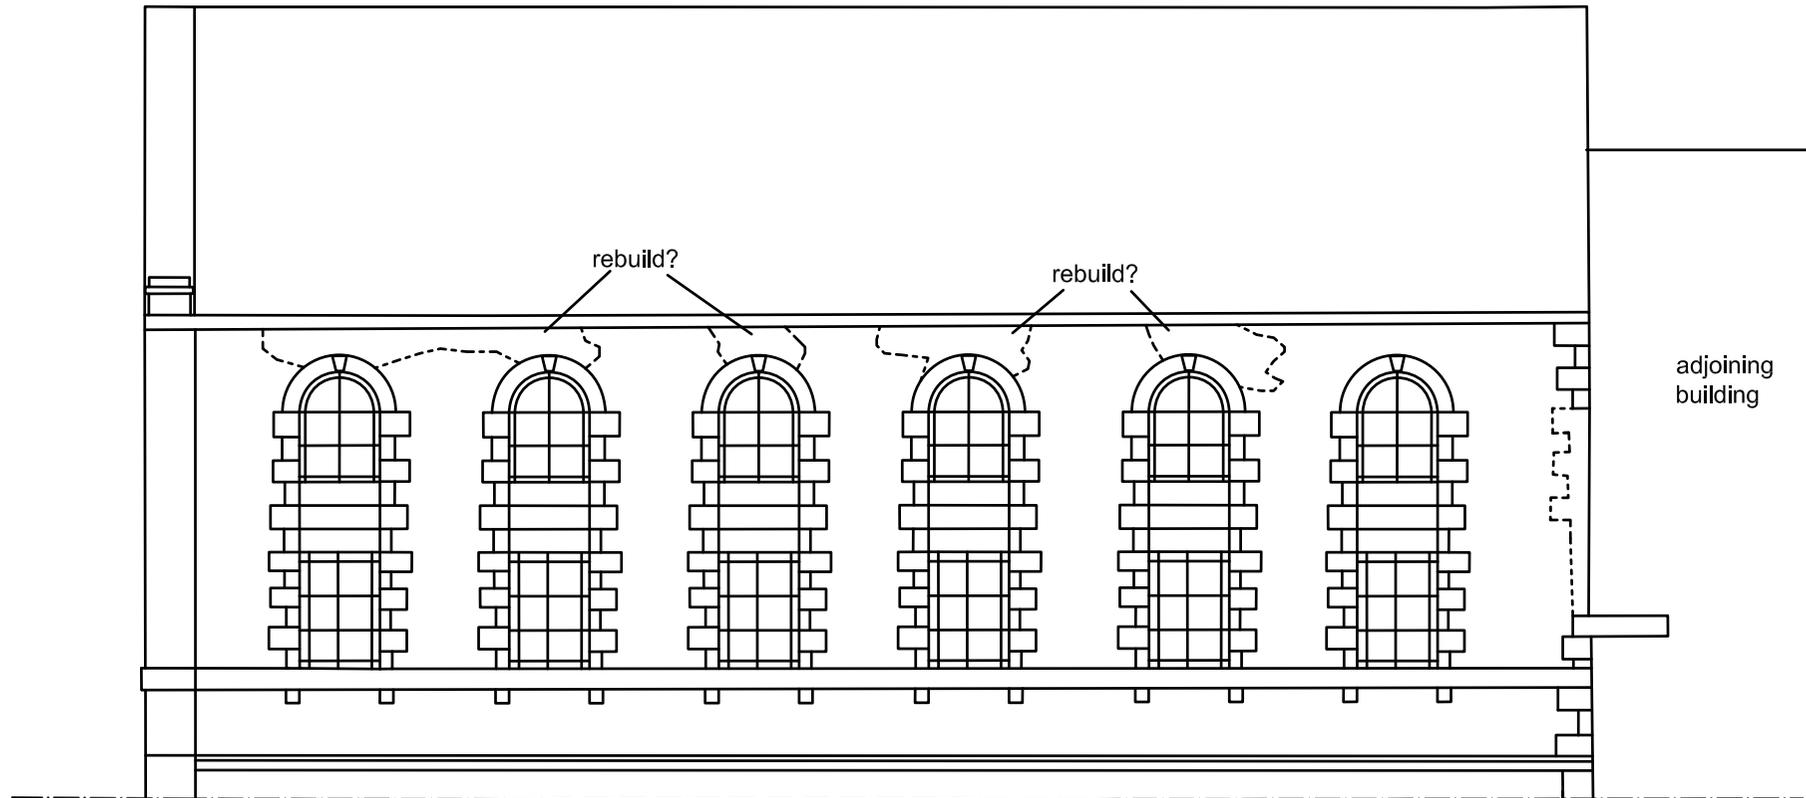
Figure 3: North-facing elevation

4.3.3 **North elevation:** the original courses of slate are visible across the majority of this elevation, the exception being a small part of the east end, which is finished with the same roughcast render as the east elevation (Fig 3; Plate 20). There is a chamfered sandstone plinth running along the entire elevation, with a rusticated central panel, and a square sandstone sill course below the ground floor windows. There are six ground floor windows, all with ashlar sandstone quoins (alternating between those that are finely finished and those that have a rusticated central panel) and flat recessed heads, also in finely dressed sandstone. All of these windows are boarded up, and above each one there is a further rusticated lintel beneath the sills of the first floor windows. There are also six windows on the first floor, each of which has a round-headed arch with a single key stone and the same alternating rusticated and finely-dressed quoins as the ground floor. The majority of the windows have elements of timber casements forming four-light frames with side-lights and quarter-

circle lights within the arched top. There is evidence for re-pointing or rebuilding above all of these windows, and beneath the eaves there is a finely-dressed square sandstone string course. The guttering and downpipe on the west side are cast iron, and there is a plastic downpipe at the east end and the scar for a further downpipe between the two. Several vents have been inserted through the plinth, and there are other blocked holes (probably also resulting from inserted vents) higher up. Where the west end of the building has been extended some of the original quoins remain (Plate 21), although most of these have been removed and the gaps filled, leaving an evident line. A ground floor doorway has been added along the join between the original church and the extension, which utilises some of the quoins in its east jamb. Two of the quoins within the jambs have been inscribed with the initials 'E, J, B' and 'A, R, H'.

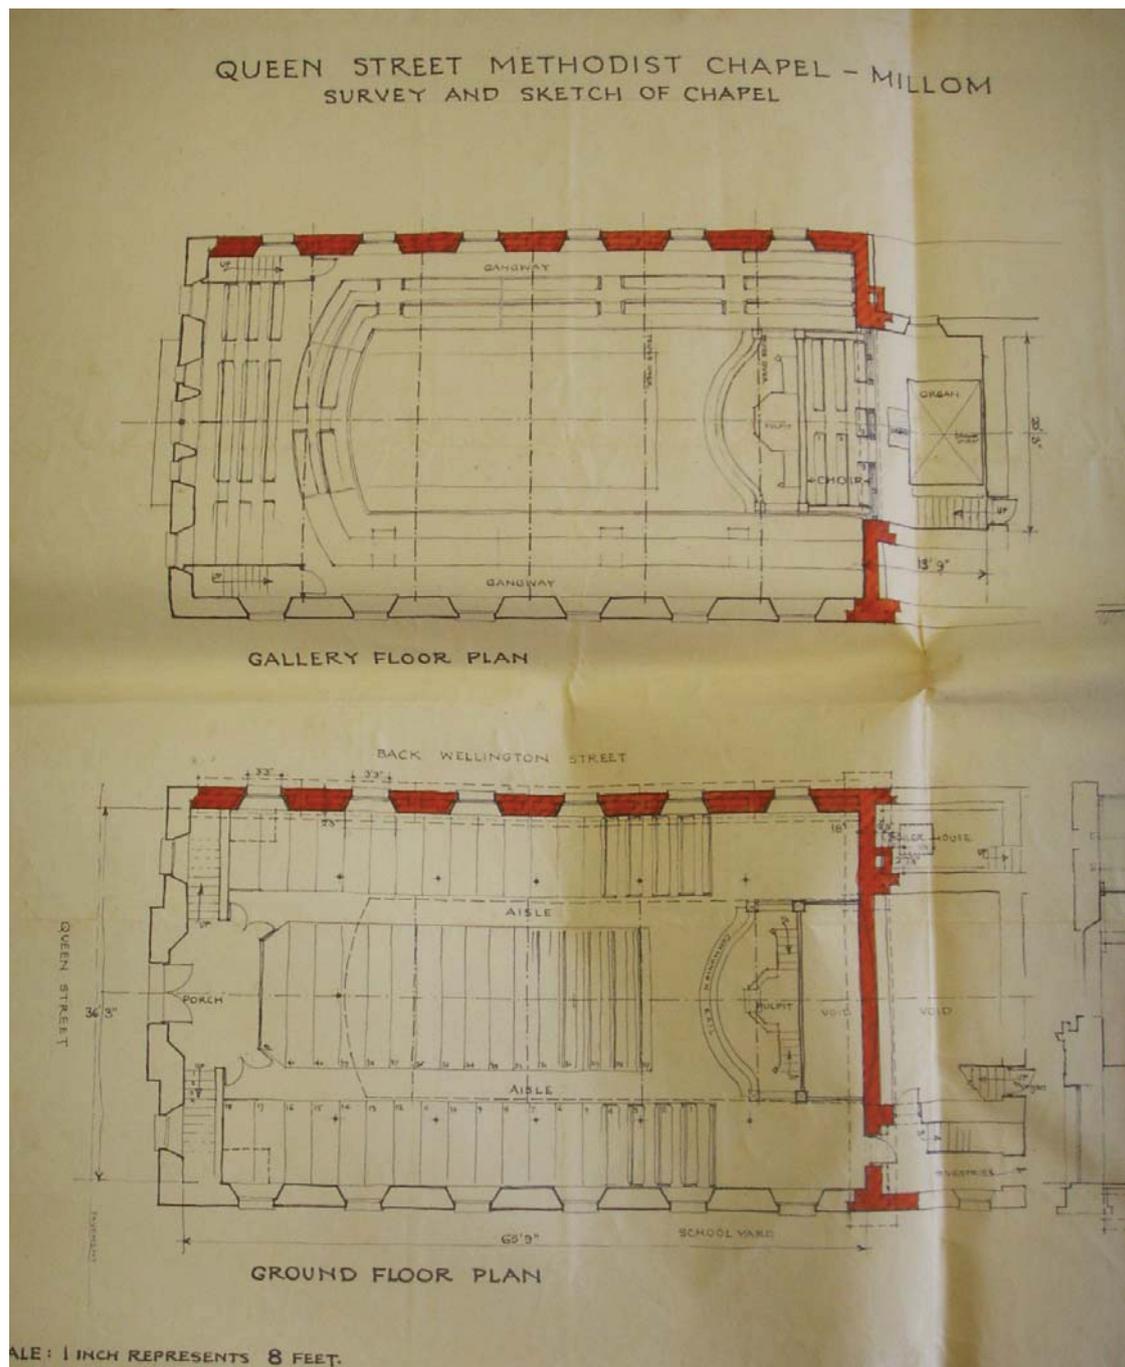
3.1.3 By the late 1950s the church was evidently in poor condition, and it was considered necessary to carry out some major repairs (CRO (B) BDF C/M/M/7/3/1-3 1958-1960). An inspection carried out on 26<sup>th</sup> June 1958 recorded that '*The church built about 80 years ago, with walls of stone 2'3" in thickness, is in quite good condition except for cross wall at the Chancel end which shows cracks in places; it has moved outwards back towards Wellington Street causing a bulge outwards at the corner and extending along the side wall for about 9'0 or so*' (*ibid*). The movement within the building was considered to be as a result of the damaged wall having been built on the line of a ditch, an area of filled ground, or area affected by water (*ibid*). The condition of the side wall was considered to be so poor that it was proposed that the building be demolished and a new church built in its place, but ultimately money was raised to carry out substantial rebuilding of the affected parts of the church (Plates 11-14). At this time some of the pews and the area around the pulpit were re-organised (Jack Giles pers comm.). The church remained in use for much of the 20<sup>th</sup> century after the renovation work (Plate 15), but was finally abandoned in 1993 (Jack Giles pers comm.), all the original fittings were removed and it was turned into a builder's store (Mark Tothill pers comm.), and the hall to the north was demolished (Jack Giles pers comm.).

Plate 12: Plans of the church showing areas needing repair in red (CRO (B) BDF C/M/M/7/3/1-3 1958-1960)

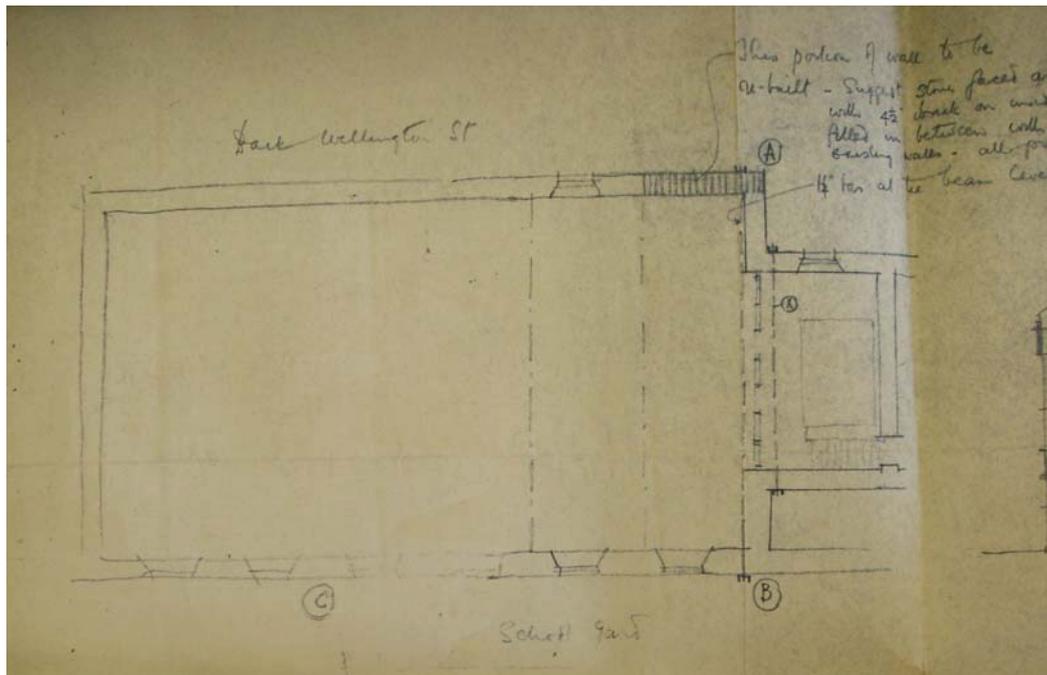
5.2.5 **Phase 4:** between 1958 and 1960 a number of repairs were carried out to the church. These seem to have concentrated in the south-west corner of the building, and are visible within the remains of the structure as a large area of brick-work in the south-west corner. The repairs do not, however, seem to have been as extensive as it was originally suggested they needed to be, although the render added to the south and east elevations has hidden the extent of the repairs in these areas.

Plate 14: Sketch plan of church showing section of the south-west corner to be rebuilt as a hatched area (CRO (B) BDF C/M/M/7/3/1-3 1958-1960)

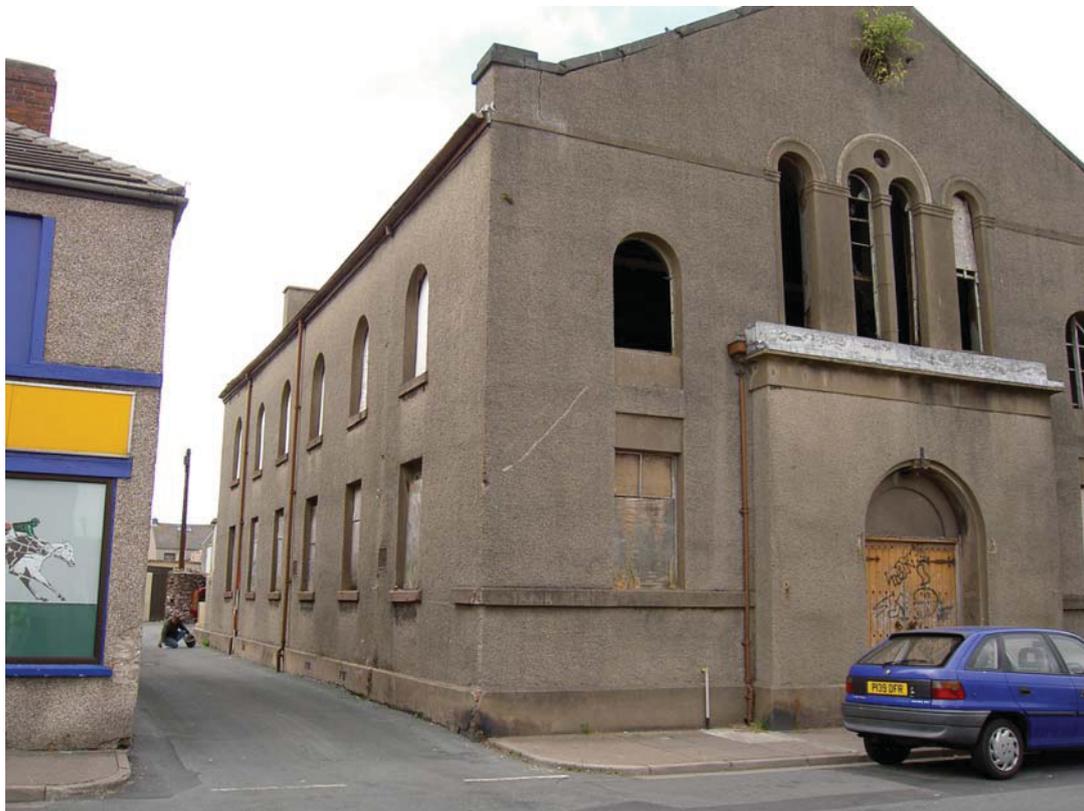
4.3.2 **East elevation:** this is the front of the building (Plates 19-20). It is entirely finished with a roughcast render, although the original string course and chamfered plinth are visible. The main entrance is situated within a square porch that projects from the centre of the elevation, and contains a large doorway with a double door constructed from tongue and groove planks with iron studs and elaborate strap hinges. The doorway has a recessed and round-headed arch (with a single key stone, attached to which is the remains of a light fitting) surround, and the projecting porch has a flat roof. There is a single flat-headed window with recessed lintels either side of the porch, both of which are boarded up, but with the remains of what is probably a six-light window surviving in one. Above these are two further round-headed windows, and in the centre there is a four-part group of narrow round-headed windows with moulded round-headed arches springing from a moulded cornice or entablature continuing the line of the string course. Above this group of windows is a small circular aperture filled with timber slats. The gable is finished with a slightly raised coping, with squat square finials at each end.

**4.3.5 South elevation:** this is entirely covered by roughcast render (Plate 19). There are six windows per floor, those on the first floor having round-headed arches while those on the ground floor have flat heads. All of them appear to have concrete sills (coloured to imitate red sandstone) and are boarded up. There is a chamfered plinth along the base of the wall, and some small areas of this are exposed beneath the render revealing it to be brick built. There is a cast iron gutter beneath the roof and two cast iron downpipes attached on the west side, with the scar of a third to the east. The top of the east end is finished with a flat coping and a squat square finial. The west end is butted by a short section of brick wall, which continues the line of the plinth, forming a small yard on the west end of the building.

Plate 19: East and south external elevations, looking north-west

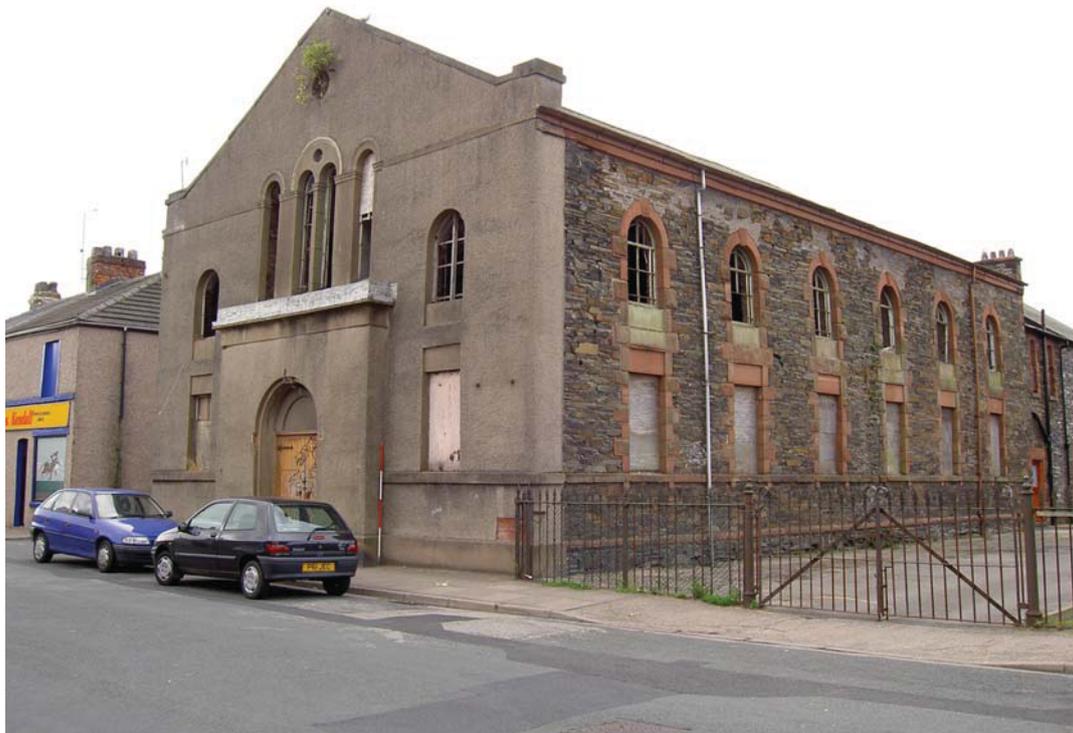
Plate 20: East and north external elevations, looking south-west

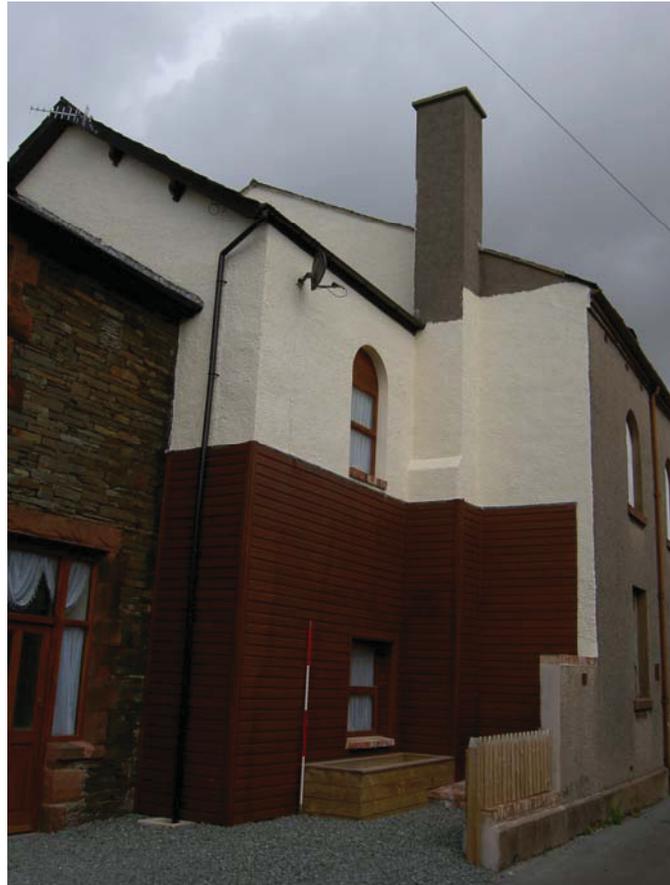
**4.3.4 West elevation:** this is largely obscured by the later extension and therefore could not be examined in detail (Plate 22). The elements that are visible have been covered by render and timber panelling and painted as part of the recent renovation of the west extension (Plate 21). A small square chimney is present, however, which has a flat coping around the top.

Plate 22: West elevation of church and adjoining extension

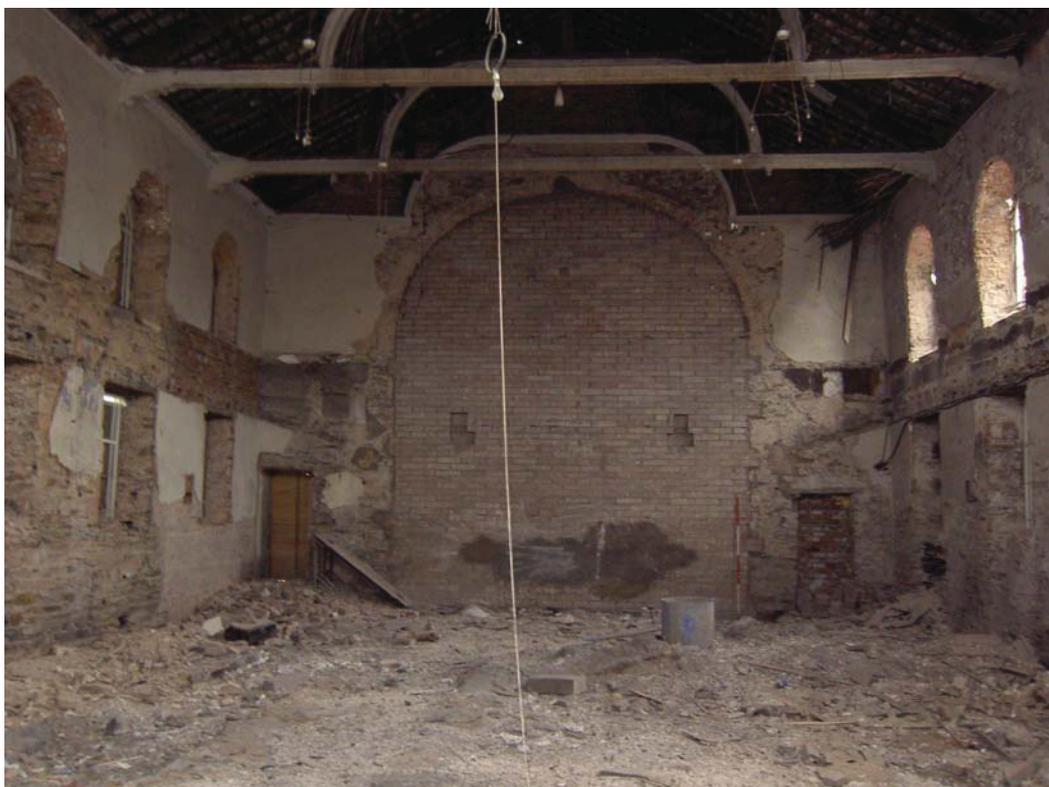
**4.4.1** The interior comprises a single large room, originally on two floors but now open to the ceiling (Figs 4-6; Plate 23). The floor is covered in rubble but no original surface survives – six low stone walls, presumably forming the bases of a timber floor, orientated east/west are present, although these end at a north/south wall at the west end with large amounts of concrete dumped on top. A small brick section is present on the north side of the centre, towards the west end. The roof is supported by five trusses, each sat on scrolled brackets set into the north and south walls (Fig 6; Plate 24). Each truss comprises a pair of queen posts supporting a collar, which in turn supports king-posts, which are notched and splayed to fit the principal rafters and have squared heads supporting the ridge purlin (Campbell 2000, 47). A three-way strap (*op cit*, 50) attaches the queen post to the collar and principal rafter and attached to the inside edges of the queen posts and the underside of the collar is a curved bracket. This is chamfered and originally supported the vaulted lathe and plaster ceiling, part of which survives at the east end and had an iron 'rose' boss set into it supporting the light fitting. There are three purlins per pitch, and the principal rafter is trenched to fit them, plus a ridge purlin, and there are two small finials on the underside of the tie beam. The walls in general comprise rough courses of slate, although the round arches over the windows are brick – some brick lying loose in the building is marked 'Whitehaven', although it is not known where in the building this originated, if at all. Some areas of the wall are finished with plasterboard.

Plate 23: General view of interior, looking west

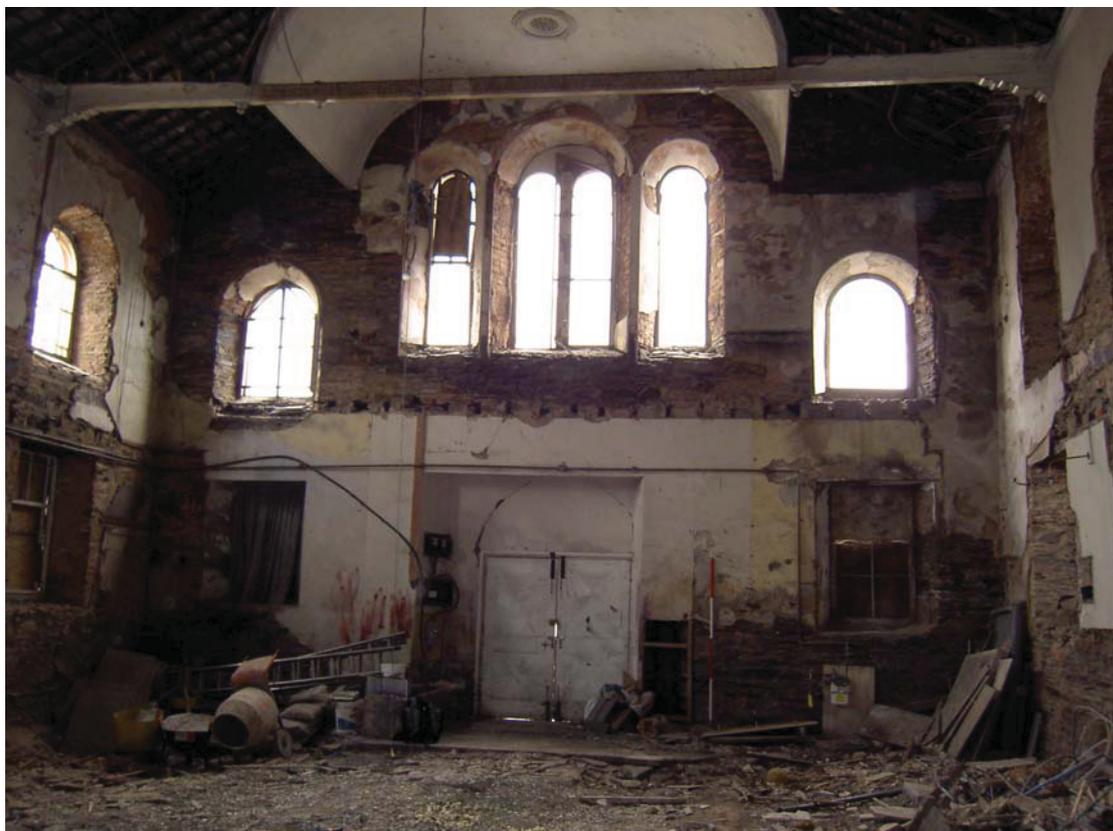
**4.4.2 East elevation:** this is finished with plaster and paint. On the ground floor there is a large double door with splayed jambs, the southern of which is boxed in with a timber stud wall around an upright cast iron I-beam (Plate 25). The windows

flanking the doorway have the remains of plain six-light casements, while the windows above these have very little of the frames remaining. The central window comprises four separate openings, formed by three apertures, the central of which comprises a large round-headed window divided into two small round-headed windows by a central mullion. All of the windows have brick arches and sloping sills.

Plate 25: General view of east internal elevation, looking east

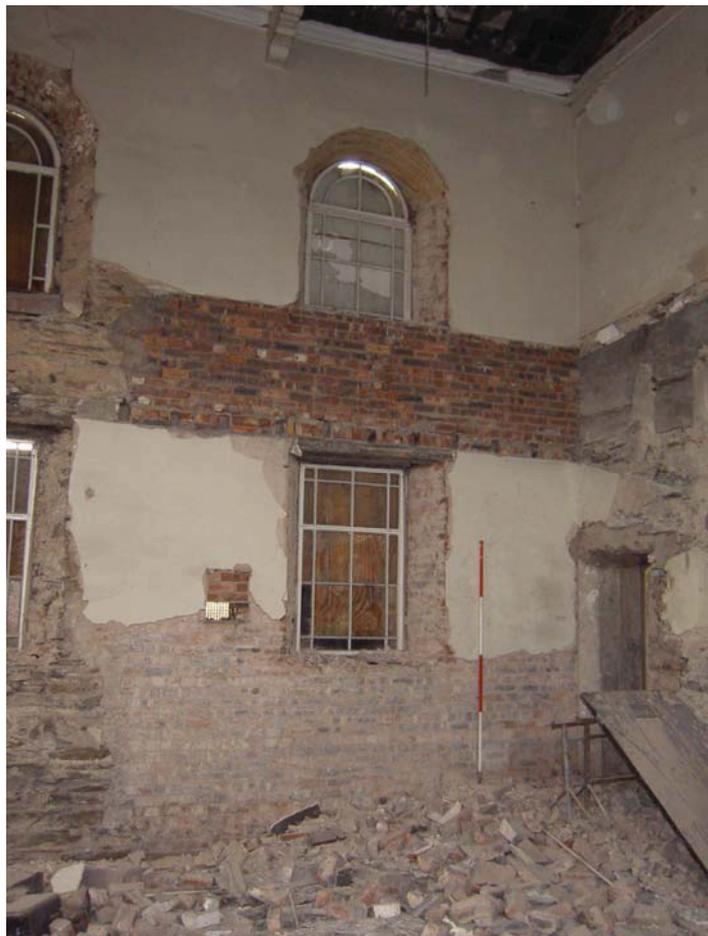
4.4.5 **South elevation:** this is essentially the same as the north elevation. However, the west end has been rebuilt in modern brick (Plate 27). Like the north elevation three vents have been inserted through the wall, and the joist holes for a gallery, with added brick, are present above the ground floor level.

Plate 27: Rebuilding in the south-west corner, looking south-west
