# HOUSE AT SLACKWOOD FARM, SILVERDALE, LANCASHIRE

## Archaeological Building Recording

Client: Adrian Waddingham

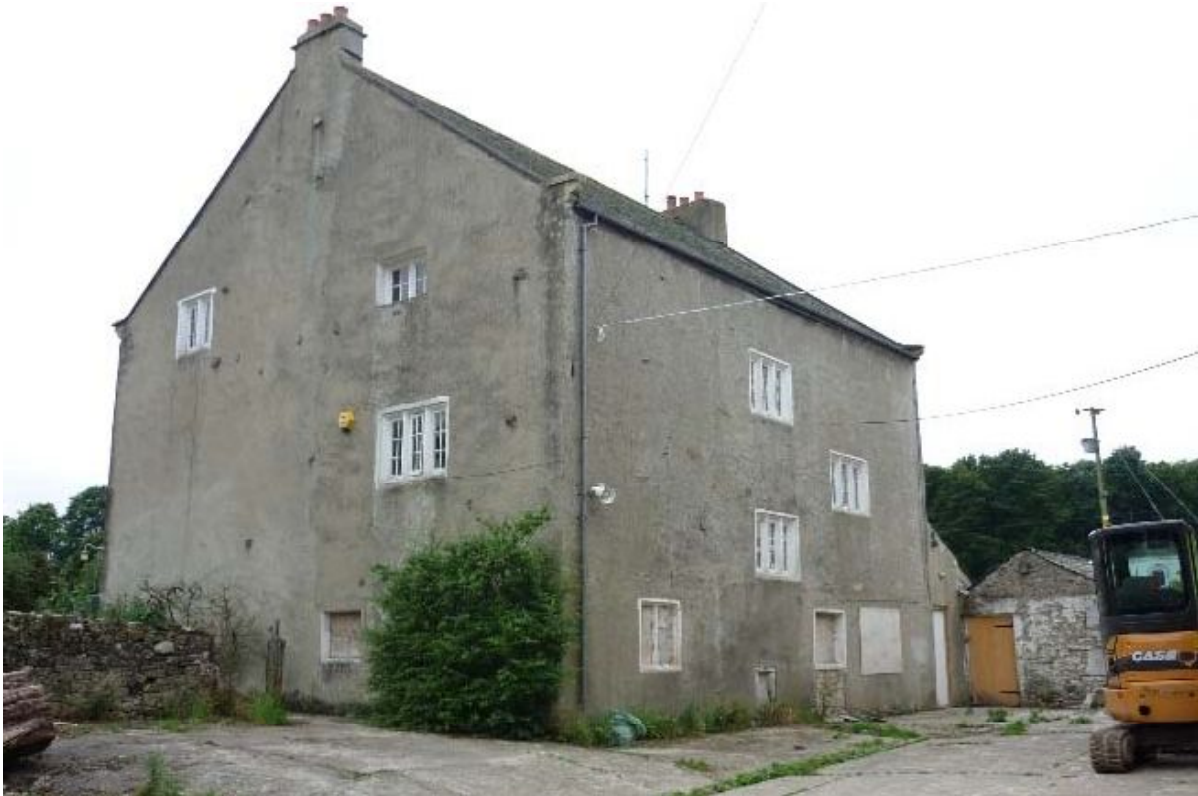
Plate 5: North and east external elevations of the house and outshuts

4.2.2 **Farmhouse – east elevation:** this formed the gable end of the house (left side of Plate 5). There was a single window on the ground floor, with a plain surround, which had been boarded over. There was a timber gatepost attached to the wall which had a modern metal gate and an opposing limestone gate post. The first floor had a three-part six-light mullion window on the north side. There were two windows on the second floor; the south window was a two-part mullion window each with six lights, the north window had plain surrounds and two four-light casements with mullion dividing. There were scrolled kneelers at either end of the elevation and a central chimney stack with three ceramic pots. There were various projecting throughstones visible through the render. The elevation was extended to the north by the gable end of an outshut located at the west side of the house (Outshut 2). There was a doorway with a heavy limestone lintel on the south side of the east elevation of this outshut where it butted against the wall of the house. The doorway had a beaded timber surround and housed a tongue and groove plank door. This elevation of the outshut had large dressed quoins to the north and was extended by a concrete block wall with a pump attached (see description in *Section 4.2.1* above) but it was otherwise plain. There were two concrete steps up to the yard to the north.

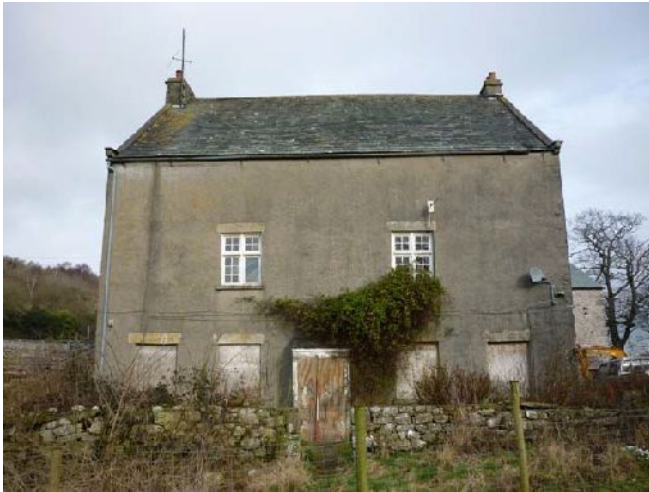
4.2.3 **Farmhouse – south elevation:** the ground level was raised slightly to the east relative to the western end of the elevation and there was a slight plinth evident below the render along the base of the wall (Figure 3). There were two plastic vents on the east side of the ground floor at ground level. The ground floor had four tall windows, with stone sills and lintels (Plate 8). The east and west lintels were both cracked. Located fairly centrally on this side of the house there was a projecting timber porch which had a slate roof and glazed sides on a concrete block base. The first floor had two windows in the same style as those on the ground floor level. (The outer garden wall to the south had a gate with rebated dressed sandstone quoins). The elevation had plastic rain water goods and scrolled kneelers at either end of the eaves. The west end of this elevation was formed by the south wall of Outshut 1 (Plate 9). The south elevation of the outshut had a single boarded window with a limestone lintel and a concrete sill that comprised several parts.

Plate 8 (left): South external elevation of the farmhouse

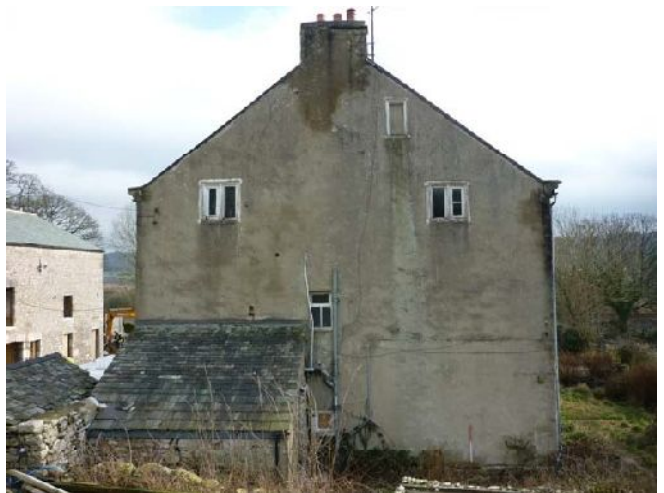
4.2.4 **Farmhouse – west elevation:** the north end of the west elevation was extended by the gable of Outshut 2 and there were large quoins behind the gatepost on the north side (see Plate 7). The west wall of Outshut 2 butted against a tall retaining wall on the south side (Plate 10), which formed part of a general retaining wall. The retaining wall returned to the east and within this section there was a low opening with a limestone lintel, and was butted by Outshut 1, which had a mono-pitch roof (Plate 11). The west elevation of this outshut was plain except for a ceramic vent and some concrete re-pointing. There was a timber barge board attached and quoins at the south-west corner. To the south of where the wall of Outshut 1 butted against the main wall of the house the house had a small one-light window, with a chamfered stone surround, and below this there was a plinth along the length of the wall (Figure 3). The first floor of the house had a central tall narrow three-light modern casement window, which was probably inserted, the surround for which was concreted over. The second floor had two two-part mullion windows, each with a later single or two-light casement in each part. There was a further blocked single-light window on the south side at the level of the attic, which had a chamfered surround. There were scrolled kneelers at either end of the elevation and a central chimney stack with three ceramic pots and the remains of a drip course.

Plate 11 (right): West external elevation of the farmhouse and Outshut 1

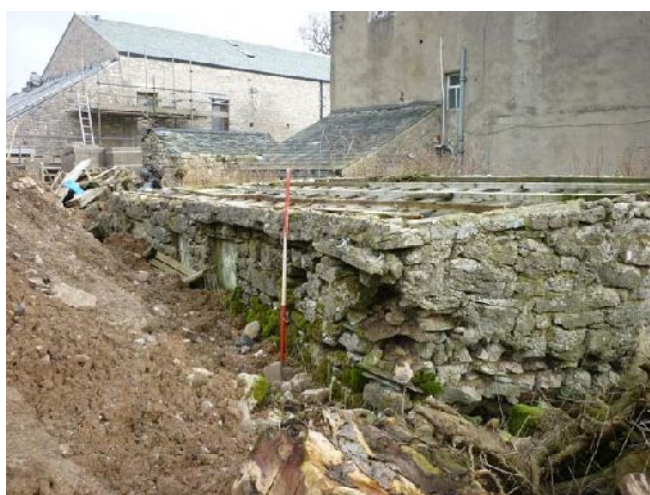
**4.2.8 Ruined outbuilding – west elevation:** the west elevation appeared to have been heavily rebuilt and there was lots of concrete used along the top (Plate 15). There were three windows on this side of the building which matched those on the east elevation (see Section 4.2.6 above), but there were two four-light and one one-light casement window on this side. There were the remains of quoins at the north end, which were largely obscured by spoil.

**Plate 15 (right): West external elevation of the ruined outbuilding**

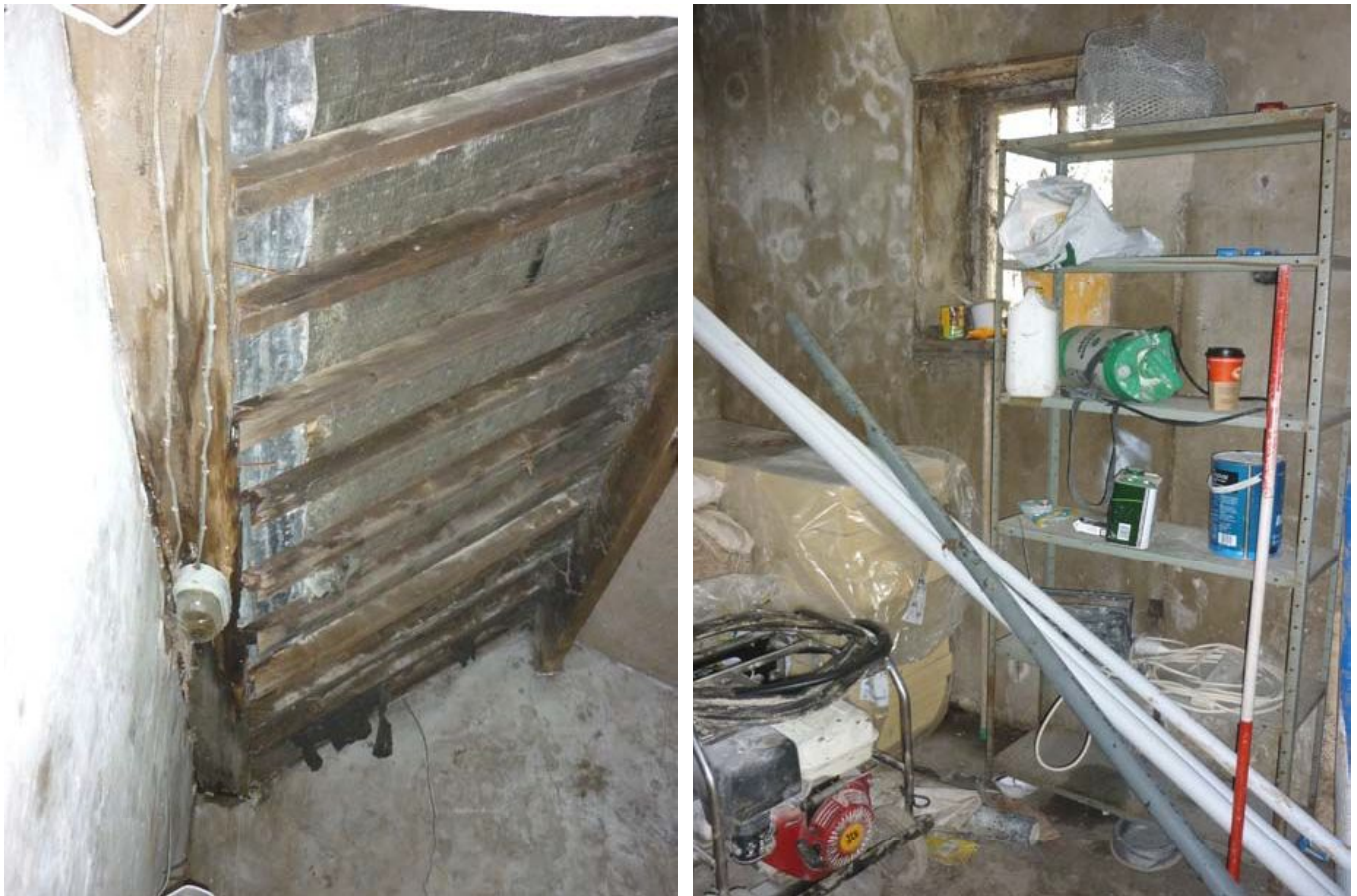
4.3.2 **Ground Floor – Room 1:** this room formed the north-west outshut (Outshut 2) and was possibly originally a pigsty, although it was being used as a store at the time of the survey. It had a concrete floor and the roof was exposed on the south side. The roof comprised machine cut rafters and had a wall plate, which projected slightly, along the south wall (Plate 20). There was also a ridge plank. The north side of the room was covered with asbestos sheeting but had a small single-light skylight. All the walls were finished with a concrete skim. The north elevation had a two-light casement window with a stone sill and lintel (Plate 21). The east elevation had a doorway on the south side with a modern plank and batten door in an earlier surround with pintels on the south side and it was hinged on the north side and had a hand-finished timber lintel. The south elevation was plain apart from some graffiti, which read “IWH”, on the east side. The west elevation had a large crack in it, but was otherwise plain.

**Plate 20 (left): Machine cut rafters along the south wall of Ground Floor Room 1**

**Plate 21 (right): North elevation of Ground Floor Room 1**

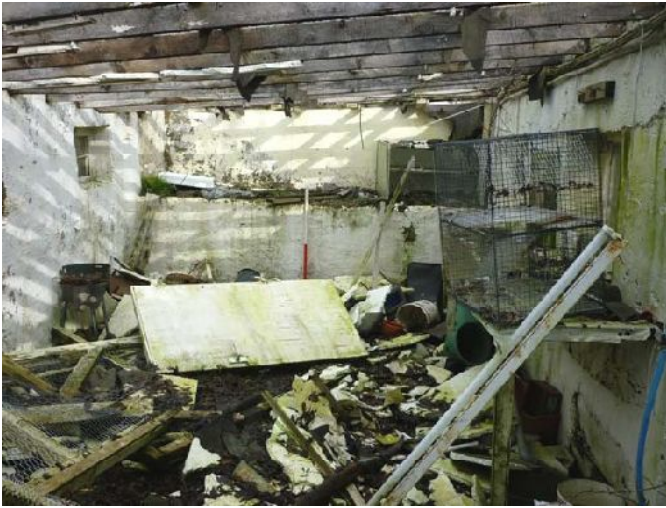
4.3.10 **Ruined outbuilding**: the floor was assumed to be concrete but was covered with debris from the collapsed roof. The rafters from the mono-pitch roof remained and there was some internal timber and mesh walling. The walls were all finished with a concrete skim and painted. The north elevation had a deep plinth and a low level shelf (Plate 40). There were three windows and a doorway on the east elevation and this elevation had a lot of concrete along the top. There was a stepped plinth and the wall was thickened at the south end. The south elevation had lots of concrete added and had an attached timber and mesh wall and a post in the south-west corner (Plate 41). The west elevation was thickened on the south side and had three windows to the north of this and a slight step out at the north end.

**Plate 40 (left): General view of the ruined outbuilding, looking north**

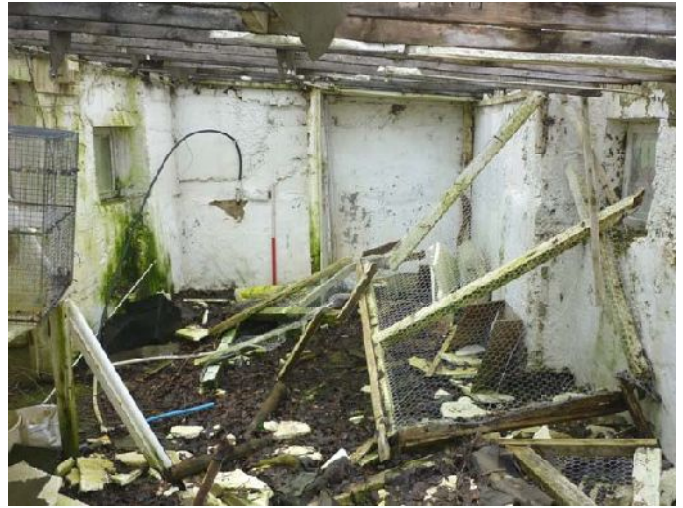
**Plate 41 (right): General view of the ruined outbuilding, looking south**

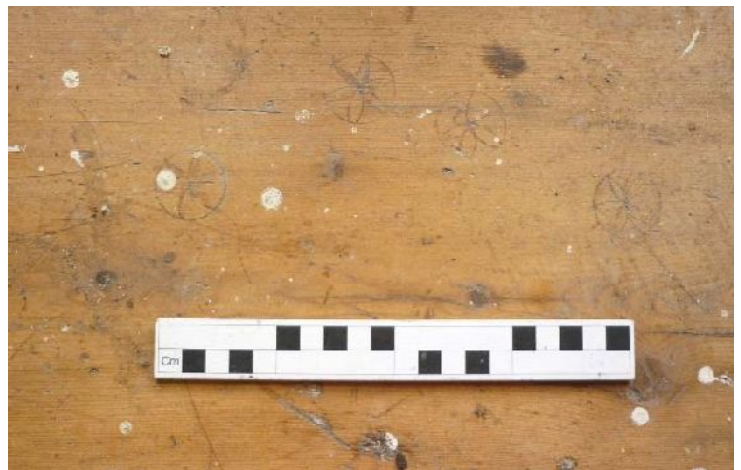
**Plate 61 (right): Daisy wheel motifs scored into the window sill in Second Floor Room 4**
