LOW BARN, MAIN STREET, BAYCLIFF, CUMBRIA

Archaeological Building Recording

Client: David Pennick
Planning Ap. Ref.: 5/05/1303
NGR: SD 28835 72315

© Greenlane Archaeology Ltd
May 2007

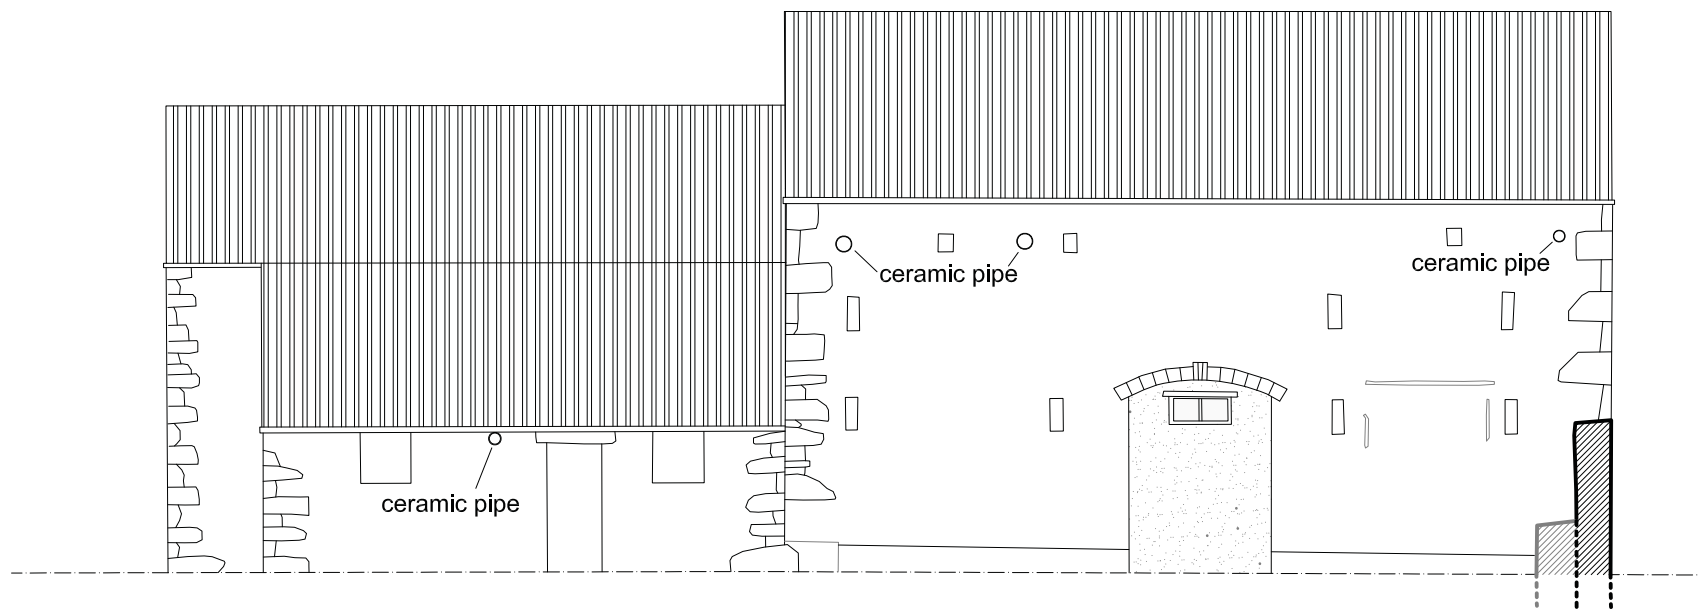
Figure 3: South-east elevation

4.2.1 **South-east elevation:** the north-east end is formed by a two storey threshing barn with a large central wagon doorway with an arched head above which is a slate drip course (Fig 3; Plate 6). The doorway has been filled with concrete blocks leaving only a small two-light window with a fixed casement. There are two rows of rectangular slit vents and another row of square vents below the eaves. While the build is in general the same as that elsewhere several of the stones have drill holes as a result of quarrying. There is a small area of render denoting the position of a possible outshut to the north-east of the doorway and at the east corner the barn is butted by a low concrete block 'wall', which appears to support a taller boundary wall to the north-east. On the south-west side there is a low concrete block butting the wall, with the ends of iron L-shaped upright posts projecting through the top, which presumably formed some sort of support or base. There is a return to the south-east at the south-west end where there is an attached outshut. This has a monopitch roof and covers the majority of the south-west end of the elevation. There are two small windows with machine-cut timber frames and lintels (formed by the wall plate) in the south-east elevation and a doorway with a hand-finished re-used timber lintel with some stop-chamfer decoration visible and a modern sheet metal door. A ceramic pipe has been inserted into the wall to the south-west of this to act as ventilation. The outshut returns to the north-west and there is another pedestrian doorway with a concrete lintel and a ceramic pipe vent above. The return to the south-west has a blocked aperture immediately adjacent to the outshut (and in fact partially covered by its south-west wall), which has a hand-finished timber lintel.

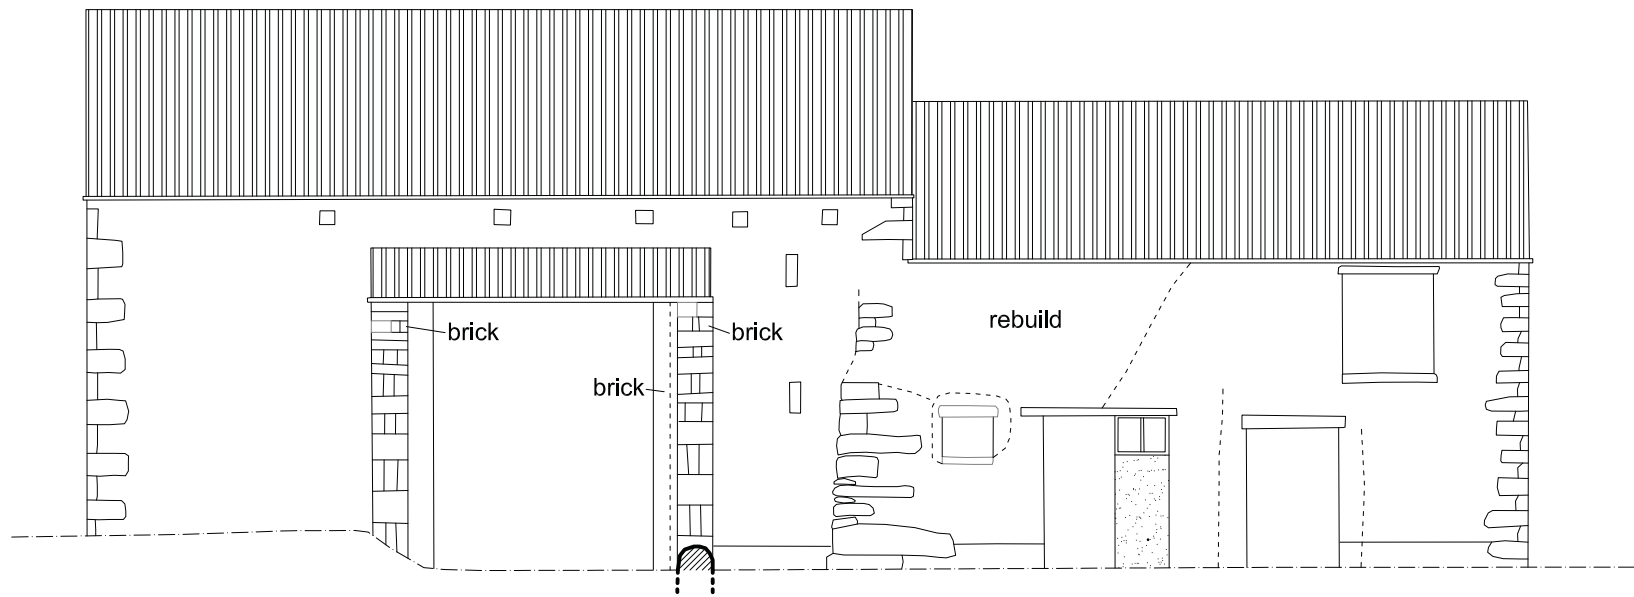
Figure 4: North-west elevation

4.2.3 **North-west elevation:** the south-west end is lower but still two-storeys (Fig 4). On the ground floor there are two doorways; the north-east was evidently originally larger and has been partially blocked with stone to form a smaller doorway and leave a two-light fixed casement window, all of which has a machine-cut timber lintel (Plate 8). The door is only half height and comprises planks supported by battens. The south-western doorway has possibly been inserted; the jambs show

signs of having been rebuilt and it has a heavy limestone lintel. The door is made from tongue and groove planks held by battens, although the top half is finished with slats only. There is a small window to the north-east of the doors with a two-light casement, the upper part of which has a night-vent opening. There is brick rebuild around the jambs of the window (the brick is dark red and machine made, with a frog), suggesting that it has been inserted and the sill and lintel are concrete. At the north-east end of the south-west part of the building there are large quoins, although these do not continue to the eaves, suggesting the upper part of the wall has been rebuilt. On the first floor at the south-west end of this elevation there is a loading or pitching doorway with a hand-finished timber lintel and stone sill.

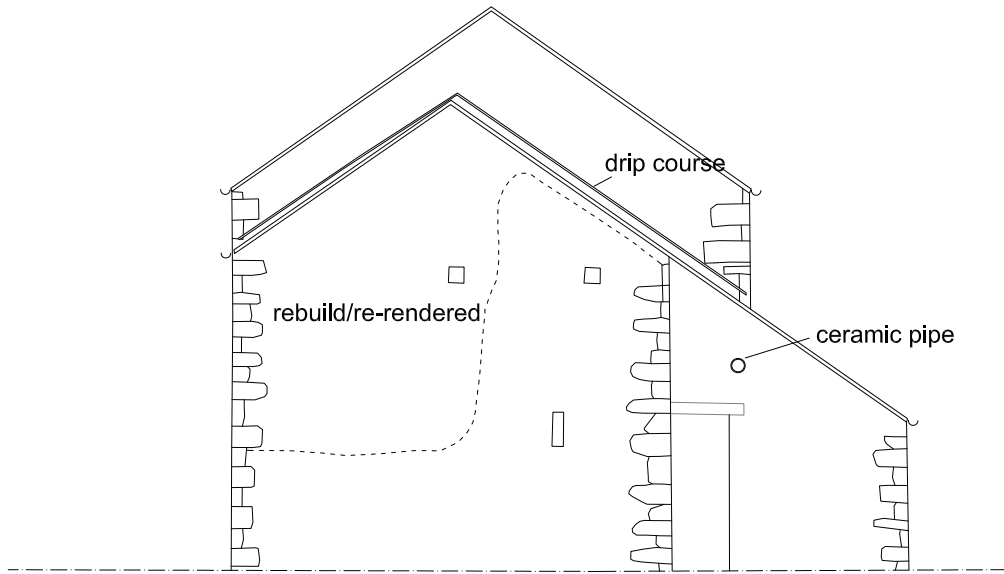
South-west elevation

4.2.2 **South-west elevation:** this forms the gable end of the building (Fig 5; Plate 7). There are two or three square ventilation slots at a high level and one slit vent below on the south-east side. Gateposts adjoin the wall on the north-west and south-east sides; the north-west is stone, the south-east iron. The gable of the taller north-east end projects above the south-west gable although it is partially collapsed and some of the roof is missing. There is a slate drip course following the gable of the lower south-west end built into the wall.

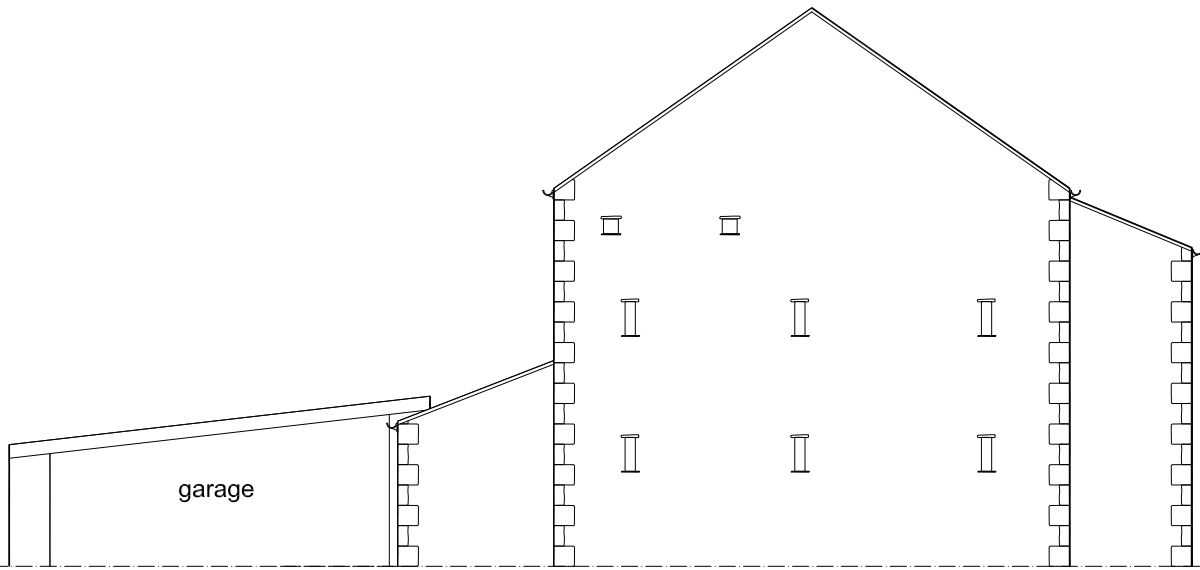
North-east elevation

4.2.5 **North-east elevation:** this forms the opposing gable end, but could not be fully accessed and was largely obscured by vegetation. It is evident from the 'as existing' architect's drawings that there are further square and rectangular ventilation slots across the elevation but it is otherwise unremarkable (Fig 5).

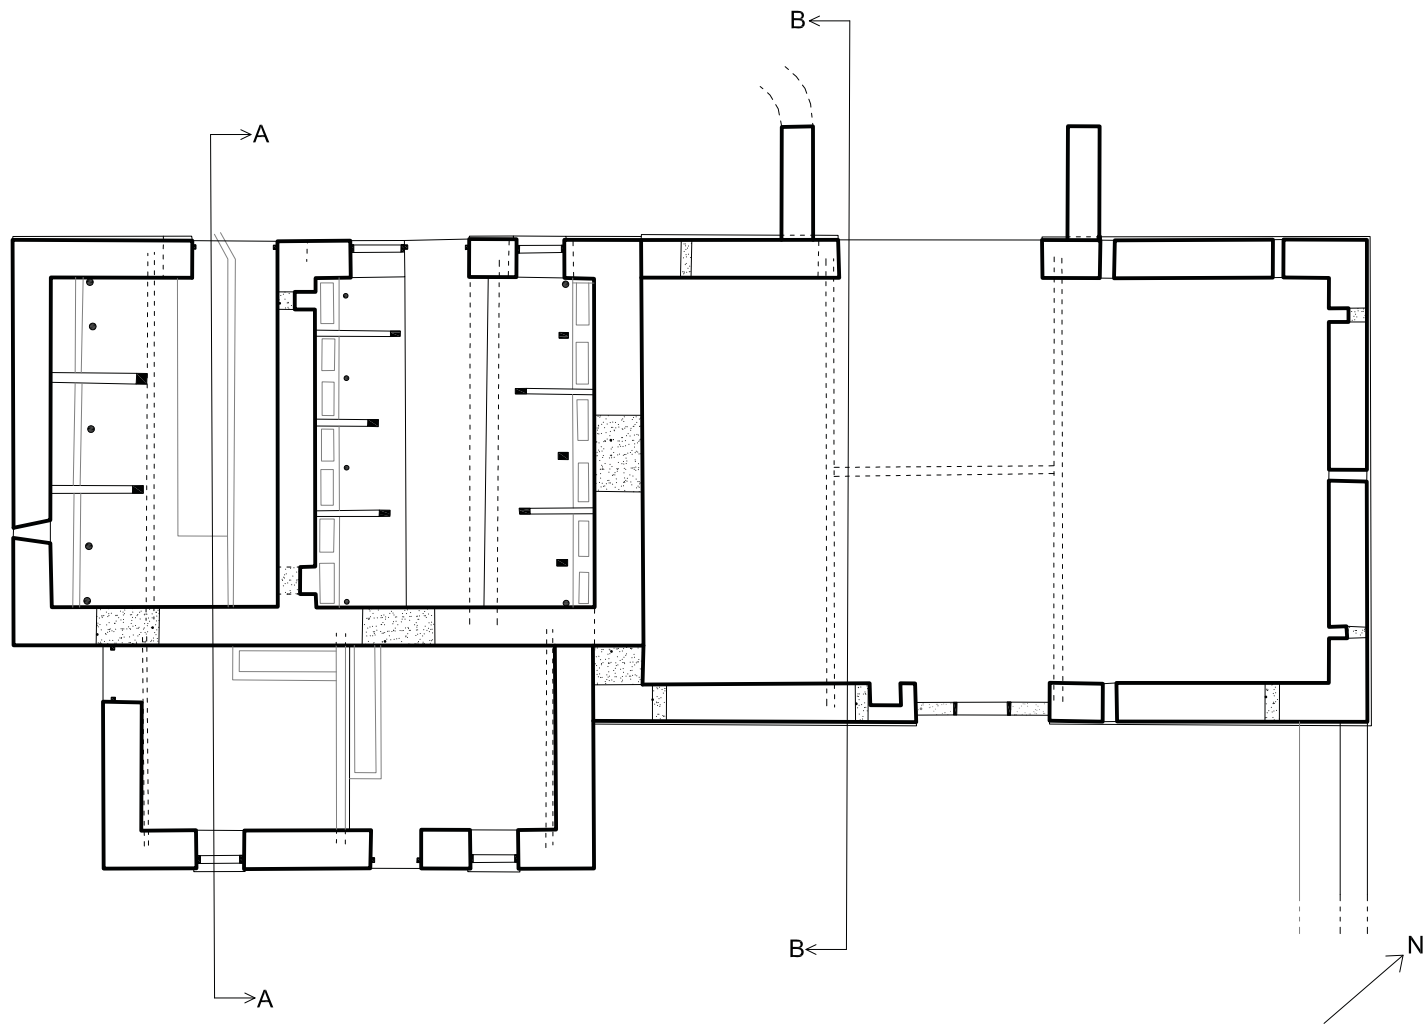
Figure 6: Ground floor plan

4.3.3 Ground floor, Room 2: this has a concrete floor with a central dung channel, formed by raised areas either side that are gridded (Fig 6). There are stalls against the north-east and south-west walls formed by timber planks beneath rails (Plate 16), with concrete blocks housing ceramic U-shaped troughs along the walls. The ceiling is supported by a very large, possibly hand-finished, beam orientated north-west/south-east on top of which are the joists. These are all hand-finished and most are re-used with various relict peg holes and joist slots, and they support timber floor boards. The walls are all finished with render and whitewash. The north-east and south-east walls are plain; the north-west has two windows and a doorway all with machine cut lintels. The south-west elevation has two narrow ventilation slots with slightly splayed jambs and there are pipes and troughs for water attached in the west corner.

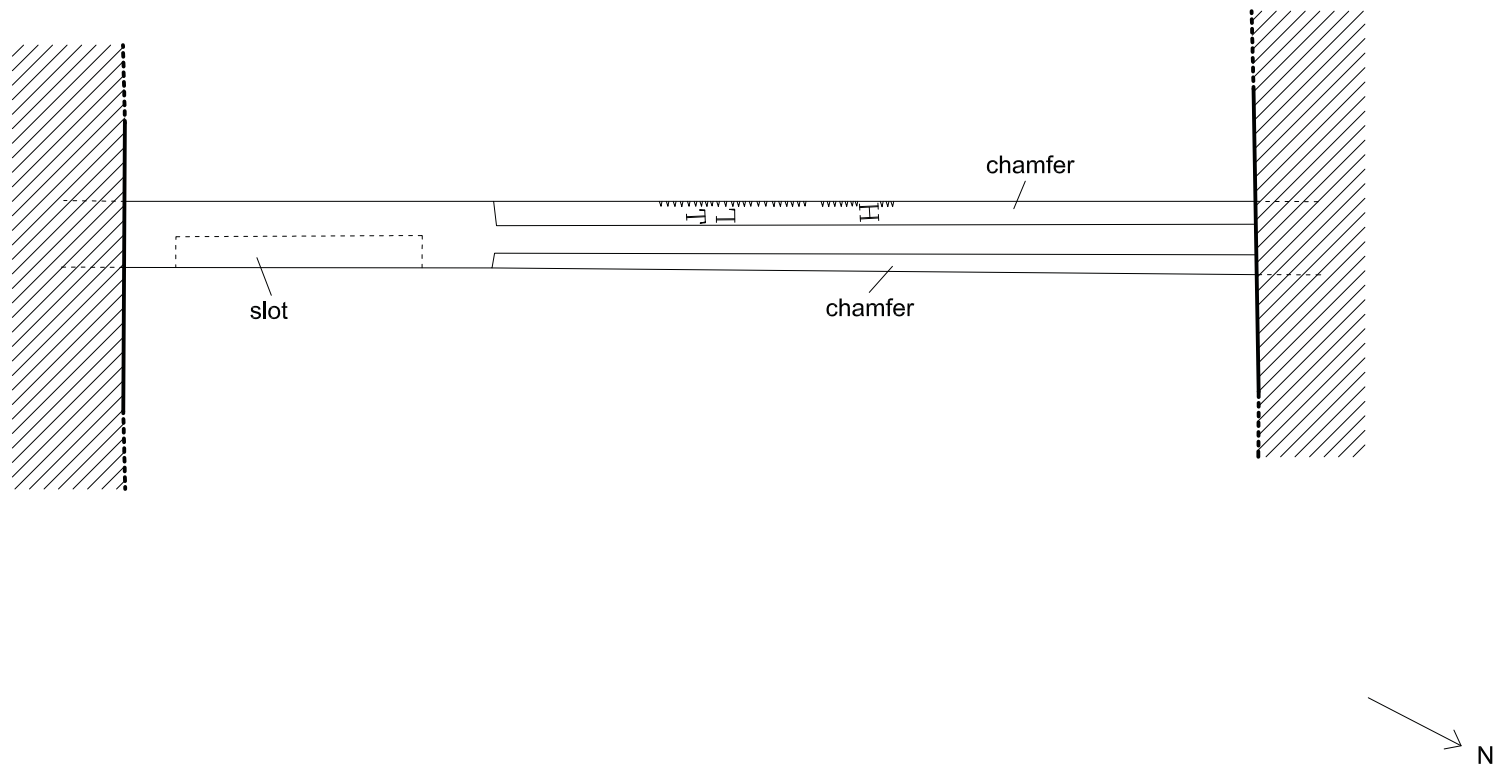
Figure 9: Detail of re-used bedpost(?)

A particular item of interest within the building was a piece of timber, perhaps a bedpost, into which had been carved letters and notches. This had been re-used as part of a lintel, probably during the construction of the threshing barn, and is thought to be of 17th century date.

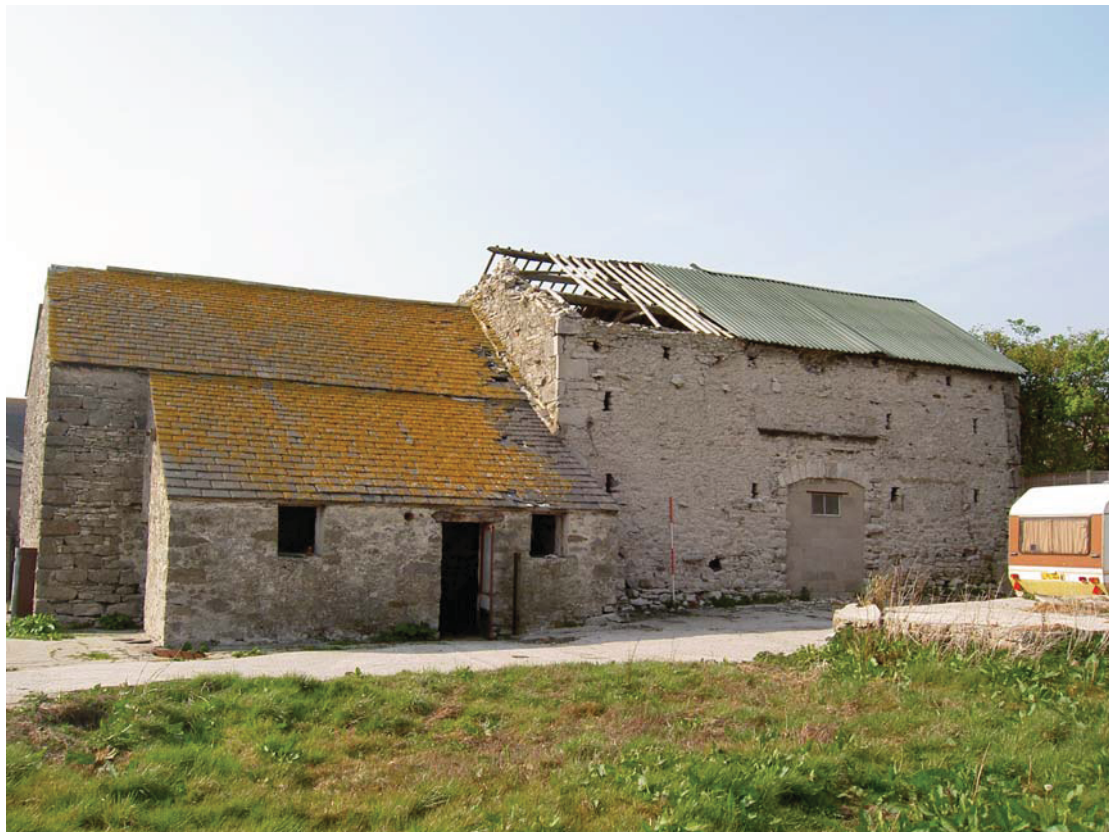
Plate 6: The south-east external elevation

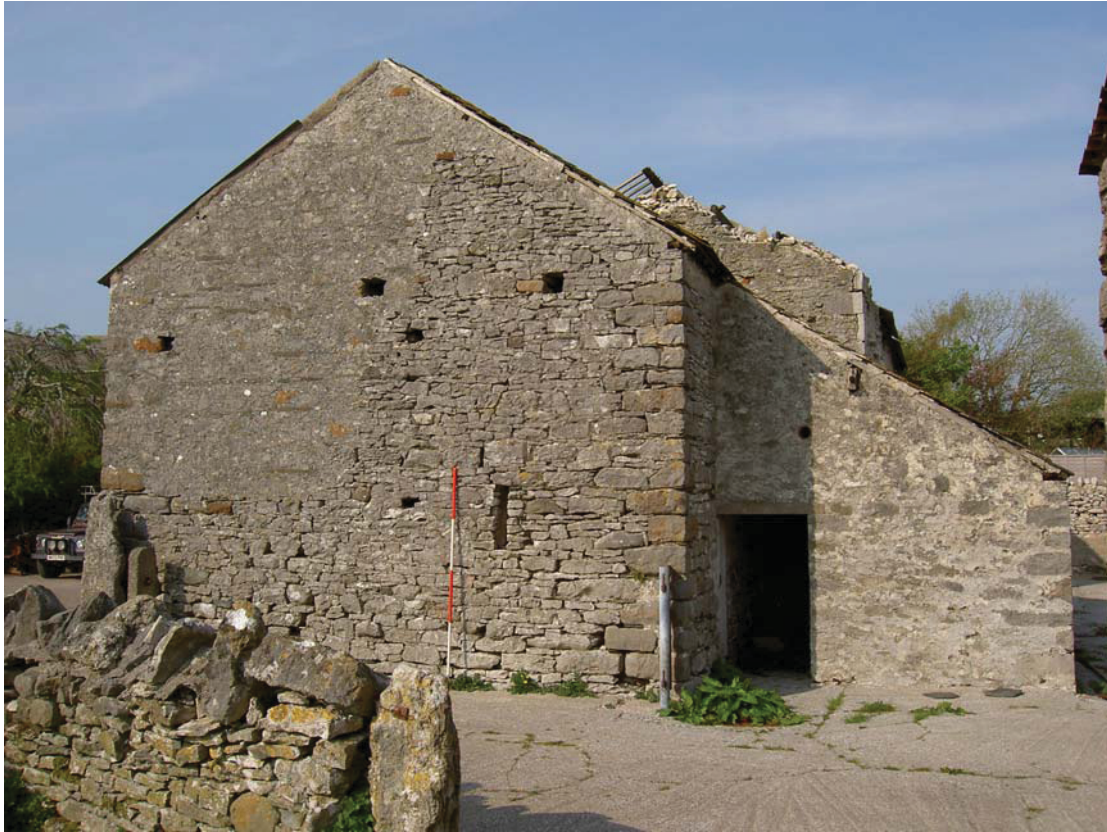
Plate 7: The south-west external elevation

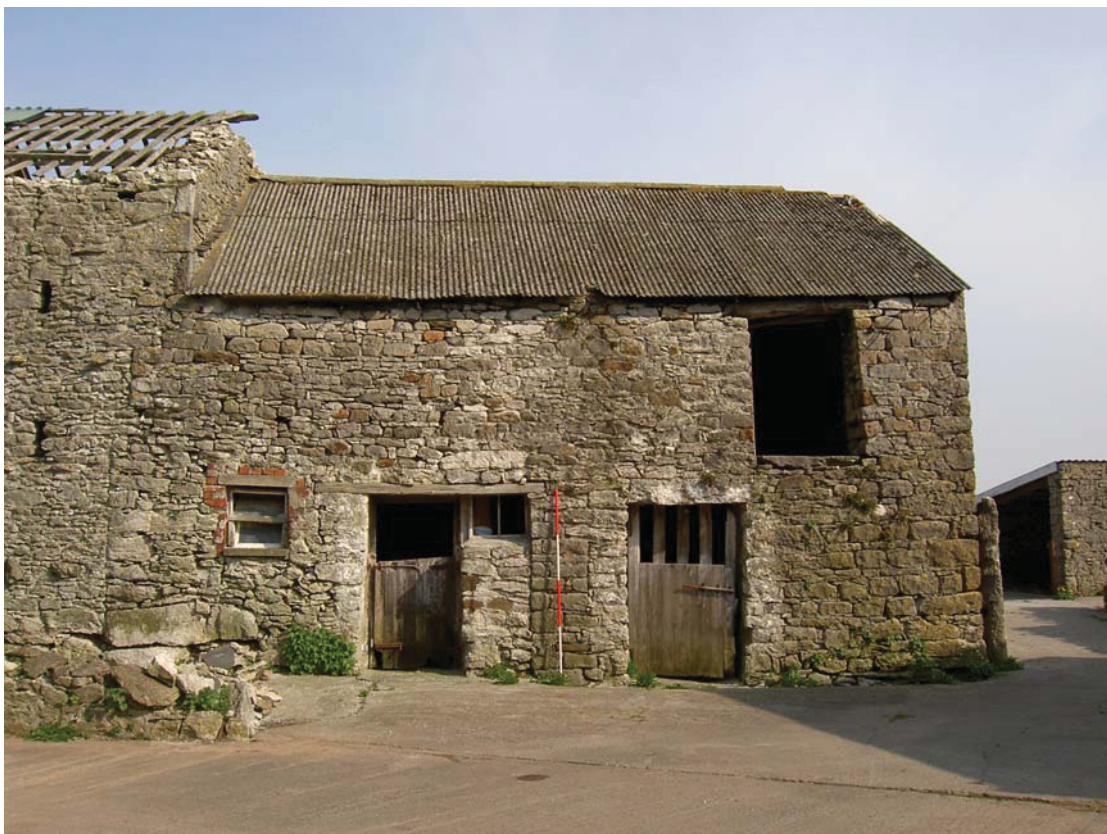
Plate 8: The south-west end of the north-west external elevation

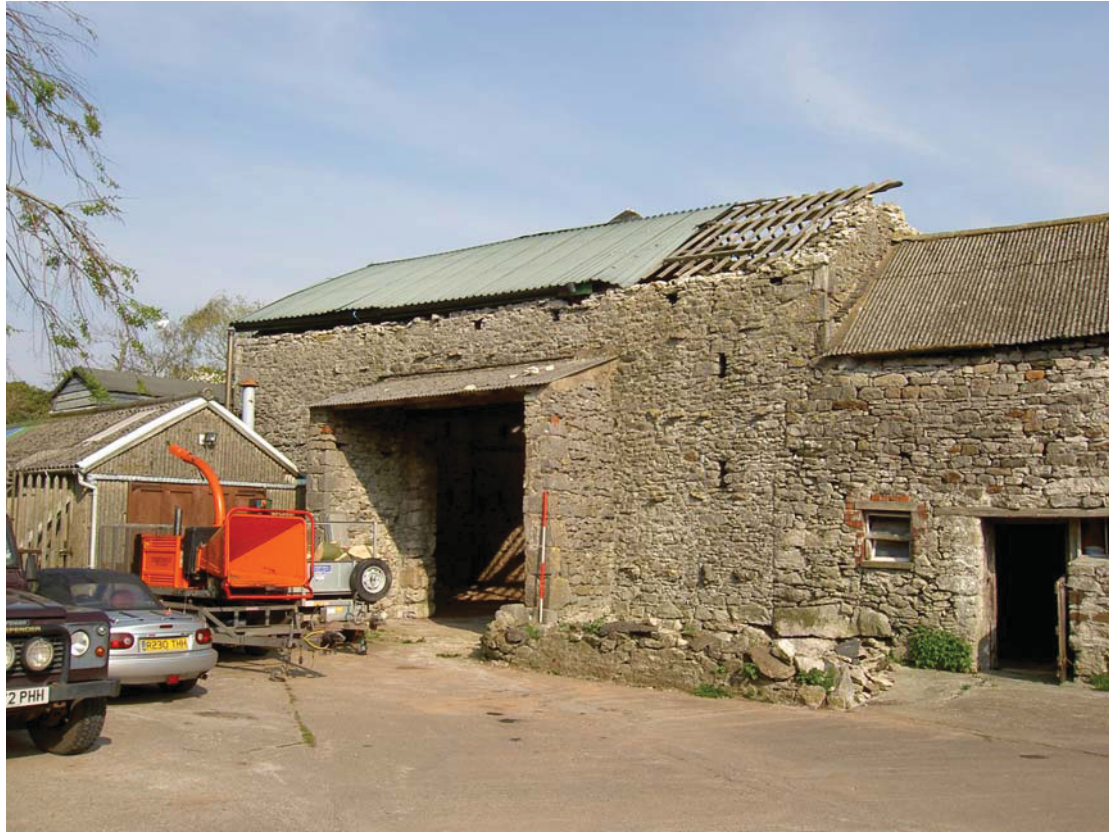
4.2.4 The north-east end of the north-west elevation butts the large quoins and raises the height of the original wall at the junction (Plate 9). There are several rows of through stones and two rows of slit vents plus square vents below the eaves. In the centre there is a large wagon doorway around which flanking walls have been added to form a porch or canopy. This is finished with corrugated concrete supported by three machine-cut purlins. The jambs of the original opening have altered to allow the doorway to be widened and raised in height. Brick rebuild is present along all of the south-west side and the top of the north-east. In addition, new lintels, in the form of U-shaped iron girders have been inserted and concrete blocks and bricks have been added to the tops of the flanking walls. The brick is all machine-made and dark red in colour. The north-east end of the elevation is obscured by later buildings, but evidently contains additional ventilation slots.

Plate 9: The north-east end of the north-west external elevation

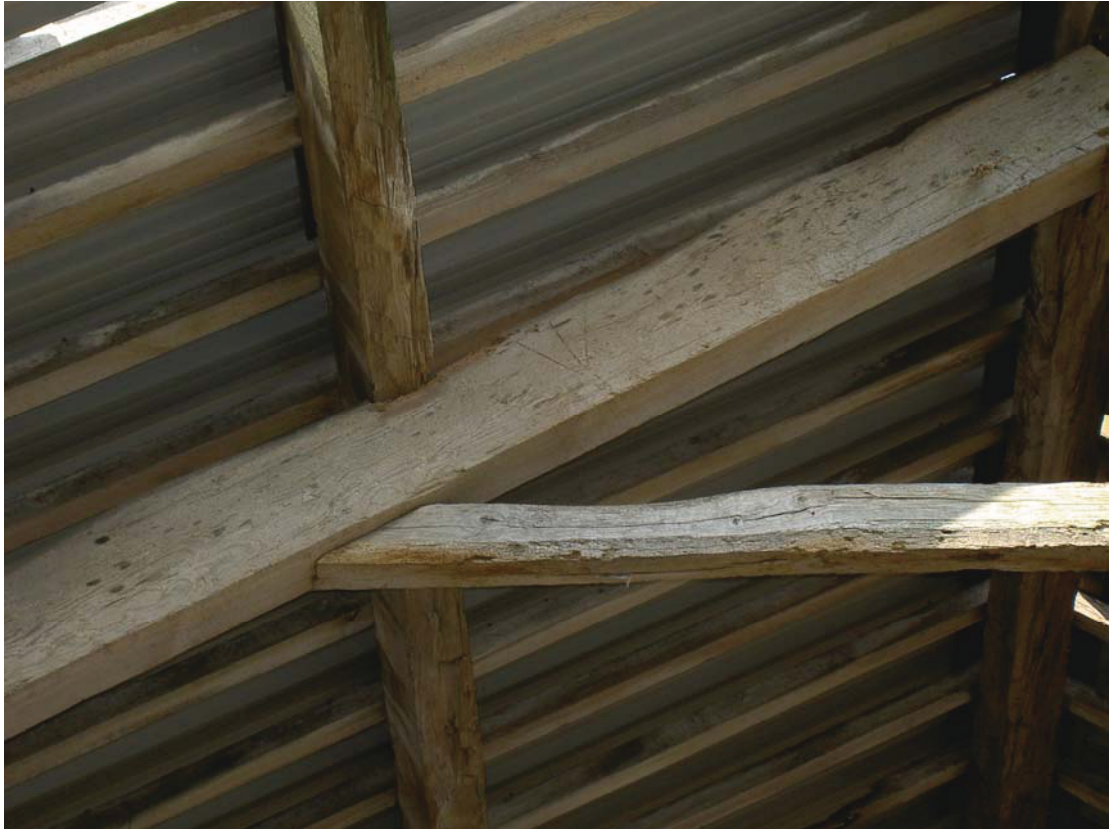
Plate 11: Probable levelling mark on truss within Room 1

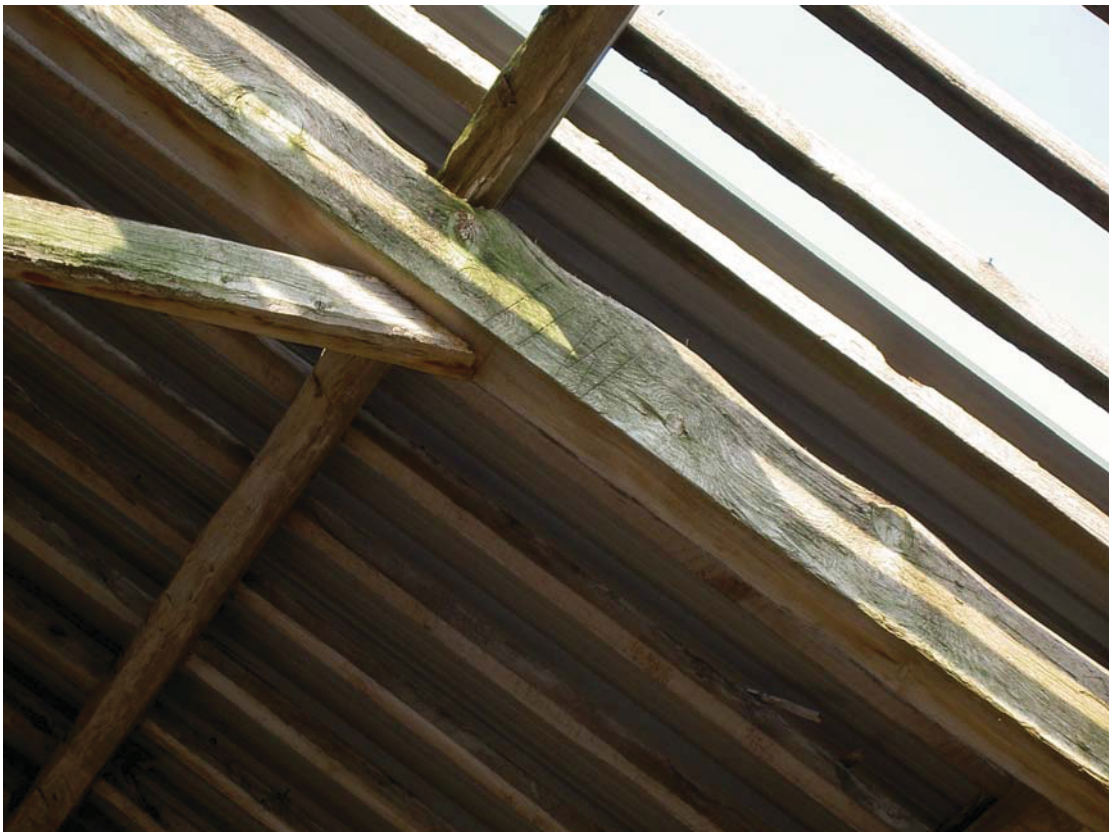
Plate 12: Levelling mark or Baltic timber mark on truss in Room 1

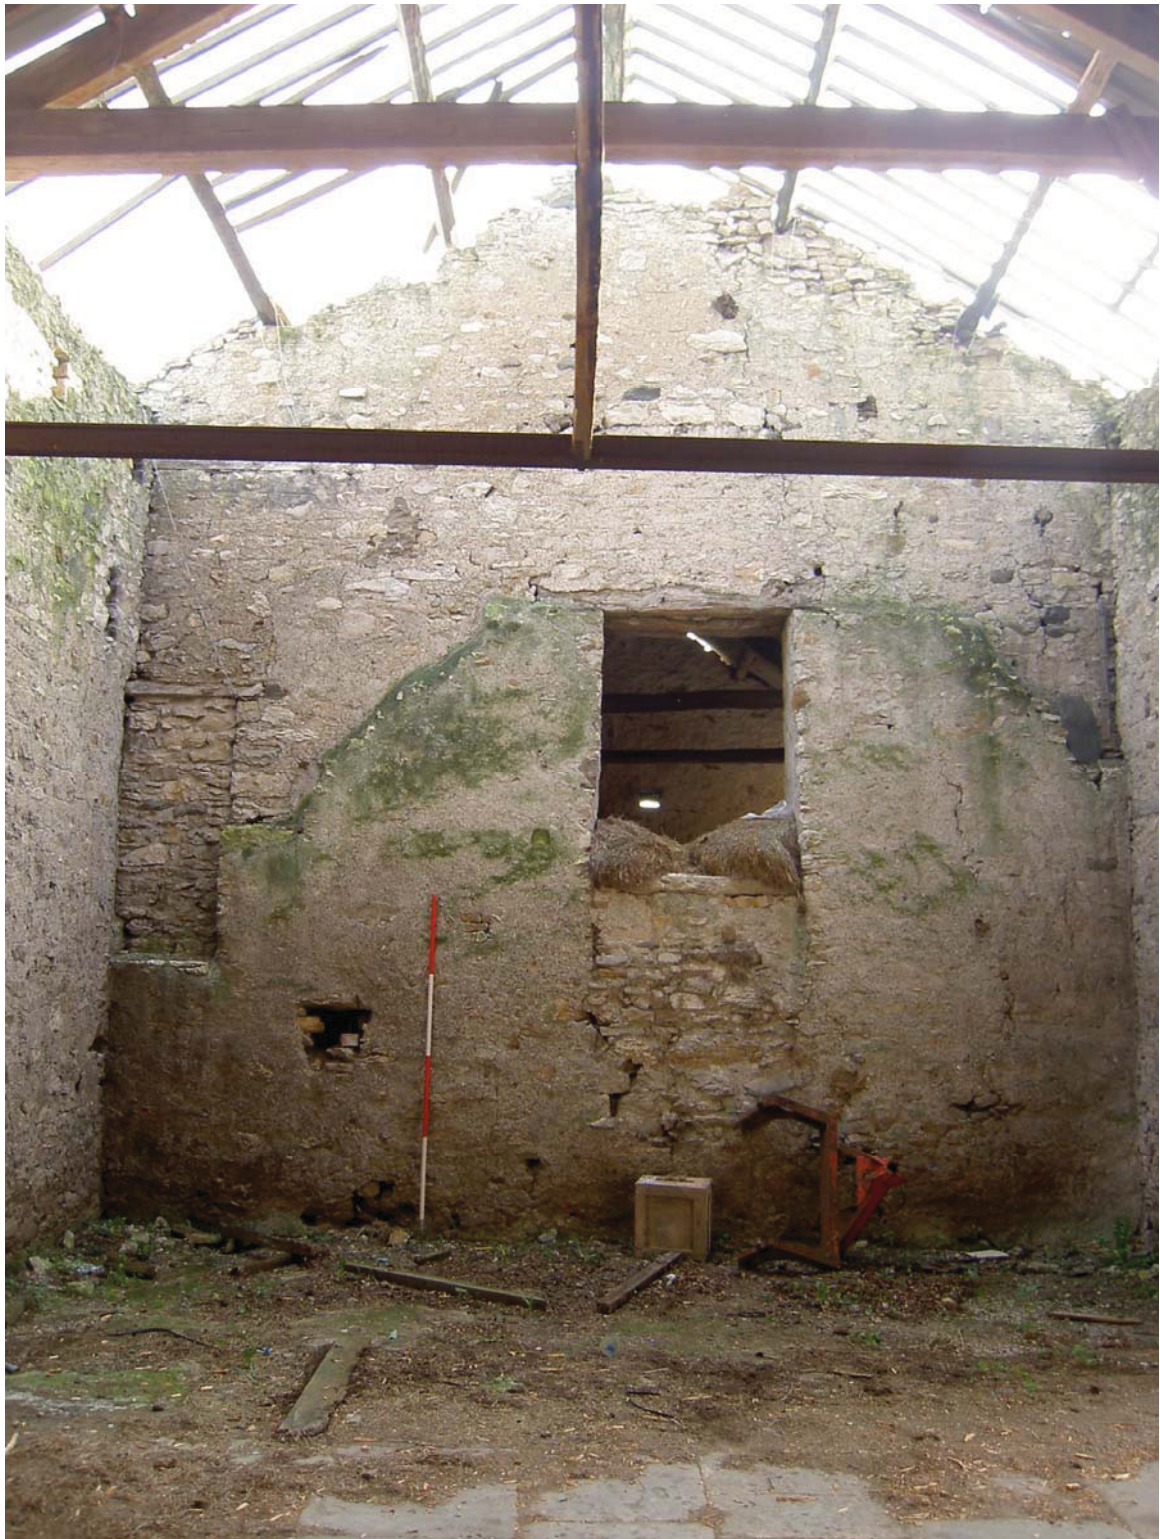
perhaps suggesting it was part of a cruck-framed building (Plate 13). There is a central aperture within this, which appears to extend to the ground floor where it is blocked with stone. This has a lintel made of hand-finished timbers, one of which is square in section at the south-east end and chamfered at the north-west end making it octagonal in section (Plate 14). It is perhaps a re-used bedpost (?), as it has a relict rectangular slot in the square-section end, which was probably the base, presumably where the horizontal side of the bed would have been attached. Along the south-west edge a series of v-shaped notches have been carved into the timber, alongside which the letters 'H', 'T' and 'L' or '7' have also been carved, (Plate 15; Fig 9). The former gable is stepped on the south-east side and there is a narrow blocked doorway (?) with a timber lintel between the ground and first floors on this side. Above the gable the wall has been extended to form the larger threshing barn. The south-east elevation has further slit and square vents and there are more re-used pieces of timber built in, including a large piece over the wagon doorway. A small alcove is present on the south-west side of this door.

Plate 13: Early gable at the south-west end of Room 1

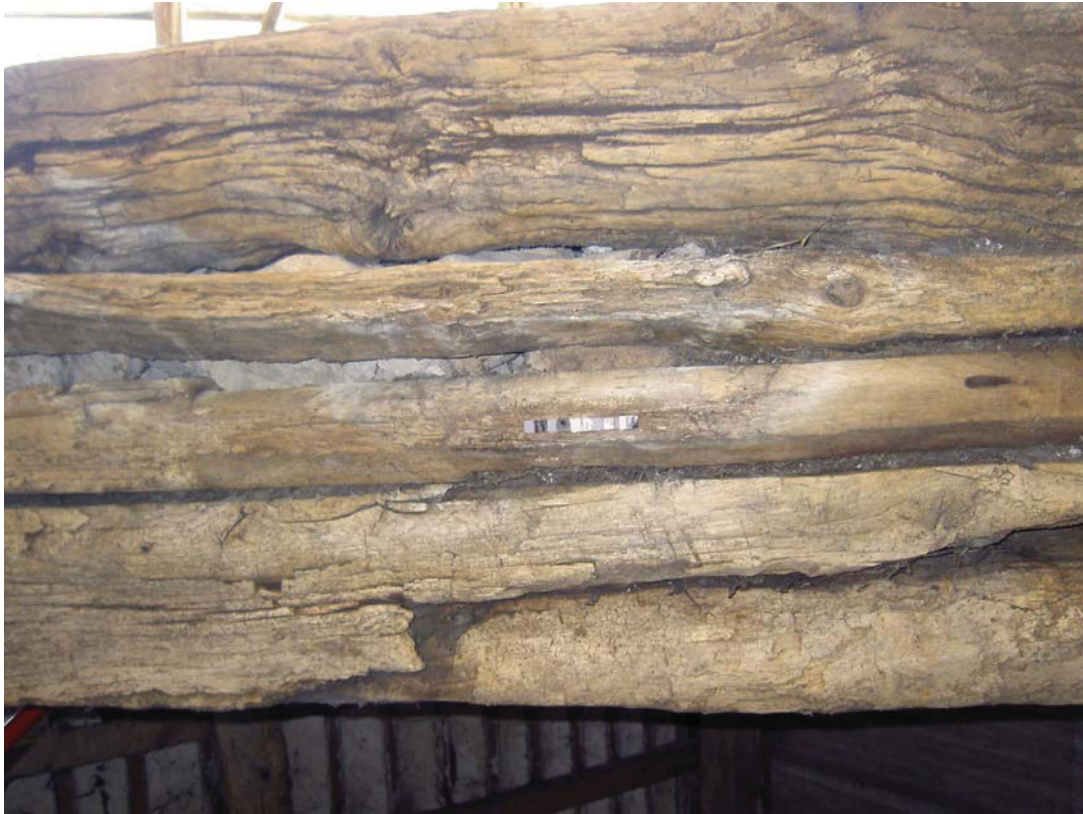
Plate 14: Re-used bedpost (?) used as a lintel in the doorway between first floor Rooms 1 and 2

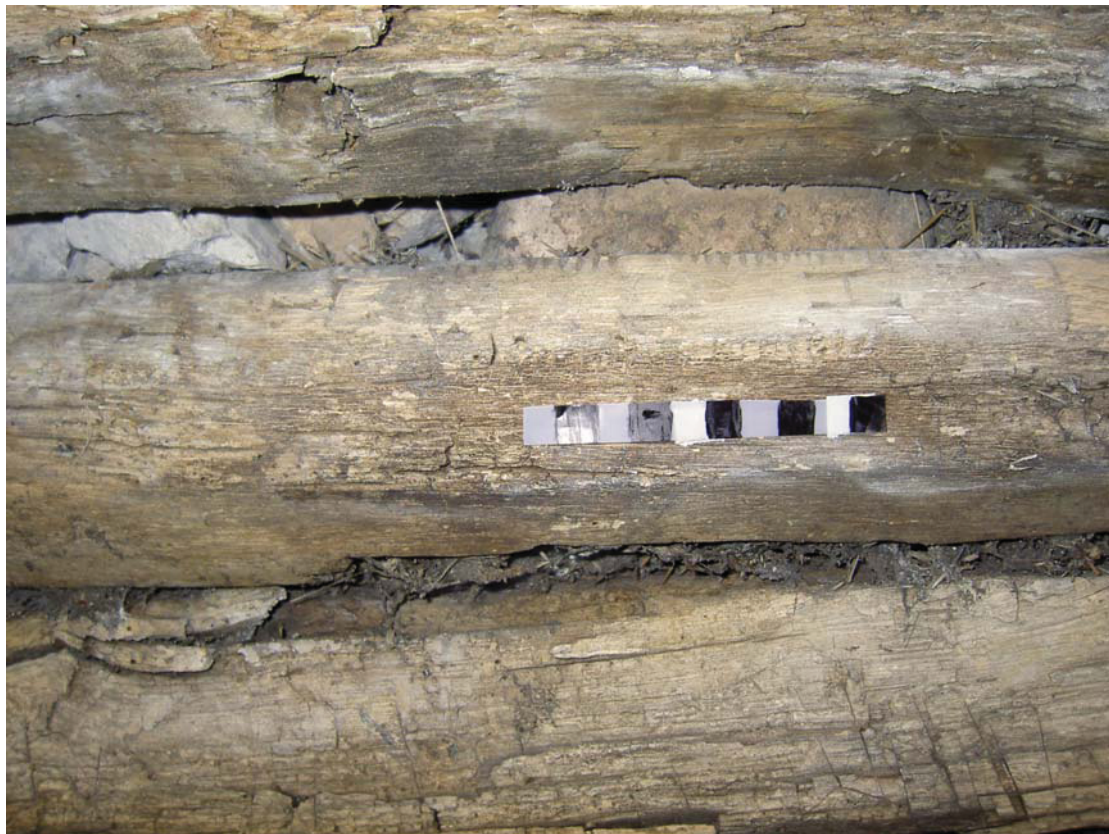
Plate 15: Detail of lettering on re-used bedpost (?)

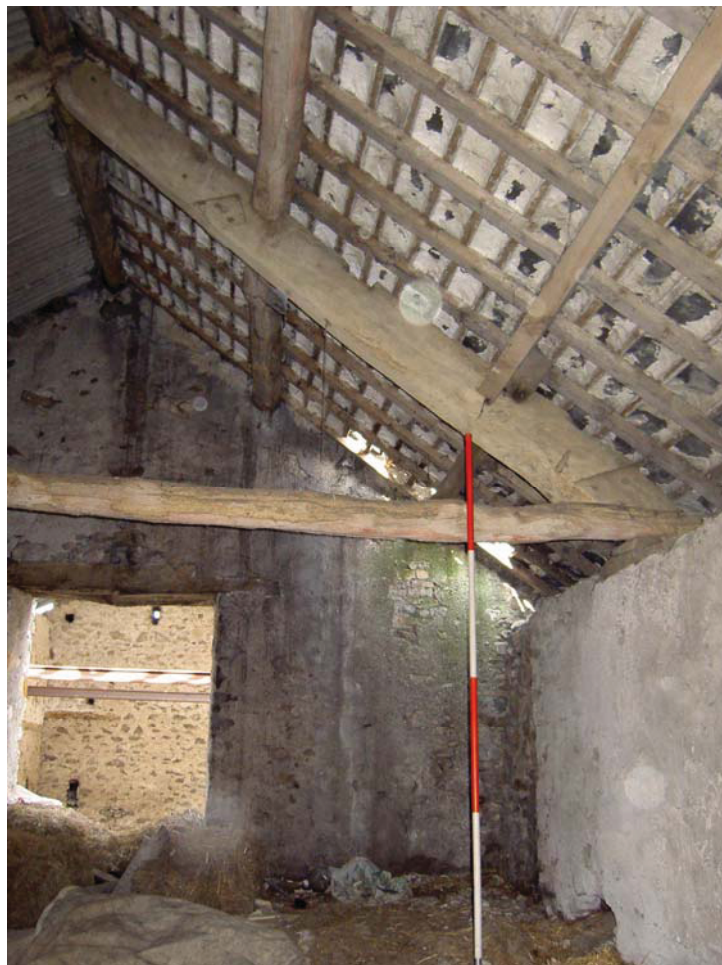
Plate 21: Detail of relict joist slots in truss in first floor Room 2
