JUNCTION OF HINDPOOL ROAD AND CORNMILL CROSSING, BARROW-IN- FURNESS, CUMBRIA

Archaeological Building Recording

Client: Positive Location
Properties Ltd
Planning Ap. Ref.: 6/05/1530
NGR: SD 1955 6905

© Greenlane Archaeology Ltd
June 2007

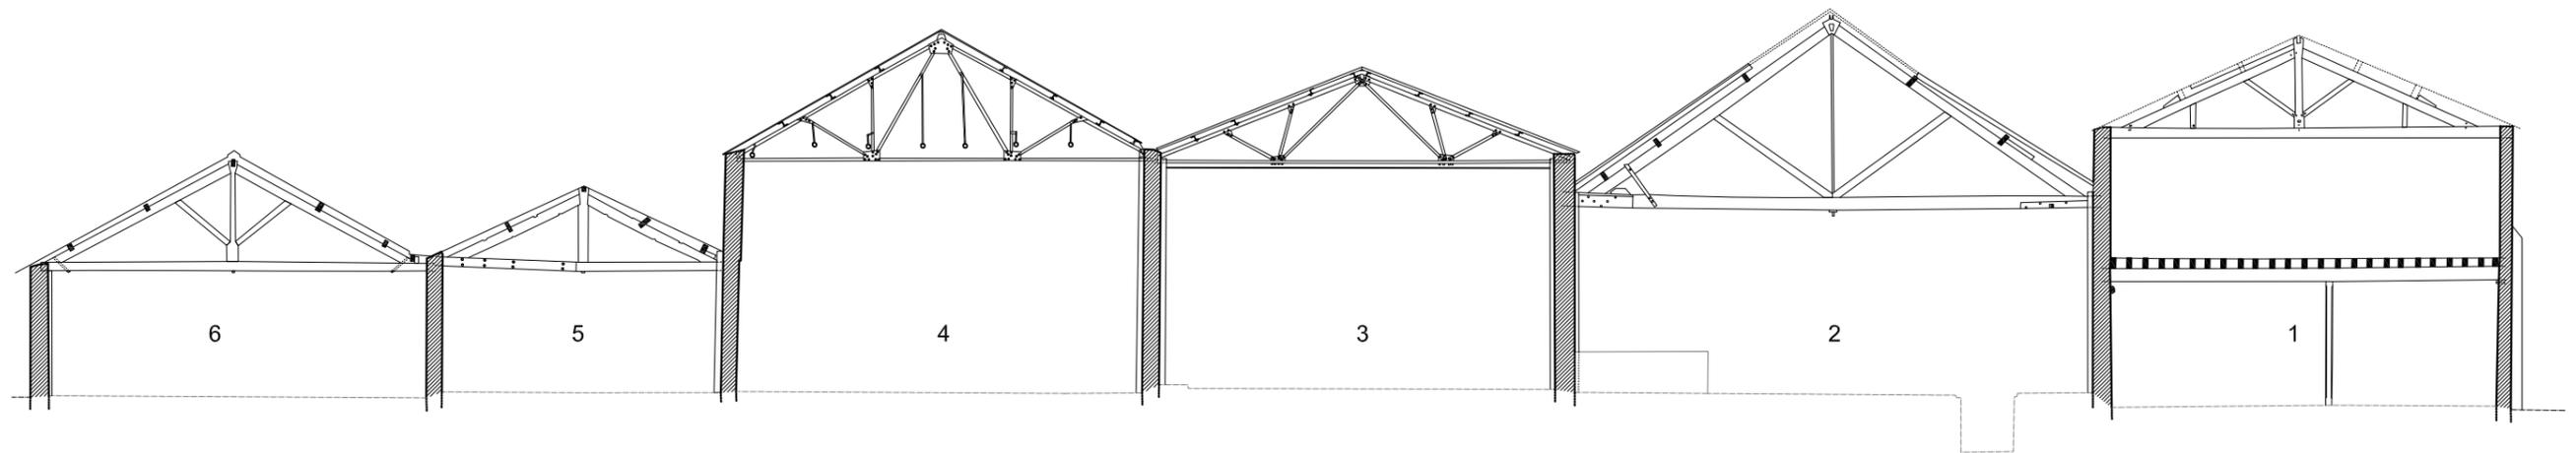
Figure 6: North-west facing cross-section

4.2.7 The first floor is divided into two halves. The north-west half is in a ruinous condition and could not be fully accessed, but the remains of the roof show that it had three king post trusses supporting a slate roof with at least one skylight. Each king post is joggled to meet the tie beams, soffitted to meet the ridge purlin, and has a pair of queen struts and angled braces (Plate 40). There are various carpenter's marks visible on one of the trusses in the form of chiselled crosses, crescents, and Roman numerals (Fig 6). Baltic timber marks are also present on the south-west end of the

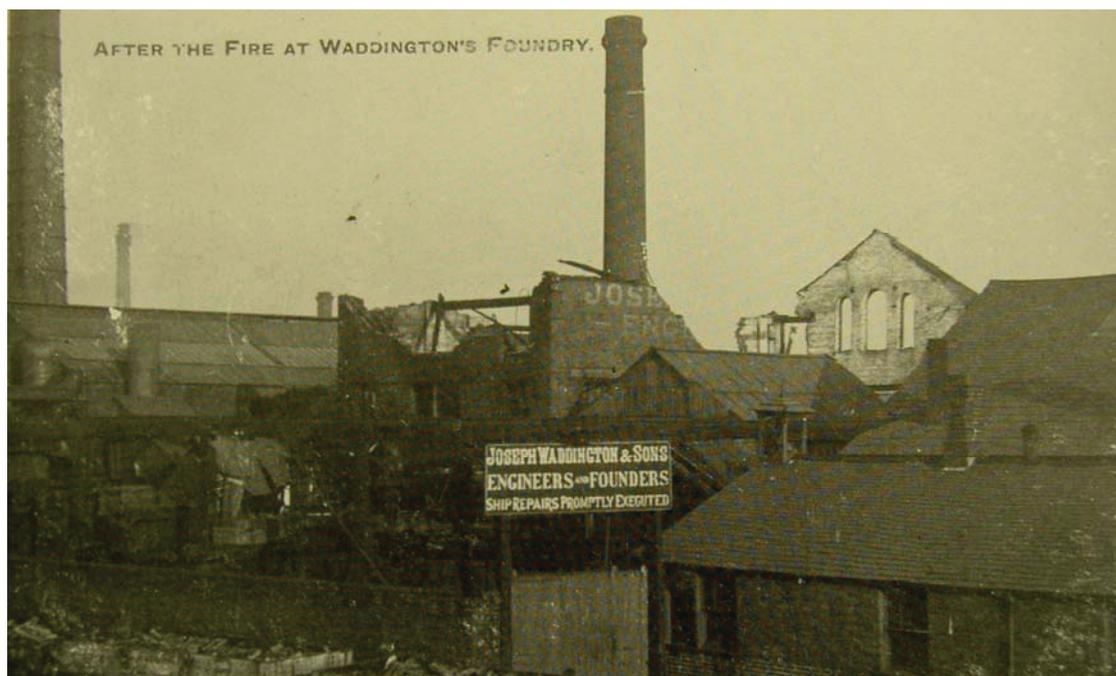
5.2.8 *Phase 4*: the fire of 1906 is recorded as resulting in a period of rebuilding as the foundry was reconstructed. The Ordnance Survey map of 1913 shows that this resulted in the construction of Buildings 3 and 4, although the physical evidence appears to contradict this. Building 4 was probably constructed at this time (Plate 3), while Building 3 perhaps only comprised a covered area, with a front (south-east) elevation only added at a later date, probably as part of Phase 6. Building 1 was also raised in height some time after 1906 (compare Plates 7 and 33), presumably as a result of the same general phase of rebuilding that followed the fire.

Plate 8: View of the foundry after the fire of 1906 (from Trescatheric and Barker 1990, 22)

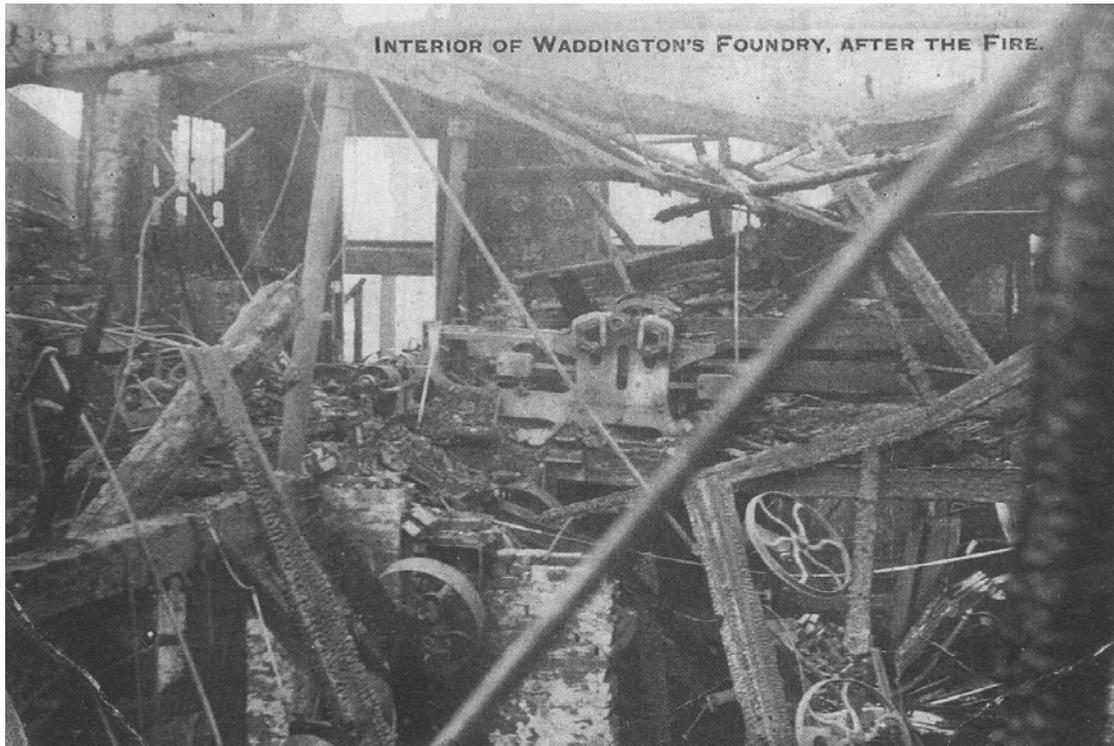
Plate 9: Detailed view of the foundry after the fire (from Myers 2000, 32)

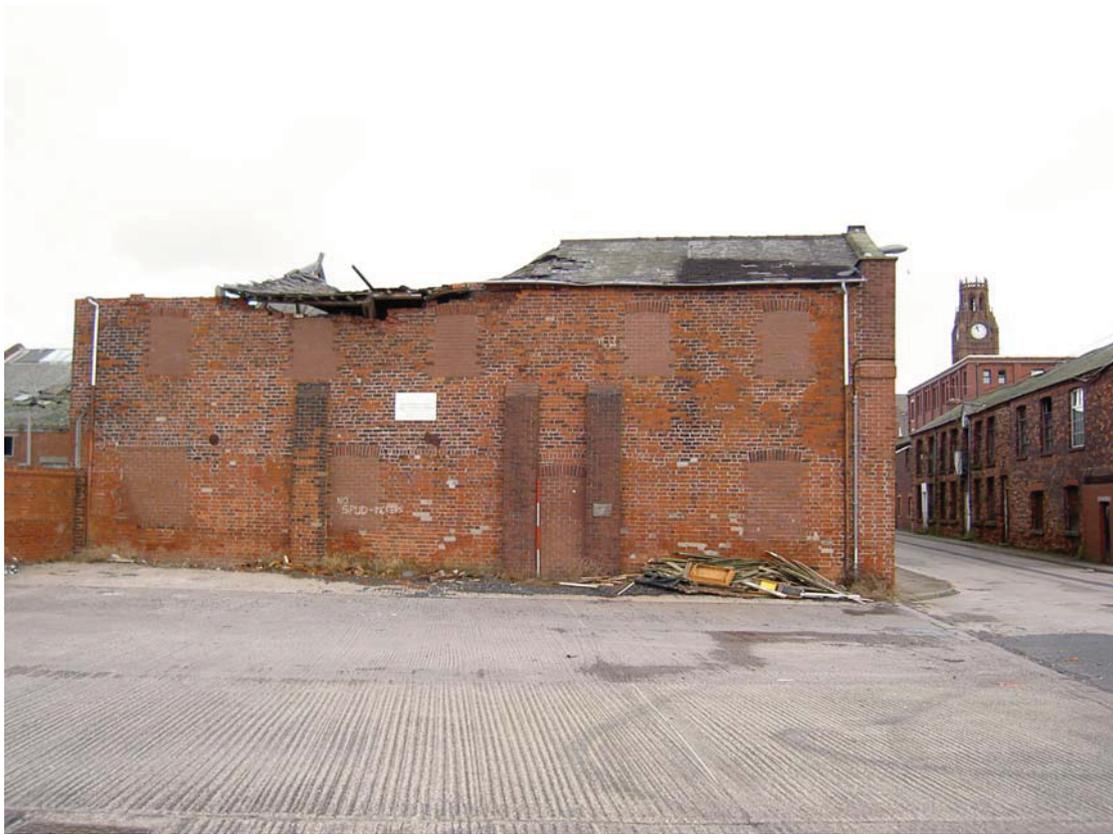
Plate 33: South-west elevation of foundry Building 1

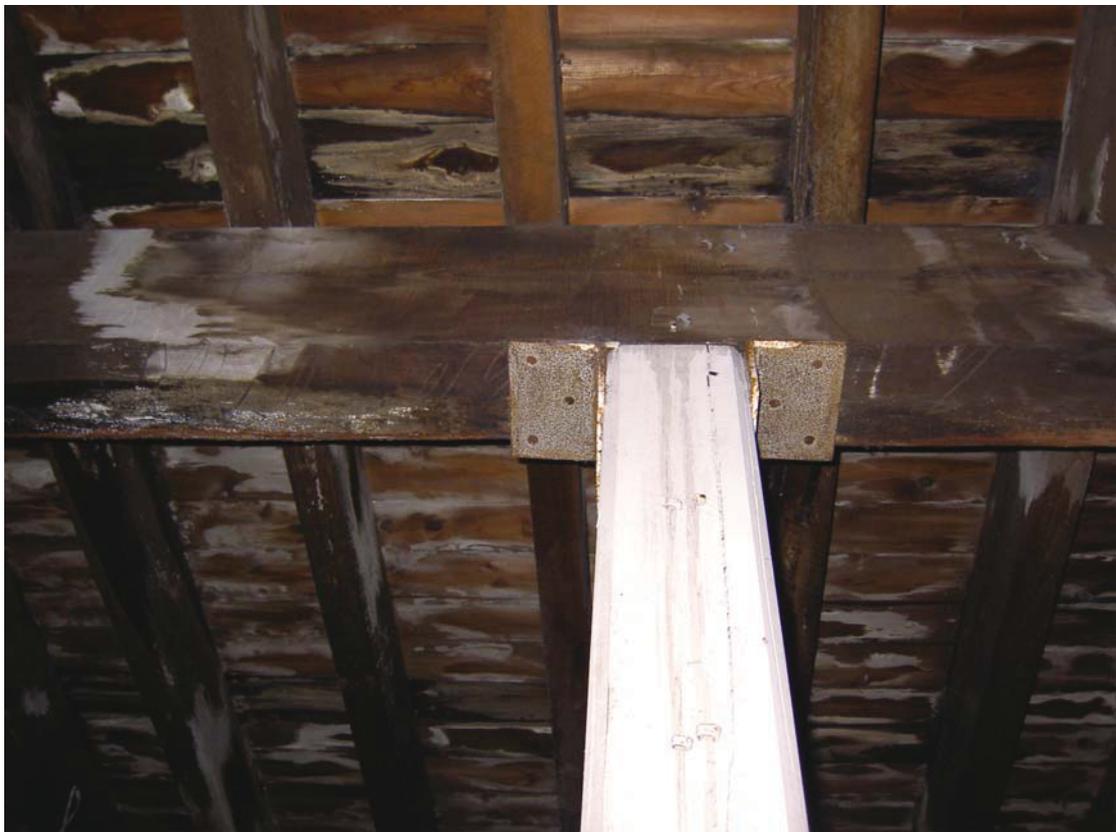
Plate 36: Baltic timber marks inscribed into a beam, ground floor foundry Building 1

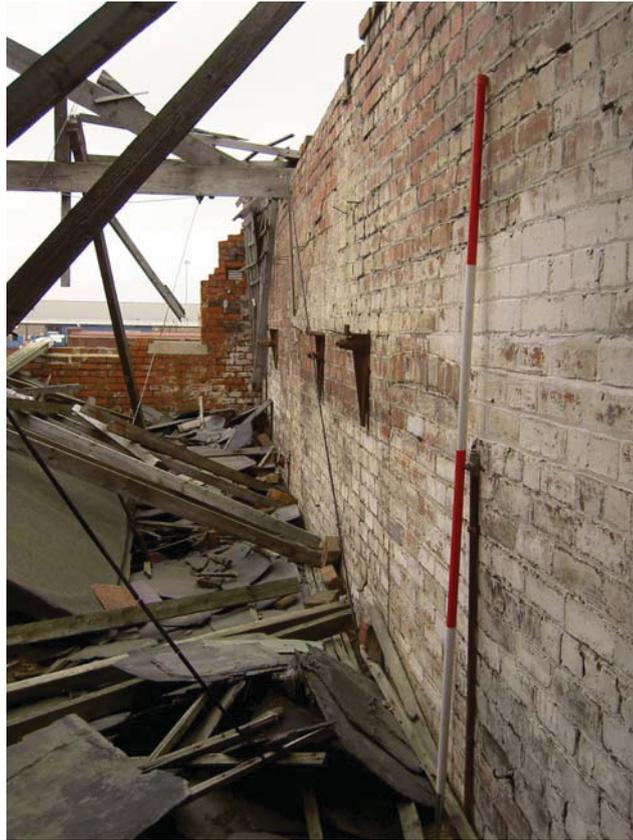
Plate 41: Iron brackets and blocked windows, north-west side, first floor, foundry Building 1

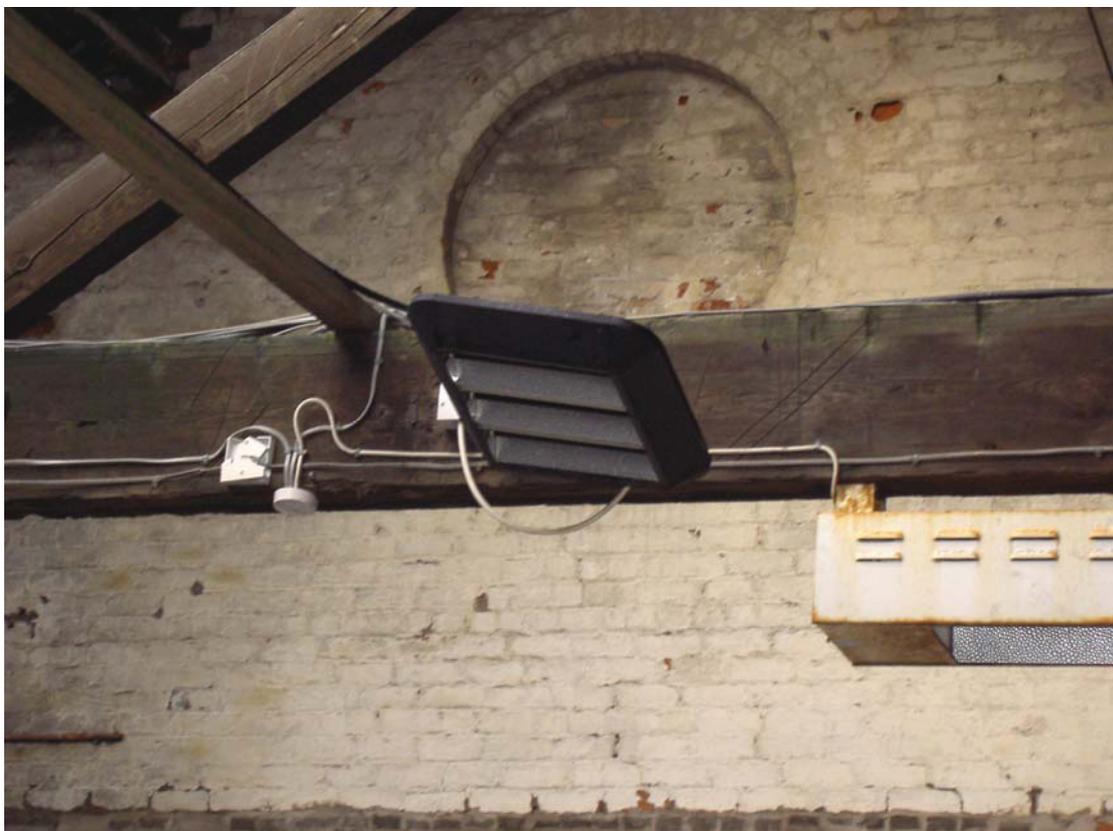
Plate 46: Baltic timber marks inscribed into tie beam, foundry Building 2

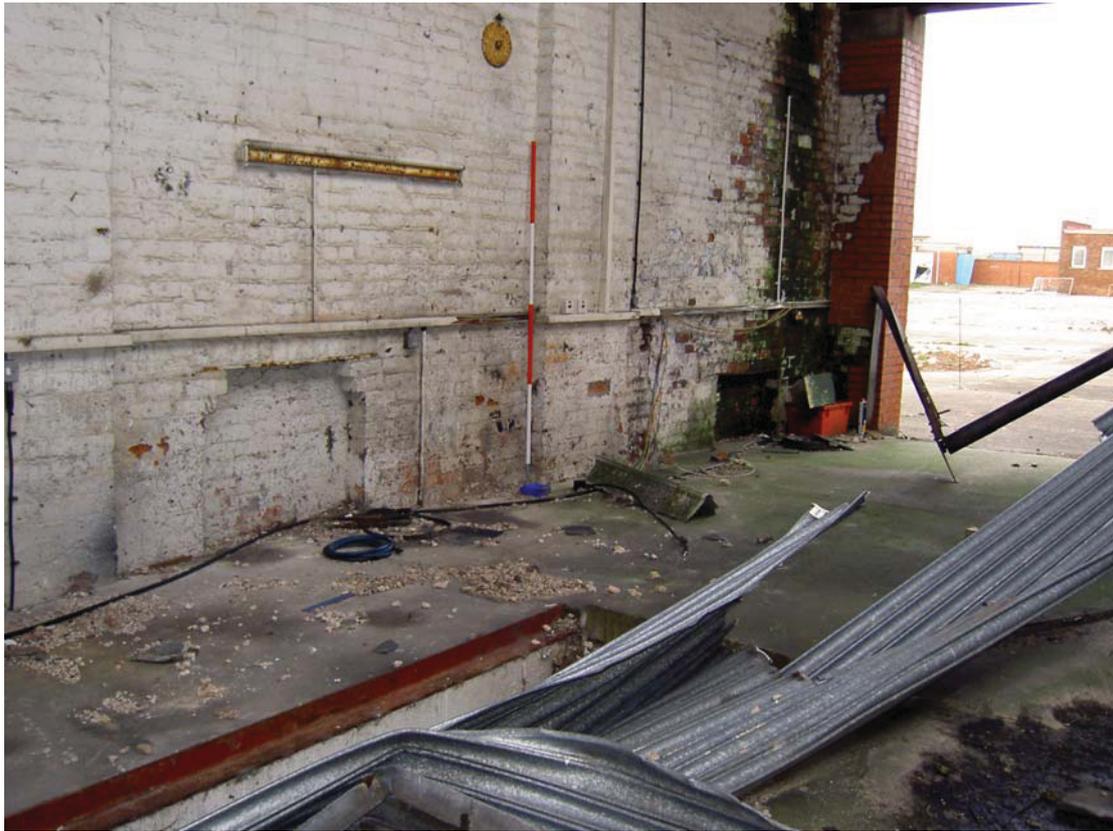
5.3.2 **The foundry**: the surviving buildings from the former foundry were probably initially used as workshops for finishing castings and detailed engineering; the small fireplaces along the wall between Buildings 1 and 2 suggest that small hearths or furnaces were utilised. It is likely that castings were carried out in the large buildings shown on the maps to the north-west, against the gasworks. The documentary evidence relating to the fire demonstrates that the original fitting and pattern rooms were situated in the centre of the site and following the rebuilding it seems probable that these were housed in some of the buildings against Cornmill Crossing, perhaps Buildings 3 and 4. The enlargement of Building 1, to incorporate what appear to be offices, might also suggest that these were originally within the block of buildings in the centre of the complex. The records relating to the requisitioning of the site in 1940 essentially confirm that the buildings present on the site (i.e. those that were

Plate 47: Hearths in the south-west elevation, foundry Building 2

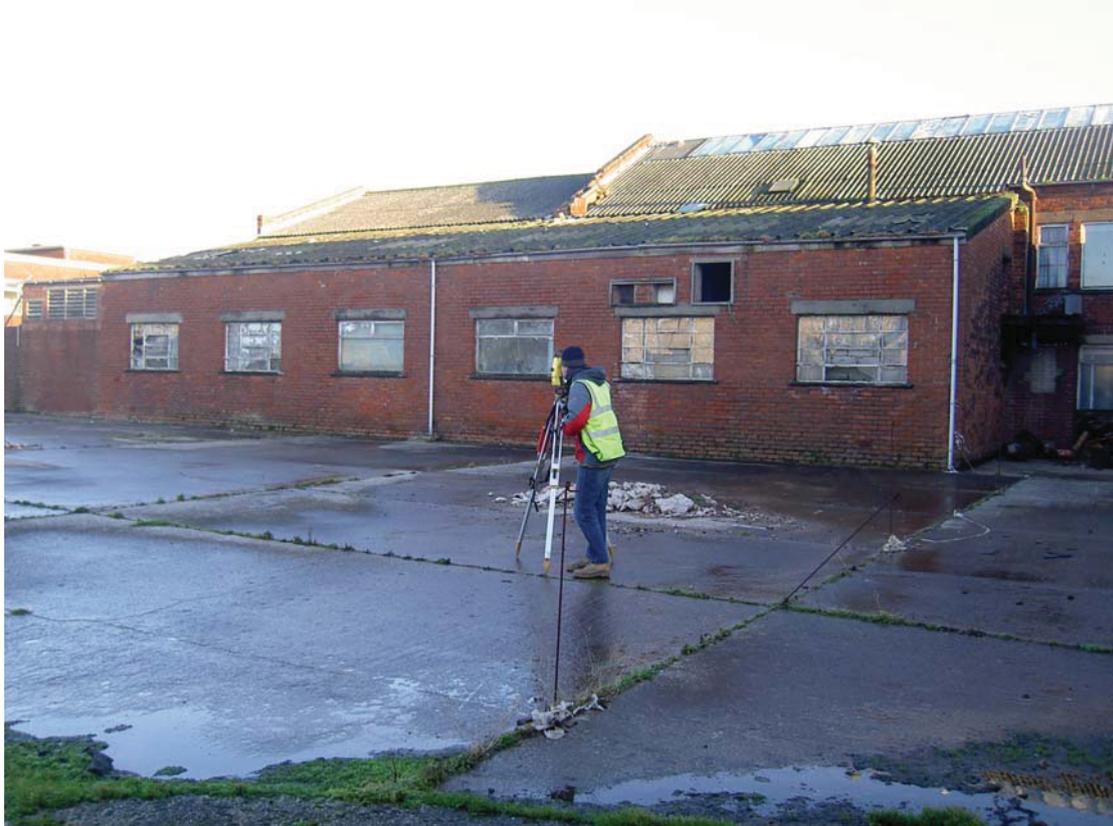
Plate 49: Outshut attached to the north-west end of the south-west elevation of foundry Building 3

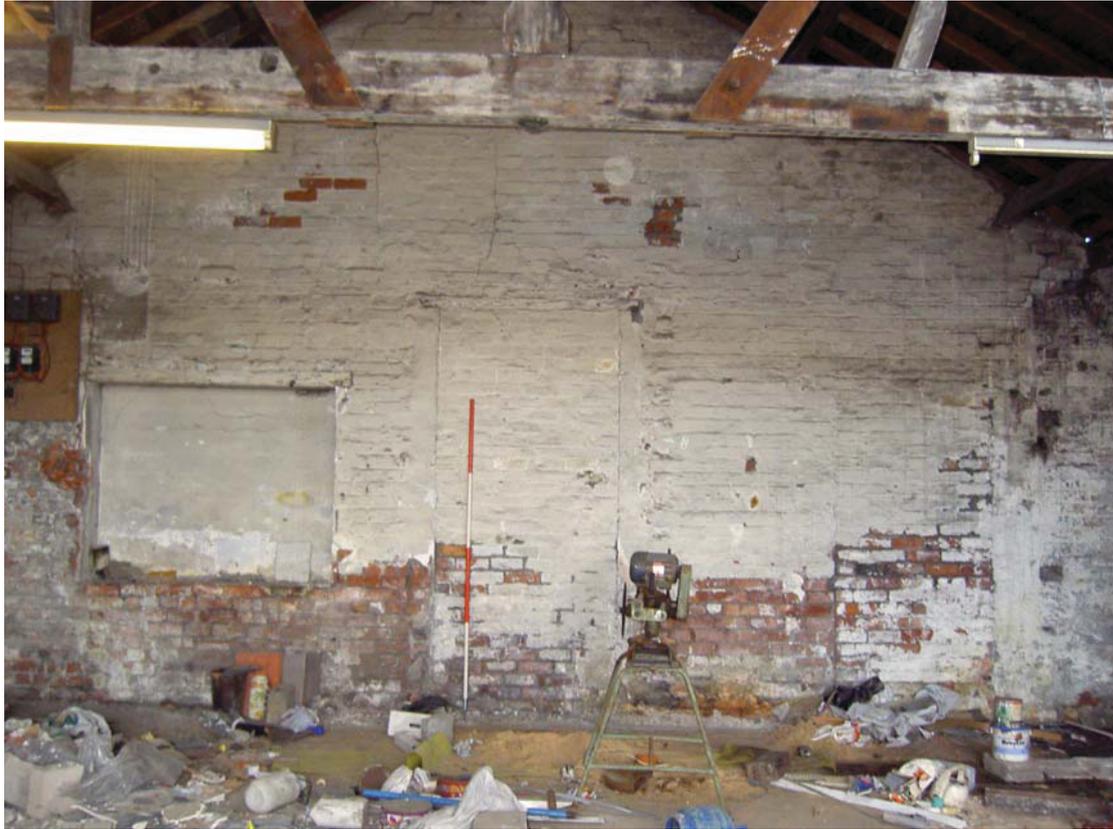
Plate 76: Blocked apertures in the south-east elevation, foundry Building 6

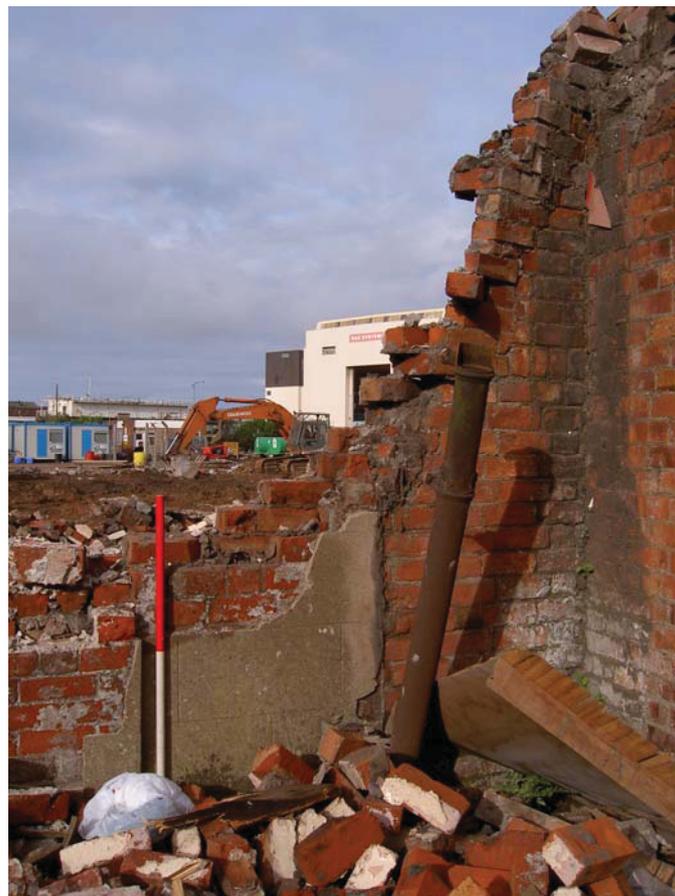
4.10.3 **Buildings 3-5:** a number of bricks marked 'CLAUGHTON' were observed within the fabric of Buildings 3-5. They had evidently been used in the extensions to the north-west ends of Buildings 3 and 4 and within the south-west wall of Building 5. In addition, they had been extensively used in the north-west wall of Building 5. The junction between Buildings 5 and 6 was apparently a large blocked doorway.

Plate 79: Blocked opening between foundry Buildings 5 and 6 revealed during demolition
