SOWERBY LODGE FARM, BANK LANE, BARROW- IN-FURNESS, CUMBRIA

Archaeological Building Recording

Client: Dave Armer, C.A.W. Ltd
Planning Ap. Ref.: 41/2006/1581
NGR: SD 1917 7231

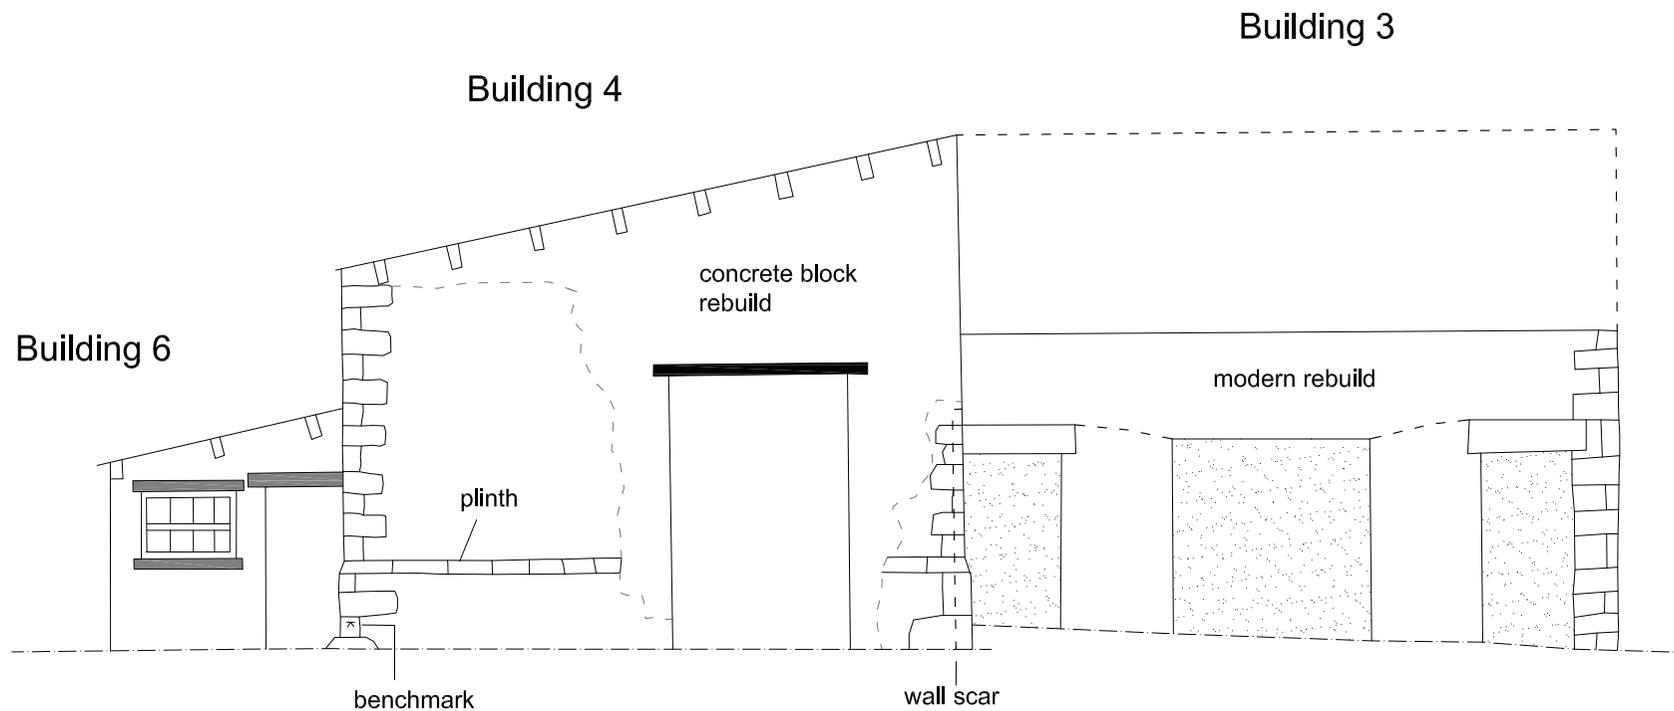
4.3.14 **Building 4, north-north-east elevation** (Figs 15, 16, and 20): very little of the original stonework on this elevation remains, there is extensive re-building of the upper northern corner of this barn (Plate 12), and the lower interior has been clad in brick. The entire doorway has been re-built in concrete blocks with a steel lintel and all that remains is a small column to the east of this where the brick cladding is missing. The stonework is roughly coursed and consists of small, flattish undressed sandstone pieces and appears to have been re-pointed in places. To the east of the doorway at about head height a timber has been incorporated into the wall which is approximately 1.50m long and between 0.05m and 0.10m thick.

Figure 10: North-north-east elevation of Buildings 3, 4, and 6

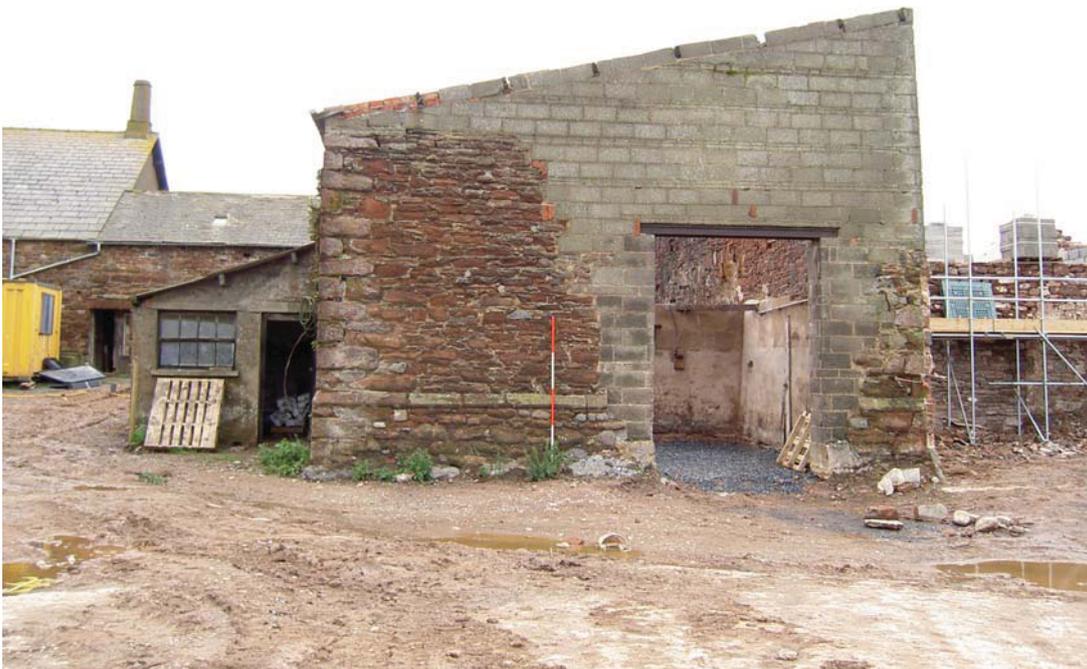
Plate 12: Building 4 from the north-north-east showing plinth

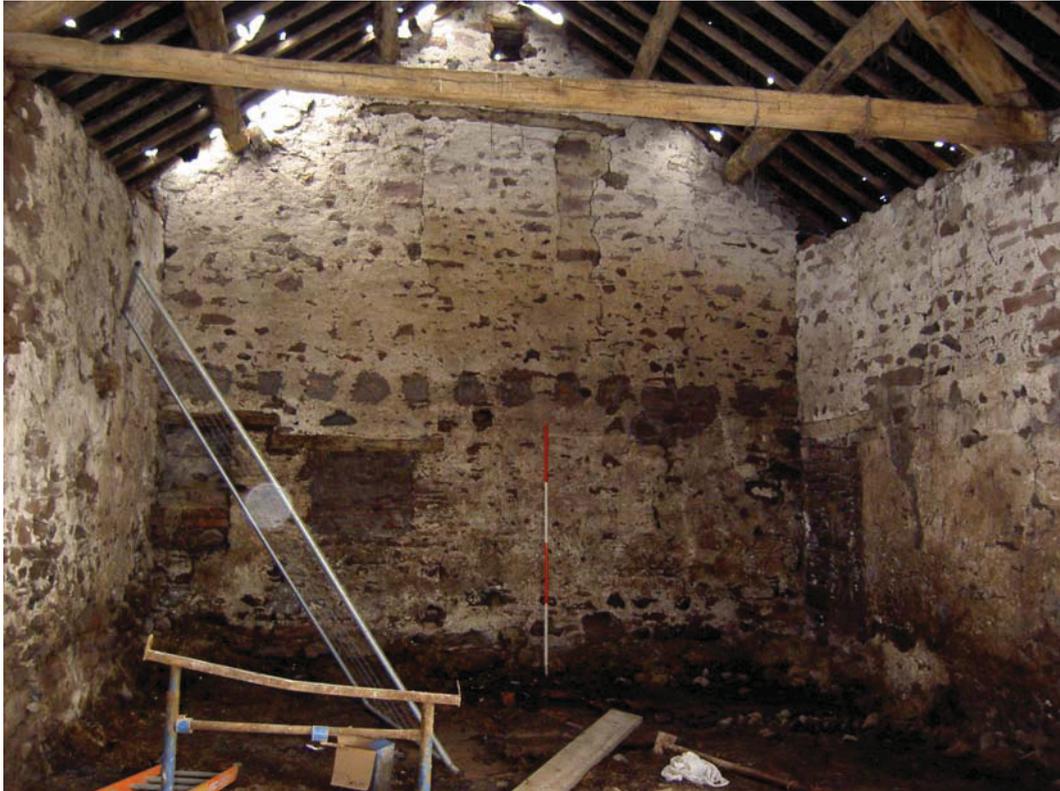
Plate 15: Evidence of half loft and blocking in south-east end of Building 2

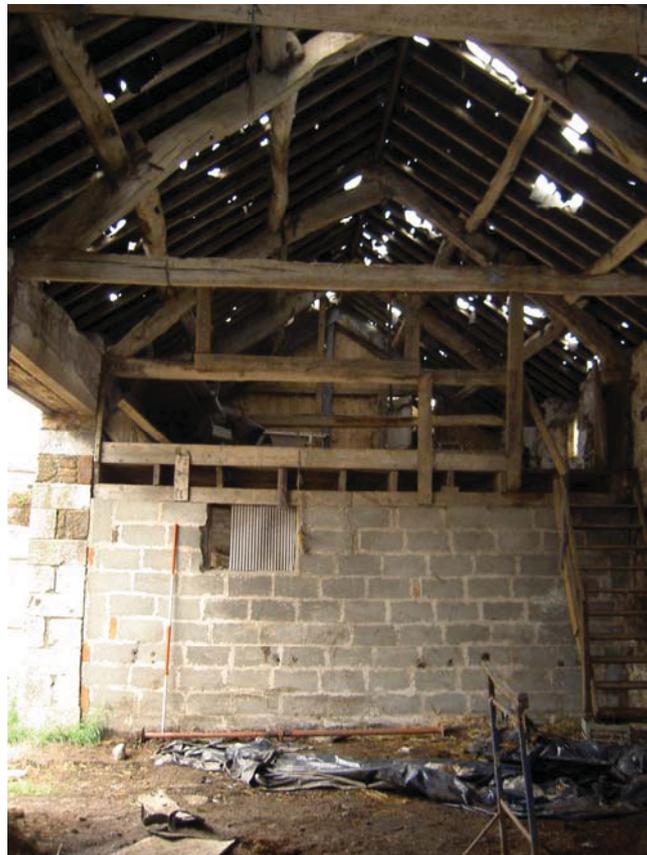
Plate 16: Inserted floor on top of blocking and re-used cruck blades in roof trusses of Building 2, looking north-west

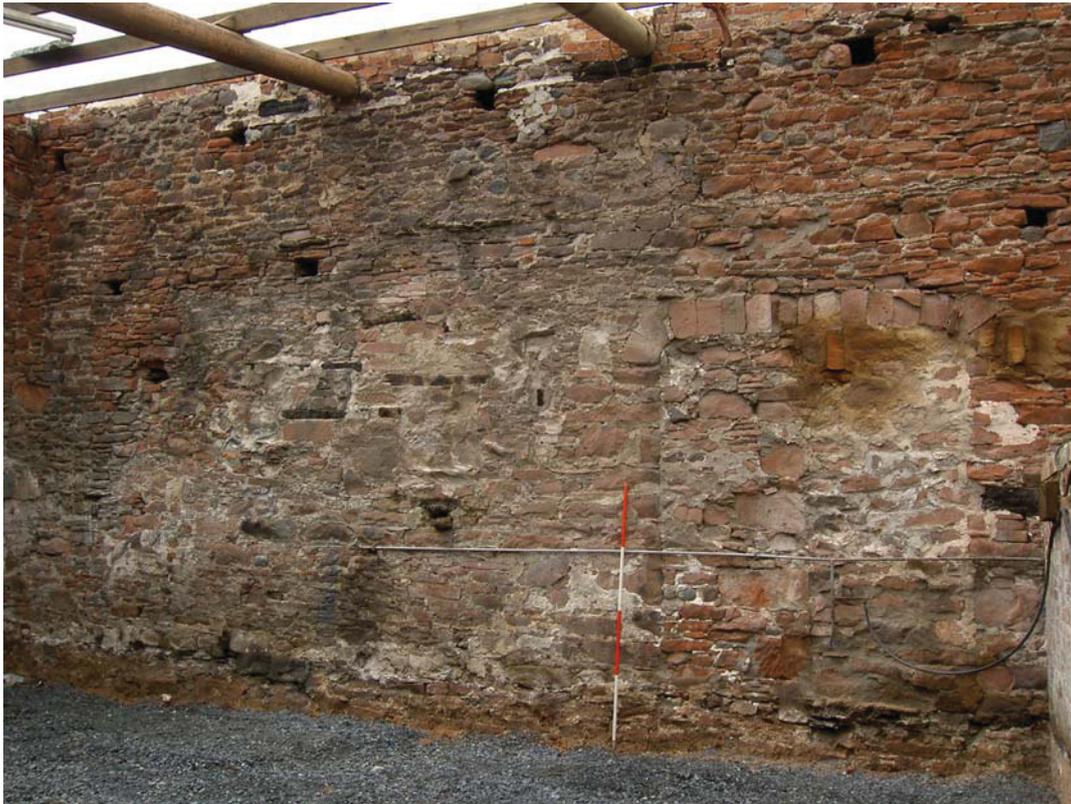
Plate 17: Interior of Building 4 showing original wall height and blocked double door and window, looking west

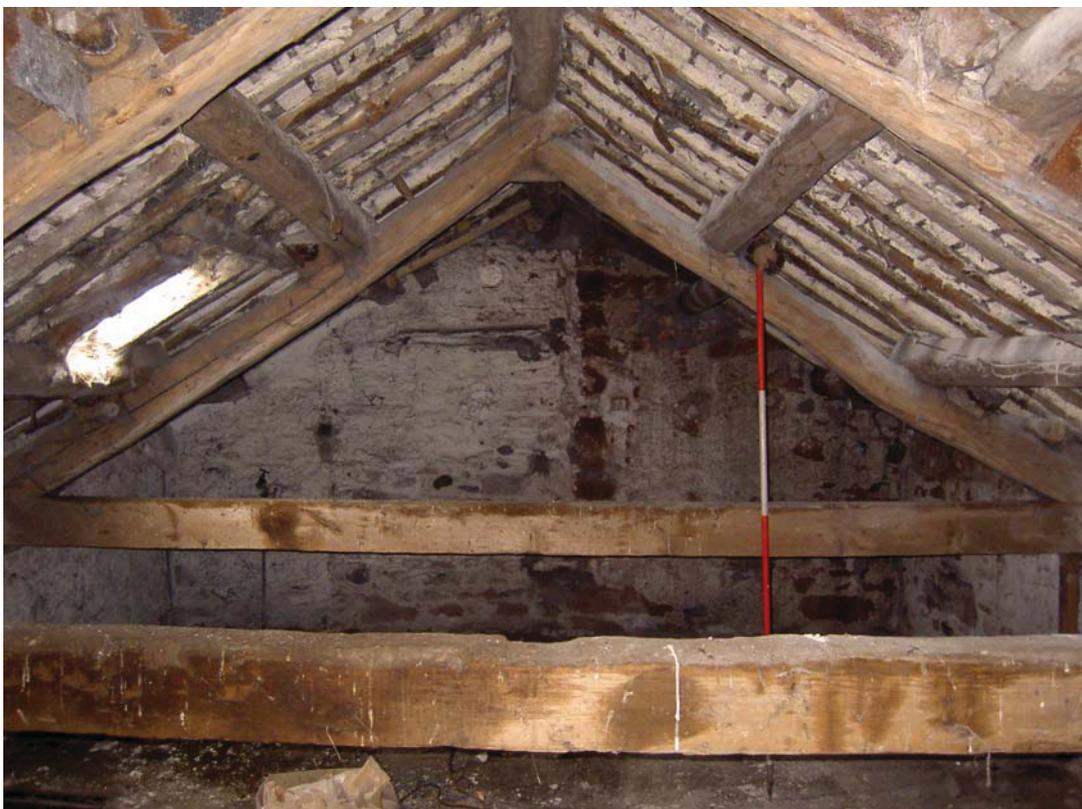
4.3.25 **Building 5, roof** (Figs 15 and 16): in the loft the tie beams of the two trusses are at waist level (Plate 18) and restrict movement around this space, further suggesting this floor is a later addition. The trusses are simple tie-beam types with no collars. There are two purlins per pitch and a ridge purlin; the purlins are round section softwood that overlap at the trusses, and some have been replaced by modern treated cut poles, possibly re-used telegraph poles. The rafters again are softwood and from the bark present appear to be untreated birch.

Plate 18: Detail of Building 5 roof structure and blocked window in west-north-west gable end of farmhouse
