# YARD 143, STRICKLANDGATE, KENDAL, CUMBRIA

## Archaeological Building Recording

Client: Aquine Ltd  
Planning Ap. Refs.: SL/06/1324-5  
NGR: SD 5150 9309

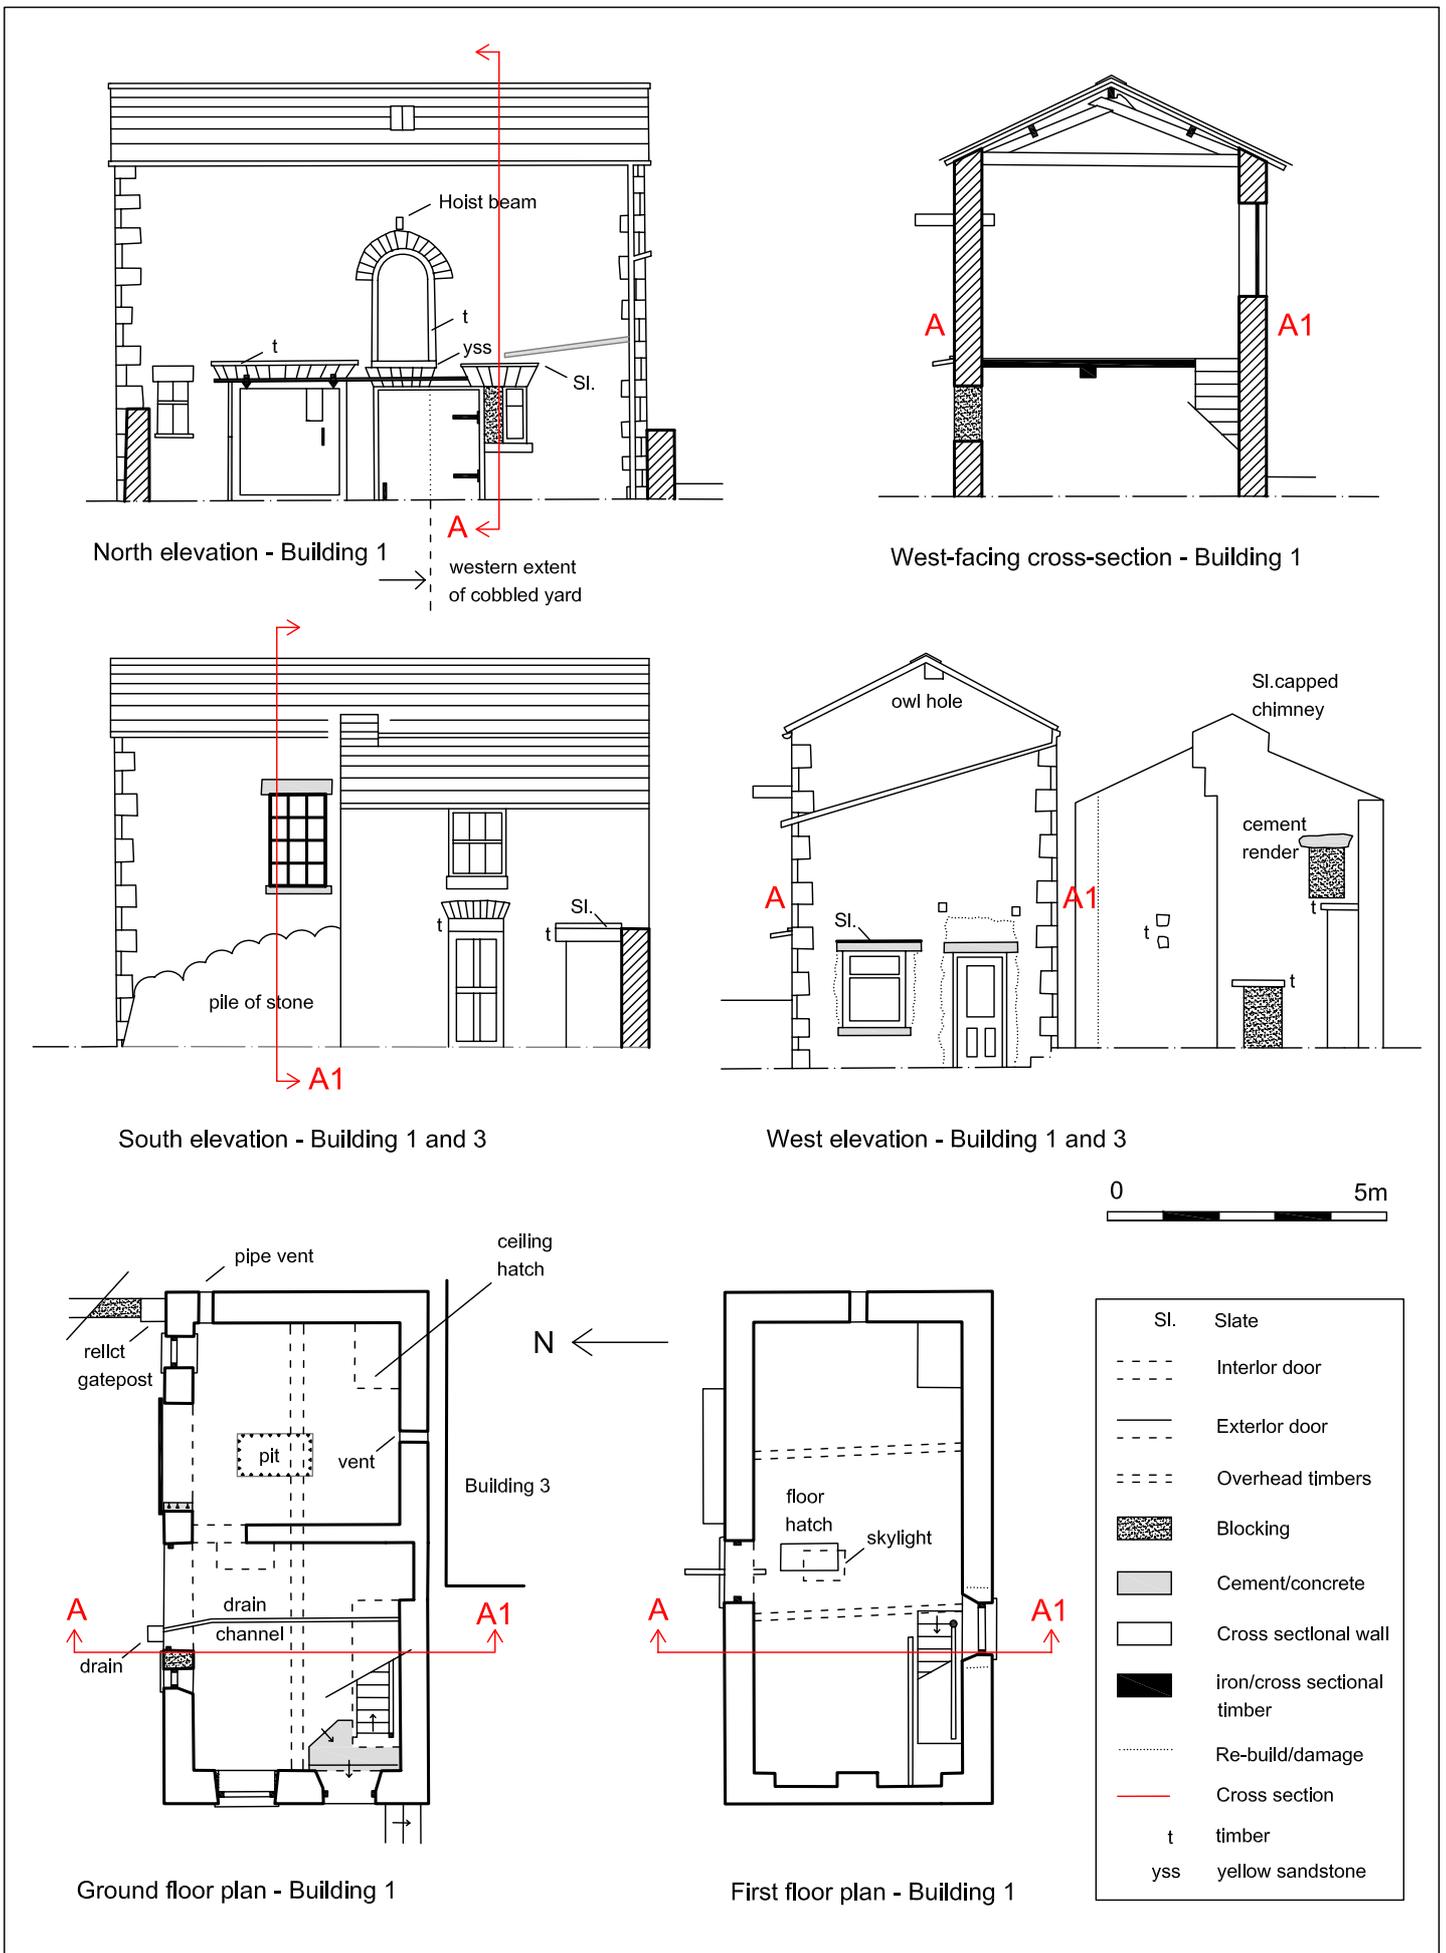
Figure 2: Elevations of Buildings 1 and 3, plans and cross-section of Building 1

4.2.1 **North elevation** (Plate 8, Fig 2): the ground floor incorporated two double doors; the sliding door to the east was hung on an iron rail and was below a narrow timber porch that was covered in felt. This doorway was original and was set below a flattened voussoir arch. The double door to the west was hung on strap hinges; this appeared to be a pedestrian door originally as the flat arch only covered the eastern side of the doorway. Both doors were blue painted and of a board and batten construction. The two small windows were located at the east and west ends, and as with the doors the east window was apparently original and the west had been modified. The east window had a narrow pink sandstone sill and a roughly squared limestone lintel. The lack of an arch over this window may suggest that it was not original, although due to its diminutive size an arch was probably not considered necessary. The window frame was a modern white painted timber construction that housed four lights, the upper two of which opened upwards and outwards on a central horizontal pivot. The western window had been reduced in size to accommodate the enlarged doorway, and this was indicated by the removal of the east part of the flattened limestone arch. This window also had a pink sandstone sill whose width indicated the window's original eastward extent. The window had a white painted fixed timber casement that housed two lights arranged vertically. A large black-painted limestone gatepost butted the east end of this elevation suggesting a former access point to the yard, and a blue painted iron downpipe ran down the west side of the elevation.

4.2.2 The upper floor of this elevation housed a loading door with an ornate 180° limestone arch over. Above the arch was a black painted timber hoist beam. The doorway was timber lined and housed a blue painted board door that bolted shut; there was also a flaky yellow-grey sandstone sill below. The rest of this upper elevation was plain except for a cement scar that was located at first floor level on the west side of the elevation, this ran downwards at a shallow angle and appeared to represent the location of a former lean-to or outshot.

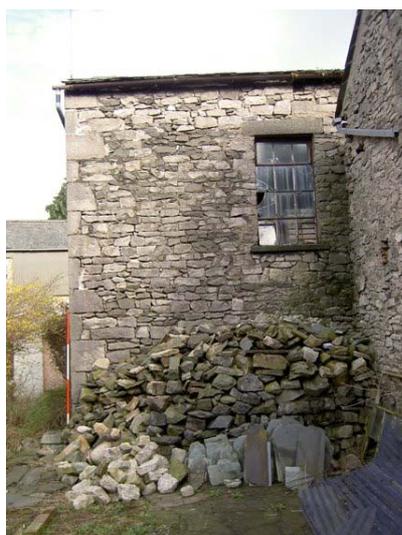
**Plate 10: South elevation, Building 1**

4.2.4 **South elevation:** only the west end of this elevation was visible (Plate 10), the remainder being obscured by Building 3. The two buildings were not actually adjoined but the 0.30m gap between them combined with the large pile of stone evident in Plate 10 made detailed inspection of the east part of this elevation impossible. On the west side of the elevation at first floor height there was a large window with a concrete lintel and sill and signs of re-build on its western side. This window housed a fixed casement cast-iron frame with 12 panes. The rest of the elevation was plain although the large pile of stones appeared to cover the remains of an outbuilding that may have been part of Building 1.

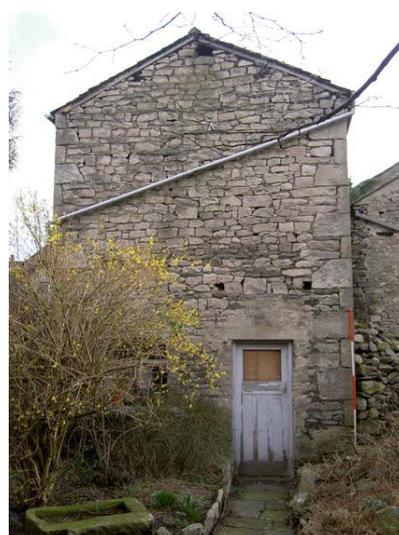
**Plate 11: West elevation, Building 1**

4.2.5 **West elevation:** this formed the gable end of the building and housed a doorway at the southern end and a window to the north both of which had been

inserted (Plate 11). The doorway showed signs of re-build all around in the form of fresher looking mortar and had a concrete lintel. The timber door was constructed from blue painted timber board and had a boarded-up upper light and a modern mortice lock with a galvanised handle. Above the corners of the doorway at a height of 2.85m there were two sockets in the wall measuring approximately 0.15m square. These could have been created to hang a porch above the doorway. At the north end of the elevation there was a window with a concrete lintel and modern white painted timber casement; the upper of the two lights was a top hung ventilator with alloy casement stays. Directly below the apex of the roof there was an owl-hole. There were three steps at the south end of this elevation that led up to the raised ground on the south side of the building. A plastic downpipe slanted down across the upper part of this elevation from south to north, taking water from the southern guttering to join the downpipe on the northern elevation at its midpoint.

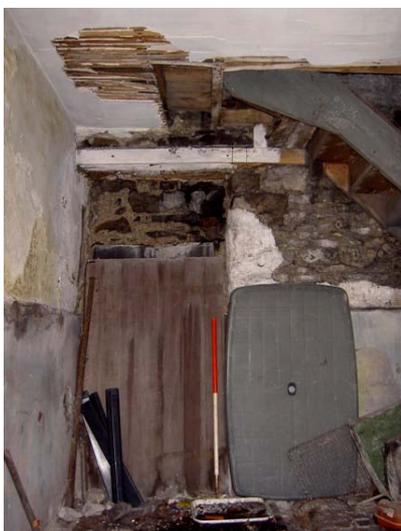
**Plate 12: Recess in wall, west room**

4.3.1 **West room, ground floor:** the walls within this room had a cement skim up to a height of 1.2m above which they were plastered and painted white, the exception being the southern elevation that was un-painted and un-plastered above the cement. The small window in the north elevation had a single splayed jamb on the west side which also highlighted the fact that it had been narrowed to make way for the double door just to the east. The east elevation was the dividing wall and housed a doorway at the north end allowing access to the east room; there was no evidence for a door in the jambs. At the east end of the south elevation there was what appeared to be a blocked doorway with a 0.3m diameter pipe inserted into the top west corner (Plate 12), probably acting as an air vent. It seems unlikely that this was a doorway due to the location of Building 3 (see Fig 2), and was probably a recess to house an original fitting. Over the recess there was a modern looking square cut softwood lintel that had been painted white. A staircase ran along the south elevation from west to east rising over the recess.

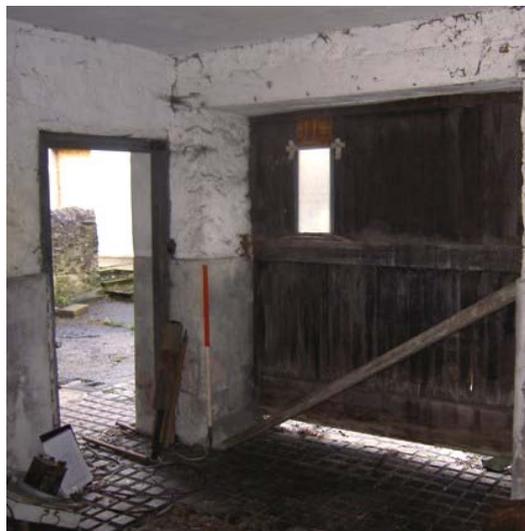
**Plate 13: Doorways, east room**

4.3.3 **East room, ground floor:** the walls within this room had the concrete skim up to 1.20m and were whitewashed above. The north elevation housed the sliding doors, the lintel above which was also whitewashed but had the appearance of hand finished oak. A similar lintel was located above the window to the east of the door. The eastern elevation had a ceramic ventilation pipe towards the north end that was 0.20m in diameter and a square section sawn timber near the south end that measured 0.1m x 0.1m and whose function was unclear. The south elevation wall had a ceramic air vent measuring 0.15m x 0.22m set in the middle of the wall. The west elevation was plain excepting the doorway at the north end that led the adjacent room (Plate 13). The ceiling was the same construction as in the east room; this was evidenced by the ragged edged rectangular hatch cut into the south-east corner. Once again the floor was laid with ceramic sets and there was a vehicle inspection pit just behind the double doorway.

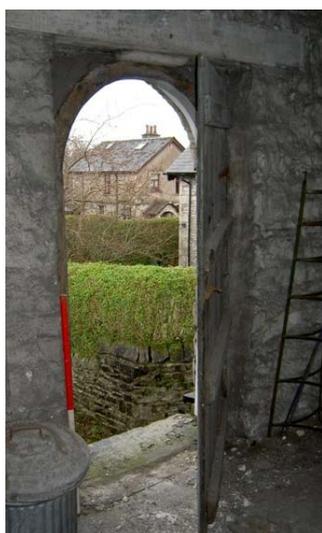
Plate 14: Loading door

4.3.4 **First floor:** all elevations showed signs of render and whitewash. The loading door had a square cut whitewashed timber lintel and yellow sandstone sill, the oak door-frame neatly followed the shape of the arched doorway (Plate 14). Above the arch the hoist beam was visible and modern looking cement was evident around its insertion point in the wall suggesting it was a recent replacement. The east elevation was entirely plain except for the owl-hole. The window situated at the west end of the southern elevation had splayed jambs both of which showed signs of re-build or insertion. The two recesses from the ground floor west elevation continued up into this floor for about a metre and were equidistant from the north and south elevations. The recesses first appeared to be part blocked apertures and were both below flat arches made from voussoired limestone blocks suggesting their originality. Whilst there was apparent blocking in the south recess at least, including brickwork, it seems likely that this was re-build above the doorway that was knocked through. The

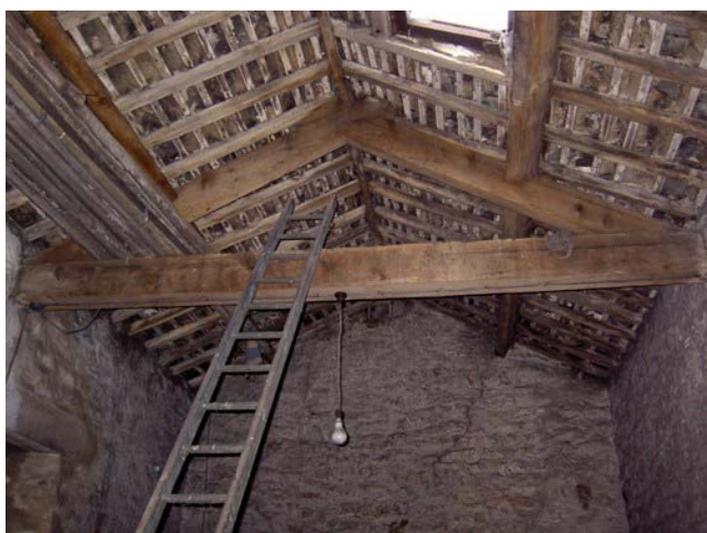
Plate 15: Tie beam truss and roof

**4.3.5 Roof:** The roof construction utilised two simple tie beam trusses that were made from hand-finished oak (Plate 15). The southern principals overlapped the northern ones and were secured with pegged mortice and tenon joints. The large hand-finished oak purlins ran past both trusses and were scarfed to shorter pieces at the east end. One of the trusses bore Baltic timber marks. The ridge purlin and rafters were fashioned from softwood and were machine cut, as were the laths, which may suggest the building had been re-roofed. The roof had been laid with green Westmorland slate and there was a small skylight on the northern pitch.

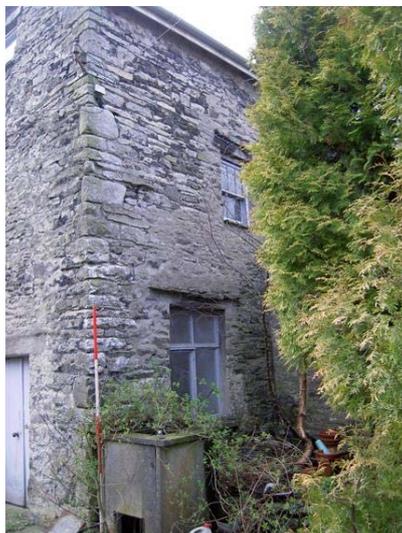
**Plate 16: North elevation, Building 2**

5.2.1 **North elevation:** this elevation formed the rear of the building, and all the ground floor except the east end of the east cottage was obscured by other buildings (Plate 16). The ground on this side was 0.5m higher than on the other elevations and a small garden area was present. This was the only corner of the building that had several roughly shaped and irregularly spaced limestone quoins. There was a ground floor window at the east end of the elevation that had a rendered timber lintel below a slate drip course and a limestone sill. The blue painted timber window frame held a side hung casement light arranged alongside a fixed casement light both of which were arranged below a shallower top hung double light ventilator. The casement stays and frosted glass suggested a 20<sup>th</sup> century date. Cement pointing around the window also indicated it was a replacement. The first floor window was located slightly further to the west and housed a white painted timber framed sliding sash type window with two rows of three vertically orientated lights. This window appeared to have a thin sandstone sill and a slate drip course over a lintel that was covered by timber board. A second first floor window that would have belonged to the west cottage can only really be described from the inside as it was too distant to be recorded externally (see 5.4.3).

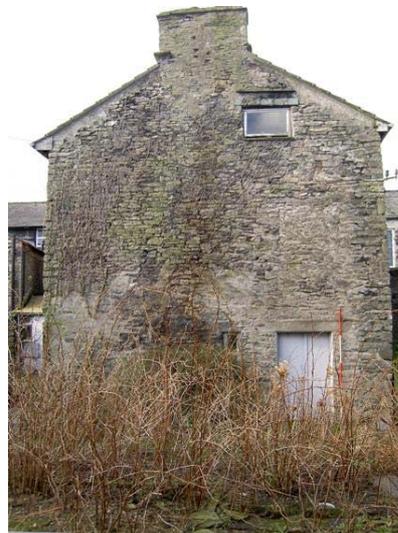
**Plate 17: East elevation, Building 2**

5.2.2 **East elevation:** this formed the east gable end with chimney stack and had a door at the north end of the ground floor with a very small window on its south side (Plate 17). The doorway had a concrete rendered timber lintel over a basic timber frame that held a pair of blue painted narrow timber plank doors. The small ground floor window had a white painted fixed casement timber frame with two lights arranged vertically, and the lintel and sill were made from sandstone. This window presumably dated from after the adjacent cottages to the north were demolished between 1912 and 1938 (see Plate 6 and Plate 7). There was a window on the first floor that had been neatly blocked with limestone rubble in keeping with the wall, this was presumably blocked prior to the addition of further cottages butting this elevation

which must have been before 1787 (see Plate 1). A further window was located to the north of the roof apex line on the second floor, again this is probably post 1912. The upper window was a modern white painted timber fixed casement with a single light and had a timber lintel covered by hanging slates and a chipboard sill.

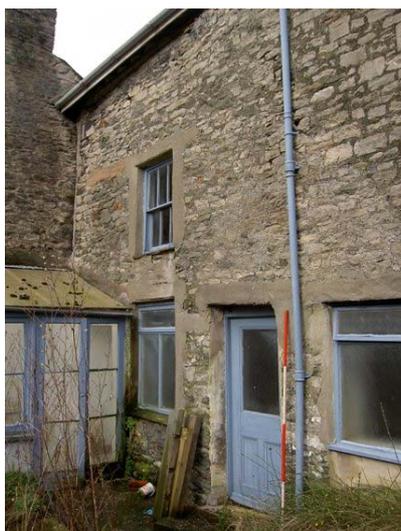
**Plate 18: South elevation of Building 2**

5.2.3 **South elevation, lower:** there were two doorways and three windows on the ground floor (Plate 18 and Plate 19). The doorway at the west end could only be accessed via the conservatory and would appear to have been inserted. The window just to the east of the conservatory had a blue painted timber window frame which held two fixed frosted lights arranged side by side below a shallow top hung ventilator. The casement stays and frosted glass suggested a 20<sup>th</sup> century date, and cement pointing around the window also indicated it was a replacement although probably in an original location. The sill was yellow sandstone and possibly original too. The doorway to the east of the window was probably the original entrance to the west cottage; this was just to the west of the downpipe that roughly demarked the original junction of the two cottages. The blue painted door was panelled and held a large frosted upper light; cement render on the door lintel obscured its fabric. The window just east of the downpipe had a modern blue painted frame with a large fixed frosted light below a shallow upper top hung ventilator again with a single frosted light. The sill and lintel were timber although once again the lintel had been rendered. This window had partly filled a blocked doorway which was the original entrance to the eastern cottage. The original window for this cottage, at the west end of this elevation, held a modern blue painted sliding sash window with four frosted lights. This window had a timber sill and a rendered lintel.

5.2.4 **South elevation, upper:** the upper cottage windows were located directly above the original ground floor windows and both held blue painted six light sliding sash windows. The window lintels had been rendered over and the sills were thin yellow sandstone. There was also a blocked aperture at the west end of this elevation which was directly above the ground floor door located in the conservatory. The lintel for this aperture had also been rendered but with a pinker-orange mortar, the sides were very straight and seemed to extend below the level of the upper windows. Some red brick had been incorporated into the blocking of this aperture, which appeared to be too tall for a window was probably an original doorway into an adjoining building.

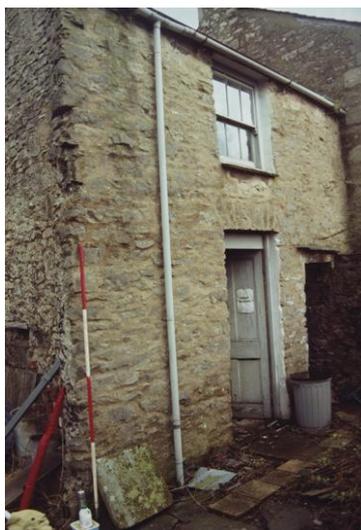
Plate 31: Building 3, south elevation

6.2.1 **South elevation:** in the centre of the elevation there was a high doorway under a flat voussoir arch (Plate 31; Fig 2). The modern looking four panel timber door was painted a pale blue. Given the height of the doorway arch it would appear that it was originally the top of the first floor window. To the east of the converted window was the original doorway which had a roughly fashioned oak lintel under a slate drip course; there was no door present. Directly above the original ground floor window there was an upper window which was a timber-framed sash type with six panes. This window had a slate sill and the lintel appeared to be formed by the wall plate. The rest of the elevation was plain except for the plastic downpipe that ran from the plastic gutter, and this feature along with the modern door and the relatively fresh looking pointing suggest that the building may have been in use until fairly recently.

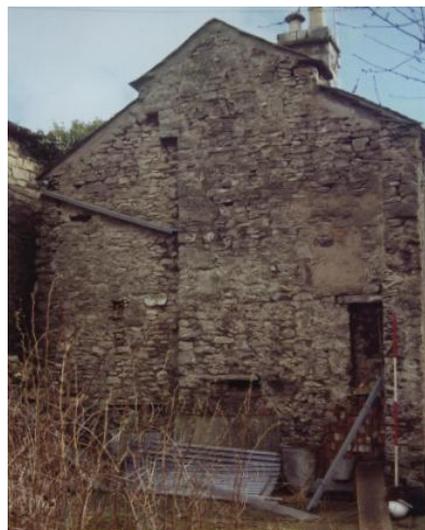
Plate 32: Building 3, west elevation

6.2.2 **West elevation:** the west elevation was the internal wall of one of the three cottages that existed between this building and Building 2 (Plate 32; Fig 2). The chimney that was originally shared had been capped with pitched slate. At the south
