ELLEL HOUSE, CHAPEL LANE, GALGATE, LANCASHIRE

Archaeological Building Recording

Client: Ellel Healthcare Ltd
NGR: 348555 455805

© Greenlane Archaeology Ltd
July 2008

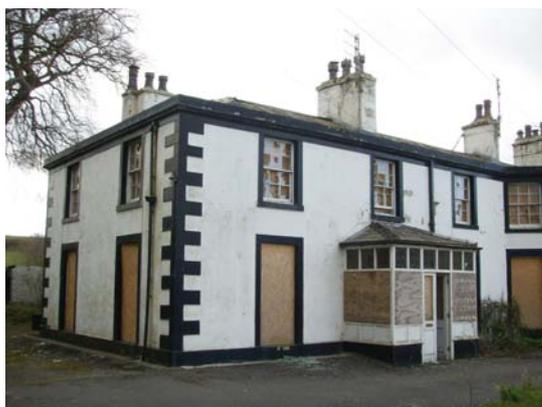
Plate 10: (left) North-west elevation from the north

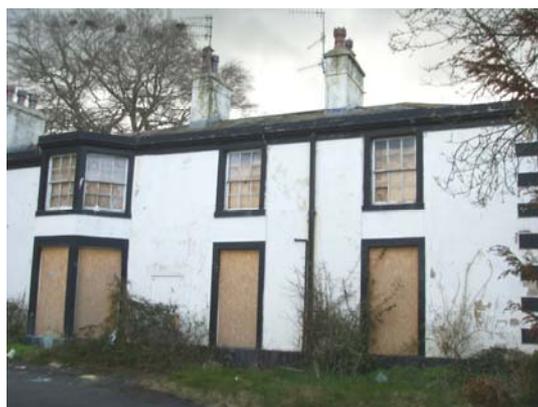
Plate 11: (right) North-west elevation from the west

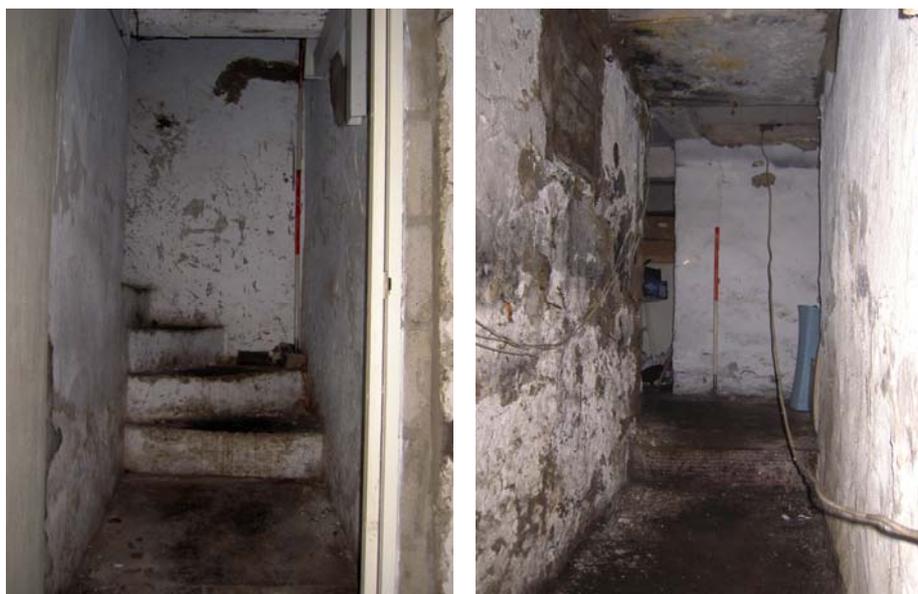
4.3.2 **Room B1:** the stairs down to the cellar were constructed from concrete suggesting they are a later replacement (Plate 21), and the doorway at the base of the stairs had a modern timber frame and door.

Plate 21: (left) Basement stairway (Room B1)

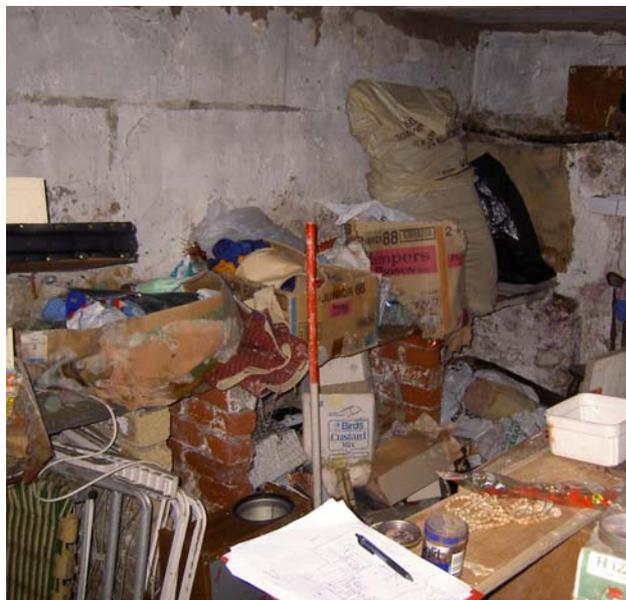
4.3.6 **Room B5:** this room was situated on the north-west side of room B2. The north-east and south-west elevations were whitewashed. The south-east elevation formed the brick partition to Room B3 and was cement rendered. The north-west elevation had a shelf running the length of the wall (Plate 24) which was approximately 0.5m deep and 0.7m high and constructed from of four stone flags supported on brick columns, two of which were constructed from yellow firebricks.

Plate 24: (right) Flag shelving on brick pillars in Room B5

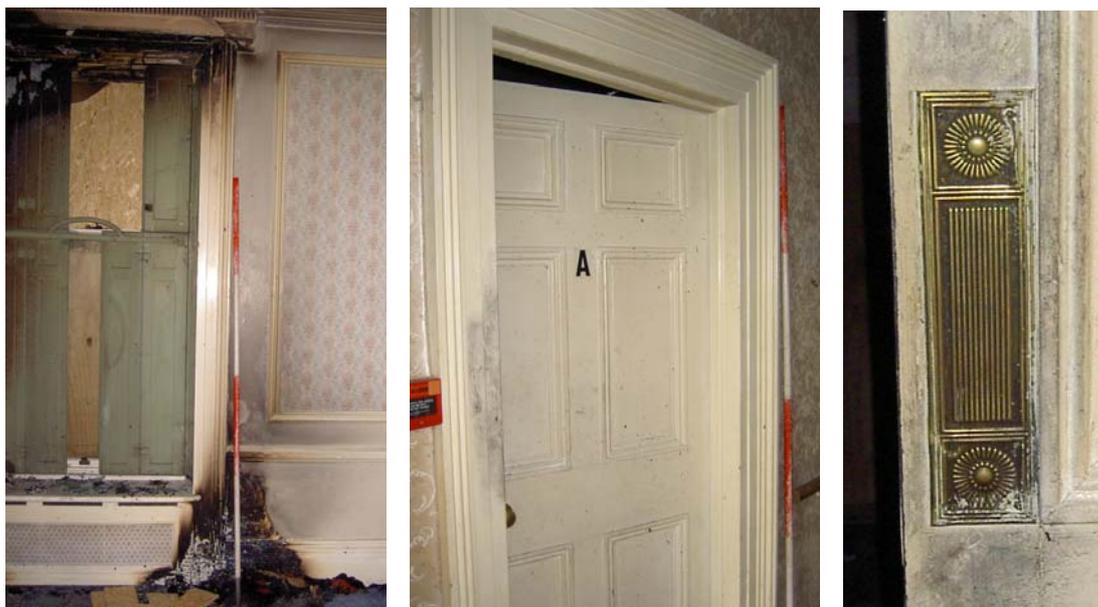
4.4.1 **Room G1a:** the elevations of this room had moulded timber skirting, window surrounds, dado rails, and panels; except for the south-east elevation, which was an inserted partition. The mouldings were largely variations of the *cyma recta* form. The floor was clad with modern blue carpet and the ceiling was plastered and had an ornate cornice running round the original elevations. There were tall windows in the north-east and north-west elevations which extended down from the cornice to a shelf approximately 0.30m above the floor, under which were radiator boxes with ornately perforated wooden grills. Both windows were fire damaged but the remains of an ornate pelmet (Plate 25) were still apparent suggesting that they once had curtains. The windows both had internal green painted timber shutters that were hinged and horizontally divided enabling the upper or lower part of the window to be shuttered independently. The north-west and north-east elevations had ornate metal grill vents which were located close to the ceiling below the cornice. The doorway in the south-west elevation was white painted and had six panels with moulded surrounds suggesting that it was probably original (Plate 26). It had a modern alloy plate with the letter 'A' affixed to its exterior side, along with a Yale lock and an ornate original brass fingerplate (Plate 27).

Plate 25: (left) Panelling on north-west elevation of Room G1a

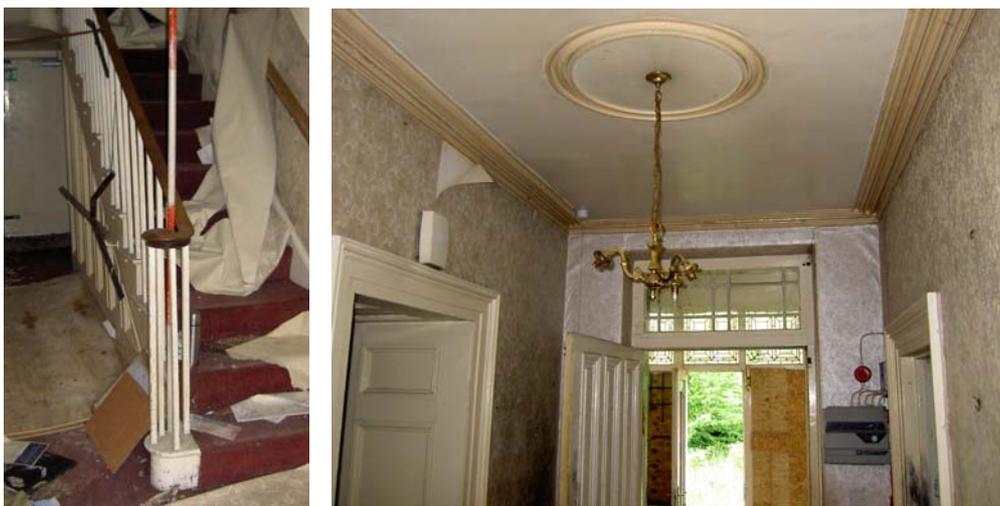
4.4.3 **Room G1c:** this room formed the hallway, and was located towards the north-east end of the house. The north-east elevation was wallpapered between the beaded skirting board and moulded cornice, and there was a modern timber handrail between the two doorways of rooms G1a and G1b. The south-east elevation had a central doorway, which was positioned within a tall former window visible externally. The doorway had a modern single panel fire door and frame with a plain surround. The staircase was located along the south-west elevation towards the rear of the main wing. Behind the stairs there was a doorway to the service passage that linked the service wing to the main house. A timber panel door under the rear of the stairs led down to the cellars, this stairway was panelled off from the hallway with moulded white painted boards. The staircase rose to a landing at the south-east end and was constructed in a late Georgian style with white-painted square section balusters supporting a varnished hardwood timber hand rail ending with a twist at the bottom step (Plate 28). A second modern timber handrail was attached to the opposing wall. To the front of the stairs there was a doorway in the south-west elevation leading to the large dining or reception room, G2 (Plate 29). The jambs of this doorway were timber panelled in the same style as the door and were extremely deep, apparently having been inserted through what was a chimney breast. The main entrance, located to the north-west of the stairs held a wide six-panelled door with a decorative over-light with side and central bars (Plate 29). The ceiling was the original lath and plaster with a moulded cornice and boss with a modern chandelier style light fitting. The ceiling had a slight downward curve at the south-east end of the hall and the floor was laid with modern carpet.

Plate 28: (left) Staircase, south-east end of Room G1c

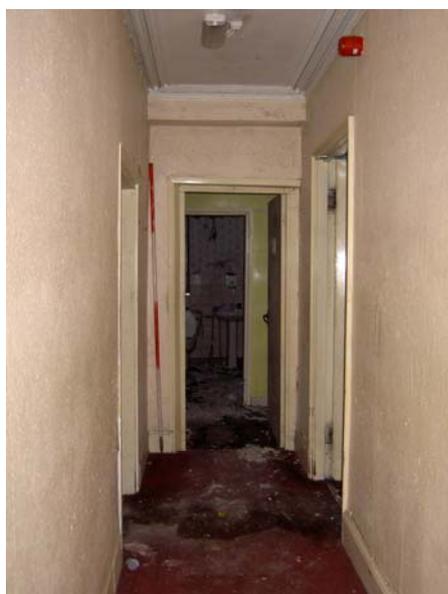
4.4.6 **Room G3b:** this was the narrow service corridor that separated the main wing from the service wing to the rear (Plate 34). All elevations were clad with painted woodchip wallpaper and had beaded skirting boards, the floor was carpeted and the ceiling was plastered, with a white moulded plaster cornice. The north-east elevation led to the rear of the main entrance hall (G1c), behind the stairs. A doorway with a modern timber frame and surround separated these two areas, a similar door and surround led into the service wing on the south-east elevation. The south-west end of the corridor led past the central division of the service wing and would have allowed access into the southern half of this wing, into what is now the bathroom (G3c). The only access into the main wing from this corridor was via the north-west elevation which led into the dining room (G2; see *Section 4.4.4*).

Plate 34: (left) Corridor G3b, from the north-east

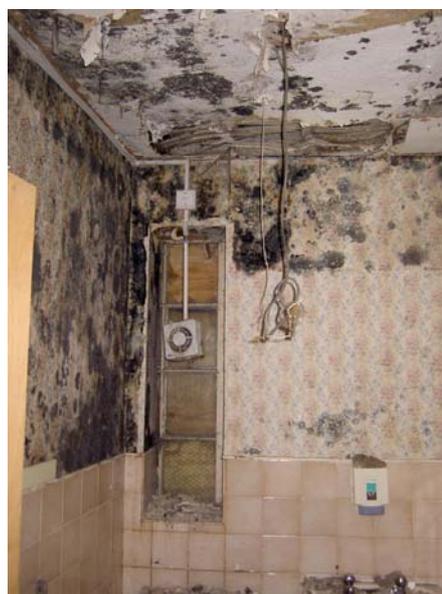
Plate 35: (right) South-west elevation of Room G3c showing interrupted window

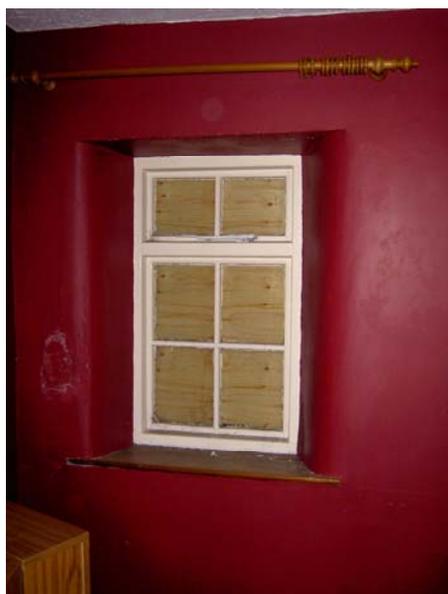
Plate 46: (left) Converted doorway in the south-west elevation of Room G12

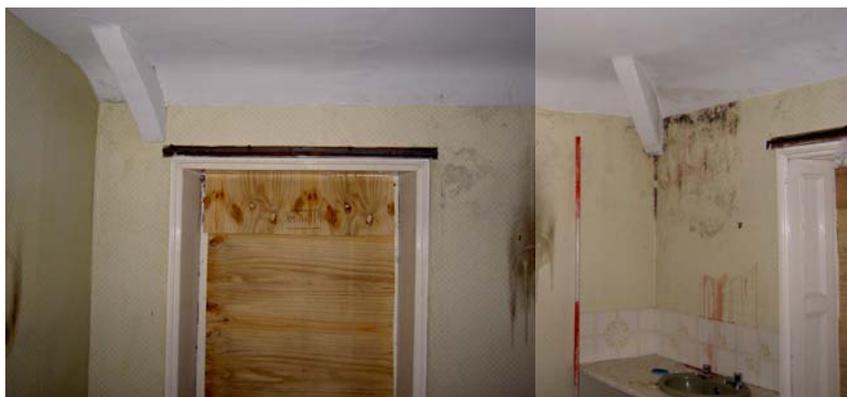
4.5.3 **Room F3:** this room was essentially a continuation of F2, the doorway was in the south-east elevation, there was a modern sink in the north corner and a radiator against the south-east partition wall. The window in the north-east elevation was recessed to floor level and had panelled jambs (Plate 49); the window in the north-west elevation was identical to that in F2. The bases of the truss and timbers supporting the roof structure projected through the ceiling (Plate 49).

Plate 49: Composite view showing truss and timber of hipped roof in Room F3

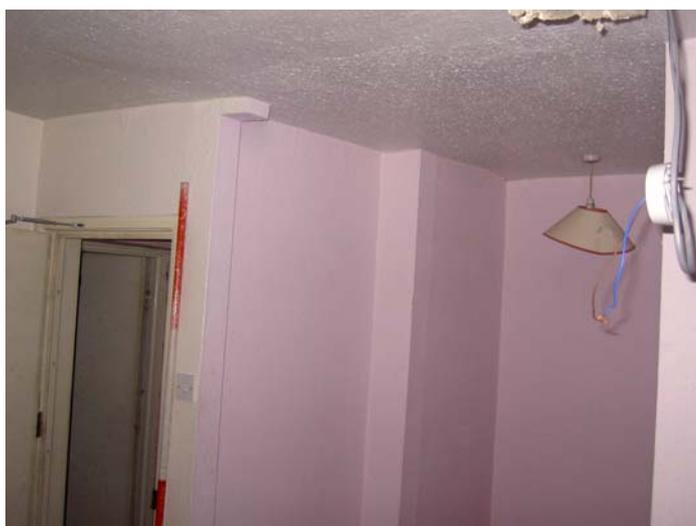
Plate 51: (left) Partition in Room F6b
