OUTBUILDING AT CHURCH HOUSE, CHURCH STREET, DALTON-IN-FURNESS, CUMBRIA

Archaeological Building Recording

Client: Mr and Mrs Dewar

NGR: SD 22542 73902

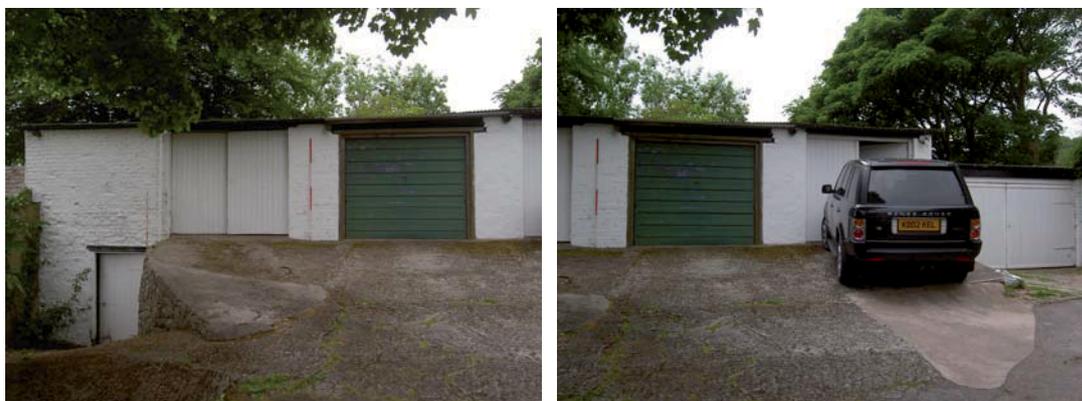
4.2.2 **North-east elevation:** the south-east end of this elevation comprises two storeys (Plate 9). The upper storey is plain, while the lower storey has a plank door with timber lintel. To the north-west are three garage doors, two of which are tongue and groove plank double doors, the other a folding metal door. Each door has a timber lintel (Plate 10). Access to these doors, which give access to the rooms in the upper level, is via a concrete ramp. At the north-west end, at a slightly lower level, is another double garage door with timber lintel.

Plate 9: (left) The south-east side of the north-east external elevation

Plate 10: (right) The north-west side of the north-east external elevation

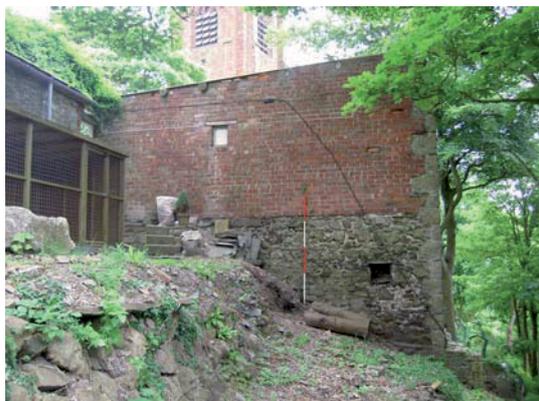
4.2.3 **North-west elevation:** the lower part of this elevation is stone, with quoins on the south-west side extending into the upper storey, which is brick (Plate 11). The bricks are hand made, and a dark orange-red, although much darker red than elsewhere, and laid in a stretcher bond. There is a small aperture at the south-west end of the lower floor. This is lined with slate and blocked with brick. There is an opening in the centre, slightly below the brick section, which has a slate sill and is also blocked with brick. This opening is also partly obscured by a more recent flight of stone steps that butt against the wall. There is another small aperture in the upper part, with a timber lintel and surround, which is blocked with board. The ends of telegraph poles, used as internal beams, extend outward through the top of the upper floor.

Plate 11: (left) The north-west external elevation

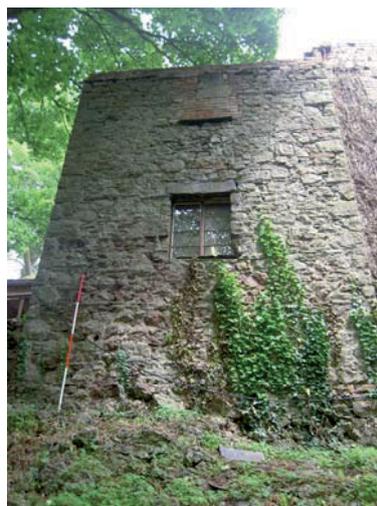
Plate 12: (right) The north-west end of the south-west external elevation

4.2.4 **South-west elevation:** the north-west end of this elevation comprises two storeys, entirely built in stone, including some red sandstone, except for two courses of brick along the top and rebuild around an inserted window on the upper floor (Plate 12). This window has a slate sill and is blocked with brick and some concrete in the upper right. The lower floor has a window with slate sill and lintel, and an eight-light iron casement. There is a slight return at the south-east to the north-east and the wall sits on a plinth at the corner. The wall to the south-east appears to butt against the north-west end, although the alterations in brick obscure the relationship. The lower part of the wall is stone with some through-stones and ceramic pipe projecting through it and the upper part is constructed from hand-made brick (Plate 13). There are two windows on the lower floor, one of which is obscured by foliage, while the other has a four-light casement and a flat brick arch. The single window on the upper floor is also obscured by foliage. The ends of round telegraph poles, used internally as beams, project through the elevation. The south-east end of the elevation turns slightly where it meets the adjoining building. The build is different from the north-west elevation, with more orange, rougher brick.

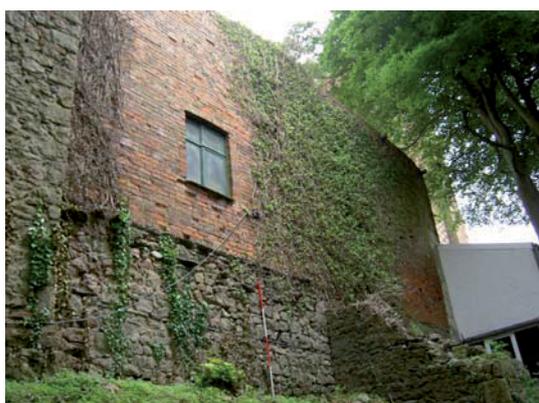
Plate 13: (left) The remainder of the south-west external elevation

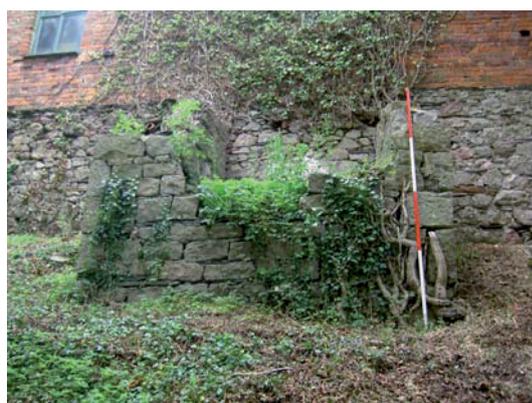
Plate 14: (right) The ruinous outshut attached to the south-west external elevation

4.2.5 There is an attached semi-ruinous and roofless outshut south-east of the centre of the elevation, the form of which suggests it originally had a monopitch roof (Plate 14). The walls are built of limestone, with dressed quoins at the corners, and it butts the south-west elevation of the main building. Other than a broken hole on the south-west elevation of the structure there appears to be no obvious entrance,

although the main wall to the north-east has been recently re-pointed, perhaps concealing a doorway.

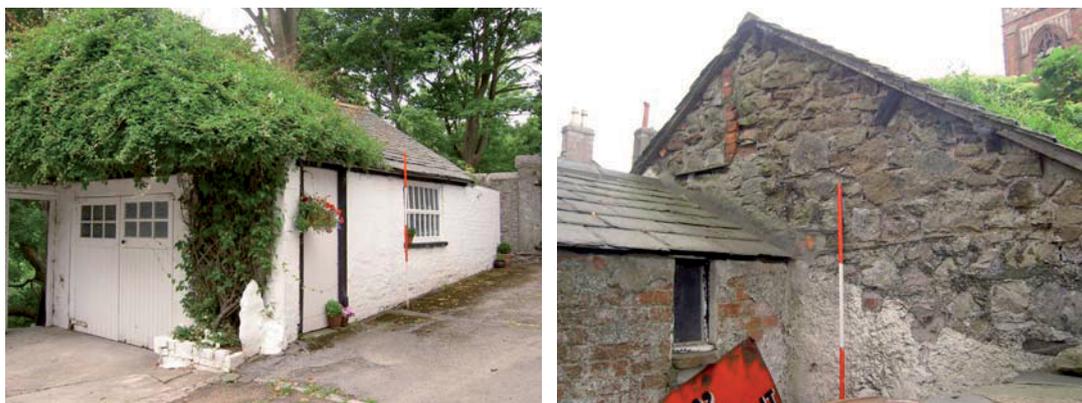
4.2.6 Detached building: the north-east elevation comprises painted brick with a doorway at the south-east end (Plate 15). This has a beaded tongue and groove door and a timber surround. The lintel is timber, and it extends along the top of the wall and forms the wall plate. To the north-west is a 14-light fixed casement window with a stone sill. The lintel for this is formed by the same long piece of timber. The north-west end of this elevation butts a wall forming a small yard, which is also built of brick capped with limestone. The north-east side of the north-west elevation is the end of the main part of the detached building, which is finished with whitewash. This returns to the north-west to form a small attached building forming an outside toilet. The north-east elevation has a doorway at the south-west end with a plank door, to the north-west of which the wall is brick. The brick butts a section of wall at the north-east end, suggesting it was perhaps originally an open side that was subsequently filled in. The north-west elevation is stone with thick mortar and lime wash and a narrow blocked vent in the centre, filled with brick. The south-west elevation is constructed from handmade brick, laid in a stretcher bond, again butting the stone wall at its north-west end. There is a small window with single-light, slate sill, and a lintel formed of by the wall plate.

Plate 15: (left) The south-east and north-east external elevations of the detached building

Plate 16: (right) The north-west external elevation of the detached building

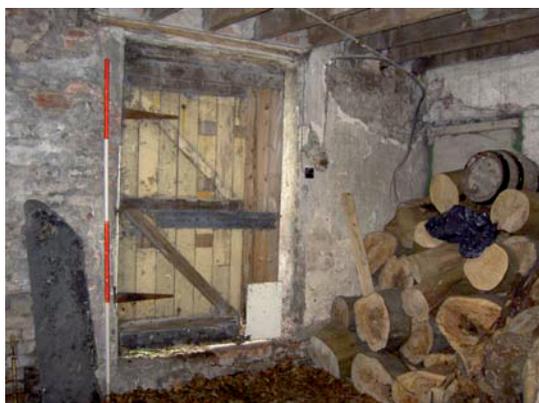
Plate 19: (left) Door in the north-east elevation of lower floor Room 1

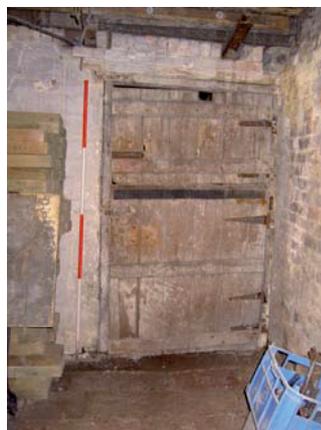
4.3.2 **Lower floor, Room 1:** this room has a stone flag floor of yellowish-grey sandstone/gritstone. A channel orientated south-east/north-west is cut into the flagstones in the centre of the room. The ceiling comprises machine sawn beams, joists and floorboards. One beam runs south-east/north-west supported by an upright post. Additional short bracing timbers have been added along the south-west side of the beam. All walls are finished with traces of plaster and whitewash. The north-east elevation is of dark red brick, laid mainly in a stretcher bond, but with some rows of headers. There is a doorway on the south-east side with a step up. This has a tongue and groove beaded plank door with diagonal battens and strap hinges (Plate 19). It also has a machine cut timber lintel. The south-east elevation is brick built, though obscured by plaster. There is a blocked aperture on the north-east side with a machine cut timber lintel. The south-west elevation is plain, with the remains of an ogee-moulded rail along the top on the south-east side, butted by the south-east elevation. The north-west elevation is of mid- to dark orange-red brick, mainly laid in stretcher bond but with some headers. There is a doorway on the north-east side with a machine cut timber lintel and a tongue and groove plank and batten door (Plate 20).

Plate 20: (right) Door in the north-west elevation of lower floor Room 1

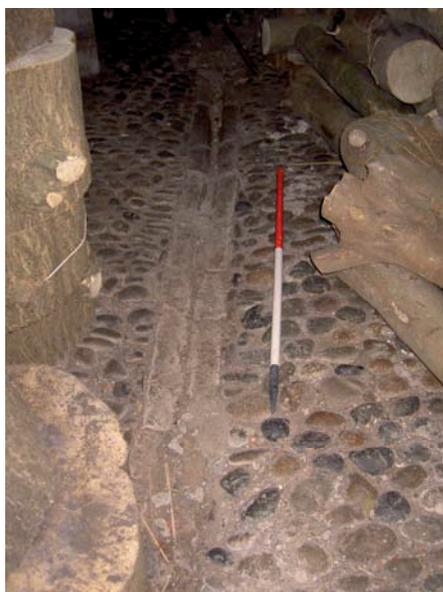
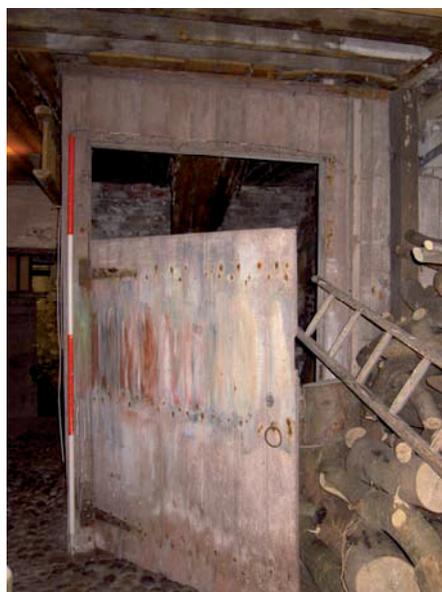
4.3.3 Lower floor, Room 2: this room has a cobbled floor with a stone cut channel running north/south to a stone drain at the south end (Plate 21). The north-west end of the floor comes to a flight of slate slab steps leading down to Room 5. The ceiling comprises relatively modern machine-sawn joists supported by iron I-beam girders on concrete buttresses against the walls, and one piece of rail track. There is an inserted timber partition in the north corner, which forms Room 3. The north-east elevation, at the north-west end is formed by the timber partition, which comprises beaded tongue and groove planks with an applied rail along the top and a row of timber tack hooks. A Oreturn in the centre houses a door in a similar material with a lock. The wall beyond is brick, mainly laid in a stretcher bond, with a blocked aperture south-east of centre. This is filled with stone and brick, including a re-used moulded piece, presumably part of an entablature or plinth (Plate 23). The lintel for this aperture is now a concrete beam on a semi-circular stone corbel on the north-west side. The lower part of the aperture is also filled with concrete, and there is a concrete buttress in the east corner. In the south-east elevation there is a doorway on the north-east side with a chamfered surround and a plank door which has recently been sawn in half. The rest of the wall is plain brick with another concrete buttress against it. The south-west end is obscured by stored wood. The south-east side of the south-west elevation is also obscured by stored wood. There is a return to the north-east in brick, although this is also obscured, and there is then a return to the north-west. Within this there is a doorway with machine cut surround, beaded tongue and groove door and a machine cut run out stop chamfered lintel (Plate 24). To the north-west is another concrete block buttress. The rest is plain, except for a timber rail along the top. The north-west elevation is lower, down three steps. It is butted by the north-east and south-west elevations, though it is essentially little more than a doorway with a chamfered surround, oversight, and a wide plank and batten door.

Plate 21: (left) Cobbled floor with drain in lower floor Room 2

Plate 22: (right) Panel wall and doorway in the north corner of lower floor Room 2

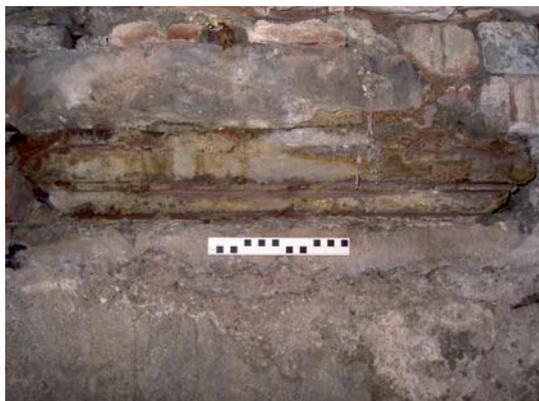
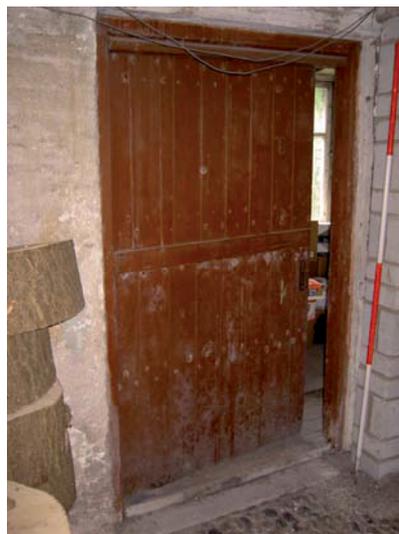
Plate 23: (left) Re-used moulded stone incorporated into blocked aperture on north-east side of lower floor Room 2

Plate 24: (right) Door in the south-west elevation of lower floor Room 2

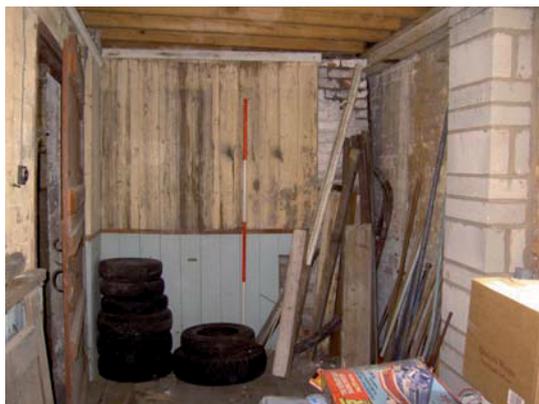
Plate 25: (left) Panelled wall and concrete pillar at the south-east end of lower floor Room 4

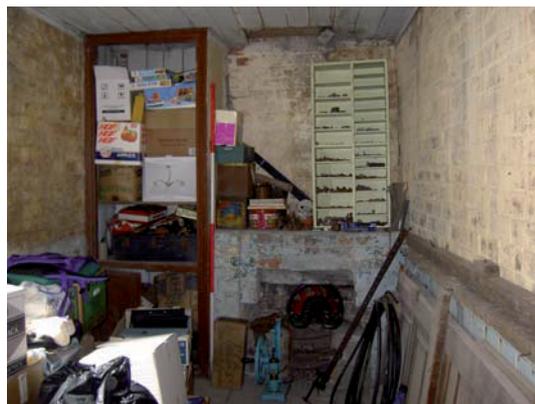
4.3.5 **Lower floor, Room 4:** the floor of this room is tongue and groove boards, except at the north-west end, which is concrete and stone. Tongue and groove boards also cover the ceiling joists, except at the south-east end where modern joists are visible and an iron I-beam runs along the south-west wall. The north-east elevation is comprised of painted brick, laid in a stretcher bond, with the lower part covered by tongue and groove boards. There is a large door on the south-east side constructed from beaded tongue and groove planks and battens, with a moulded rail along the top. The south-east elevation is of brick, but is largely covered by tongue and groove planks (Plate 25). The south-west elevation is of brick build, with a concrete pillar south-east of centre supporting the iron I-beam (Plate 25). To the north-west of this is a window, with a four-light hinged casement, and a moulded rail above. The north-west elevation has a fireplace with a low hob grate on the north-east side, and is mostly of hand made brick (Plate 26). A cupboard is built into the space on the south-west side. It has an ogee moulded surround, and a beaded and plain square panel door surviving at the base, and two shelves.

Plate 26: (right) Fireplace and cupboard at the north-west end of lower floor Room 4

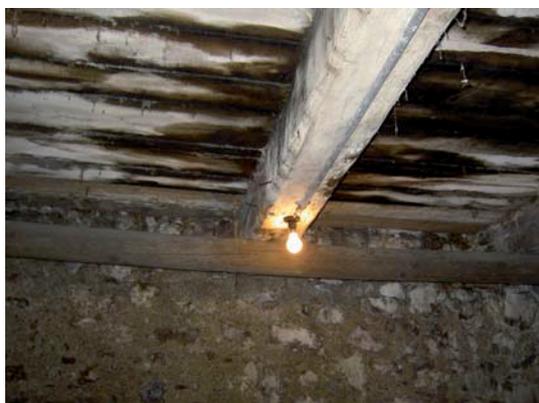
Plate 27: (left) Chamfered beam in lower floor Room 5

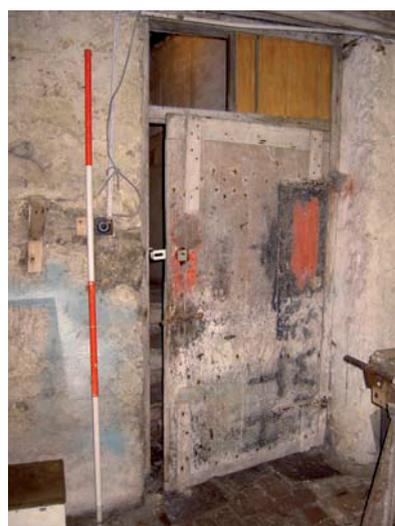
Plate 28: (right) Door in the south-east elevation of lower floor Room 5

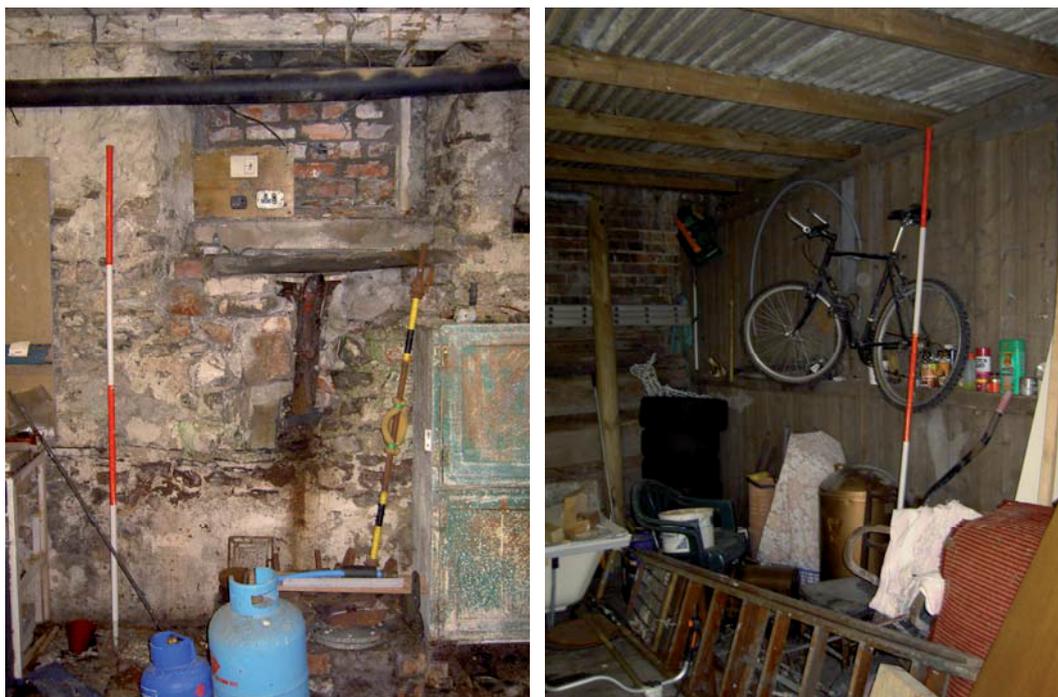
4.3.6 **Lower floor, Room 5:** this room has a laid brick floor, with a concrete base in the south corner, and a brick base, on the north-west side. There are two beams oriented north-east/south-west. The beam on the south-east is machine cut, truncated at the south-west end and resting on a square-section timber post. The north-west beam is adze finished and chamfered (Plate 27). Both beams are supported at the north-east end by an inserted telegraph pole acting as a north-west/south-east orientated beam. The north-west beam also rests on a similar pole at its south-west end. All the walls are built of stone, with the remains of whitewash on the north-west wall. The north-east elevation is plain. The south-east elevation has various attached brackets for shelves. There is a door in the centre; with tongue and groove boards and early strap hinges and an overlight (Plate 28). The south-west elevation is plain except for a metal hinged casement 10-light window, with a re-used timber lintel containing many peg holes. The north-west elevation has an attached board and battens. A timber rail runs along the top supporting floorboards. There is a small aperture on the south-west side with a stone lintel, which is blocked with brick. In the centre of the elevation is another larger aperture, blocked with brick. It has a chamfered timber surround and a timber beam on the top of the wall acts as a lintel. Below a channel has been cut into the wall to house an iron pipe, the remains of which survive (Plate 29).

Plate 29: (left) Blocked window with iron pipe and brick base below in north-west elevation of lower floor Room 5

Plate 30: (right) Timber partition forming the north-west elevation of upper floor Room 1

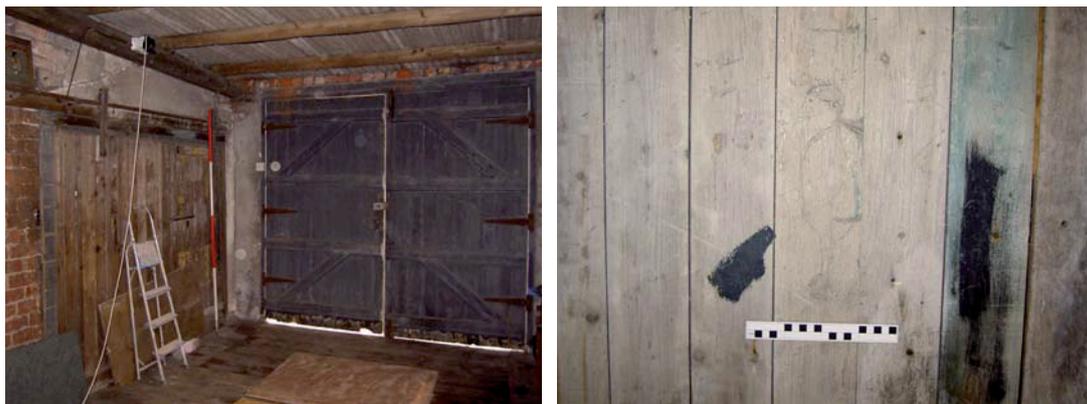
Plate 31: (left) Doors in the north corner of upper floor Room 3

Plate 32: (right) Graffiti on door in the south-east elevation of upper floor Room 4

4.3.10 Upper floor, Room 4: this floor comprises timber boards and a monopitch corrugated concrete ceiling. The ceiling is supported by seven telegraph poles orientated south-east/north-west. The south-east, north-west, and north-east walls are built of brick, and the south-west wall is of stone. The north-east elevation is taken up by a large garage door of beaded tongue and groove planks and run out stop chamfered battens, with a timber lintel. The north-west elevation is of painted brick, in a stretcher bond. There is a small aperture north-east of centre, with a timber lintel. There is a pillar in the centre of the elevation supporting one of the beams. The south-west elevation is of stone, with a central window with a slate sill and a re-used timber lintel. The elevation also has many regular holes and slots. The south-east elevation has a central buttress or chimneybreast, the south-west side of which is stepped. To the north-east of this is a wide aperture, with a moulded surround, a roll-moulded sill, approximately 0.75m above the floor level, and a plank door. The door displays some graffiti, including a cartoon of a man, which appears to be entitled 'Workman'. The figure is depicted with a speech bubble containing the caption 'workers [??] time you [??] on. No?' (Plate 32).

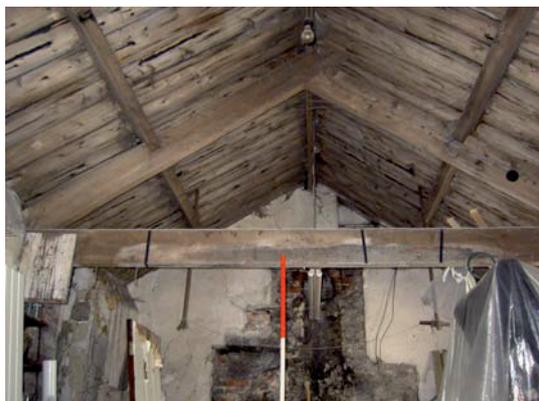
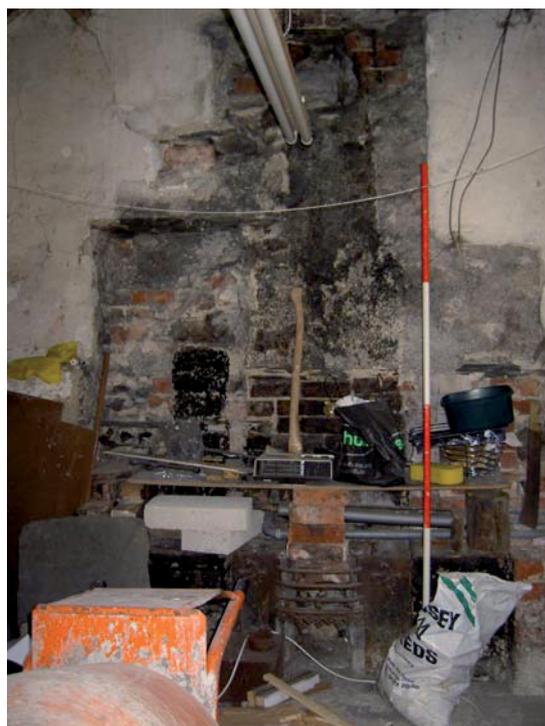
4.3.11 Detached building, Room 5: the floor of this room comprises stone flags. The ceiling is open to the gabled roof and has a single truss in the centre of a basic tie beam type, with principals overlapping at the top and lap jointed together (Plate 33). There is plank sarking fixed to the battens, and the walls are finished with plaster and whitewash. The north-east elevation has a window on the north-west side. This has is a 14-light fixed casement, with a slight pillar to the south-east supporting the truss. Another pillar south-east of this forms the side of a doorway, the door of which is constructed from beaded tongue and groove planks and battens. A timber runs along the top of the wall, forming the lintel for both door and window and the wall plate. The south-east elevation has a double door on the south-west side. This has been inserted or widened, with concrete around the jambs. The lintel is iron and the double doors are tongue and groove plank and batten, with six over lights in each. The south-west elevation is plain apart from a window on the north-west side. This is blocked with brick, forming an alcove. The north-west elevation has a low wide fireplace with a re-used, perhaps Georgian hob grate. There is a scar of a larger hearth evident on the same basic plan, but evidently reduced to its current height. Above is a hole for the flue, now blocked with brick, and a possible alcove (Plate 34). An aperture above and to the north-east of the circular flue hole has been filled with concrete. There are shelves topped with timber, which evidently originally formed part of the original hearth, either side of the scar.

Plate 33: (left) Truss in the detached building (upper floor Room 5)

Plate 34: (right) Scar of a hearth in the north-west elevation of the detached building (upper floor Room 5)
