BARN AT SLACKWOOD FARM, SILVERDALE, LANCASHIRE

Archaeological Building Recording

Client: Adrian Waddingham

Planning ref.:
09/00367/CU, 09/00368/LB

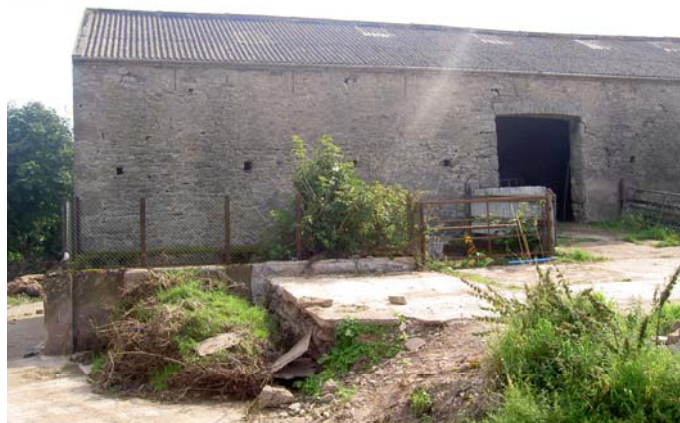
Plate 6 (left): East end of the north elevation

4.2.2 **North elevation:** due to the addition of the bank along most of this side of the barn, the visible part of this elevation only comprised the upper floor level which corresponded to Room 7 (Plate 6) and Room 6, which obscured the west part of Room 7 (Plate 7) - the original barn (see Figure 2). It would appear that the only part of this elevation that was not banked was the east end; however, the lower level of this end of the elevation had been subsequently obscured by a concrete slurry tank (Plate 6). The main feature of the north elevation was the central wagon door which had a flattened limestone arch and limestone quoins. This doorway could only have been added after the bank was added to this side of the barn, and, due to its height, after the walls had been heightened; cracks occurring around the west side of the doorway and some modern re-pointing to the jambs further suggesting that it was not an original feature of the building. To the east of the doorway there was a row of four square vents half way up the wall which would originally have been close to the original wall top; higher level vents had also been incorporated into the added upper section of wall of which two were still visible externally. The majority of the elevation to the west side of the doorway had been hidden behind the relatively recent addition of a shippon (Room 6). A fenced and gated enclosure had been added to the east of the shippon and this explained the concrete skin on the wall of the barn between the wagon doorway and the shippon. One of the lower level vents was evident just above this concrete skin; the rest had evidently been hidden behind the shippon.

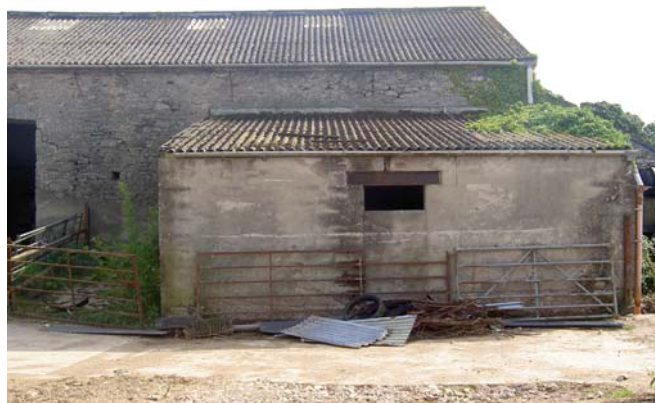
Plate 7 (right): Room 6 at the west end of the north elevation

4.2.3 **Shippon:** this building (Room 6) was constructed from concrete blocks that had been rendered with cement on the east and north elevations. The mono-pitch roof was clad in corrugated asbestos which suggests that the re-roofing of the main barn and the construction of this outshut were roughly contemporary. The eastern elevation of this building housed a tall and wide central doorway with a modern timber lintel, otherwise it was entirely plain. The north elevation housed a tall pedestrian width doorway that had been blocked up most of the way to form a small window at the top (Plate 7). The blocking had been completed with concrete blocks and rendered with cement in keeping with the rest of the elevation. There was a lintel over the doorway that was constructed from a small length of steel 'I'-beam. The west elevation contained a single pedestrian doorway; a concrete step had to be climbed to permit access to Room 6, which suggests that, along with its width, it was for human use only.

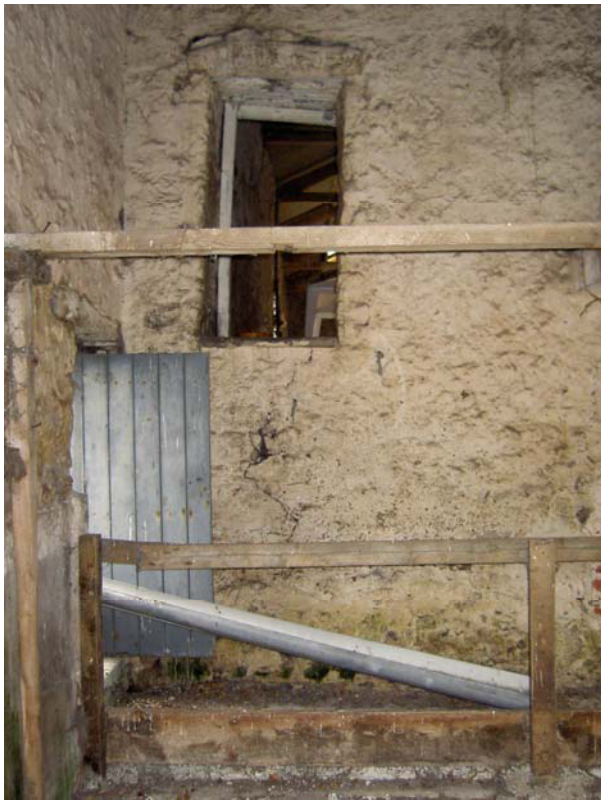
Plate 8 (left): Original access to the upper floor in the west elevation of the main barn

4.2.4 West elevation: this elevation was largely hidden behind an outshut (see Figure 3), but its original features were clear from within that building (Room 5). There was a pedestrian doorway at the north end of the west elevation of the main barn, which accessed the upper floor (Room 7) and was over 2m above the floor of Room 5 (Plate 8). The height of this door suggests that the addition of the east outshut had involved the removal of a natural bank at this end of the barn. It was evident from the ground level on the exterior north and west sides of Room 5 that it had been sunk below ground level, presumably so cattle could access it from the farmyard to the south. The doorway into Room 7 had an irregularly shaped, roughly squared oak lintel that was hand finished and appeared to be original, and a plank and batten door was still attached to the timber doorframe. In the central section of this elevation there was a roughly square pitching door; this was originally located just under the original gable apex before the wall height of the barn was raised. This pitching door was now crammed in just under the mono-pitch roofline of the added shippon (Plate 9), its timber plank door had been sawn horizontally so the lower half still opened outwards, and this suggests that Room 7 was still in use as a hayloft when the shippon was added. Approximately below the pitching door there was an inserted pedestrian door through which access to Room 4 could be gained. The jambs of the doorway were constructed from red bricks and these had also been used to partly block the doorway to within 0.20m of the top. The remaining part of this elevation was plain excepting the whitewashed render that had been added when it became an internal wall; the rebuild around the inserted half-truss timbers was also clearly evident. The top of this gable end elevation was visible over the roofline of Room 5; this part was entirely plain and noticeably lacked an owl hole in its original and raised phases.

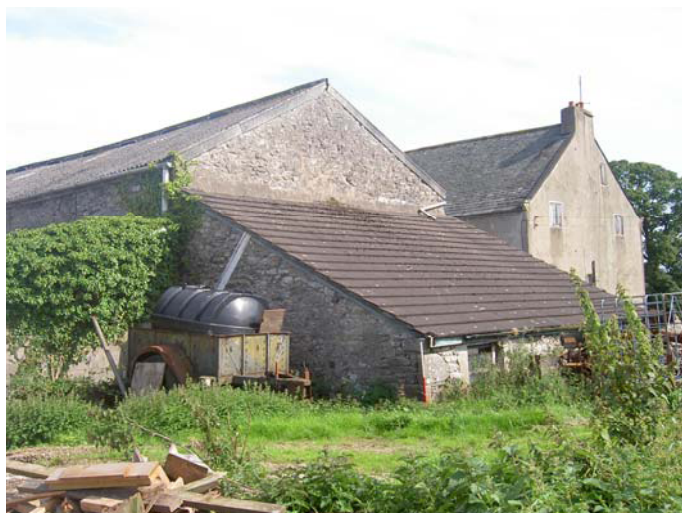
Plate 10 (left): Lean to shippon, Room 5, from the north-west

4.2.5 **Shippon:** this shippon (Room 5) was constructed from limestone rubble and had been re-roofed with modern composite tiles and plastic guttering. The north elevation was largely buried beneath a bank which represented the original ground surface in this area. A passage had been cut through the bank at the east end of this elevation to facilitate pedestrian access from the north side of the main barn; this passage sloped downwards to the south. The passage was formed by the west wall of Room 6 and a concrete block wall revetted the bank on the west side. This doorway accessed the feeding passage of the shippon on the east side and was clearly intended for human use only. The elevation was otherwise plain. The west elevation was once again largely buried and the only features were two inserted windows that flanked a single original square window that had been blocked with red bricks. The inserted windows were identical and the red bricks that formed the jambs suggested that they were added when the smaller original window was blocked up. The inserted windows had concrete sills and simple timber frames which loosely held a single pane of glass; it would appear that initially they held an inward opening top ventilator over a lower single fixed pane. The south elevation of the shippon had two doorways: the eastern doorway allowing access into the feeding passage which led out through the single doorway on the north side of the room; the west doorway allowed the cattle into their stalls at the west side of the shippon. Both doorways were original and had limestone lintels and quoins, quoins on the west end of Room 4 clearly illustrated that this shippon (Room 5) was a later addition to the original barn. The only other feature on this elevation was a narrow slot vent which was located above and slightly to the west of the eastern doorway.

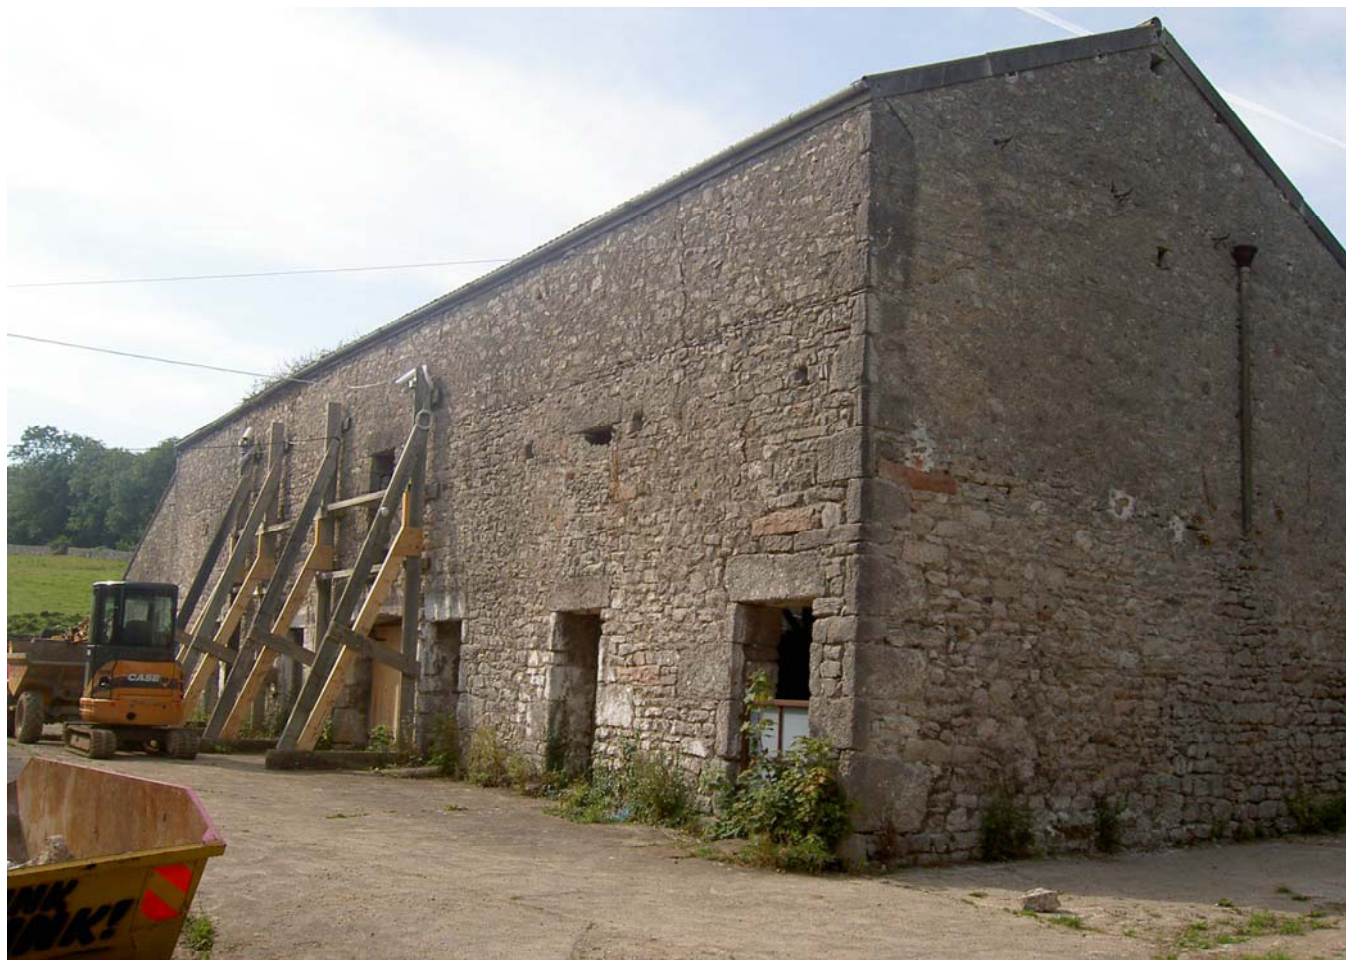
Plate 12: South elevation, from the east end

4.2.6 **South elevation:** this elevation fronted the farmyard and was two floors in height along its entire length (Figure 2). This elevation is described in sections that relate to the individual rooms that comprise the ground floor, starting from the west end at the junction with the shippon (Room 5), which was described in Section 4.2.5. The upper floor area (Room 7) will be described in conjunction with its ground floor counterpart.

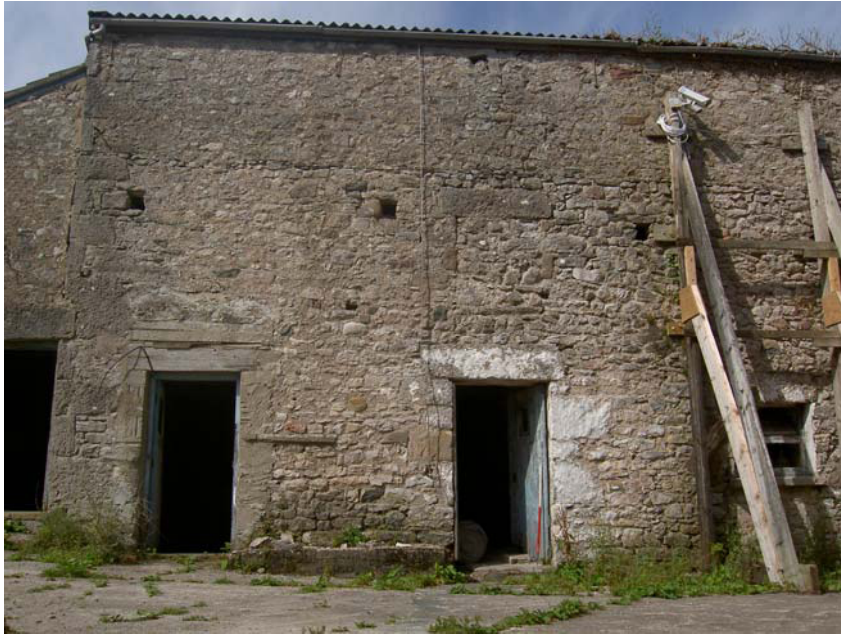
Plate 13 (left): West end of the south elevation with blocked pitching door over Room 4/4a

4.2.7 Room 4 had two doorways; the west one had clearly been inserted when the concrete block subdivision (Room 4a) was created (Plate 13). This doorway had cement render around the jambs, there was a square cut timber lintel over the door and a concrete lintel above that. The eastern doorway was original with whitewashed limestone quoins and lintel; over the doorway there was a blocked pitching door that would have allowed hay to have been passed into the loft above (Room 7). The pitching door was flanked by square vents (the east of which was over Room 3) and there was one at the west end of this section of the elevation; these were part of the original (lower) barn construction. As with all the external elevations the junction where the original wall was raised was clearly evident.

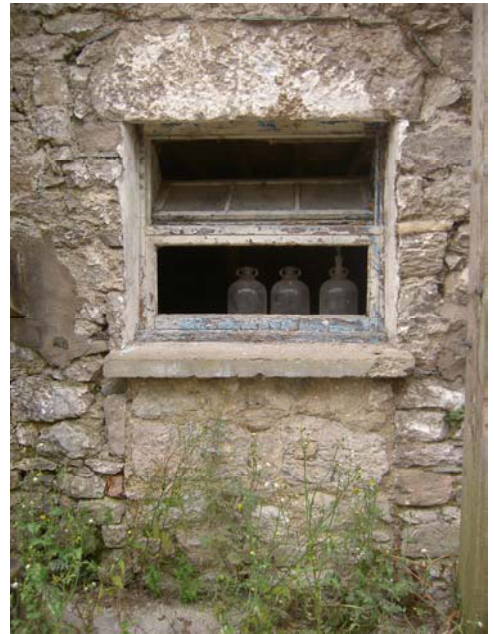
Plate 14 (right): Blocked doorway, Room 3

4.2.8 Room 3 was immediately to the east of Rooms 4 and 4a and had two doorways; the west one had been inserted and then partially blocked at a later date to form a window. It appeared from the timber casement of the window that the doorway had been inserted then converted to a window quite early on; the lack of quoins in the lower part of the doorway showed it was not original (Plate 14). The timber casement held a three-light inward opening top ventilator which was guided between timber fan-shaped guides to a wooden stop, below this was a single lower fixed light. The eastern door was in close proximity to the one just described and had whitewashed quoins; both doorways had whitewashed limestone lintels.

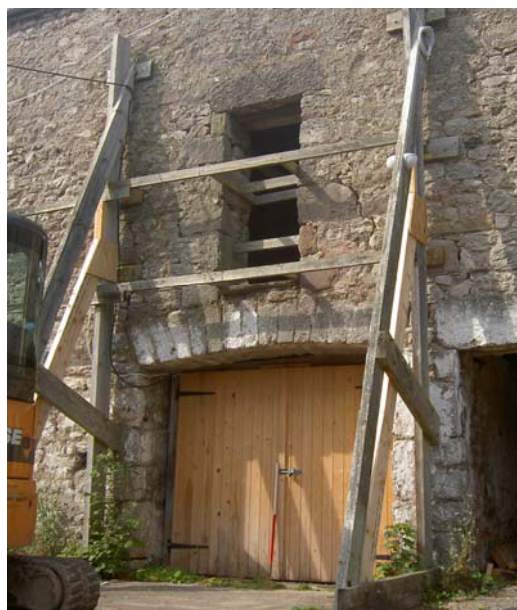
Plate 15 (left): Wagon doorway of Room 2 under an inserted winnowing door of Room 7

4.2.9 Room 2 was approximately in the centre of the barn and had a wide arched wagon doorway that was almost as wide as the interior space. Immediately above the doorway there was a pedestrian sized doorway that accessed Room 7, which appeared to have been inserted or at least substantially enlarged despite its limestone quoins and lintel (Plate 15). This is indicated by the way that the lintel for this aperture was higher than the roofline of the original barn; its sill was also below those of the pitching doors to the east and west. The wagon door had been fitted with modern plank and batten doors.

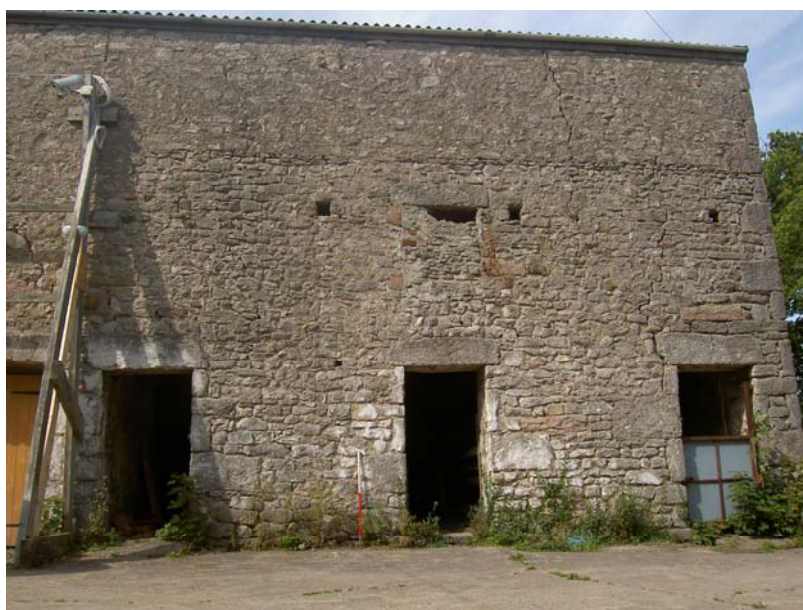
Plate 16 (right): shippon, Room 1

4.2.10 Room 1 was the largest ground floor room and was evidently designed as a shippon; there were three original ground floor doorways spaced evenly along the elevation with a pitching door over the central one (Plate 16). Each doorway had substantial quoins and a limestone lintel; the central doorway gave access to the feeding passage and was flanked by doors that gave cattle access to their stalls. The upper pitching door had rudimentary quoins which were a mixture of limestone and red sandstone; an iron hook affixed to a quoin on the east side would have related to a timber door. The pitching door had largely been blocked with limestone rubble and the occasional brick, though a small irregular aperture

still existed at the top. There were square slot vents on either side of the pitching door and a further one close to the east end of the barn.

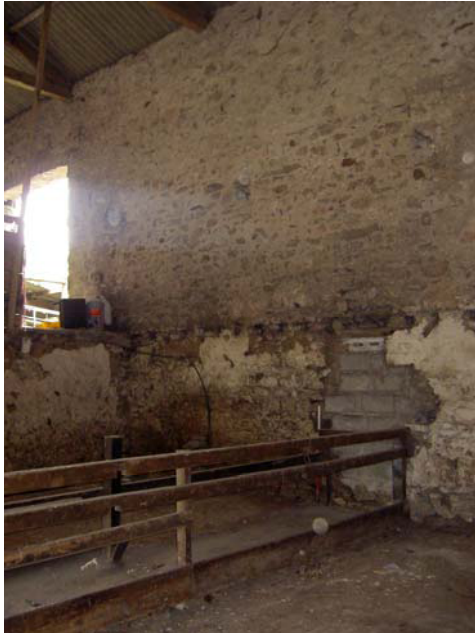
Plate 17 (left): Room 1, from the south-east

4.3.1 **Room 1:** each of the four elevations were rendered and whitewashed in keeping with the use of this space as a shippon. The arrangement of the shippon was evident on the floor with two parallel post and rail fences partitioning the central feeding passage from the stalls at the east and west ends. At least one of these rails was constructed from a re-used timber beam, with joist slots that had been numbered. The stall areas and the feeding passage were cobbled; the dung channel and slight plinth on either side had been concreted. This was the only lower floor room where the ceiling had been removed. Three beam slots were evident in the east elevation, and the sawn beam ends were evident in the partition wall at the west side of the room. The joist slots in the north and south elevations still contained sawn, squared, softwood timbers that appeared to be 19th or 20th century in date.

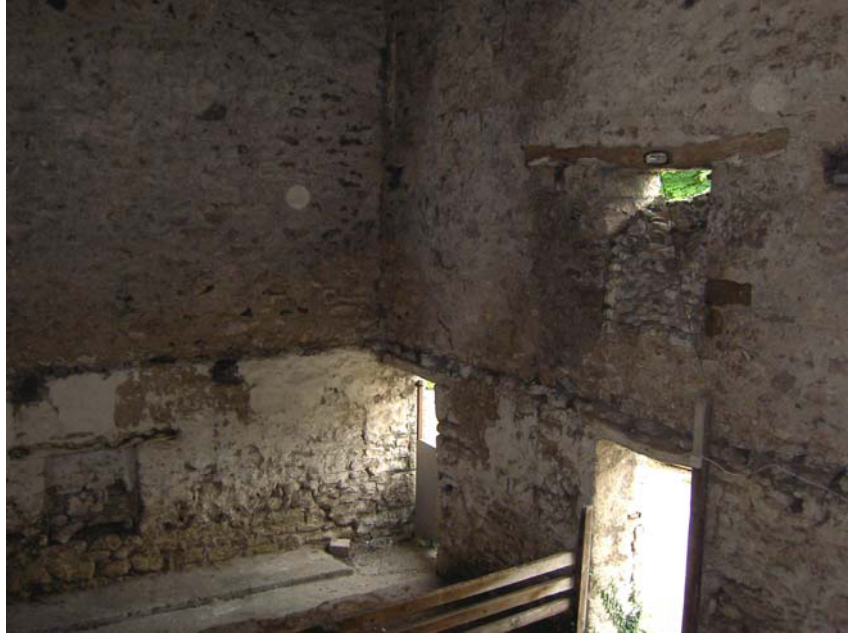
Plate 18 (right): Room 1, from the north-west

4.3.3 The east elevation was plain except for a central alcove in the wall which had a whitewashed oak timber lintel (Plate 18). It seems possible that this was a part blocked window as its location seemed to correspond to a slab of stone in the exterior wall, but there was no other evidence on the exterior for a blocked window or quoins, so it seems probable that this feature was a purpose built alcove. A second owl hole had been added when the wall height was raised, suggesting that hay or other crops had subsequently been piled up at this end of the barn, and that it would have had an upper floor at this time.

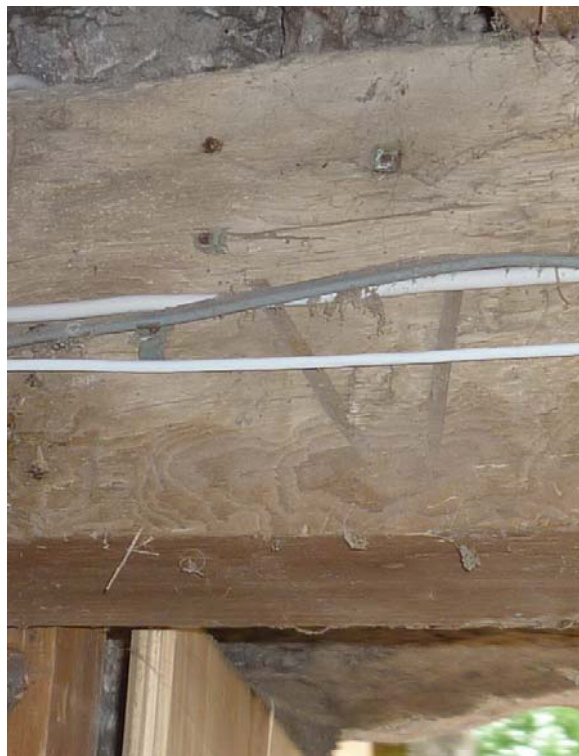
Plate 19 (left): South beam of Room 2

4.3.6 **Room 2:** this room was accessed through the wagon doorway and comprised a narrow space with a compacted earthen floor, which might have overlain an earlier cobbled surface. There was a square of concrete in the centre of the floor, as well as a concrete base in the south-west corner. The ceiling comprised three east/west beams supporting modern narrow softwood boards. The ceiling beams were modern square cut softwood timbers as were the joists, the most southerly of the three beams had two 'v'-shaped markings at the east end (see Plate 19). The room was being used for storage purposes at the time of the study; it would have presumably originally formed a cart shed.

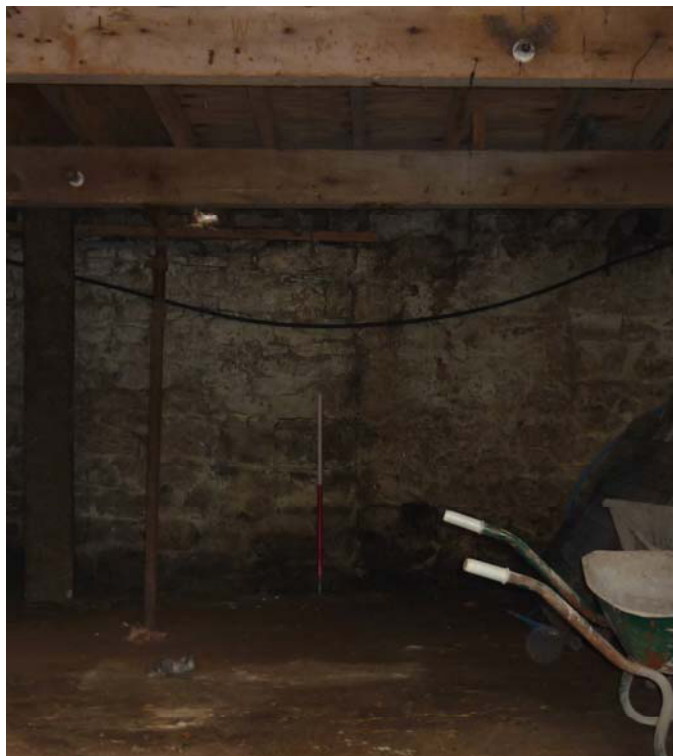
Plate 20 (right): Blocked pedestrian doorway in the north elevation of Room 2

4.3.7 The north elevation was plain except for a blocked pedestrian doorway (Plate 20); this would have been rendered obsolete when the bank was added to the north side of the barn. It would appear that the ceiling had been inserted in this part of the barn, or at least altered, as the lintel over this blocked door must have been removed to allow the joist sockets for the floor above.

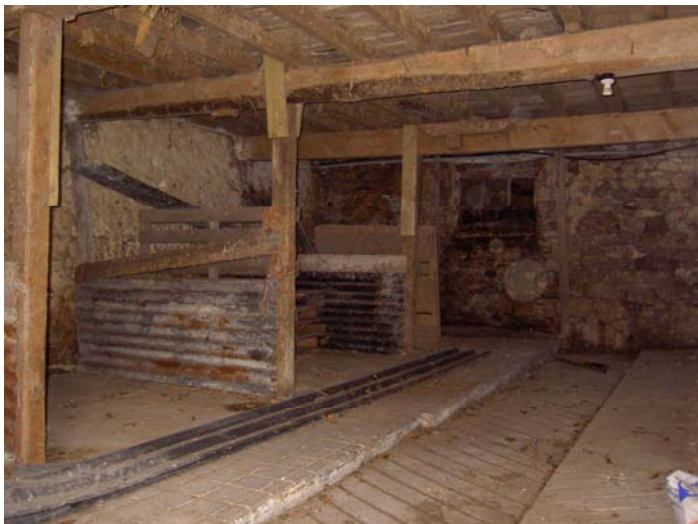
Plate 21 (left): Interior of Room 3 from the south

4.3.12 The north elevation was whitewashed and rendered and plain except for a window that was located slightly nearer to the west end (Plate 21). The loose earth bank created to the rear of the barn could be seen through the window; the timber casement was still in the window and contained three square lights set over a single lower light.

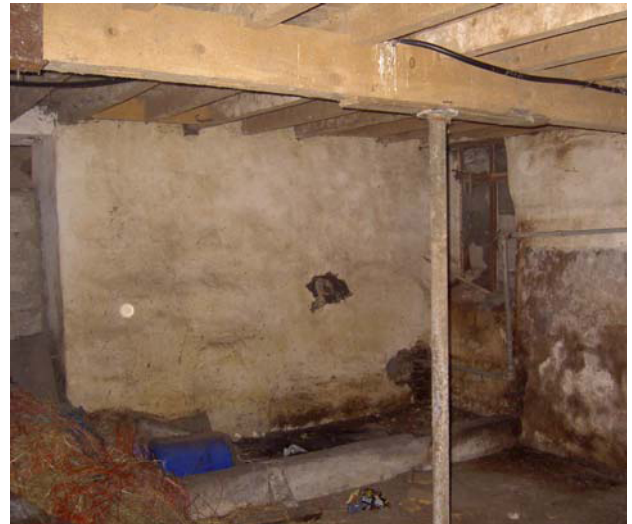
Plate 22 (right): North-west corner of Room 4

4.3.16 **Room 4/4a:** the south-west corner of Room 4 had been sub divided by the addition of a concrete block wall, this sub-division (4a) had apparently put Room 4 out of use. Room 4a was entirely coated in a concrete skin; there was a triangular shaped ledge in the north-west corner of the room and three block plinths in the north-east corner that looked like supports for shelves. There was a single north/south steel 'I'-beam that which was clad in plasterboard like the rest of the ceiling. The 'I'-beam rested on the north block wall, where it was attached to a timber beam that spanned the rest of Room 4 before keying into the north elevation. All the ceiling timbers for Room 4 were modern machine sawn softwood, and the beam was assisted by a central steel column (Plate 22). The floor of this room was concreted and had a central dung channel running north/south with concrete trough bases along the west wall; no stalls were evident however.

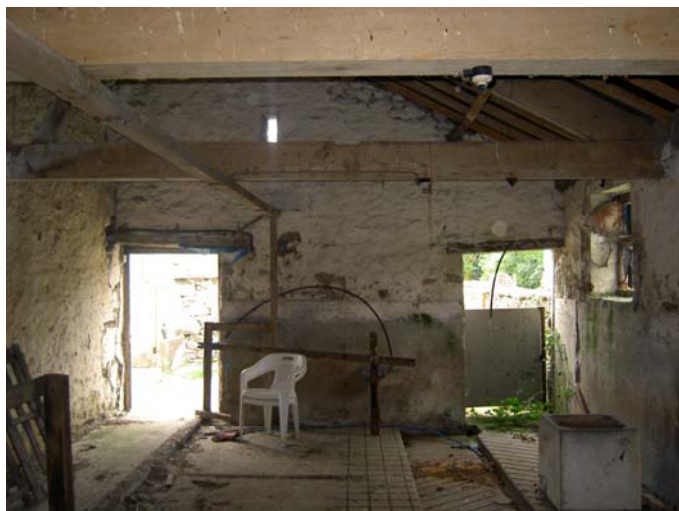
Plate 23 (left): Room 5 from the north

4.3.21 **Room 5:** this shippon was the only addition to the main east/west barn range; the feeding passage ran along the east side of the room, with the dung channel on the west side behind the stalls. The north, west and south elevations had a concrete skin up to a height of approximately 1.50m, above which height they were whitewashed. The floor was constructed from grooved concrete and the stall partitions were visible as scars within this concrete. The freestanding post and rail fence that held the stall partitions was still standing at the north end of the room and was constructed from modern softwood timbers; it is probable that this replaced an earlier stall arrangement when the floor was concreted. The roof timbers comprise two mono-trusses with a single angled brace (Plate 23); these are keyed into the west wall of Room 5 and the exterior side of the original barn at the east end. The presence of Baltic timber marks on the purlins suggests a 19th century date for this addition (Plate 24); the principle rafters also bore some timber marks. The rafters and roof cladding had evidently been replaced quite recently, and they were separated by felt. The east elevation of this room has previously been described as the exterior west elevation of the main barn (see *section 4.2.4*). The features on the north, east and south elevations have also been adequately described in *section 4.2.5*, which pertains to the exterior of this building.

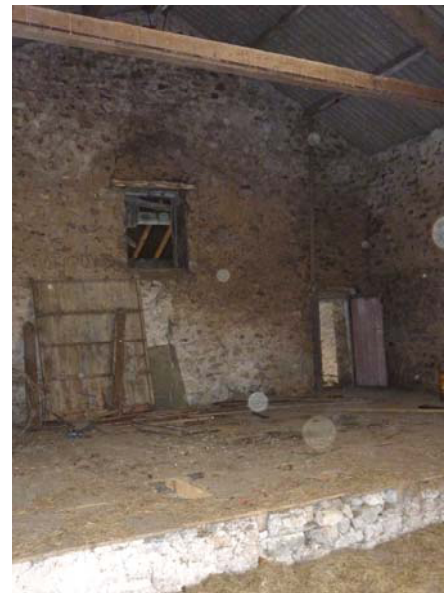
Plate 26 (right): West end of loft/Room 7

4.4.1 The upper floor was a single undivided space, the flooring was missing at the east end and a low partition/fencing had been added to screen this area off for safety reasons. A winnowing door had been inserted in the south elevation below a timber lintel (Plate 25). The floorboards were a mixture of widths, and it is thought that the more frequent narrow boards represented repair work. At the west end of the room there was a raised area that was 0.45m higher than the main floor level (Plate 26); this allowed the underlying room (4/4a) to be of a sufficient height despite being further up the slope than the rooms to the east. The roof timbers comprised six tie-beam trusses with two purlins per pitch supporting corrugated asbestos sheets. These sawn softwood timbers were probably contemporary with the raising of the barn walls and the addition of the outshut (Room 5), which would suggest that they are 19th century in date and imported from the Baltic regions. Some hand finishing/trimming by axe was evident on the faces of some of these timbers that were slightly scalloped in places. The principle rafters of the trusses were soffitted and these joints were braced by additional timbers on the outer faces (see Figure 3). It seems likely that the braces were related to the addition of the asbestos sheets which required two ridge purlins which would have replaced the single original purlin.
