143 SALTHOUSE ROAD, BARROW-IN-FURNESS, CUMBRIA

Archaeological Building Recording

Client: Anne Martin

Planning ref.: 175/2004/0725

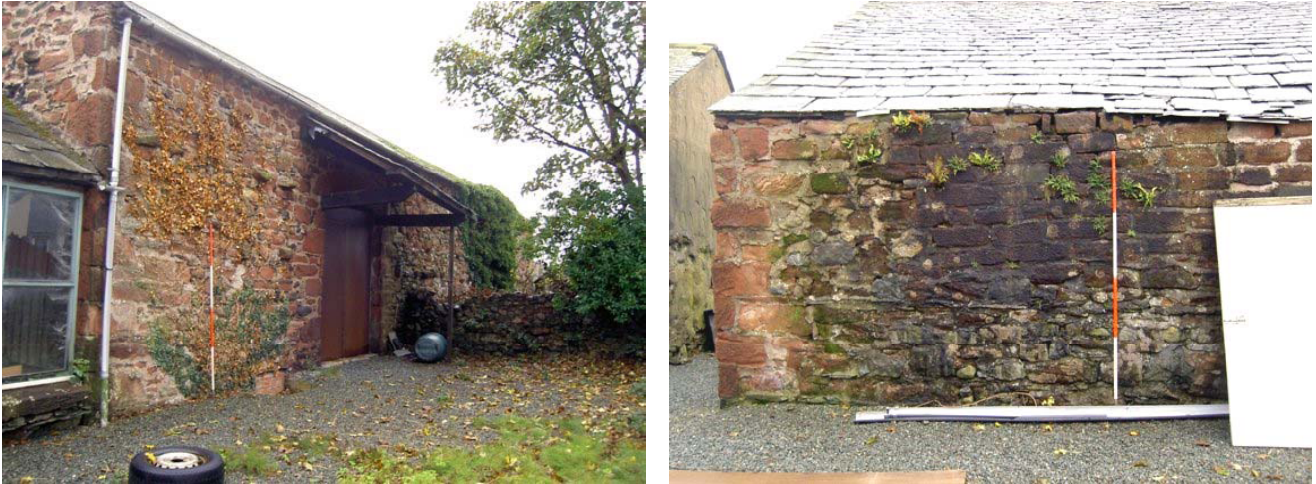
4.3.1 **West elevation:** it was not possible to fully access the south end of this elevation as it was adjoined by a neighbouring garden but it clearly contained many of the features evident elsewhere in the building such as rows of square ventilation slots and through stones. There is a large wagon doorway towards the north end with a neatly finished flat voussoir arch and large quoins, covered by a monopitch slate canopy (Plate 7). The canopy is supported by horizontal beams and a single post on the south

side. To the north of the wagon doorway there is a low level aperture, which is evidently inserted and extends below the ground level on this side. It has a thin iron bar forming its lintel, brick in the jambs, and has been blocked with modern red brick. The extension to the north has a large four-light window with a modern casement. This was evidently originally a large doorway, which has been partially blocked at the bottom and had a large sill inserted to make a window. The rest of the north extension is plain, although a large section is constructed, perhaps rebuilt or repaired, from re-used neatly dressed blocks and some pieces of grey slate (Plate 8). The north-west corner is finished with roughly dressed large quoins.

Plate 7: (left) The wagon doorway in the west elevation

Plate 8: (right) The re-used stonework in the west elevation of the north extension

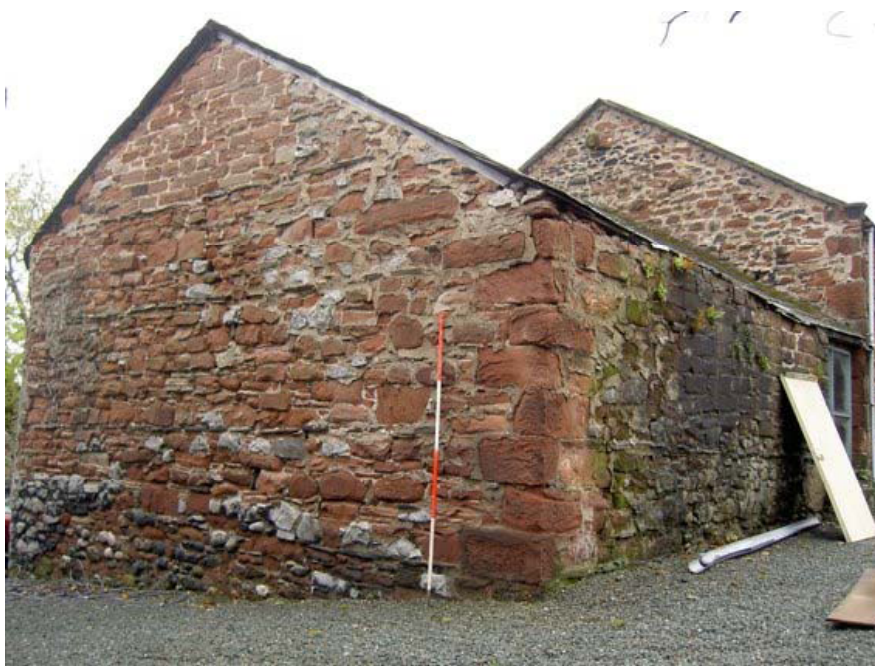
4.3.2 **North elevation:** the lower part of the original north external elevation of the barn is covered by the gable end of the northern extension (Plate 9). The gable end of the north extension is constructed from a mix of materials, mainly sandstone and limestone blocks and some water worn volcanic pebbles, with levelling courses of slate, and a large area rebuilt in re-used dressed blocks below the apex. The west end is finished with quoins while the east corner is curved. Above this the upper part of the barn's original north elevation is visible; it is finished with neat sandstone coping supported by squared kneelers at each end, with quoins below. There is a square owl hole near the apex, which has been blocked with brick.

Plate 9: The north elevations

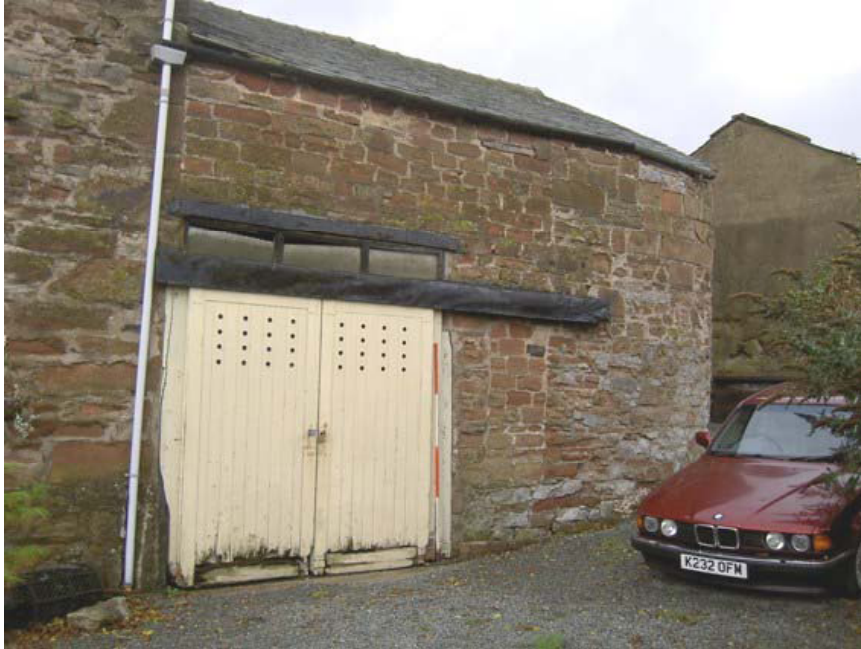
4.3.3 **East elevation:** this forms the main front of the barn, with the lower extension at the north end (Plate 10). The lower part of the extension is constructed from a mixture of limestone and sandstone, while the upper part is constructed from a mixture of re-used dressed sandstone blocks. It has a large doorway on its south side with a sliding plank door with a brick-lined channel for housing it on the north side. Above the doorway is a fixed casement three-light window with a timber lintel, and the door is perforated by numerous ventilation holes. There is a window to the north of the doorway which has been blocked with more re-used dressed sandstone, above which is a butt-joint suggesting that the upper part also originally had a window or has been extensively rebuilt.

Plate 10: The east elevation of the north extension

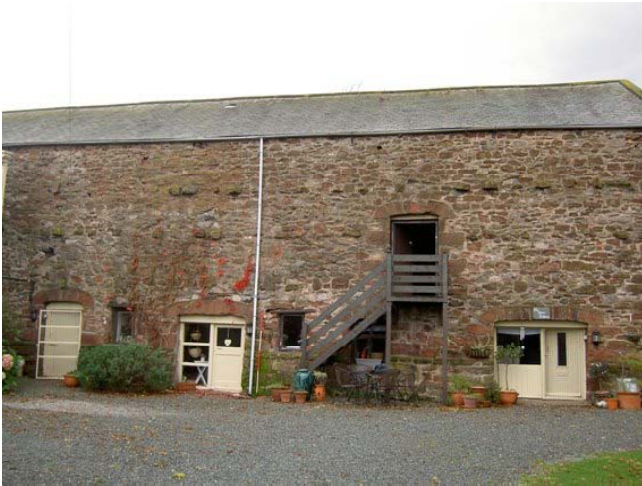
4.3.4 The main barn, which forms the majority of the elevation, has two wide doorways and two pedestrian doorways on the ground floor, with another former doorway having been partially blocked to form a window (Plate 11 and Plate 12). All of these have neatly finished voussoir arches and rougher dressed quoins and house modern timber casements, either hinged or fixed, and doors. In addition, there are two small windows, perhaps inserted, with narrow timber lintels and modern fixed timber casements. A slightly angled plinth runs the full length of the elevation, although it is cut by the doorways, and there is a re-used piece of engaged column(?) built into the wall above the second doorway from the south (Plate 13 and Plate 14). A metal pipe has been inserted through the wall at the far south end, and the concrete used to hold it in place is scored with the date '1966'. The upper floor level has at least one row of square vent slots visible, although many of these have been blocked with brick and so were difficult to identify. There is also at least one row of through stones running across the whole elevation. There is a single doorway on the north side, accessed by a modern flight of timber steps, though it was presumably originally a pitching doorway. It has a neat voussoir arch in the same style as those on the lower floor, although dressed with a scored 'herringbone' finish, which houses a modern metal door.

Plate 11: (left) The north end and centre of the east elevation of the main barn

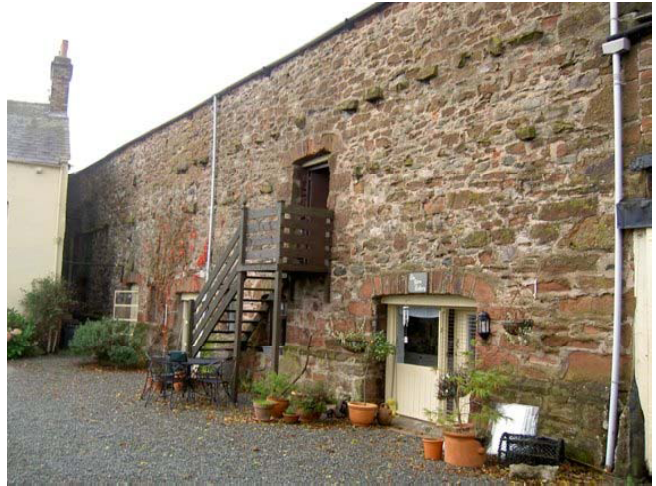
Plate 12: (right) The south end and centre of the east elevation of the main barn

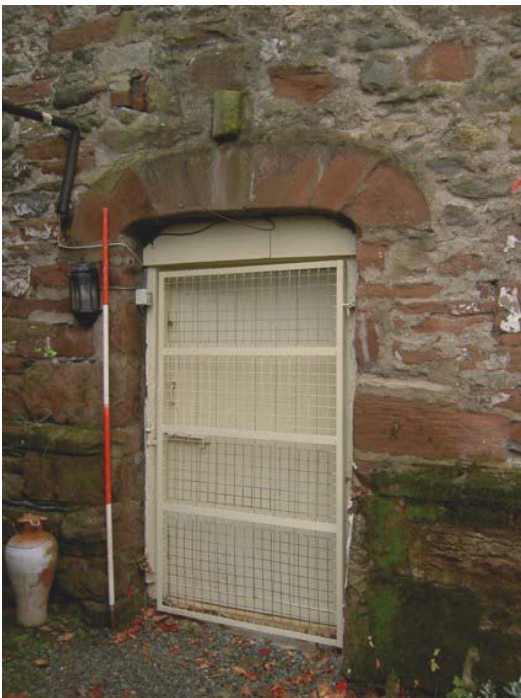
Plate 13: (left) Doorway on the south side of east elevation with re-used column fragment above

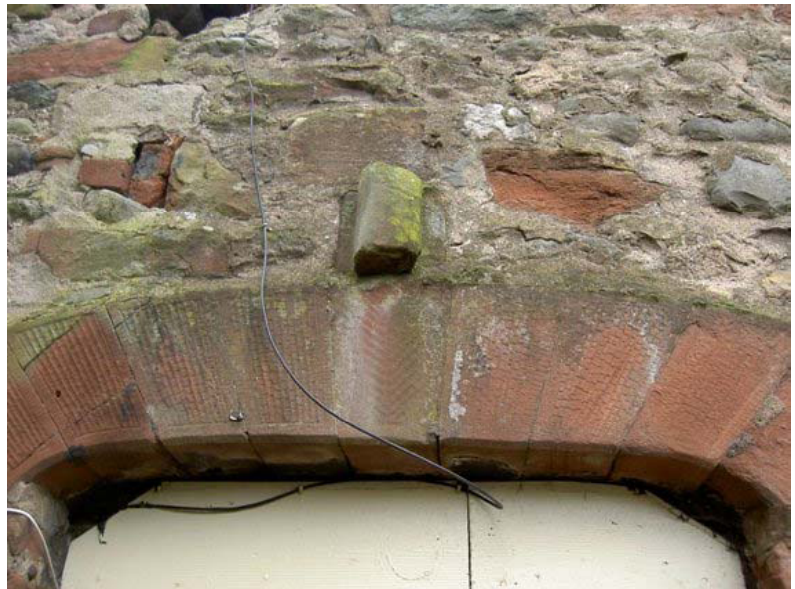
Plate 14: (right) Detail of re-used column fragment

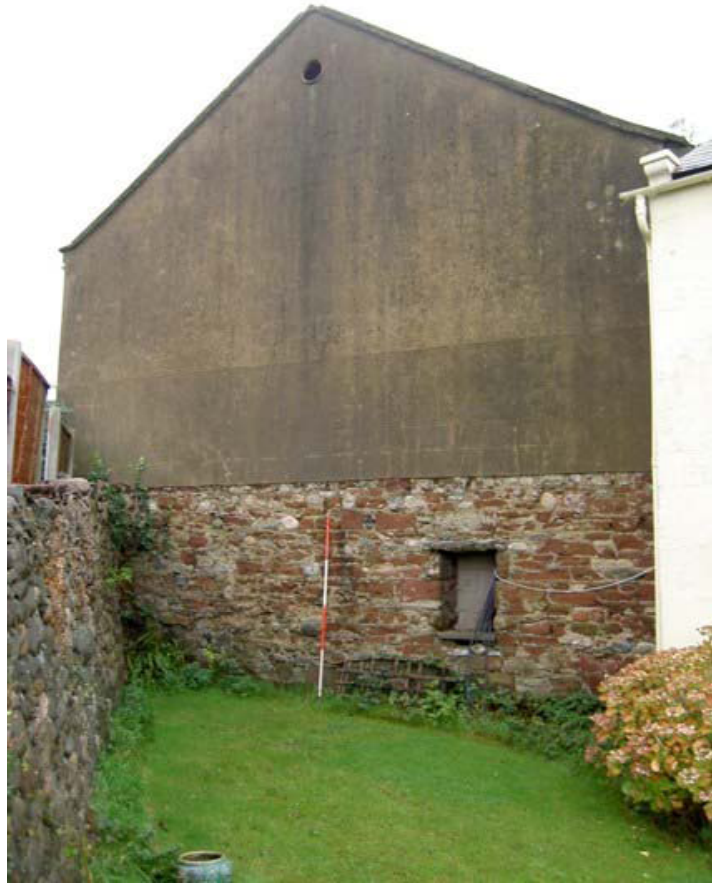
4.3.5 South elevation: this is relatively plain; the upper part has been covered with concrete render, which is scored to give the appearance of ashlar blocks. An owl hole is evident, however, which has been lined with a red earthenware pancheon, which forms a circular opening. The lower part, between 2m and 2.5m above the ground, from west to east, is the original sandstone. There is a small window on the east side with a concrete sill and limestone lintel, which has been blocked internally with concrete blocks, leaving an alcove on the outside. The gable is topped with the same sandstone coping with square kneelers that is present at the north end.

Plate 15: South elevation of barn

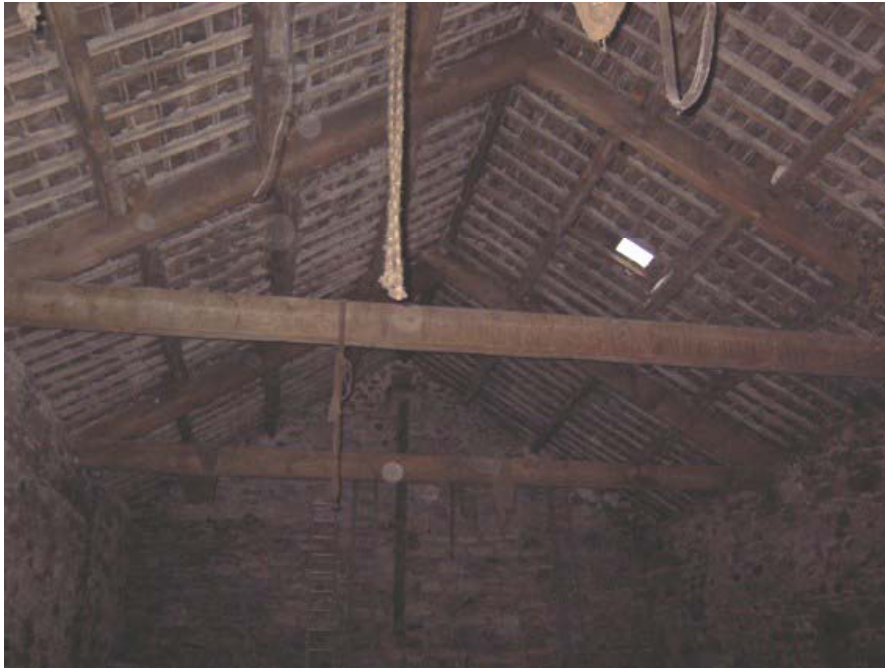
4.4.1 **Upper Floor, Barn:** this comprises a single large room, open to the roof. The walls are all exposed stone, with some patchy plaster, particularly at the north end of the east and west elevations and the north elevation. The floor is finished with sheets of chipboard, and steps up towards the south end. The roof is supported by five tie beam trusses all constructed from a neatly hand-finished and hand-sawn timber with a slight stop chamfer (Plate 16). In each case the principal rafters are joined by a simple lap-joint, the west side resting on the east; these joints are presumably held by pegs but these were not evident, nor were there any other construction marks although there were possible hewing marks on the underside of one of the tie beams. The ends of the tie beams sit on timber plates built into the east and west elevations and there are three purlins per pitch, the ends of which overlap at each truss, and a diagonally-set ridge purlin. The room is illuminated by two small two-light skylights.

Plate 16: Trusses within the upper floor

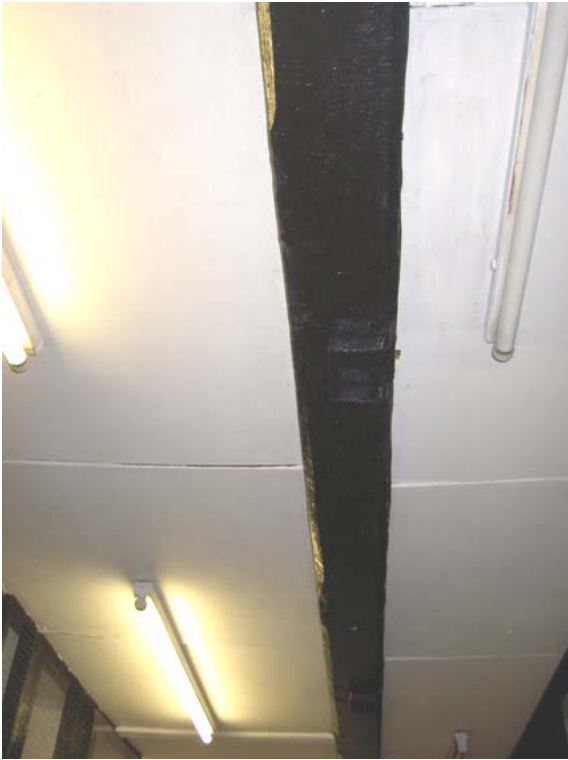
Plate 19: (left) Beam in the ceiling of Room 2, showing chamfer

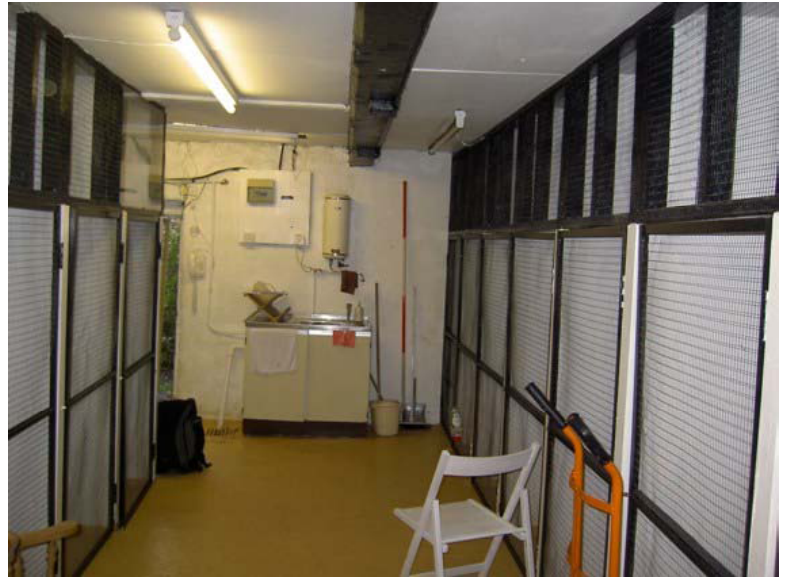
4.4.4 **Lower Floor, Barn – Room 2:** this was evidently originally a cow house that was subsequently converted for use as a cattery. It has a painted concrete floor, with a slotted drain on the east side, and a plasterboard ceiling, with a single east/west beam with stop-chamfer decoration denoting the position of original stall posts (four in total) and three looped iron brackets attached, which extend through the ceiling and presumably attach to the floor above in some fashion (Plate 19). The walls all have a modern painted finish. The north and south elevations have had modern partition walls added to form pens for the cattery, each with a window and with a mesh door at the end of the pen (Plate 20). The east elevation has a modern sink attached and a fuse box and there is a doorway on the north side with a rough timber lintel and a plank and batten door.

Plate 20: (right) General view of Room 2

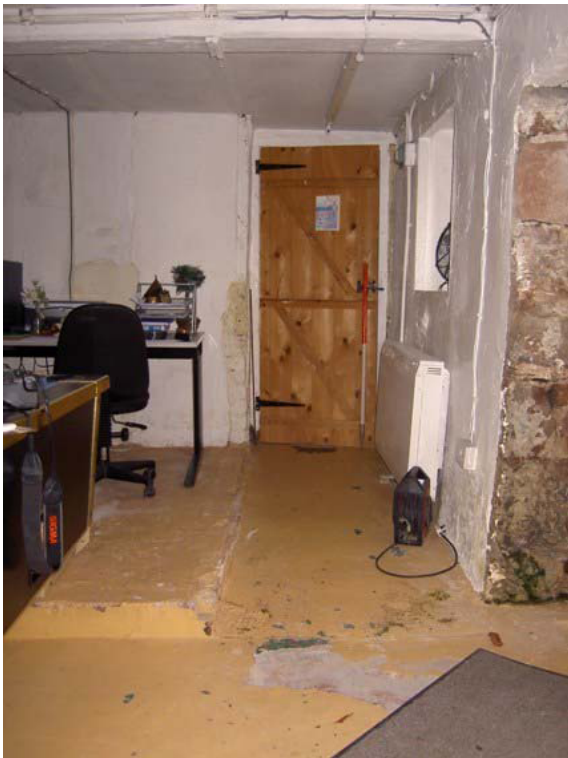
Plate 21: (left) Channel leading to the doorway in the north-east corner of Room 3

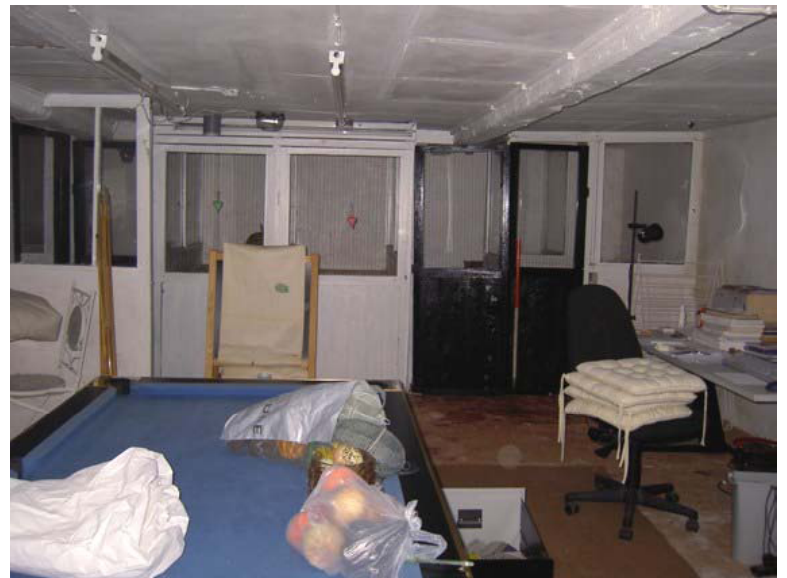
4.4.5 **Lower Floor, Barn – Room 3:** this room too was evidently originally used as a cow house and subsequently converted for use as a cattery. Similarly, it has a painted concrete floor, which is raised on the north and south sides to form a central dung channel, with a further extension of this running towards a doorway in the north-east corner (into Room 4; Plate 21). The ceiling is finished with plasterboard and has two beams orientated east/west, again finished with chamfered decoration denoting the position of original stall posts. All of the walls have a modern finish; there are inserted partitions forming pens for the cattery against the west wall (Plate 22), and scars for what were evidently originally more of these against the rest of the north and south elevations. The east elevation has two windows with slightly splayed jambs, either side of a large doorway, with a heavy timber lintel, housing a modern door and window. This lintel might have been re-used as it has a stop-chamfer decoration at the south end but not the north.

Plate 22: (right) Pens against the west elevation of Room 3

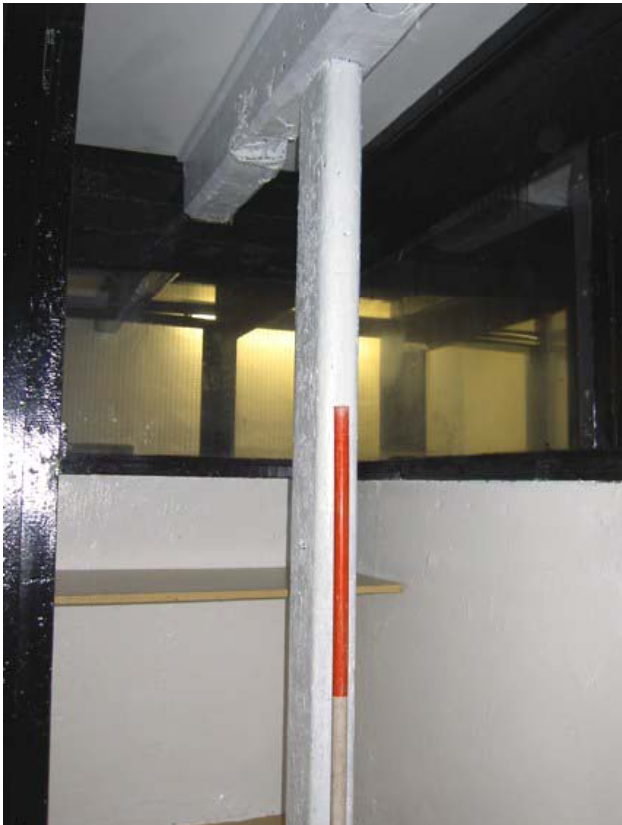
4.4.6 Lower Floor, Barn – Room 4: this has a plain, painted concrete floor. The ceiling is finished with plasterboard and has two beams orientated north/south. These are essentially plain, although they are both slightly chamfered and have a large notch cut out towards the north end; the western beam has a large post supporting it just to the north of this notch (Plate 23). The walls have an entirely modern finish throughout and there are inserted modern partitions across the centre of the room, extending from the west elevation, forming pens (Plate 24). Each wall has a single window and each pen has a mesh door. The north elevation is plain, while the east elevation has a small window and doorway, the latter with a rough timber lintel, and there is a slotted drain in the floor adjacent to it. The south elevation has a doorway towards its east end with an ovolo-moulded surround and modern timber six-panel door. The west elevation has a small high-level window at its north end, with a hinged single-light iron casement (Plate 24).

Plate 23: (left) Empty slot in beam and added post, lower floor Room 4

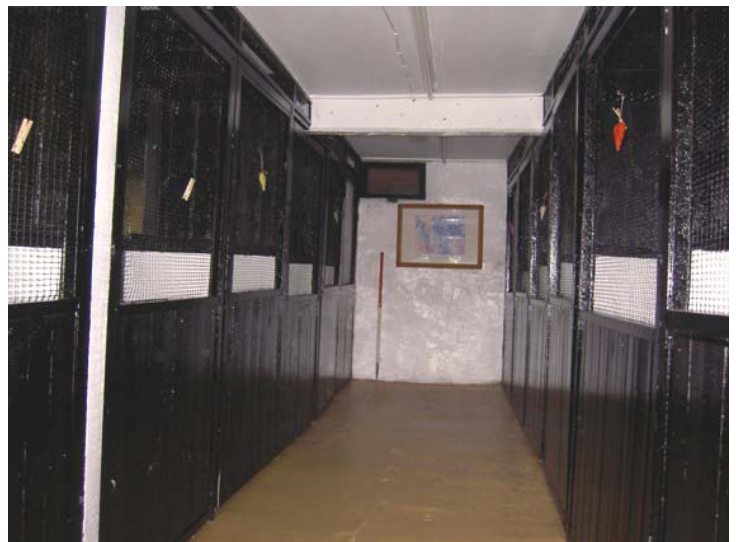
Plate 24: (right) Pens in lower floor Room 4

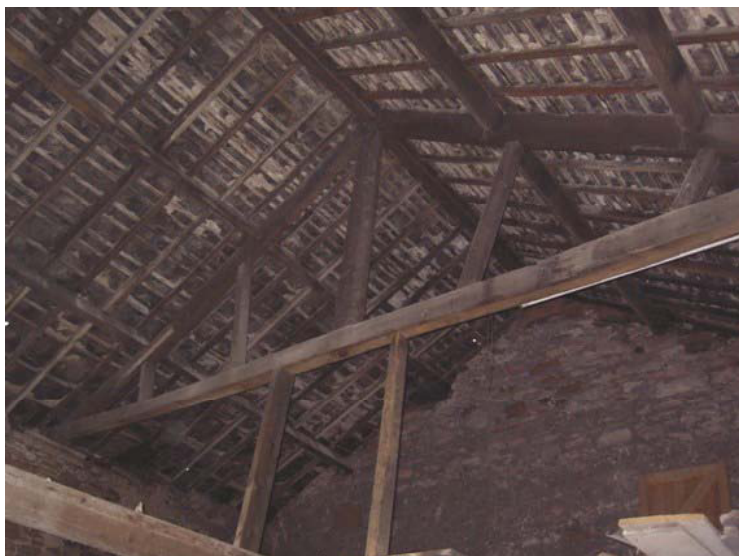
4.4.7 Northern extension: an upper floor only really exists on the north side of the room, where it is accessible via a short flight of timber steps. Its floor comprises tongue and groove boards supported by joists orientated east/west and incorporating elements of the timber superstructure relating to a former horse engine (see *Section 4.4.8* below). There is a single king post truss, which is slightly notched to accommodate the principal rafters and bolted to the tie beam (Plate 25). The truss also has two pairs of angled braces and two upright posts butt the base of the tie beam extending from the structure below, and there are Baltic timber marks on the north face of the tie beam. There are two purlins per pitch, all of which are machine cut, and a vertically set ridge purlin. The walls at this level tend to have a patchy plaster remaining. The north elevation is plain. The east elevation has been reduced in thickness above the large doorway and has clearly been rebuilt in this area. The south elevation is formed by what was the original north external elevation of the main barn, and has two visible rows of square ventilation slots, each with two slots, and at floor level in the centre of the elevation there is a square aperture with a large timber sill with sawn off projecting timbers either side. There is a doorway at the west end, which is evidently inserted as the east jamb is clearly rebuilt, which has a thin timber lintel. The west elevation has a large window on the south side, with a timber lintel.

Plate 25: (left) Truss in the north extension

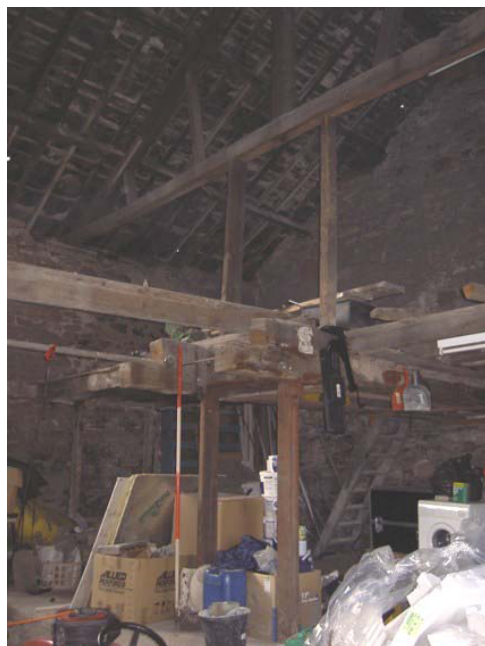
Plate 26: (right) Horse engine structure in the north extension

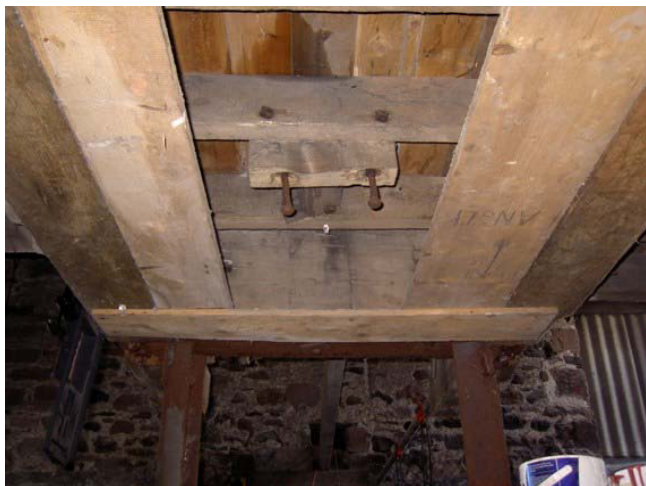
4.4.8 The ground floor of the north extension has a concrete floor, which is lower in the south-east corner to enable vehicular access. There are apparent scars in the remaining area, perhaps for fixings of some sort although some perhaps just reflect the way in which the floor was laid. The north half of the room has a ceiling formed by the partial floor above and incorporated into the centre of this is a large structure, presumably associated with a former horse engine. This comprises two heavy timber beams orientated north/south, apparently sawn off at the south end (with stubs still *in situ* in the south elevation), which are each supported by a vertical I-beam at the south end, bolted on via L-shaped brackets (Plate 26). The two timber beams each have Baltic timber marks on the underside and there are additional planks and fixings attached to the structure (Plate 27 and Plate 28). All of the walls have the patchy remains of a rough whitewash and there are timber plates forming wall plates beneath the joists and beams of the upper floor throughout. The north elevation is plain. The east elevation has a blocked window on the south side, filled with re-used dressed stone, with some evidence of rebuilding, and a large doorway with three lights over and an iron girder forming its lintel. The south elevation is relatively plain at this level, as is the west elevation although there are two upright timbers attached to the joists against it.

Plate 27: (left) The horse engine structure from below

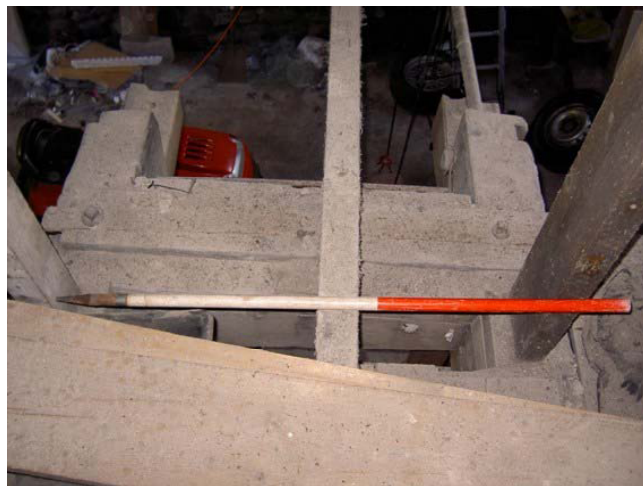
Plate 28: (right) The horse engine structure from above
