# 22 MARKET STREET, FLOOKBURGH, GRANGE-OVER-SANDS, CUMBRIA

## Archaeological Building Recording

Client: Bryan Hill

Planning ref.: SL/2009/0104

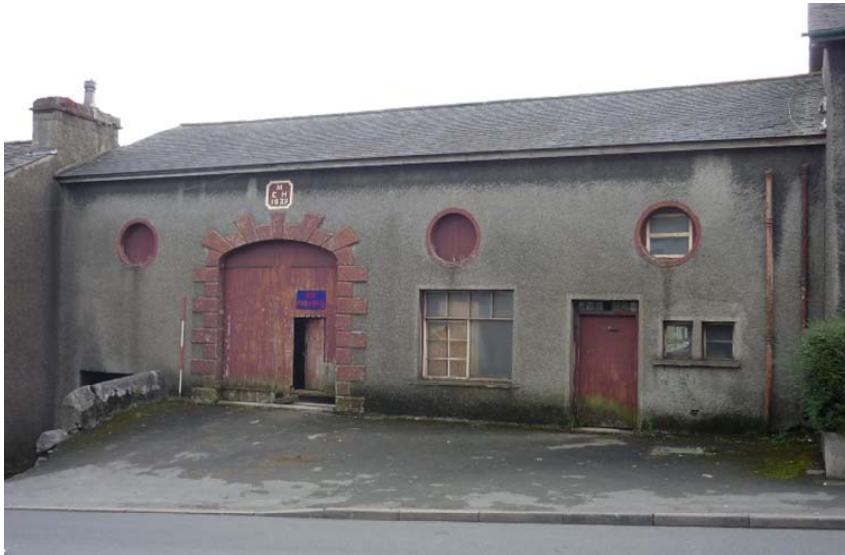
4.2.1 **Main Barn, North elevation:** the north elevation fronts onto Market Street (Plate 3; Figure 3). The roof was un-graduated blue slate, with sandstone ridge tiles. The frontage was roughcast rendered with pebbledash. The upper-floor was approximately street-level; the pavement in front of the building slopes down from south to north, and follows the lay of the road. The through passage to the rear sloped steeply from the road to the level of the shippon to the rear, passing below the east end of the threshing barn. The main access to the building was through a large wagon door to the west of the through passage. The doorway was quoined with large well-dressed and painted limestone quoins with a voussoir arch. There was a painted datestone centrally-situated immediately above the doorway inscribed with the letters M, E and H and the year 1839 (Plate 4). The double-door was timber-constructed and possibly original, with a smaller winnowing door built into the west side of the double-door (see *Section 4.3.2*). There was a further doorway to the west, with a plain timber frame, set within a concrete surround. The door was plain, with a seven-light casement window above. There was a large window with a wooden frame, concrete surround, and stone sill between the two doorways; the lower section of the window was a sliding sash, but the upper section was a fixed casement. There were two further two-light casement windows to the west of the small door with a similar concrete surround and sharing a stone sill. There were three high-level circular windows with similarly painted limestone surrounds; two to the west of the double door, and one above the passageway. The two windows either side of the wagon door were closed with timber batten doors; the circular window space to the west end of the elevation had a roughly square two-light window inserted behind it with a painted wooden frame.

**Plate 3 (left): North elevation**

5.3.2 It is recommended as much of the original appearance as possible be maintained, especially with regard to the north elevation of the main barn, which forms an attractive façade and is the most visible part of the site. Internally, retaining as much original timber as possible, particularly the trusses, would also be ideal.

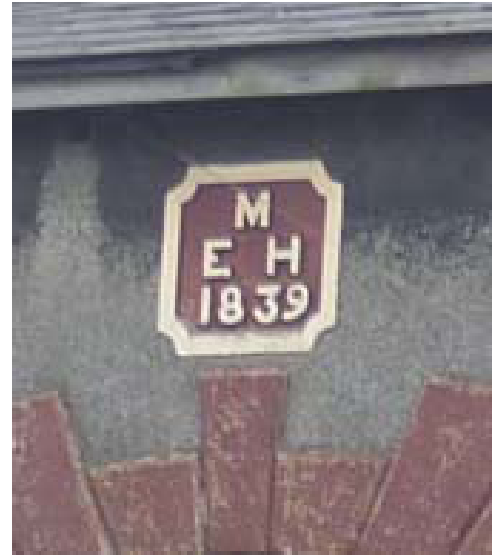
**Plate 4 (right): Detail of datestone**

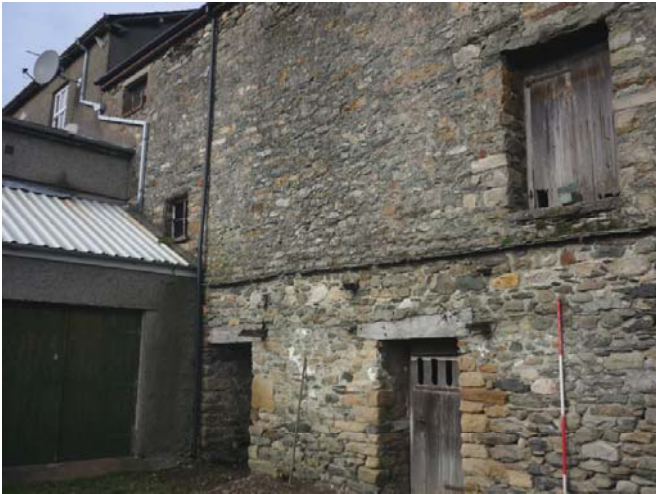
**4.2.2 Main Barn, South Elevation:** there were three skylights in the roof which were presumably inserted when the building was recently re-roofed. A modern four-light casement window with a red brick sill and concrete lintel had been inserted just below the level of the roofline at the west end of the elevation (Figure 3), presumably when the building had been split over two floors. There was a window and door at the level of the threshing floor (Plate 5); the window was to the west end of the elevation, and the doorway was opposite the large wagon door on the north elevation. The window and doorway appear to be original; they were quoined, and each had a stone sill and lintel. The south-east corner of the building was quoined with substantial limestone blocks. A slate drip course projected over the upper (winnowing) door, and square sectioned timber stubs in the wall indicated that this may have been canopied at one time. The remains of a slate-roofed porch jutted out from the wall above this doorway; some stubs of broken timbers projected from the wall slightly below and roughly in line with this slate roof and they probably at one time had acted as supports for the roof prior to its removal. Some red brick was observed in the construction of the wall near to this doorway. Remnants of a further slate-roofed canopy were evident along the length of the shippon below the level of this door. Again, broken timber roof supports were visible in the fabric of the shippon wall, but the roof had long since been removed. There were three quoined doorways on the level of the shippon to the west of the passageway. The quoins appeared to be a mix of limestone and sandstone; the lintels for the doorways were the original, gnarled, old oak timbers (the appearance of the doors is described in *Section 4.3.9*). A large (possibly re-used?) chamfered timber beam extended across the east doorway and over the through passage (Plate 6). The beam had various slots cut into it, which suggest it might have been re-used (Plate 7). A garden wall delimits the property edge and butted against and obscured the east end of the elevation. There were two recesses in the garden wall immediately to the south of the main barn, but their function was unknown (Plate 6).

Plate 5 (left): West end of the south elevation

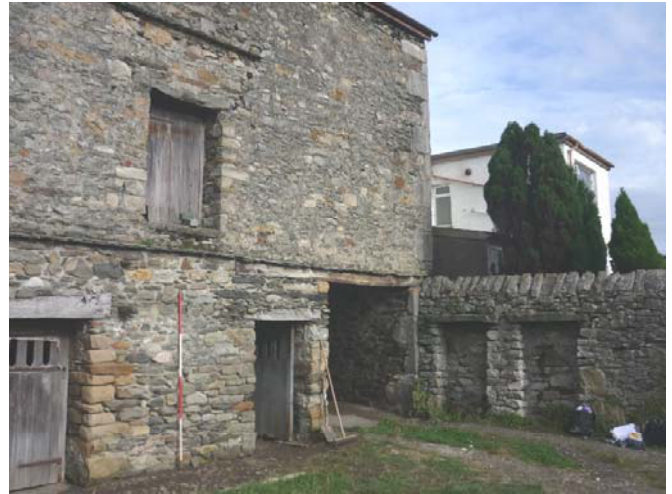
Plate 6 (right): East end of the south elevation

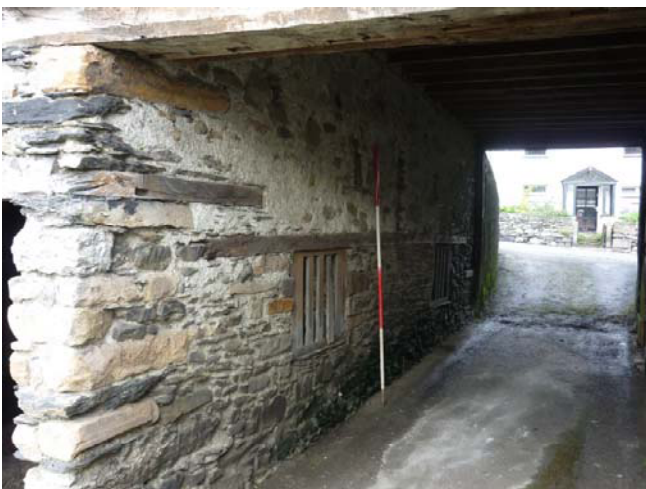
Plate 7 (left): East wall of the shippon, viewed from the through passage

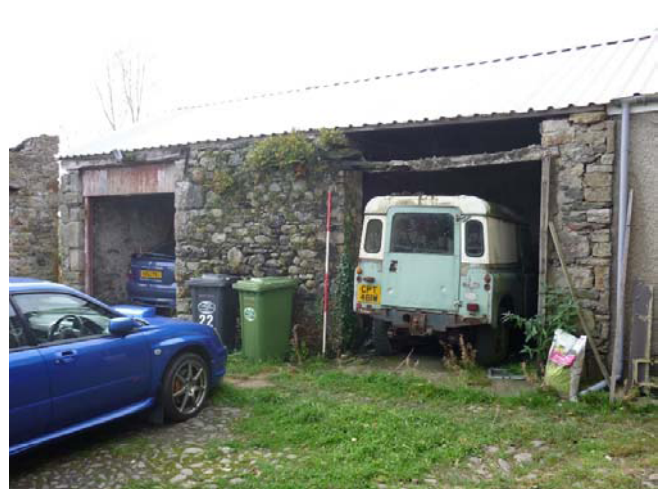
4.2.4 **Garage:** the garage which forms part of this property to the south of the main barn was built from the same local rubble stone material and had substantial limestone quoins to the corners of the building and a corrugated metal roof (Plate 8). It probably was originally a cart shed. The two doorways on the east elevation were quoined and sat below large, gnarled and heavily bowed oak timber lintels. The remaining elevations were plain. A garage covered in roughcast render filled the space between the garage and the main barn, which it butts against.

Plate 8 (right): East elevation of the garage

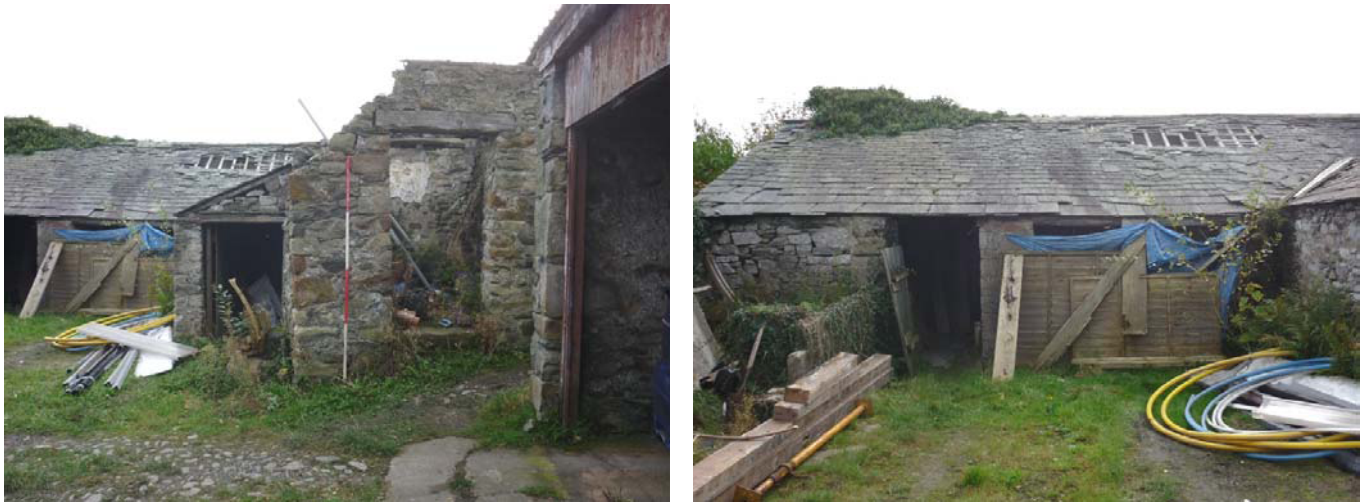
4.2.5 **Small barn:** the small barn to the south end of the site was similarly built of local stone work with limestone quoins with various blockages and additions made using modern breeze blocks. The barn seems to have originally been a single-roomed square building which was accessible only via a stepped-up doorway with a heavy timber lintel in the north elevation (Plate 9; Figure 5). There appears to have been a window above and to the west of this doorway at some stage but all that remained was the sill. The L-shaped barn to the south and east appears to have been a later addition, with the main element of the barn aligned east/west (Plate 10), with a wing projecting northwards at the west end which butted against and slightly overbuilt the original square building (Figure 7). The original square-roomed building was currently without a roof, although there were remnants of a slate roof still visible. The L-shaped barn had a graduated slate roof which was mostly collapsed. A doorway in the south elevation had been half-blocked with brickwork below the voussoir arch. There was a further small extension to the south-west corner of the L-shaped building which had been built from modern block work and which had mostly fallen down. This extension partly obscured a 12-light casement window which was quined in the west elevation of the L-shaped barn and which had a limestone lintel.

**Plate 9 (left): Original square structure to the north end of the small L-shaped barn**

**Plate 10 (right): Main east/west section of the small L-shaped barn**

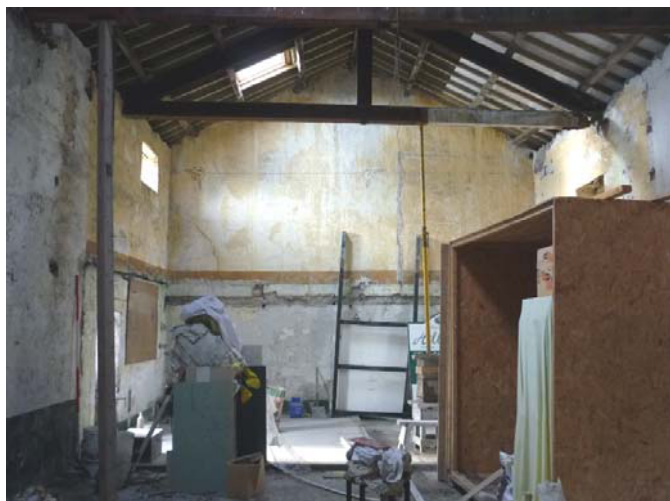
Plate 11 (left): West elevation of the upper floor of the main barn

**4.3.5 *Upper-floor of the main barn, west elevation:*** the west elevation forms the gable end of the barn and was open to the roof. The wall was plain and plastered and whitewashed below the floor scar; it was painted yellow above (Plate 11). There were three beam slots at first-floor level and the wall was painted a darker yellow just above the level of the beams. There was a small box partition to the north end of the elevation, rising to the height of the wall on the first-floor level (look at the right-hand side of Plate 11).

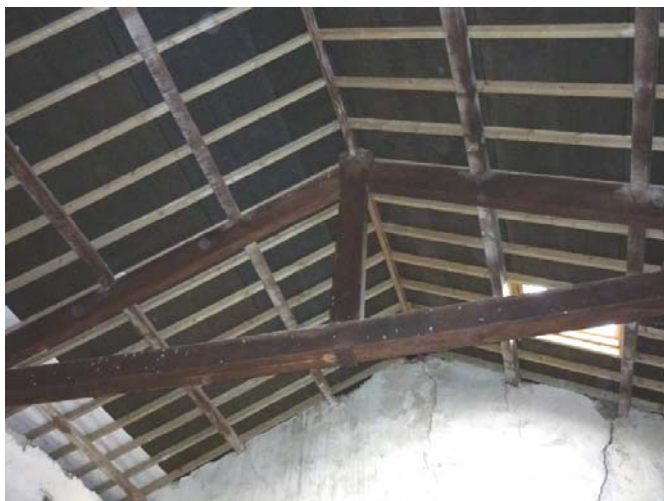
Plate 12 (right): Truss at the east end of the main barn

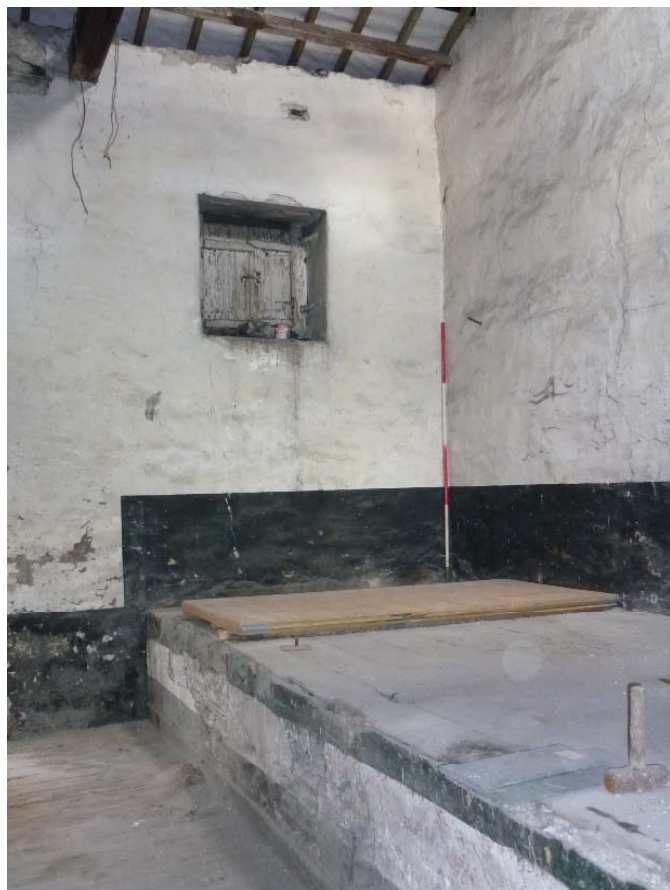
Plate 13 (left): Raised floor to the east of the threshing floor above the through passage

**4.3.3 *Upper-floor of the main barn, east elevation:*** the east elevation above the raised floor area was plain (Plate 13).

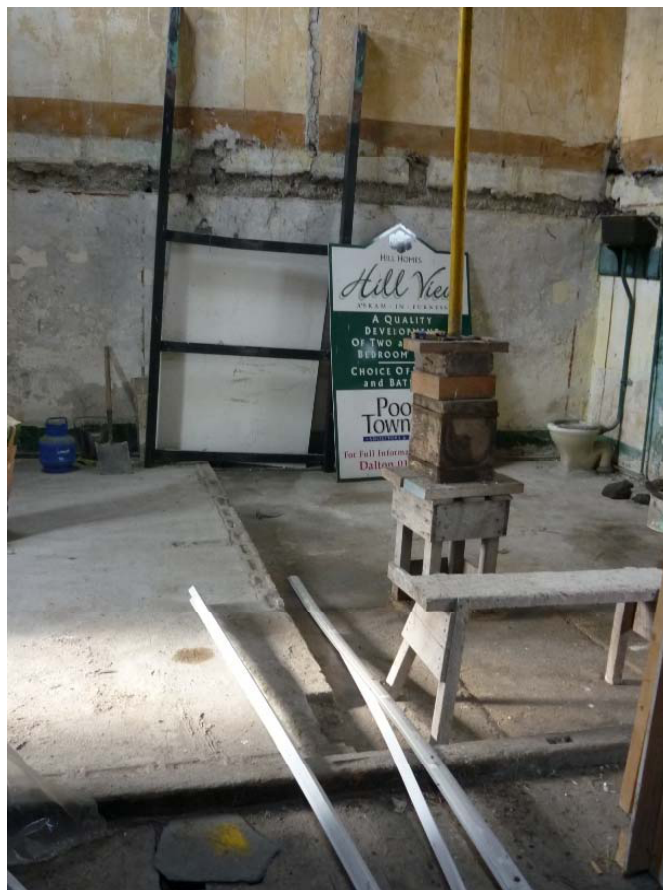
Plate 14 (right): Floor divisions within the partition area

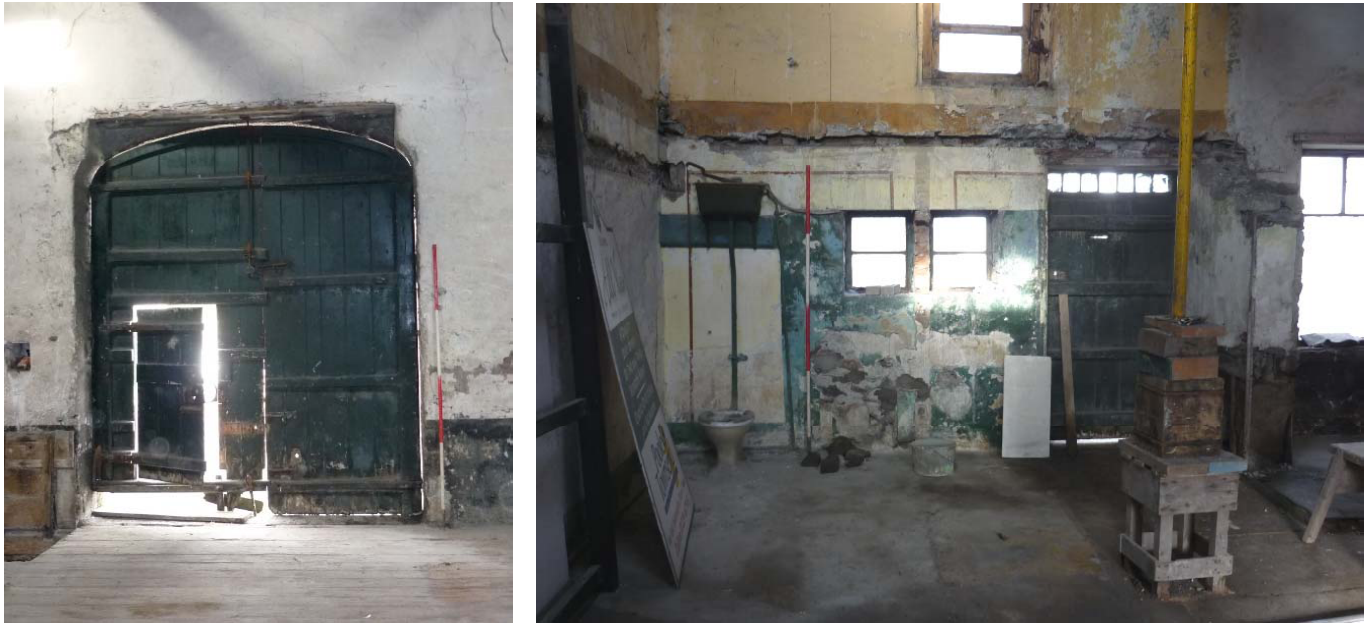
**Plate 15 (left): Wagon door in the north elevation of the threshing floor**

**Plate 16 (right): Partitioned west end of the threshing floor**

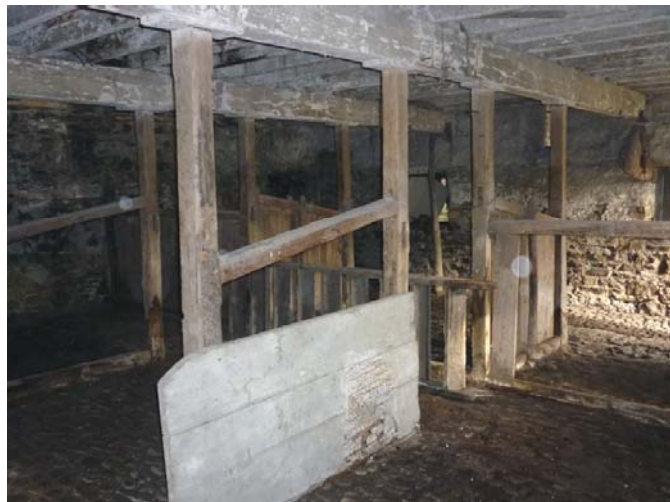
**4.3.6 *Lower-floor shippon, the main barn:*** the lower floor of the building still had wooden stalls *in situ*, having once been used as a stable or shippon (Plate 17). The east/west aligned sawn timber floorboards of the threshing floor above were exposed in the ceiling, resting on the north/south aligned joists which in turn rested upon two larger east/west support beams (Plate 18). There was a sloping slate chute to the floor above in the north-west corner of the room and a central hatch in the ceiling at the north end of the feeding passage which allowed access to and from the upper floor. All the ceiling supports were square-cut and do not appear to have been re-used and are probably original. The two main east-west support beams each sat atop some thin pieces of timber set above four posts which also separated the stalls; a diagonally-set piece of timber, with a chamfered top edge, was slotted between the outer posts to separate the stalls from north to south, and horizontal timbers were slotted north/south along the two inside rows of posts and to the wall to enclose the feeding passage. The vertical posts were square-cut and chamfered above and below the level of the feeding passage, running centrally, north/south across the room. The floor arrangement was effectively mirrored either side of the feeding passage, with three east/west aligned stalls to either side and a north/south aligned dung channel

**Plate 17 (left): Stalls in the shippon**

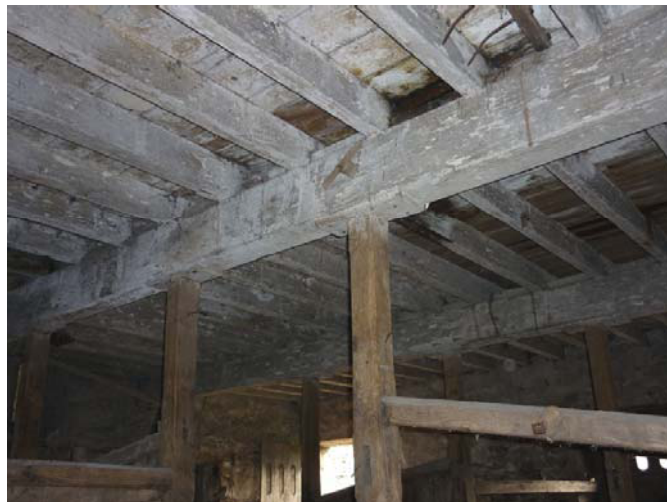
**Plate 18 (right): Exposed boards of the threshing floor, viewed from the shippon**

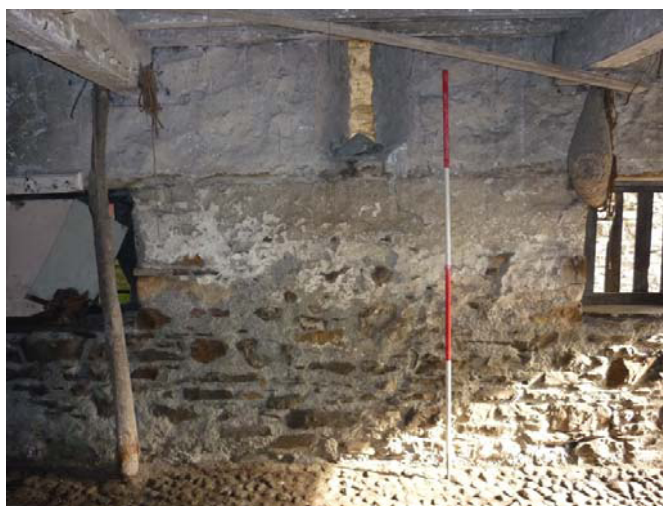
**4.3.8 Lower-floor shippon, east elevation:** the stone fabric of the wall was exposed to the height of approximately 1.6m, above which the wall was rendered with a white plaster to the height of the ceiling (Plate 19). This render obscured two ventilation slots which had been visible from the through passage (see Section 4.2.3; Plate 7). There was a central slot window at ceiling height which was open to the through passage and there were two lower-level windows, below the height of the plastered render. The lower windows were situated below a square-cut sawn timber lintel (more easily visible from the through passage, see Plate 7), either side of the central slot window, which sat above the level of the lintel. The two windows were identical, each with a slate sill, wood frame and through slots open to the passageway.

Plate 19: East elevation of the shippon

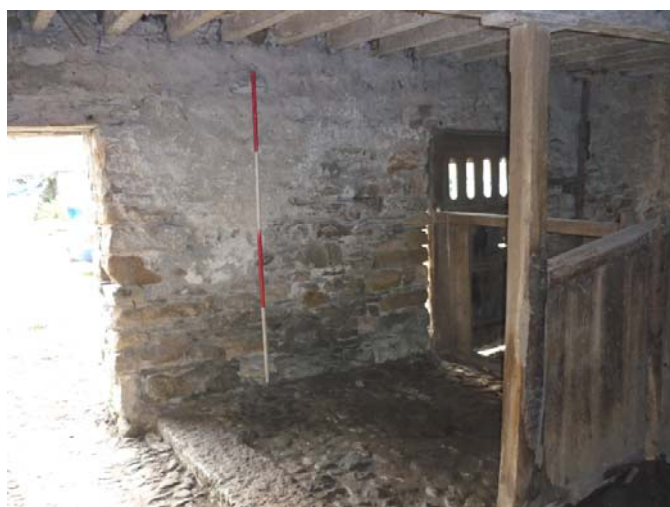
4.3.9 **Lower-floor shippon, south elevation:** the white plaster partially continued from the east elevation onto the south wall, below which the stonework was exposed (Plate 20). There were three doorways along the south wall; the east and west doorways were aligned with the dung channel against the east and west walls (Plate 21), and the centre doorway provided access to the feeding passage. The centre doorway had a plain wooden frame, with chamfered edges, housing a wooden timber-board door with oval-shaped window slots (Plate 20). To the west of this doorway there was a possible tethering post and some metal items lay on the floor. The outermost doorways were unframed and were presumably for the use of animals; the eastern doorway had a timber door (similar to the central door) but it was less securely attached to the lintel.

Plate 20 (left): South elevation of the shippon

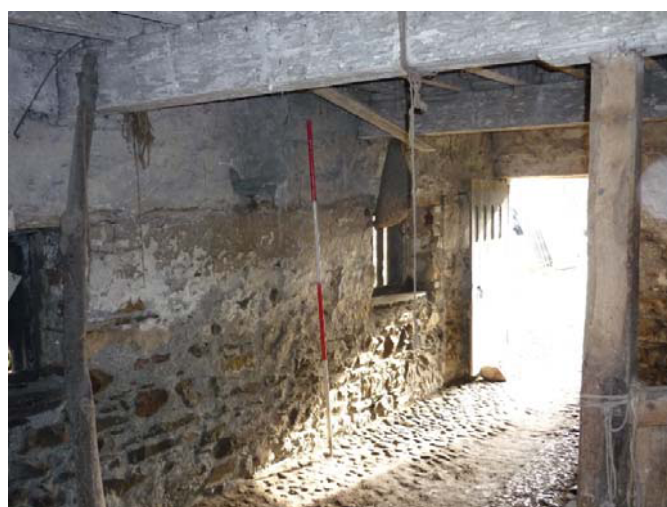
Plate 21 (right): South-east corner of the shippon

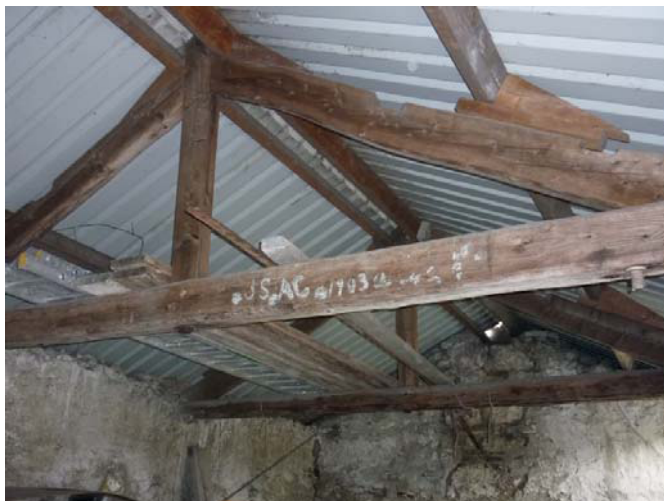
4.3.11 **Garage:** the walls of the garage were plain, though the roof structure is of more interest. The roof of the garage was supported by two king post trusses with two purlins per pitch overlapping at the trusses (Figure 8). The purlins were braced with additional wedge-shaped pieces of timber, but the ridge purlin was absent. It is notable that the support timbers had notches to the upper side which bore no relation to their current purpose; they had clearly been re-used in the construction of the roof. Re-use of

construction materials was not an uncommon practice, perhaps especially in the construction of traditional farm buildings; owners and builders achieved considerable economy through the re-use of materials from nearby defunct buildings whenever they were suitable and available (Tyson 2000, 43). Unfortunately, there is no historical record of the source of the re-used timbers in this case.

**Plate 22: Internal support structure of the garage roof**

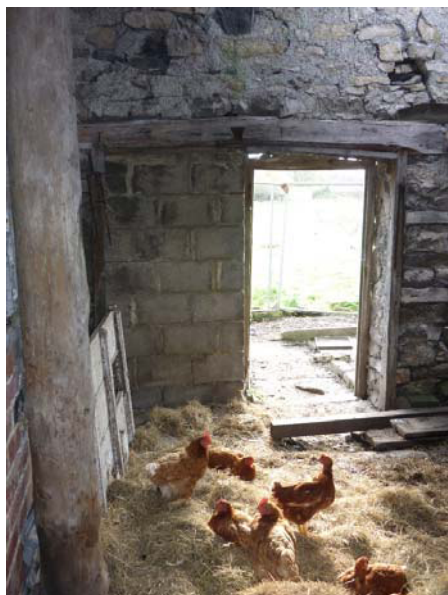
4.3.12 **Small barn:** the doorways of the small barn were each set below heavy timber lintels (Plate 23). The main east/west section of the L-shaped barn had been divided by a modern brick partition (Plate 24); the western end was currently used as a tool shed and storage and the eastern end was used as a chicken coop. Some of the walls were finished with a white plaster or cement render but elsewhere the stone fabric remained exposed. There was limited access to this barn at the time of the site visit. The roof structure was relatively simple and comprised a rafter (with two purlins) pitched against the wall above each truss; it was notable that much of the timber used in the construction of this truss was rounded with a squared end and was perhaps re-used (Plate 24).

**Plate 23 (left): Part-blocked doorway in the south elevation of the small L-shaped barn**

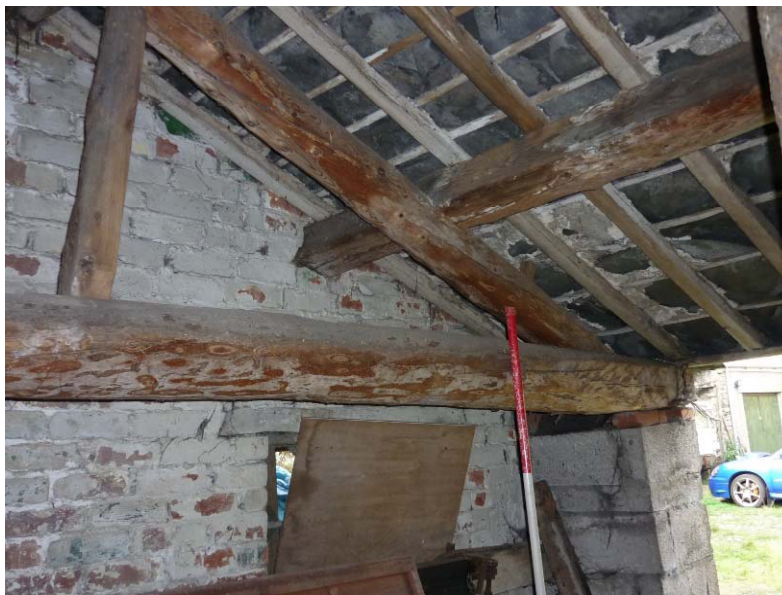
**Plate 24 (right): Roof structure and partition wall inside the small L-shaped barn**
