PIEL VIEW FARM, BIGGAR VILLAGE, WALNEY, BARROW-IN-FURNESS, CUMBRIA

Archaeological Building Recording

Client: Storey Sharp
Construction

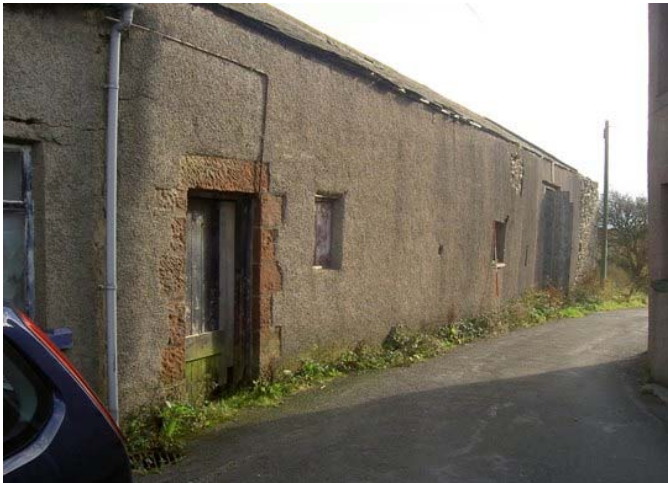
Plate 6 (left): West external elevation from the north

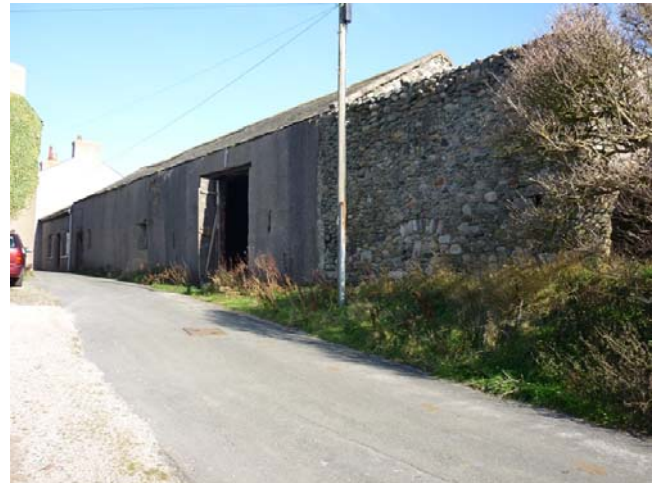
Plate 7 (right): West external elevation from the south

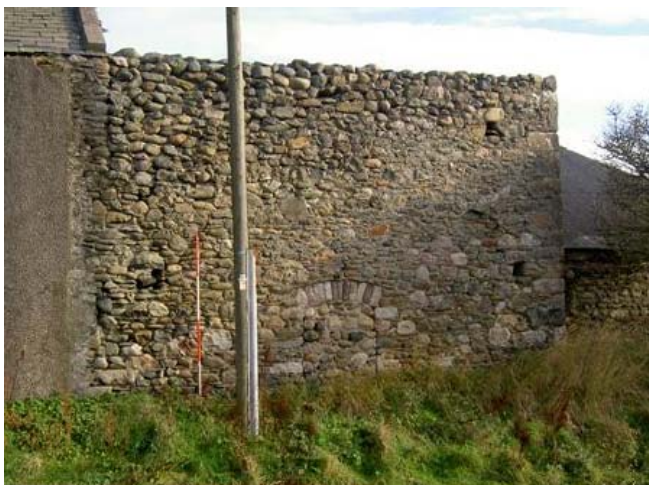
4.2.4 The end of the rendered part of this elevation corresponded with the junction of Building 1 and Building 3, although no quoins were evident in this region, which perhaps indicates that the two buildings were contemporary, or that some re-building of this area had been carried out (Plate 8). Building 3 was un-rendered and un-roofed and contained a central doorway, which was blocked, with a square vent slot on either side and a second higher slot evident on the south side. The doorway had an ornate arch (Plate 8) formed by roughly dressed stones under a shallow slate drip hood, the jambs were quoined with some of the more angular beach stones. The doorway was only 1m in height, perhaps suggesting that considerable banking had formed above the original ground level. The quoins at the south end of this building were formed from stout and random beach or field boulders; the top of the wall was horizontal but it seems probable that this originally formed the gable end of Building 3.

Plate 8 (left): Junction of Building 1 and Building 3 at the south end of the west elevation

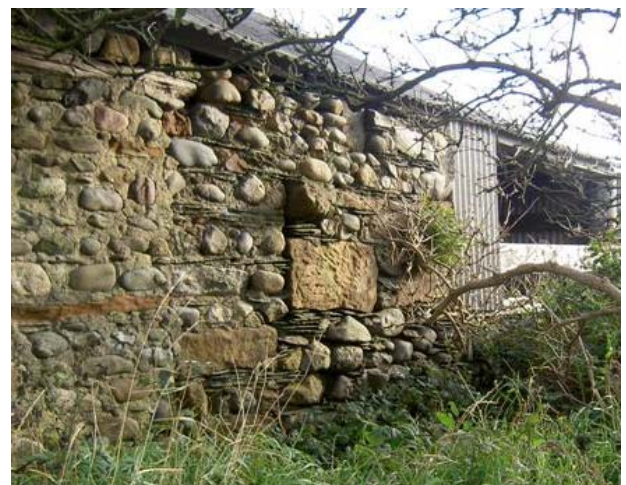
4.2.5 The final section of this elevation is that belonging to Building 4 (Plate 9), the former horse gin case, which was set back from the main elevation by about 1m. This elevation contained a higher proportion of locally sourced quarried stone, such as limestone, red sandstone and slate, which had been used between courses. The north half of this elevation was full height and contained what might have been a blocked doorway; it was wider than would have been necessary for a pedestrian, so it was perhaps to provide access for horses, although it might have been an aperture to provide ventilation. This blocked doorway had a roughly-squared oak lintel (Plate 9). The south end of the elevation was mostly open above knee height, with two horizontal planks spanning the gap between the wall at the north end and the vertical timber post which formed the south-west corner of the building.

Plate 9 (right): Blocked doorway in Building 4

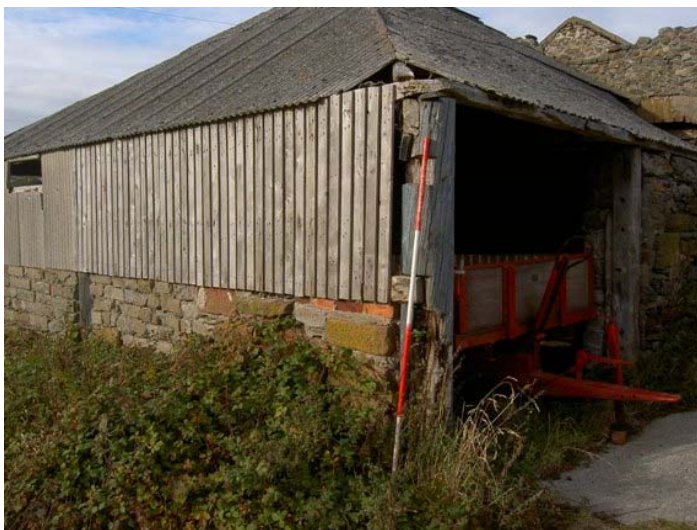
4.2.6 **South elevation:** the west end of this elevation was formed by Building 4, the horse gin (Plate 10). This side of the building was of modern construction with circular timber posts at each corner and one in the middle; these upright timber posts resembled telegraph poles. The lower half of the elevation was constructed largely from concrete blocks, with some ashlar blocks of red sandstone, as well as brick, forming the east corner; above this section of the wall vertical planks had been affixed to horizontal planks which spanned the gap between the upright posts. The timber was all modern.

Plate 10 (left): Horse gin (Building 4), viewed from the south-east

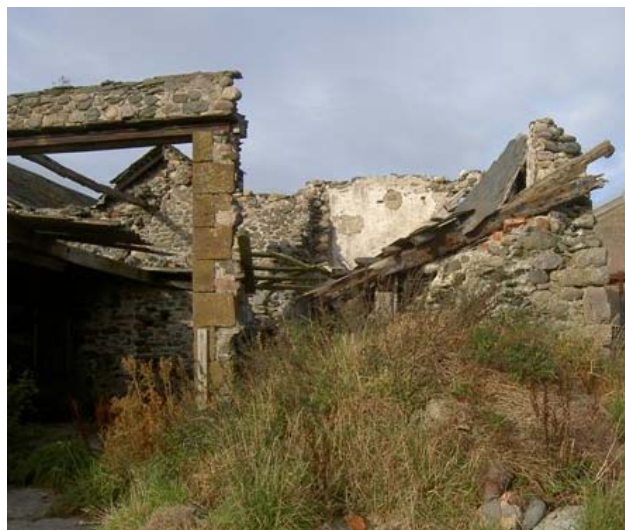
4.2.7 East of the horse gin, the remaining part of the elevation, which was formed by Building 3, was set back several metres from the horse gin. There was a large wagon doorway at the west end of Building 3 (see Figure 3); this doorway had clearly been inserted as the blocked original wagon doorway with its neat red sandstone arch was evident just to the west of this doorway (see *Section 4.3.20* for full description). The later doorway was much higher, and had an iron beam lintel over ashlar red sandstone and red brick quoins (Plate 11). To the east of the wagon doorway (Building 3) the wall was very dilapidated and only a small section remained at the east end, where the beach cobble construction was evident as well as large irregularly shaped quoins.

Plate 11 (right): East end of the south elevation, Building 3

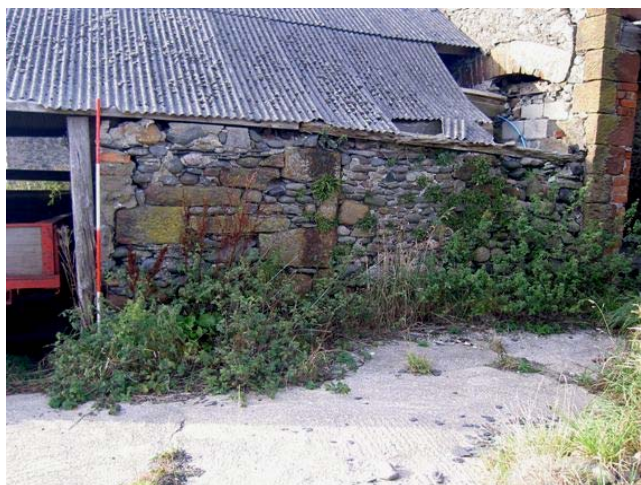
4.2.8 **East elevation:** the most southerly part of this elevation was the east side of the horse gin, Building 4, which had a large opening at the southern end. This doorway was two and a half metres wide, formed by two upright timber posts braced at the top by the wall plate which extended over the aperture; no quoins were present on the north side. The remaining section of wall clearly butted against the southern side of Building 3, illustrating the phasing of these two buildings (Plate 12). Within this section of wall there was a blocked doorway, 1.25m wide, which corresponded with a doorway on the opposite wall (see *Section 4.2.5*). Red sandstone quoins were present on both sides of the doorway which had been blocked with random cobbles; these were smaller than those generally used in the walling. As with the west elevation of this building it was noticeable that more large red sandstone blocks had been incorporated amongst the cobbles to the south of the doorway.

Plate 12 (left): Blocked door in the east side of Building 4

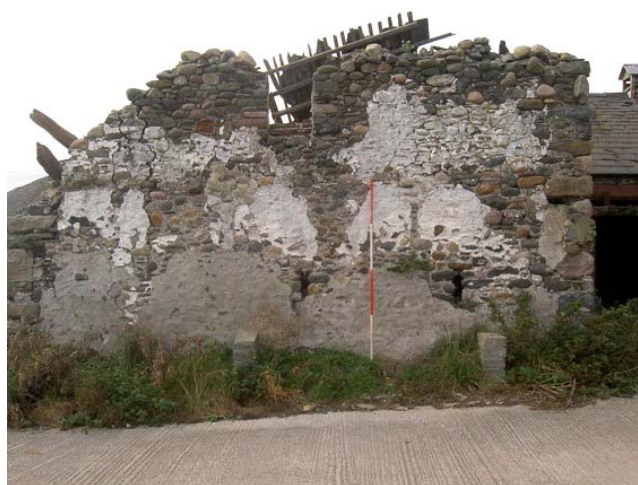
4.2.9 The east elevation of Building 3 was quite plain and showed some vertical loss, as it was presumably a gable end; render had also been added to some of the lower areas which may have obscured some features. The added render and whitewash (Plate 13) related to the fact that this had at one time been an internal elevation of another small building added to the east end of the range between 1843 and 1891 (see Plate 1 and Plate 2), which has been removed. On the lower level of this elevation there were two slot vents which were set beneath stone lintels and had rudimentary quoining; one slot was located centrally, while the second was set towards the north of the elevation. There was possibly a third slot at the south end of the elevation which might have been obscured by external render. The upper part of the elevation contained a centrally-located window which had utilised flattish stones as quoins; the lower part of the aperture had been partially blocked and no sill was evident, and the lintel was also absent because the wall had been truncated.

Plate 13 (right): East elevation, Building 3

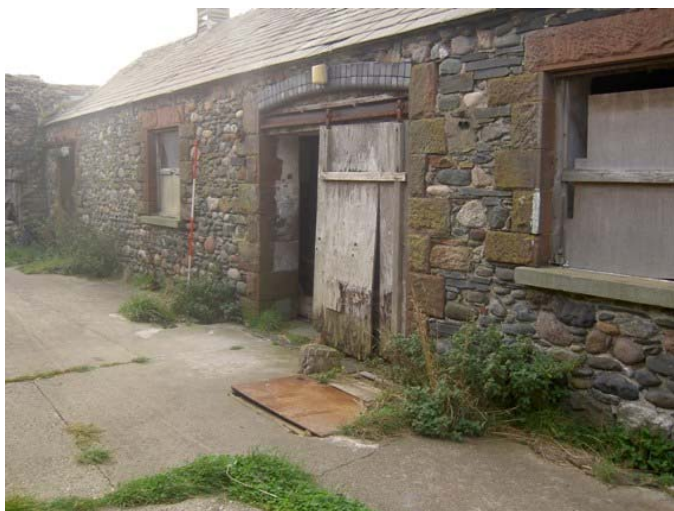
4.2.10 The east elevation of Building 2 (Plate 14) was clearly a later phase of development, using concrete sills and very regular red sandstone quoins and lintels which were neatly banded on the inside. Building 2 was originally built as a shippon and had two windows on either side of a central double-width door. The window at the south end of the elevation had recently been converted to a pedestrian doorway; this was evident from the lack of quoins either side of the doorway below the level corresponding to the height of the sill of the other windows. The central doorway also had regular red sandstone quoins which were set under an arch created from a double row of end set bluish grey bricks, the lower row being bull-nosed to create a rounded underside to the arch. The arch was a decorative feature set into the wall above a square-sectioned timber lintel to which a steel bar had been affixed; the plain board door was hung from straps with rollers which slid along the steel bar. The north half of the doorway was hidden behind the sliding door and had been blocked to form a pedestrian doorway, which was presumably done when it ceased to function as a cow house.

Plate 14 (left): East elevation of Building 2

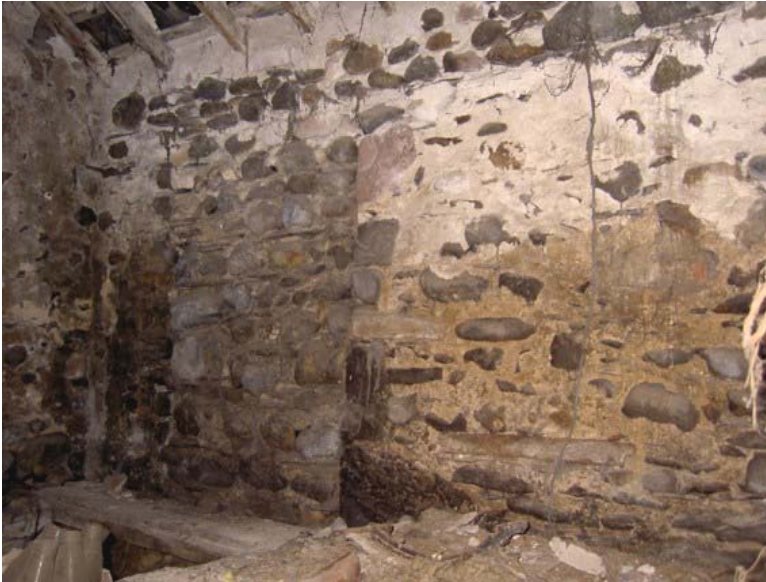
4.3.2 **Building 1, east elevation:** there was a blocked original upper-level door at the north end which served the half loft in this area (Plate 18). This must have previously been accessed by a flight of external stone steps, which would have been removed when Building 2 was constructed. The original lower-level door would have accessed the underside of the original half loft and suggests that an earlier partition existed in this area, Room 1a. There were two further pedestrian doorways in this elevation between which was a blocked wagon doorway; the most northerly of the remaining pedestrian doorways was blocked with modern board and was roughly quoined using selected beach cobbles under a re-used oak lintel. The blocked wagon doorway, which was roughly central in the elevation, appeared to have been blocked in two stages, so it would have acted as another pedestrian doorway for some time. The quoins on the north side of the doorway were evident as was the original oak lintel; the southern quoins were obscured by render. Over the south side of the lintel some horizontally set slates projected inwards from the elevation which appeared to correspond with the height of some timbers in the wall to the north. It is possible that these may have been the original truss seatings, and that the barn's roof height has been raised slightly. While this is conjectural, and would mean the trusses have moved their locations slightly, it was certainly noticeable that above this line there was more flat slate built into the wall than at the lower levels. There was a small alcove in the wall to the south of the wagon doorway, which had cobble jambs and a whitewashed timber sill; this was probably a part blocked vent or winnowing slot. The southern pedestrian door had the original cobbled jamb to the north side, while the south side was quoined in quite well finished red sandstone. The lintel over the doorway was stained black and appeared to be more recent than many of the other timbers which suggest that this doorway was remodelled or inserted (Plate 19). The quantity of pedestrian doorways in this elevation is unusual but might be explained by the extra partition indicated on the 1891 Ordnance Survey map (Plate 2), which would have led to the requirement for the second most northerly doorway.

Plate 18 (left): Blocked upper-level door to the half loft in the east elevation of Building 1

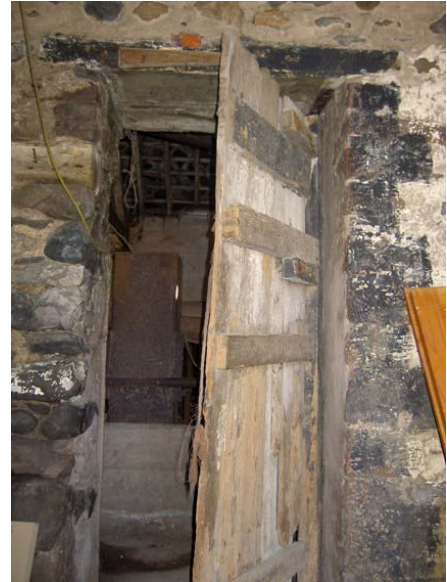
Plate 19 (right): Altered doorway towards the south end of the east elevation of Building 1

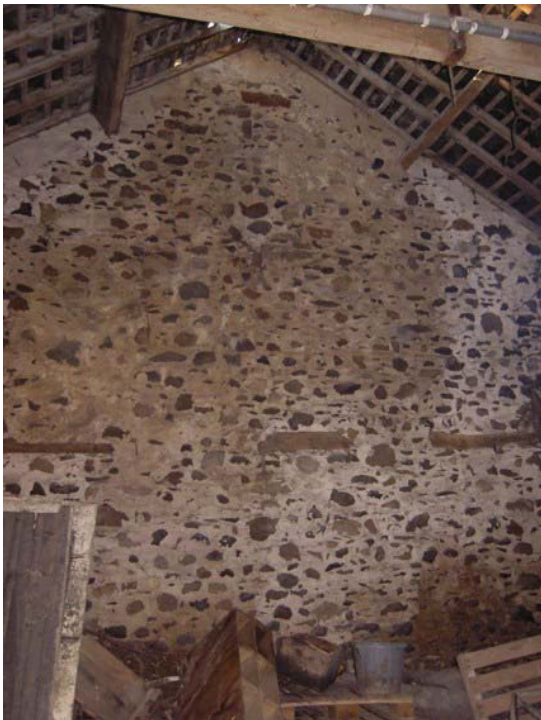
4.3.3 **Building 1, south elevation:** this gable end elevation was very plain and the only definite feature was a blocked owl hole below the roof apex. The owl hole appeared to have a red sandstone lintel (Plate 20) and there is a possibility that this was not an original feature, many of which utilised the more flattened beach cobbles for lintels. Lower down there were three horizontal timbers in the wall evenly spaced across the elevation; it would seem likely that these related to former apertures but unfortunately the render obscured any evidence for this.

Plate 20 (left): South elevation of Building 1

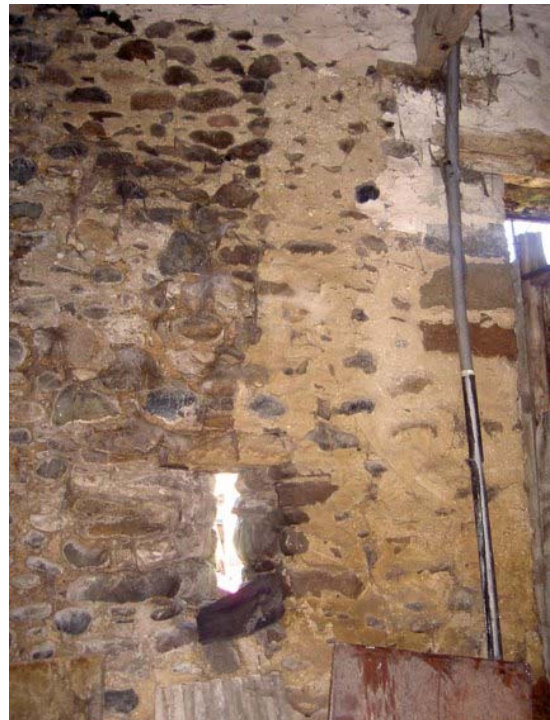
Plate 21 (right): Re-build of the south side of the wagon doorway in the west elevation of Building 1

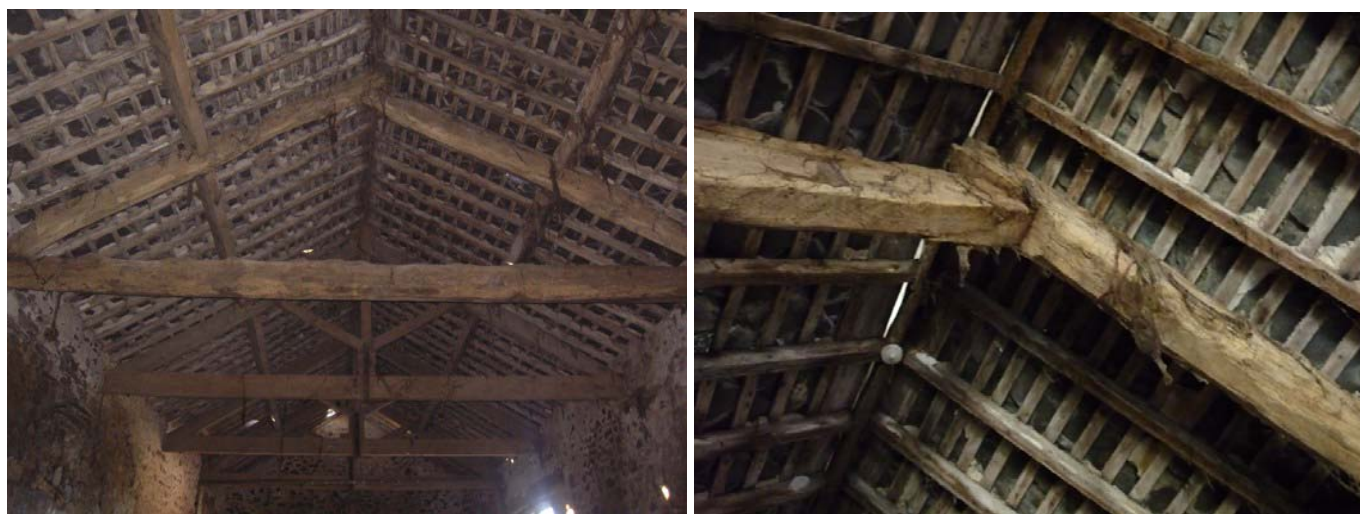
4.3.5 **Building 1, roof:** there were six trusses in the barn, four softwood king-post types with joggled braces, and two of the original oak tie-beam variety (Plate 22). One truss re-used an earlier timber (Figure 4). The re-used timber was the eastern principal rafter and had the scar of a lap joint on its lower north face; this contained at least one peg hole. This timber also had a stop-chamfered inside edge which distinguished it from the other oak timbers (Plate 23); all the purlins had been replaced and the two original purlin scars were also evident on this and the other earlier principal rafters. The square-cut softwood purlins tended to run two trusses before overlapping; it is probable that these replacement purlins were the same age as the replacement king-post trusses which were very similar to those found in Building 2. The roof was clad in slate which was capped by sandstone ridge tiles; these presumably had been salvaged from the earlier phase of roofing.

Plate 22 (left): Trusses viewed from the north, Building 1

Plate 23 (right): Fourth truss from the south end of Building 1, showing stop-chamfer

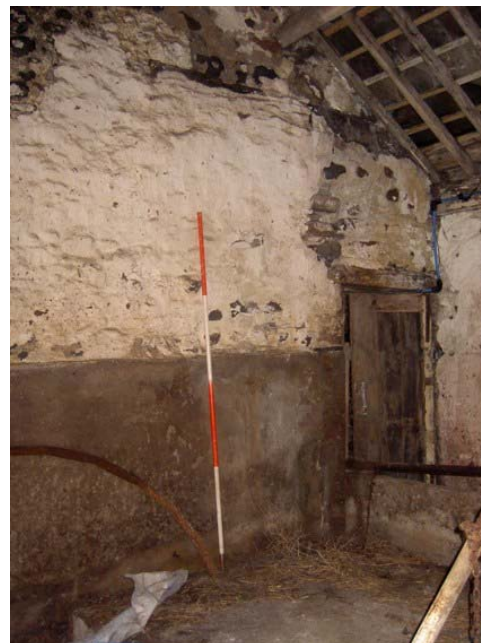
4.3.9 **Building 2, south elevation:** this gable end elevation was largely plain except for a pedestrian doorway at the west end which accessed the feeding passage. This elevation was the north exterior side of the pre-existing barn, Building 3; the gable had been formed by adding stonework to the top of that wall. Over the pedestrian doorway there was a large oak lintel that was the remnant of a wagon door that accessed Building 3 from the north; this had been mostly blocked when Building 2 had been added, leaving only the pedestrian access (Plate 25).

Plate 25 (right): Lintel above the blocked wagon door in south elevation of Building 2

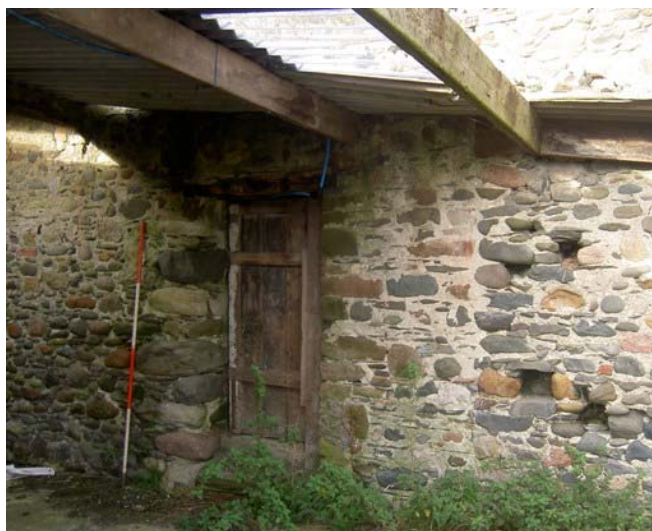
Plate 26 (left): North interior elevation of Building 3 showing the part blocked wagon doorway

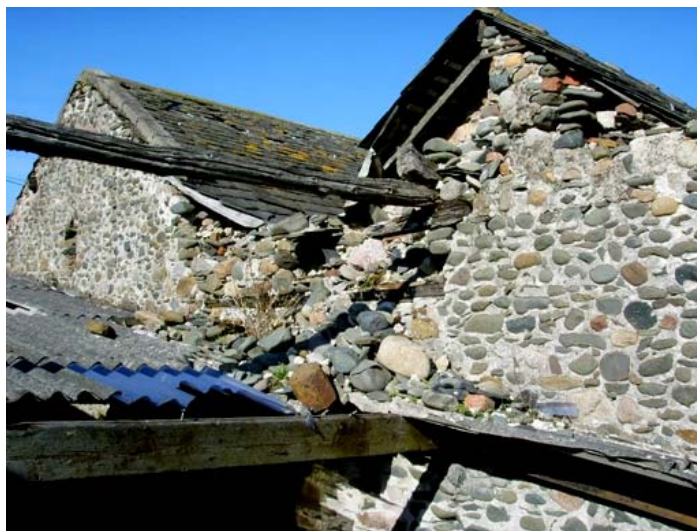
Plate 27 (right): South elevations of Buildings 1 and 2; note the relict tie-beam of the former roof

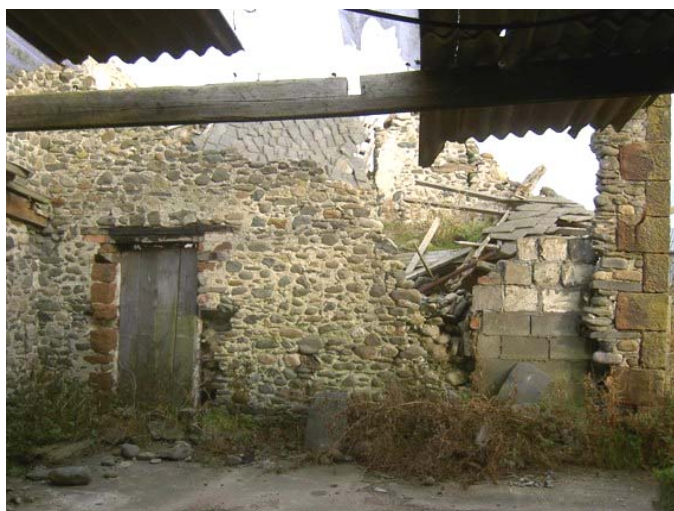
4.3.15 **Building 3, east elevation and access to Room 3a:** this elevation was badly damaged, and evidently comprised at least three separate episodes of building (Plate 28). At the north end was the original beach cobble wall with a doorway into Room 3a, this doorway had been raised in height, and also appeared to have been inserted. There were red sandstone quoins on the north side of the doorway which suggested a slightly later date than the beach cobble walling; the quoins on the south side were

Plate 28 (left): Internal wall which separates Room 3a, viewed from the west from inside Building 3

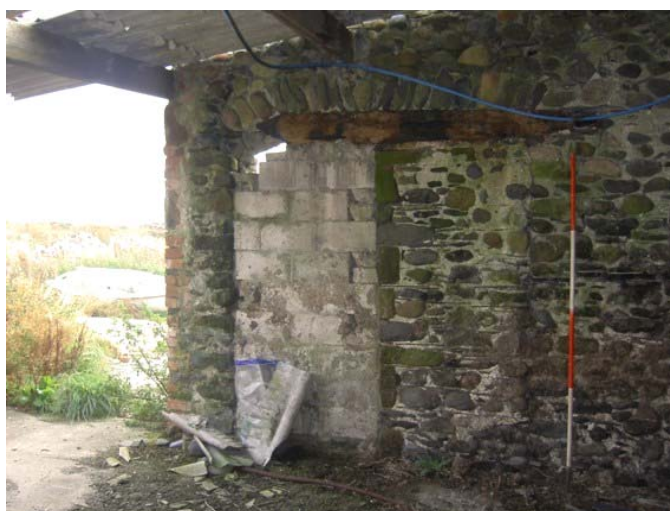
Plate 29 (right): Blocked wagon doorway in the south elevation of Building 3

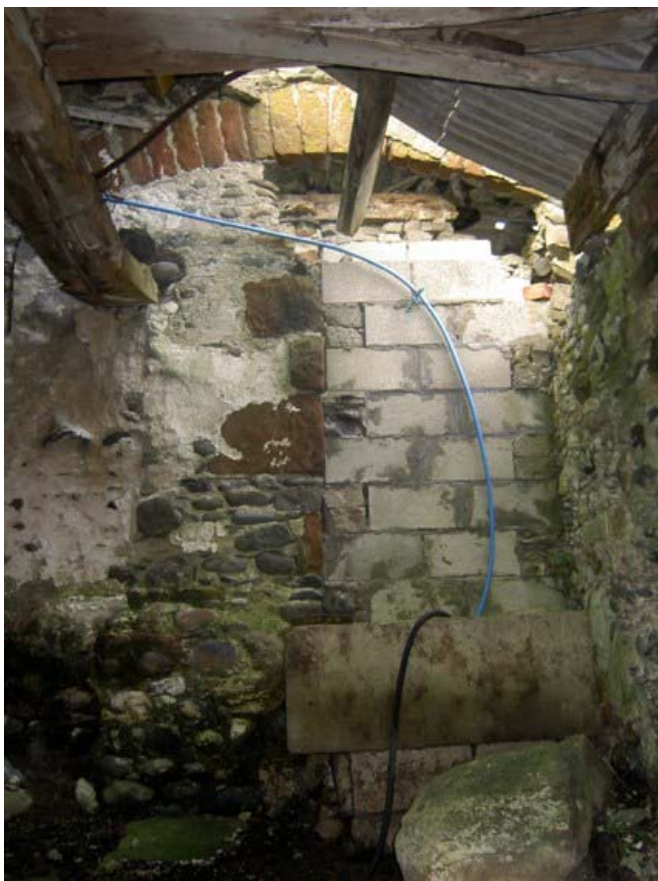
Plate 30 (left): Blocked door in the south elevation of Building 3, viewed from inside Building 4

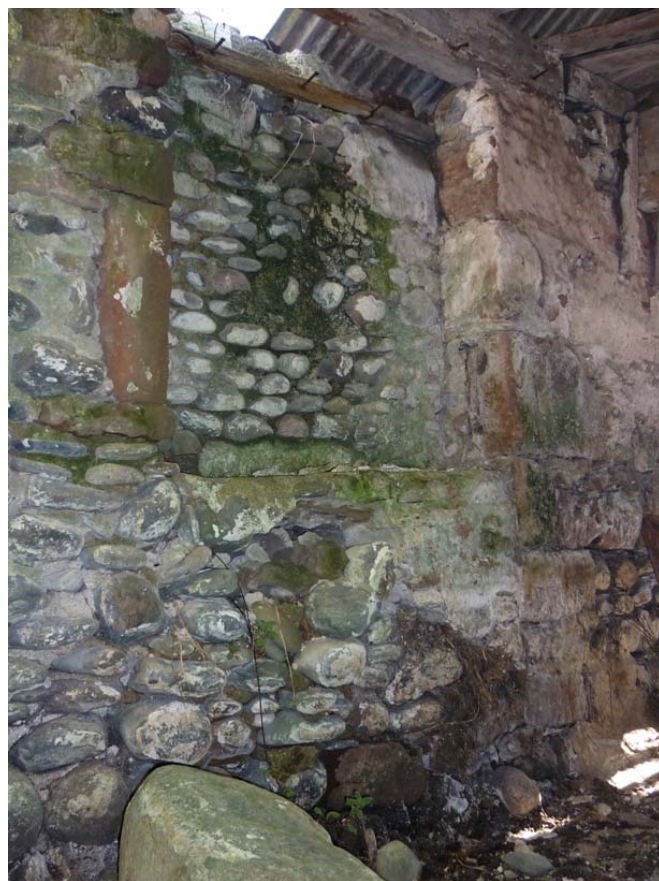
4.3.21 **Building 4, east elevation**: this elevation contained a blocked doorway or window (Plate 31), and the south end of the wall formed the north end of a new, wider entrance. The blocked aperture had red sandstone quoins running down to ground level on the south side, but the quoins only went half way down on the north side. The area that had most obviously been blocked was the upper area, suggesting that most recently it had been a window. Given the height differences in the external and internal floor levels it seems likely that this aperture might have been constructed merely to increase light and ventilation into the building, in order to prevent the horses overheating during their long hours of toil.

Plate 31 (right): Blocked window or doorway in the east elevation of Building 4

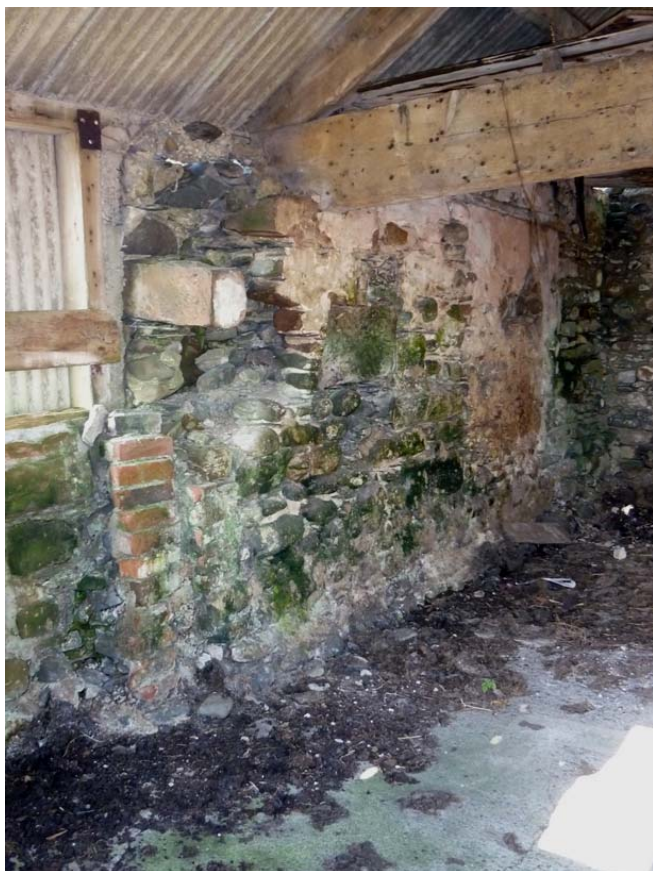
4.3.23 **Building 4, west elevation:** this elevation was very similar to the opposite elevation, except that there was no entrance at the south end where the original wall was truncated, instead the same low wall as in the south elevation was present. The area above the low wall was not boarded and acted as an unglazed window. The remaining elevation was plain except for a blocked doorway in the centre; this had an oak lintel and was 2m high on the inside, but little over a metre above ground level on the exterior. An entrance way is marked in this area on the 1843 map (Plate 1), but this arrangement appears to have changed by the time the 1891 Ordnance Survey map was produced (Plate 2). It seems likely that this was a doorway to allow horses to access the building, and that when it went out of use a bank was allowed to form on the exterior side of the building. There was some remodelling to the south end of this elevation that involved red brick; as it seems that the south end of this building was originally rounded, the brickwork may be part of this arc or just an attempt to patch up the end of the wall (Plate 32).

Plate 32 (left): Re-build of the west elevation of Building 4
