BOLTON PERCY GATEHOUSE,  
BOLTON PERCY, NORTH YORKSHIRE

ARCHAEOLOGICAL OBSERVATION,  
INVESTIGATION AND RECORDING

Report no: 2009/346.R03  
Version: Final  
Date: February 2010  
Author: Shaun Richardson & Ed Dennison

The Vivat Trust  
20 Cowcross Street  
London  
EC1M 6EJ

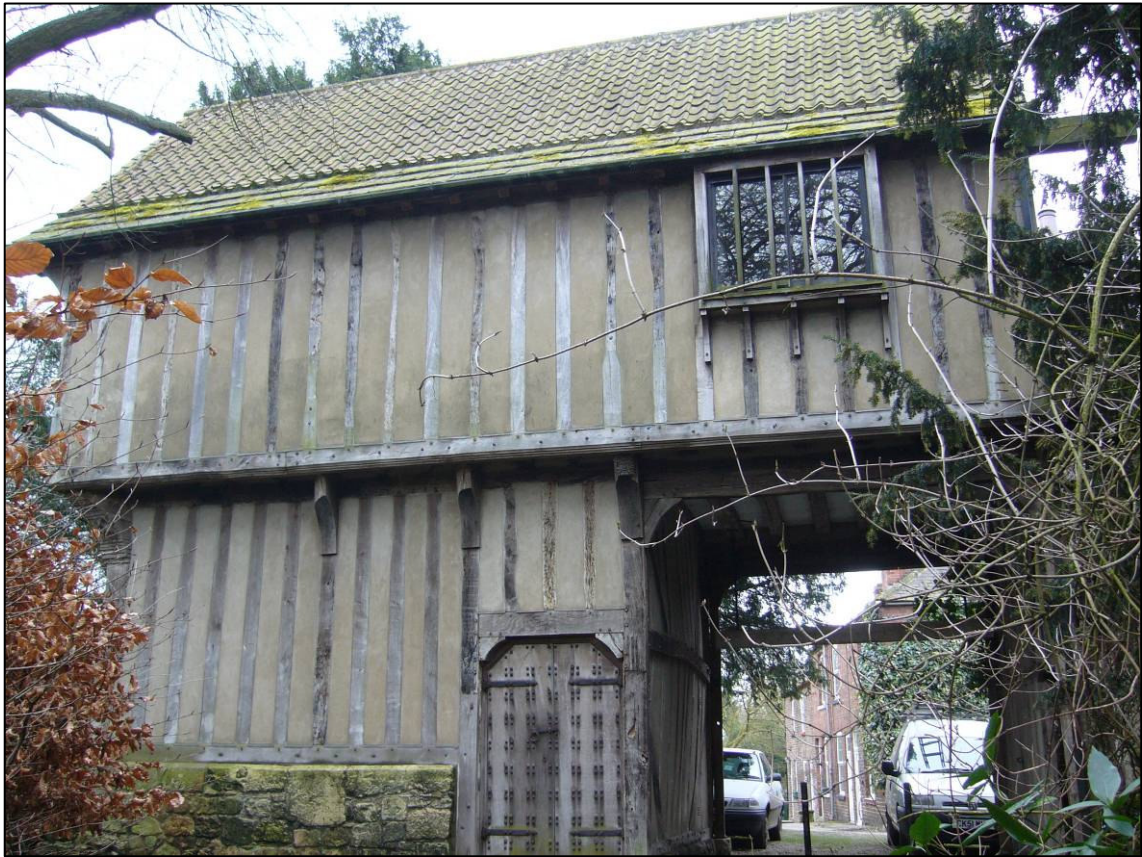
Plate 5: North elevation of gatehouse prior to repairs, looking south-east.

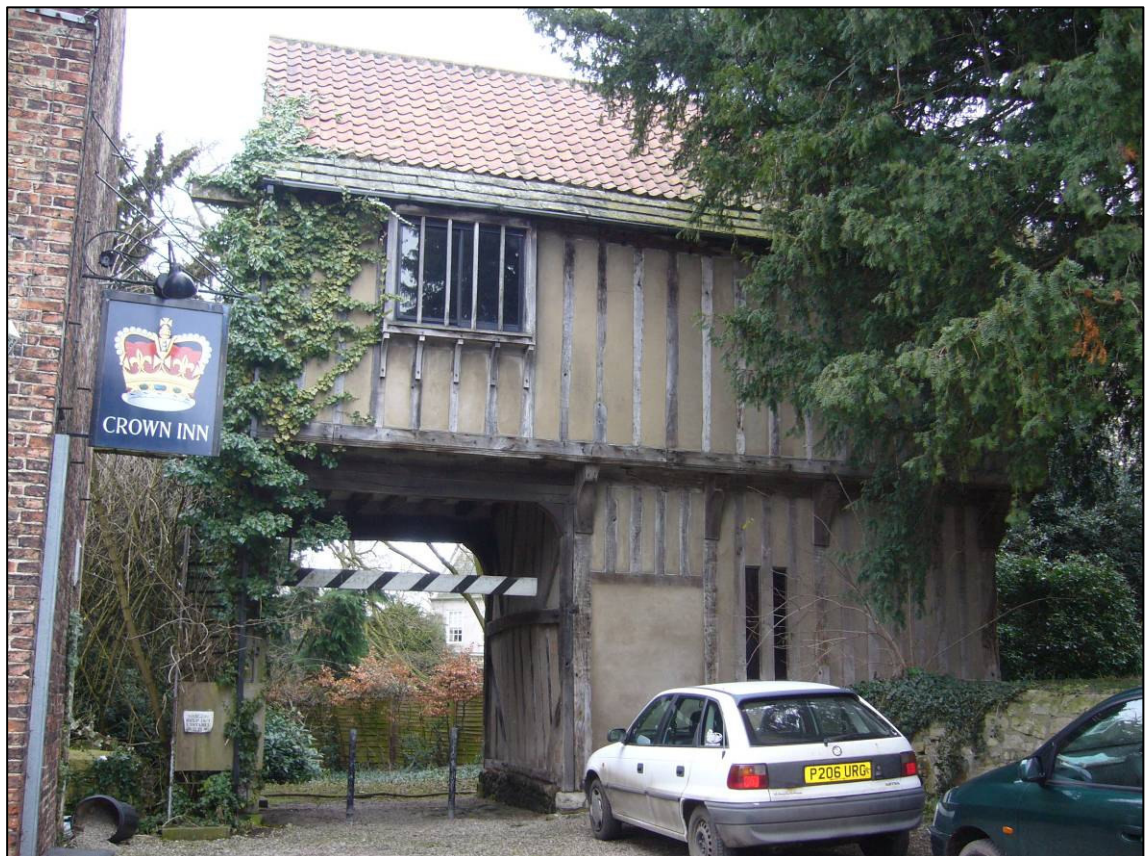
- 3.9 The chamfered plinth to the south elevation is broken by a doorway, now blocked, but which formerly led into the east part of the gatehouse (see plate 6); one of the February 1968 "First Survey" sketches shows a six-panelled door in the doorway (YCA B46/1 shelf O4F). As elsewhere, close studding rises from a sill beam resting on the plinth; the space between two of the ground floor joists has been partly glazed to create narrow slit lights. Both the studding and the posts flanking the doorway bear regularly spaced braces which support the jetty bressumer of the first floor. The projecting end of each brace was originally decorated with a carved nailed-on plaque but only two of these survive to the south elevation, a king's head and an acanthus leaf. Further close studding rises from the bressumer, and the first floor has a slightly projecting window of five narrow lights to its west end, a

Plate 6: South elevation of gatehouse prior to repairs, looking north-west.

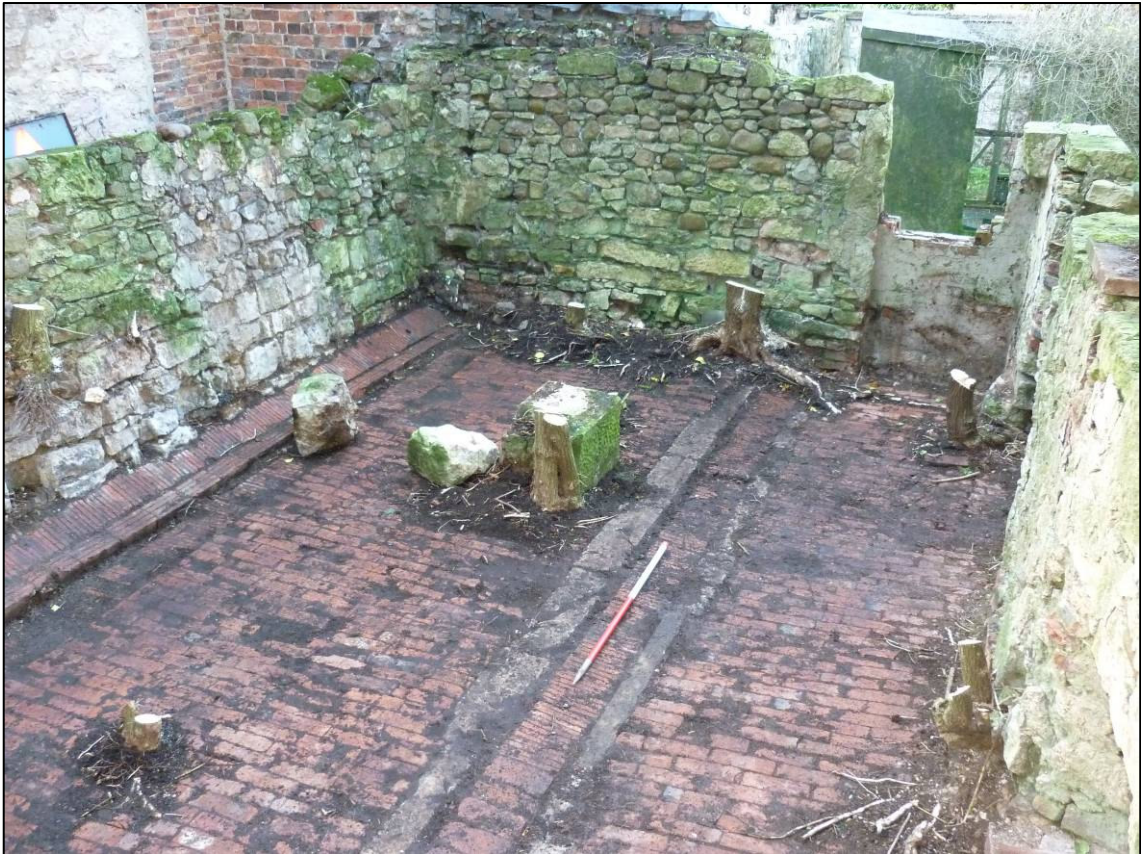
- 3.22 Following clearance, the interior of the west part of the gatehouse was revealed to be largely paved with brick, and preserves clear evidence for it being used for either stabling or as a cow house (see plate 12). There is a c.1m wide strip at the east end of the floor where the brick paving is missing; this equates roughly to the area shown to the east of the inserted brick wall on the July 1970 plan, although there is no trace of the wall itself. One of the February 1968 "First Survey" sketches shows the floor level as being raised in line with the gap in the paving, stepping up by as much as 1m to support the brick wall shown in July 1970. It therefore appears that after 1970 this "step" in the floor level was dug out, perhaps as part of the 1972-74 works.

Plate 12: West cell of gatehouse after clearance, looking south-west.

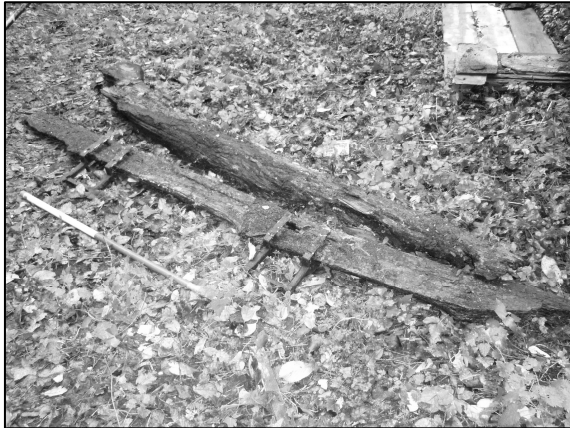
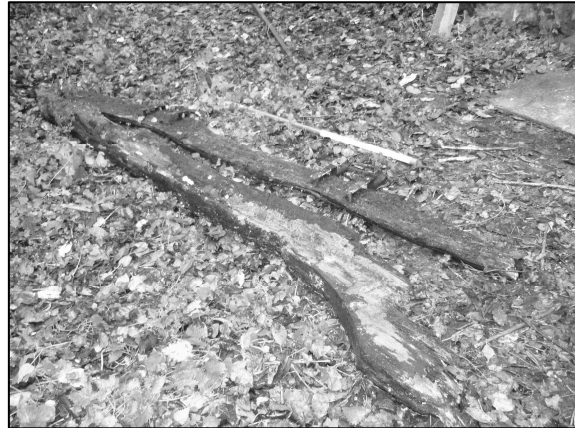
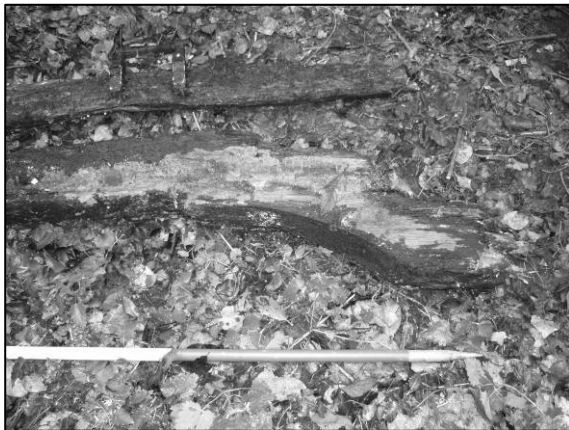
This timber measures 2.65m in length, 0.14m in width and has a maximum depth of 0.41m, although for the majority of its length it is only 0.21m deep. The profile of one surface of the wider end is reminiscent of a post head (see figures A1/1); although the timber seems rather narrow for this purpose, it could have been split down from a larger piece or simply just rotted into several pieces. On the opposite surface, there are the remains of two mortices; if the timber did form the remains of the head of a post, then the relative placing of these mortices might suggest that they housed an aisle tie and aisle principal or rafter, although a brace to a jetty bressumer is more likely, given that such features are shown in this position on the c.1973 photograph reproduced by Kvarud (1991).

Photo 2/452: Timbers 1 & 2 - general view.

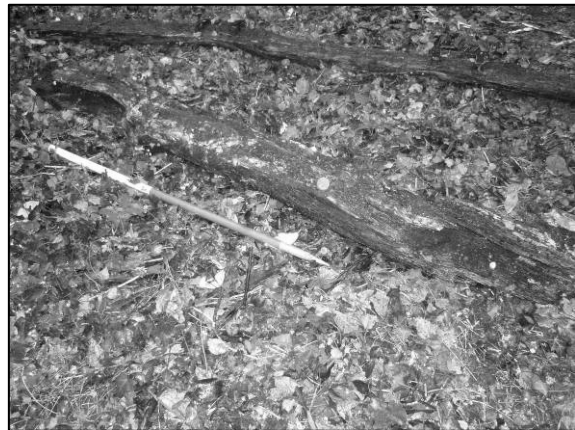
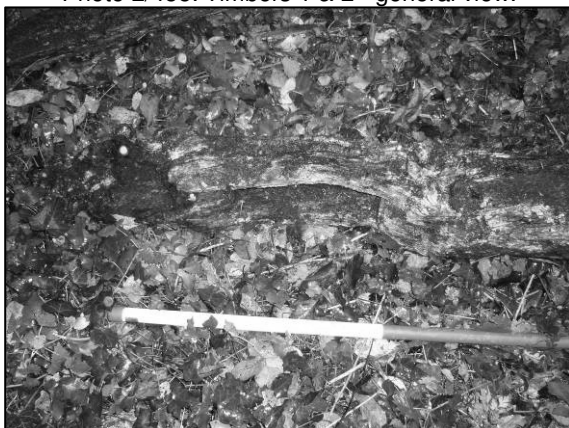
Photo 2/465: Timber 1 - detail of mortices.

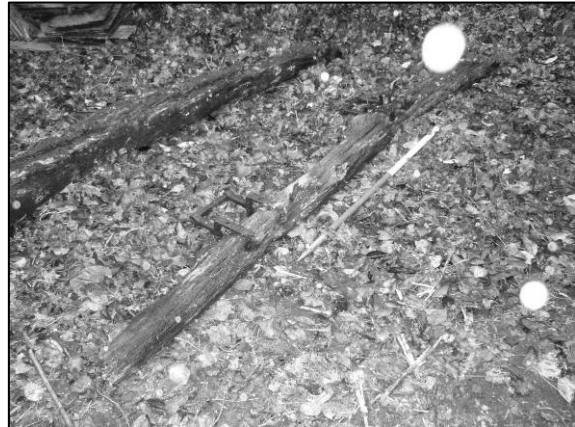
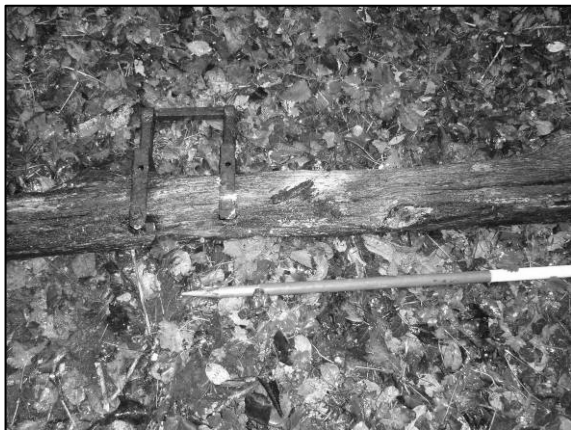
This timber measures 2.75m in length, 0.08m in width and 0.18m in depth. One end is slightly splayed or angled, and might form the remains of a scarf joint. There are two wrought-iron brackets attached to the timber. Each is formed by a pair of flattened straps, slightly raised from the surface of the timber, and once joined by bolts running through the timber; these are or were secured by square nuts. At their base, the straps joint to form a thicker (circular section) piece, which projects beyond the timber. The thicker pieces to both brackets have an eye at the project end, through which a thick wrought-iron bolt is placed. These brackets are sometimes seen where a timber has later timbers strapped on to it in order to provide extra support.

Photo 2/468: Timber 2 - detail of wrought-iron brackets.

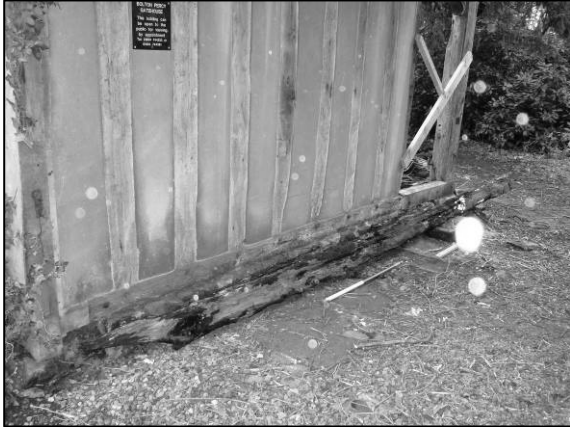
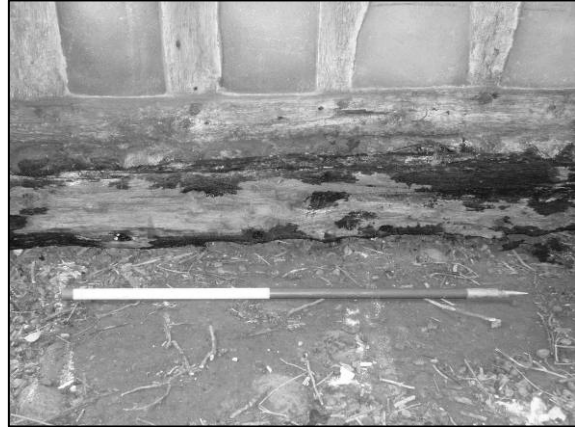
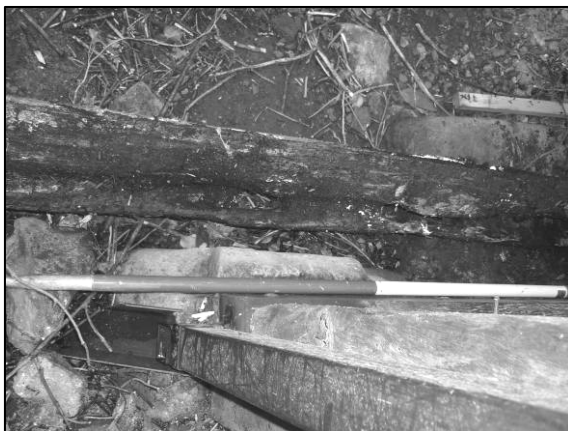
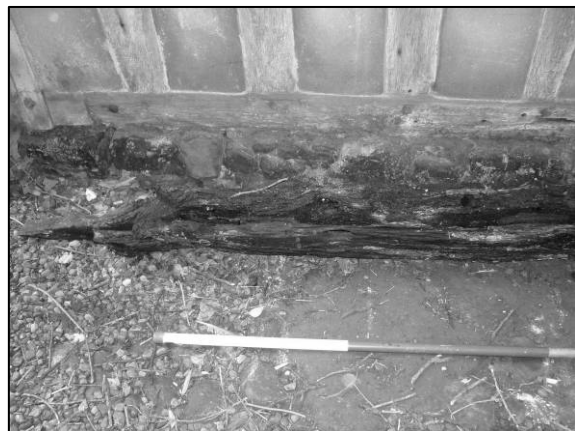
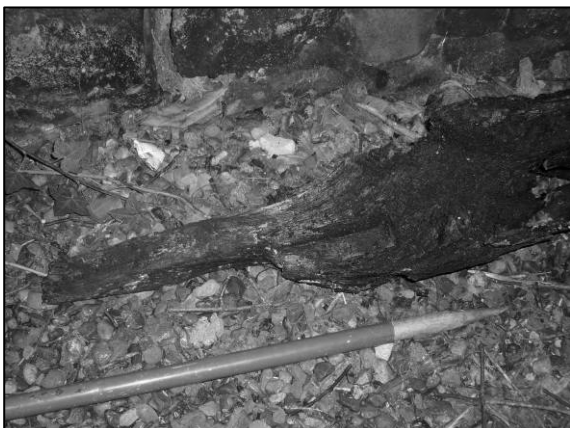
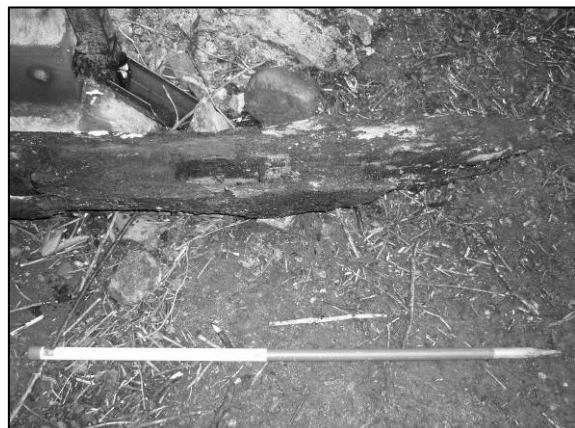
This timber measures 5.40m in length, 0.15m in width and 0.21m in depth. It appears to form part of a mid-rail, with the very decayed remains of either a stop-splayed or possibly a face-halved and bladed scarf joint at one end. There are 14 mortices for studs in the top, spaced at equal centres and averaging 0.20m in length, although two slightly wider examples may once have housed braces (see figure A1/1). There are a group of four peg holes at one end of one side, and two peg holes at the opposite end of the same side. The condition of the soffit was so poor that it was not possible to tell if there were any corresponding mortices for these peg holes in the soffit. The length and form of the timber suggest that it may be the west part of the jetty bressumer with a stop-splayed scarf at one end in the west part of the gatehouse on one of the "Survey no. 3" drawings.

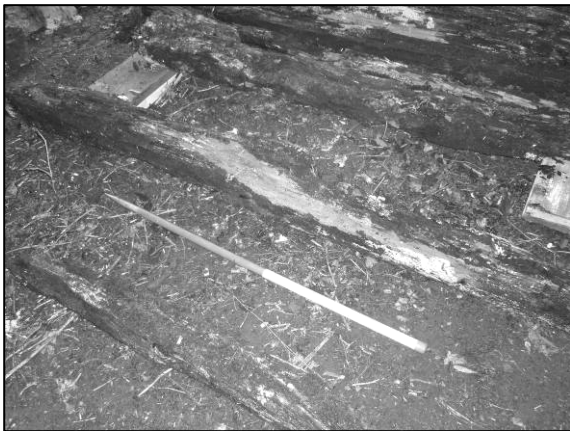
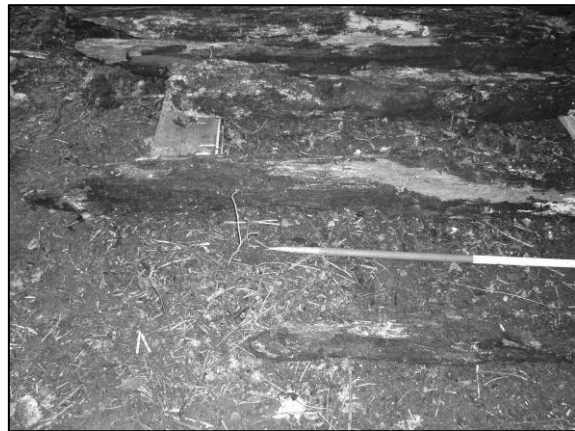
This timber measures 2.26m in length, 0.17m in width and 0.20m in depth. It is very decayed and preserves no other features.

Photo 2/475: Timber 5 - general view.

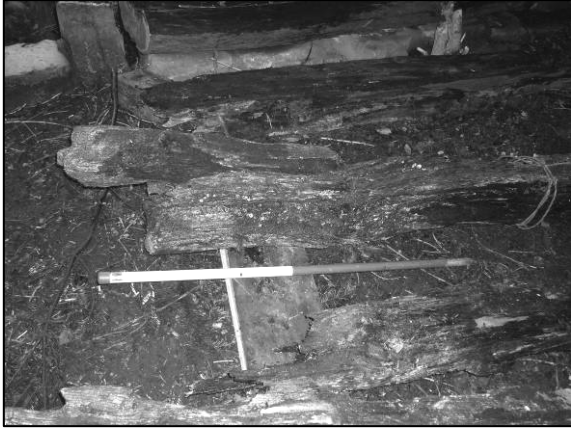
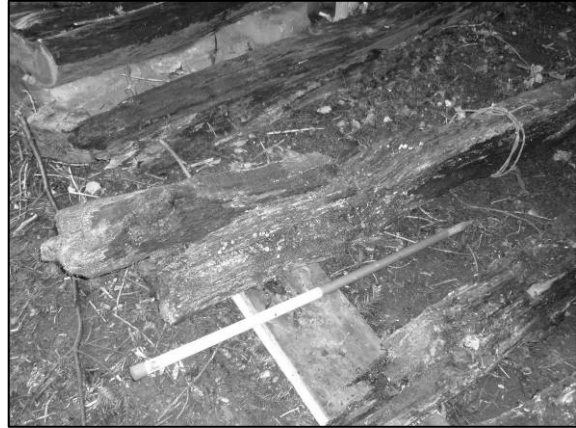
This timber measures 3m in length, 0.25m in width and a maximum of 0.30m in depth, although the majority of the length is only 0.20m deep. The timber is slightly jowled to the wider end; a cut out at this end almost certainly once housed an arcade or wall plate, suggesting that the timber is the remains of a post.

Photo 2/500: Timber 13 - general view.

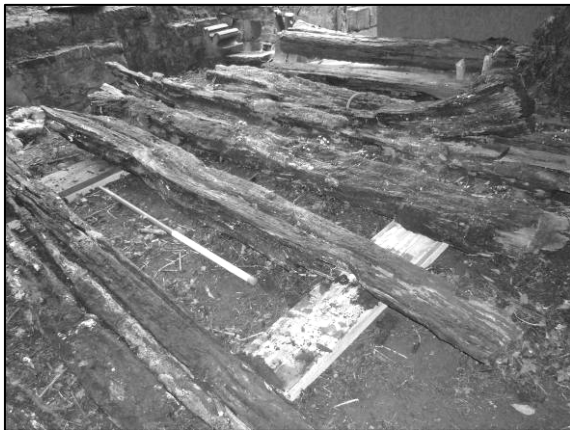
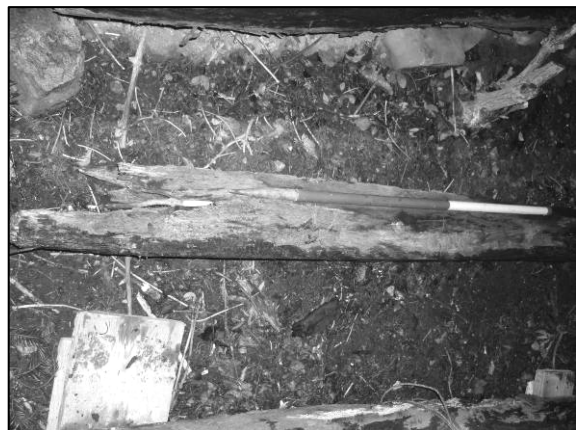
This timber measures 2.60m in length, 0.15m in width and 0.22m in depth. There are 3 mortices for studs in the top, spaced at equal centres and averaging 0.20m in length. There are a group of three peg holes to one end of one side, corresponding to the mortices, with a further two peg holes to the opposite end where the timber is very decayed. It may form the remains of a sill beam.

Photo 2/502: Timber 14 - general view.
