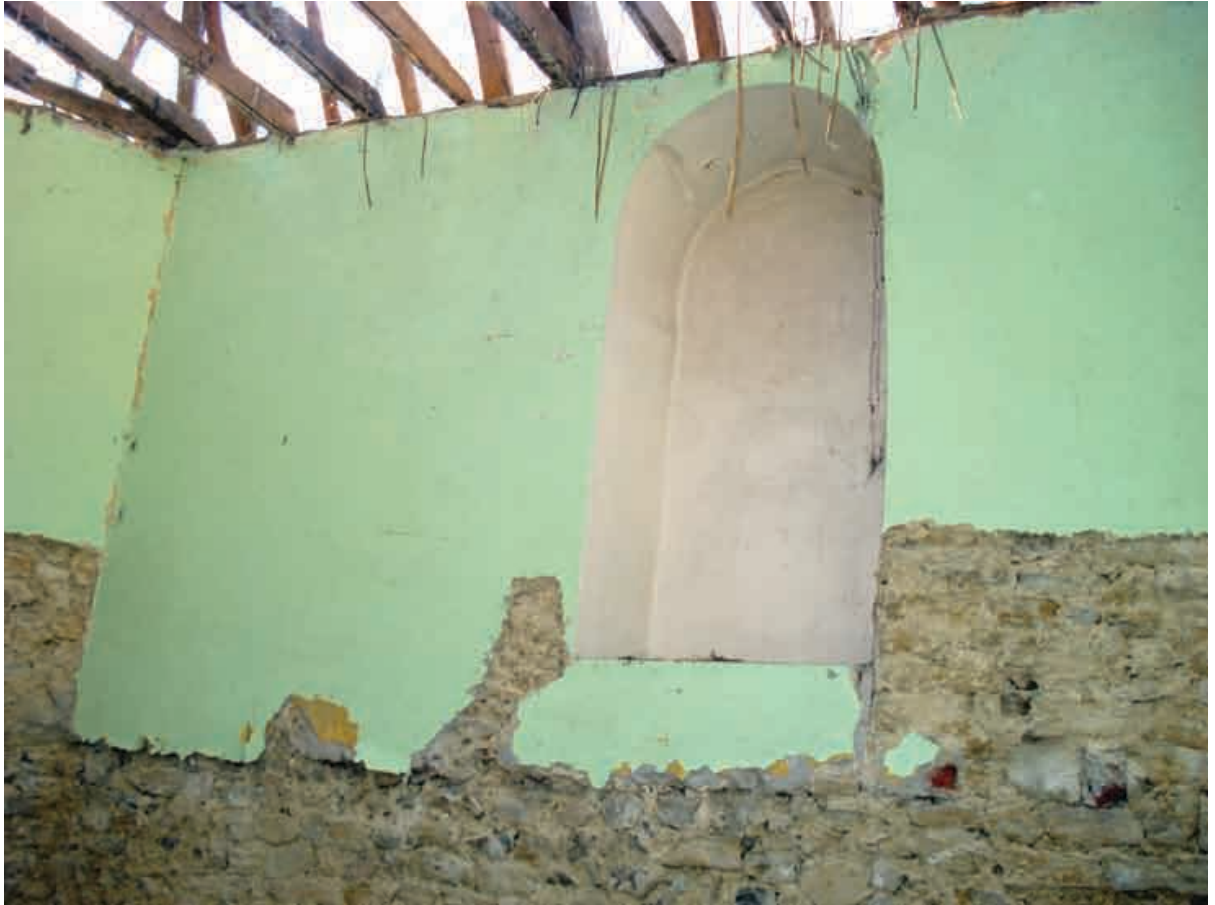
Plate 5 The blocked gallery doorway, showing infilling at bottom and floor-joist sockets blocked with bricks to right, looking northwest.

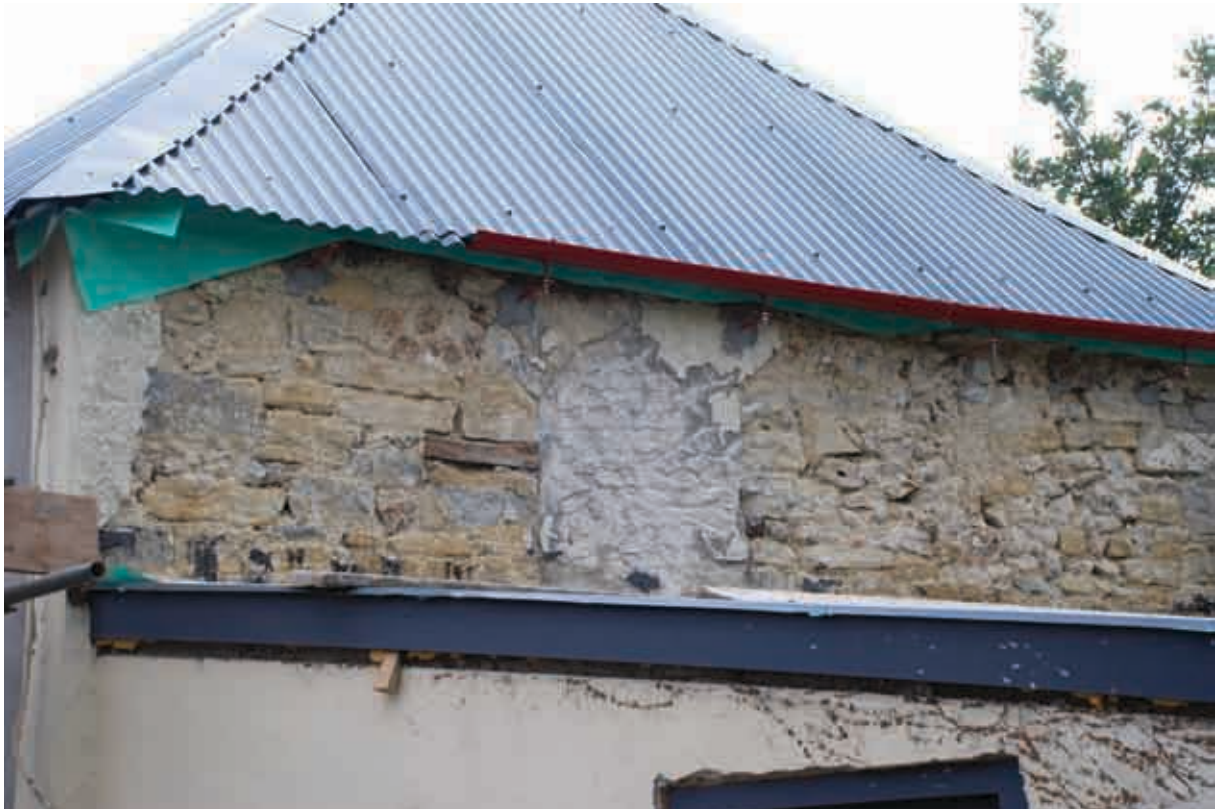
Plate 6 The blocked gallery doorway visible above the lean-to roof, looking south.
