Historic Building Recording  
Roof Repairs at  
Hamilton's Land  
Linlithgow

LL05

**HISTORIC BUILDING RECORDING  
ROOF REPAIRS AT HAMILTON'S LAND  
LINLITHGOW**

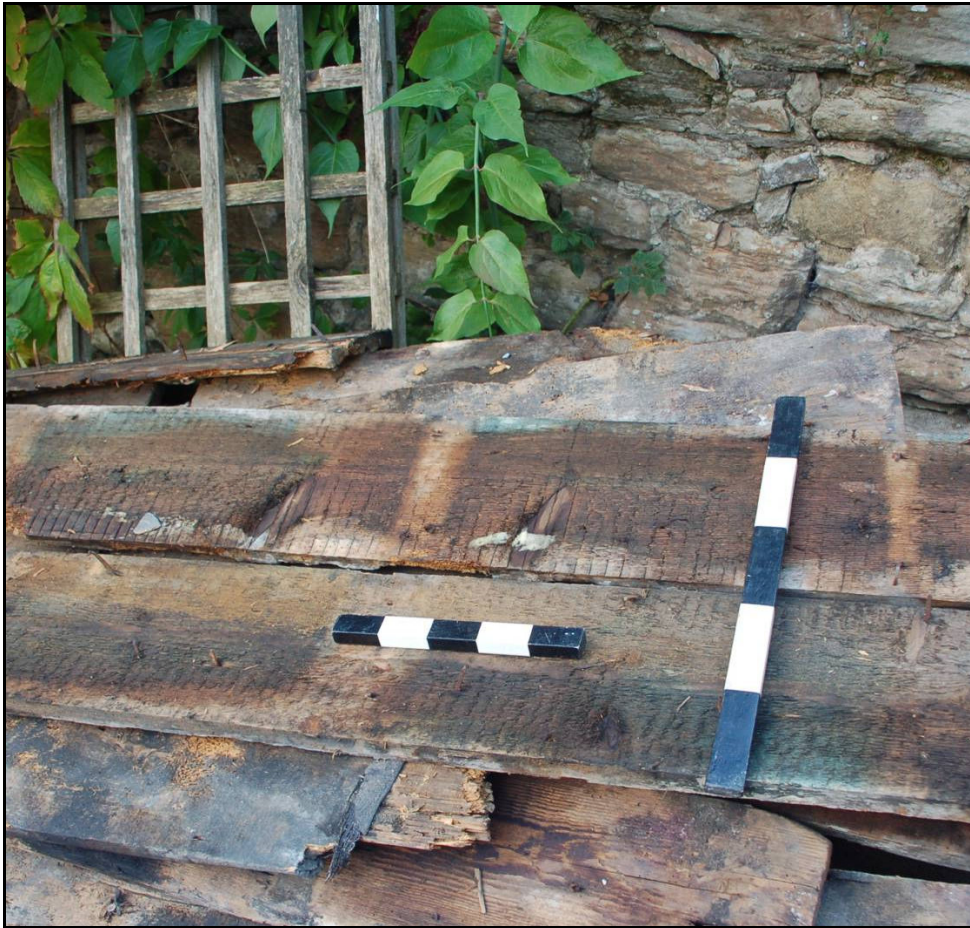
The old sarking was found to comprise sawn softwood planks, probably Scots pine. Close inspection of the wood showed the saw marks to be straight but irregular, consistent with pit sawn timber. The maximum length of sarking planks was recorded at 3700mm, but many were shorter. A variety of thicknesses and widths were recorded including 220mm x 20mm, 240mm x 28mm and 220mm x 25mm. Due to the sporadic nature of the roof inspections no phasing of the sarking could be established.

*Photo of sarking*

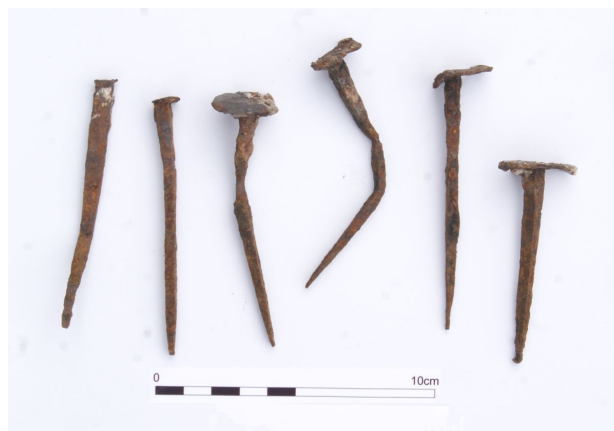
The stone slates had been removed prior to inspection of the building but it was clear that they had been attached to the sarking using square sectioned nails with large heads. These had been hand forged from wrought iron and are commonly known as clout type nails. Similar nails had also been used to nail the sarking to the rafters. Many of these nails had lost their heads when the stone slates were removed due to the soft nature of the iron. The wide variety of nail lengths recorded (from 62mm-85mm) is to be expected from hand forged nails.

*Some of the nails taken from the sarking*

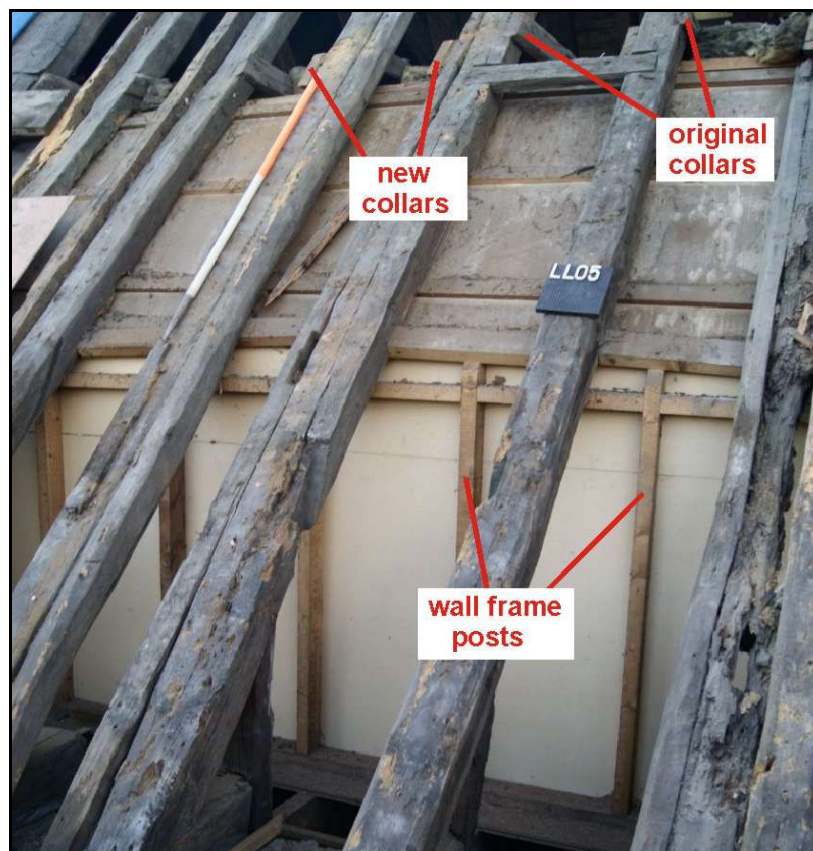
The modern attic conversion had led to the various alterations of the original fabric of the N roof. Inspection below the wall head of the N wall showed no trace of any old floor joists; instead modern floor joists appeared to have been inserted into heavily cemented joist sockets, which may or may not have been original. At the S side of this roof these floor joists were built into modern brick walls constructed on steel I-beams. The joists supported wall frames for the new conversion which were situated so that the floor space in the converted area was about three quarters of the overall roof span. The tops of the wall frame posts were nailed to short planks which bridged the spaces between the original rafters. From here the sloping ceiling of the conversion (made from fibreboard and thin planks) was nailed to the underside of the original rafters.

*Photo showing modern attic conversion*

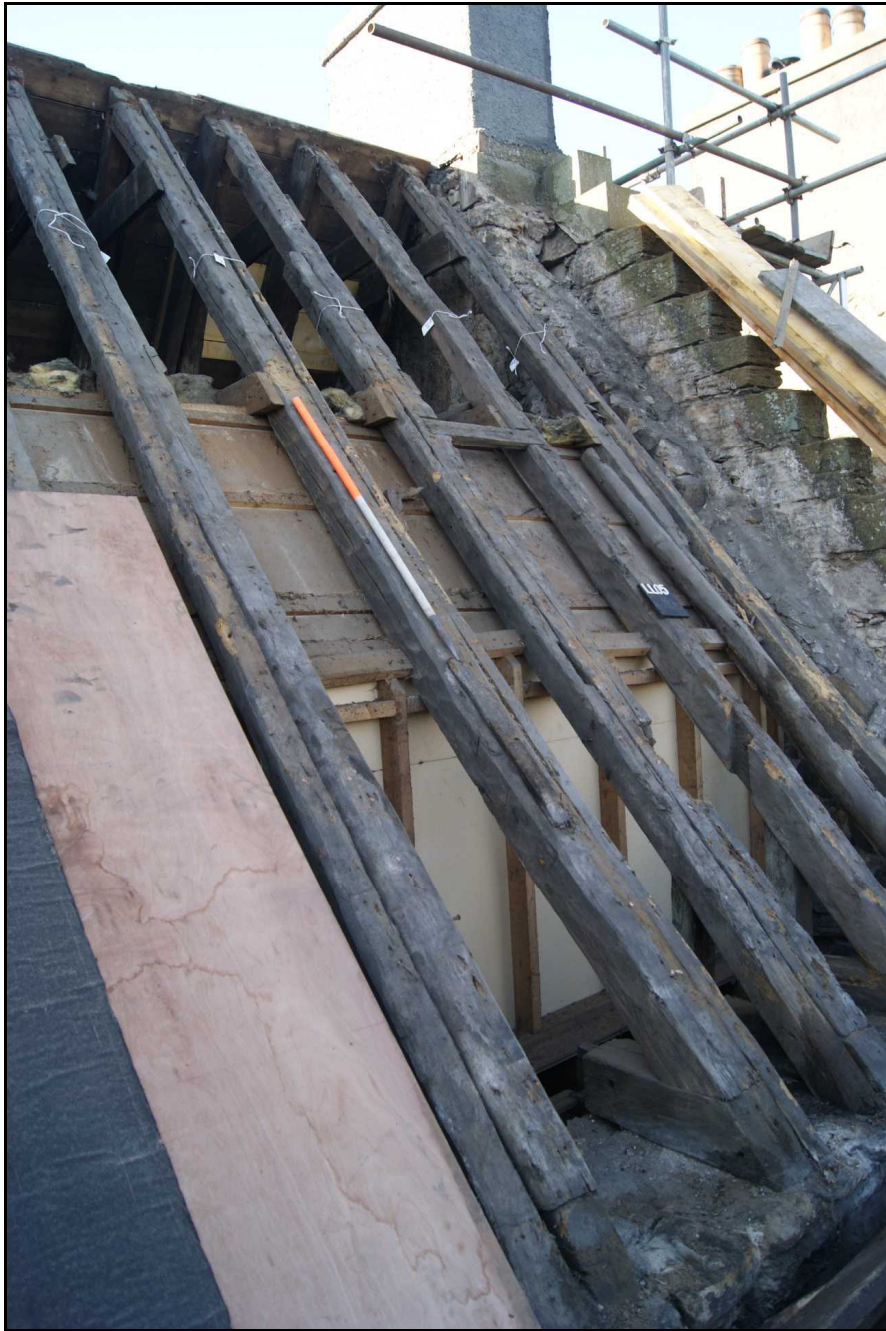
*Photo of rafters, N pitch of the N roof*

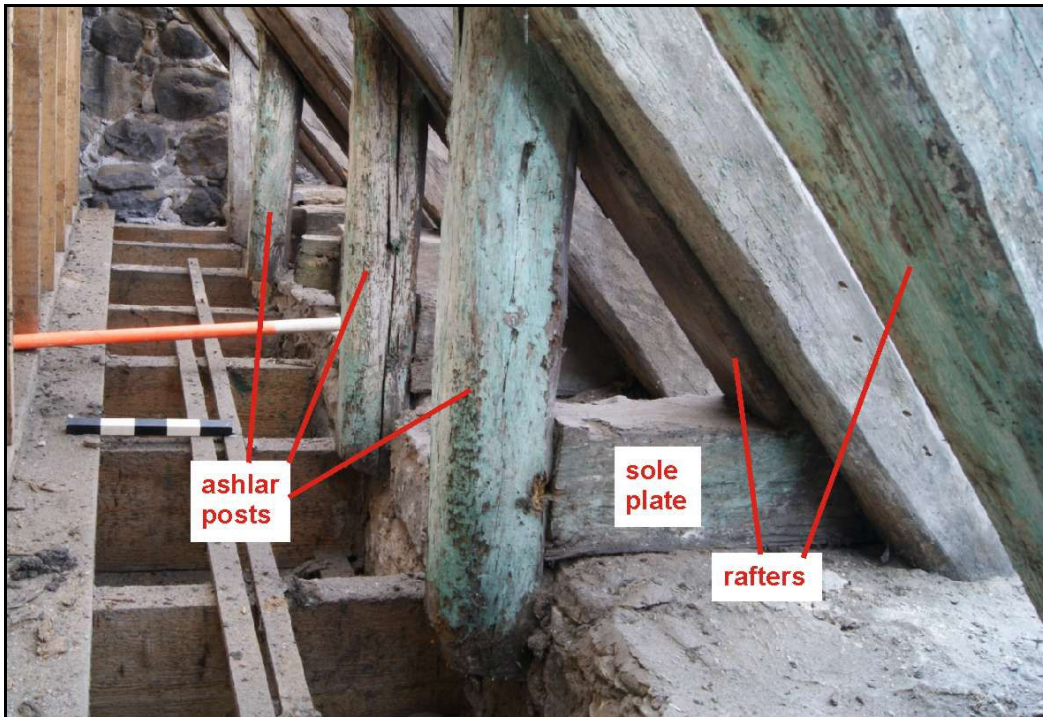
*Photo showing ashlar posts and sole plates at the N wall*

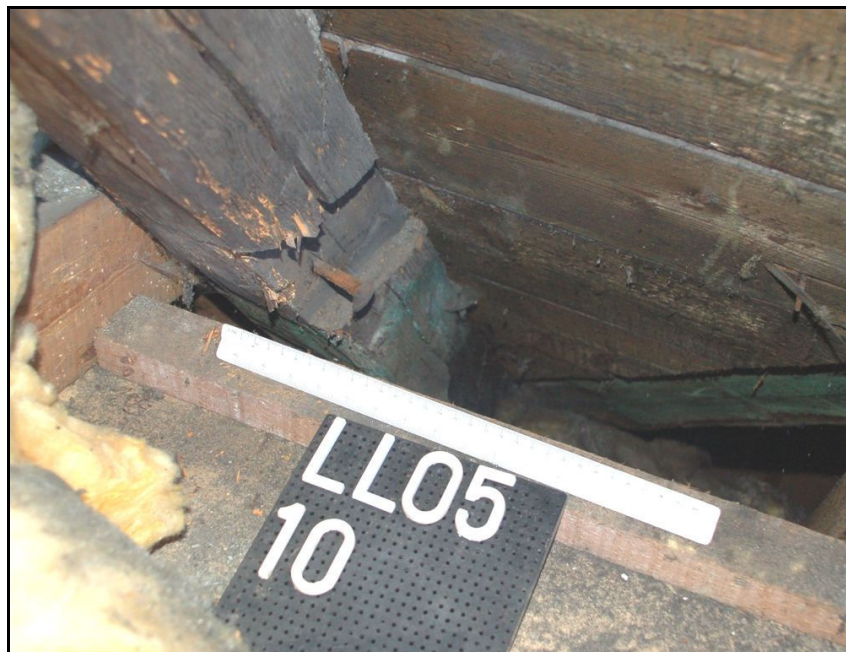
Photo showing lap joint where collar removed (rafter group 10) and iron spike/nail

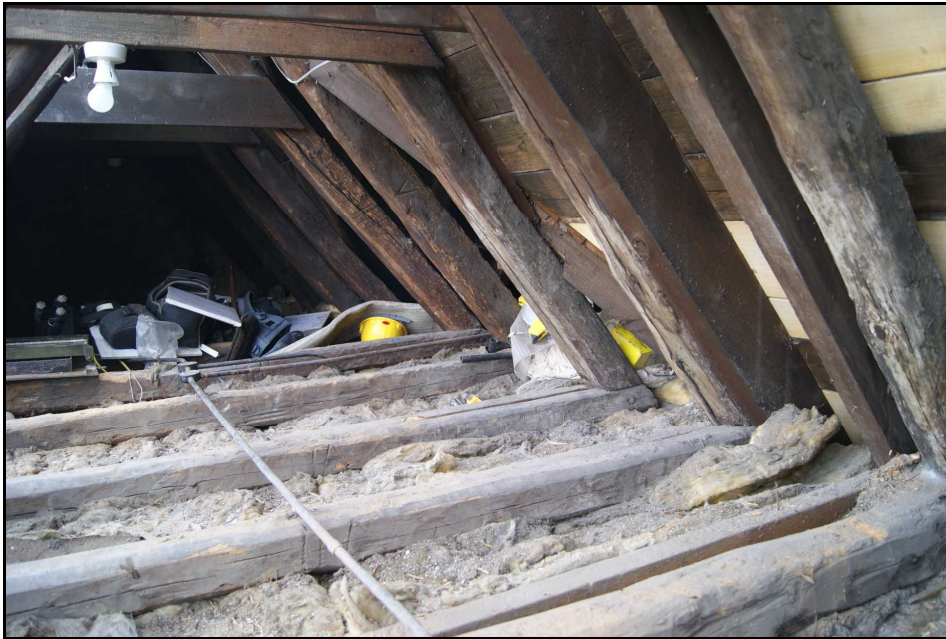
*Photo showing collars of the N roof*

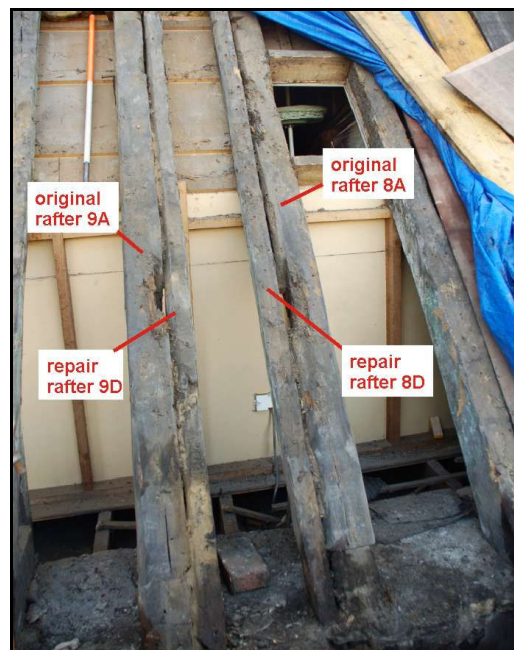
Fairly extensive repairs were found to have taken place to the roof over the years. Hewn and adze-trimmed timbers 1D, 1E, 3E, 4E, 5D, 6D, 7A, 8D and 9D/E had all been nailed to original rafters to strengthen the N facing roof pitch.

*Photo showing some of the repairs to the N roof*

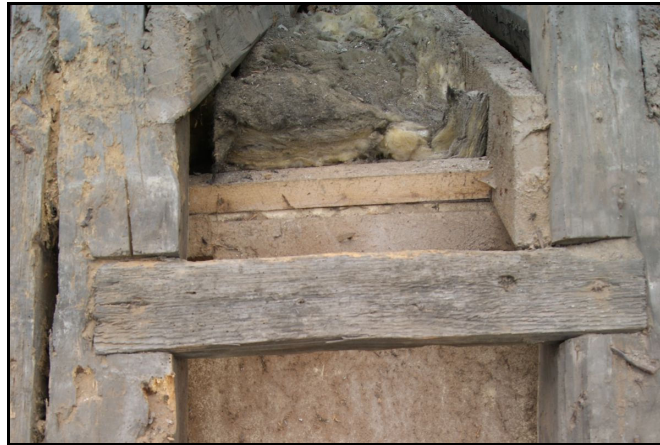
*Photo of bridle beam 30*

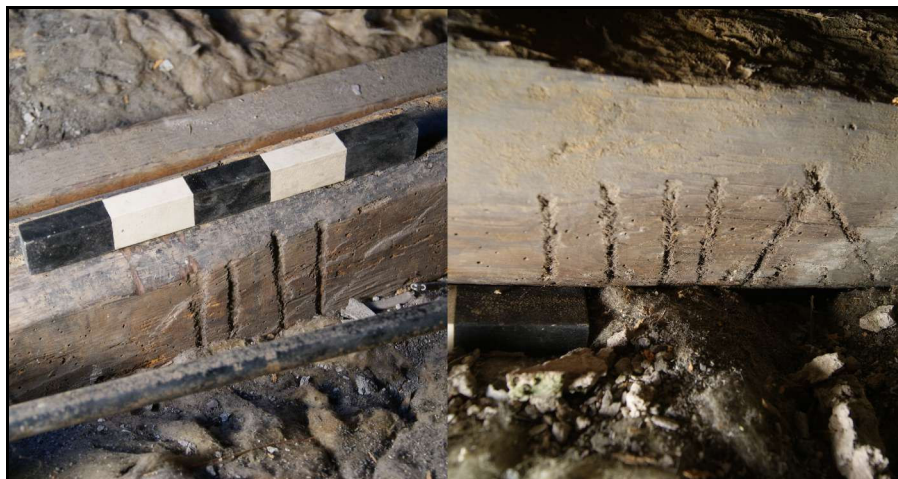
*Photos of assembly marks in the N roof*

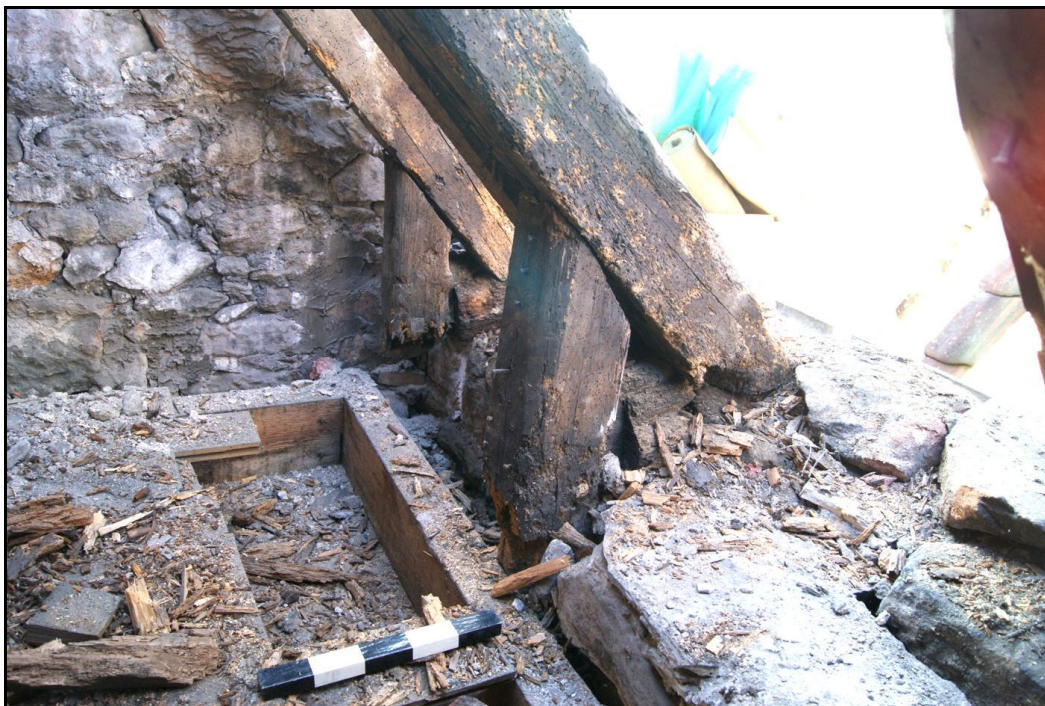
*Photo showing ashlar posts on the W side of the S roof*

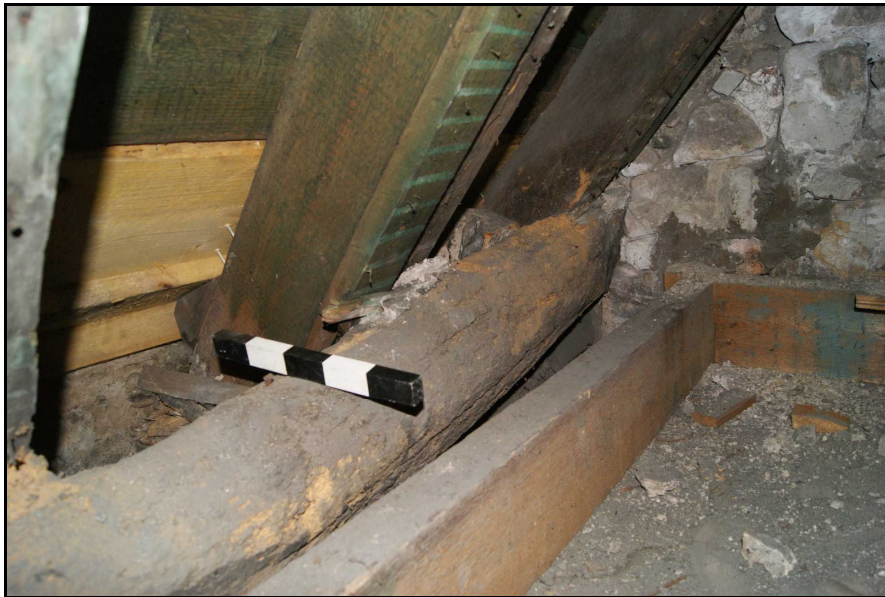
*Photo showing beam 26 with 27 below*

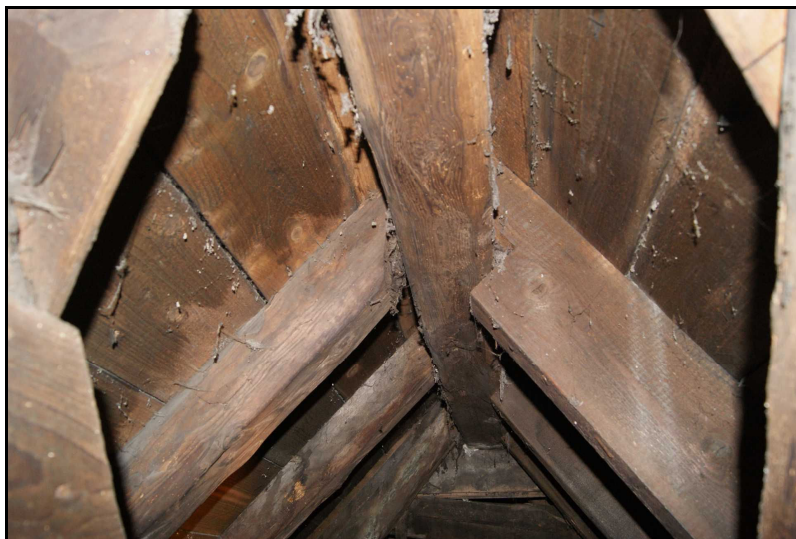
*Photo showing ridge plate 25*

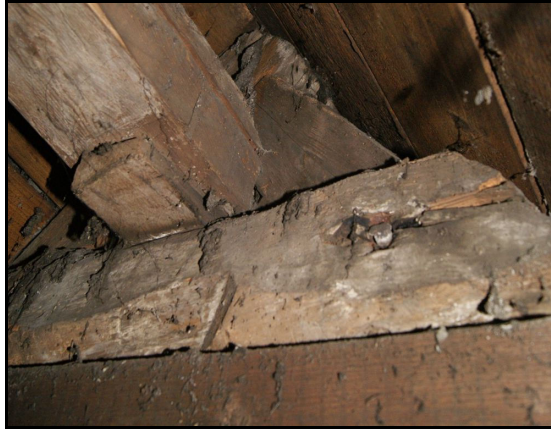
*Photo showing collar 34*

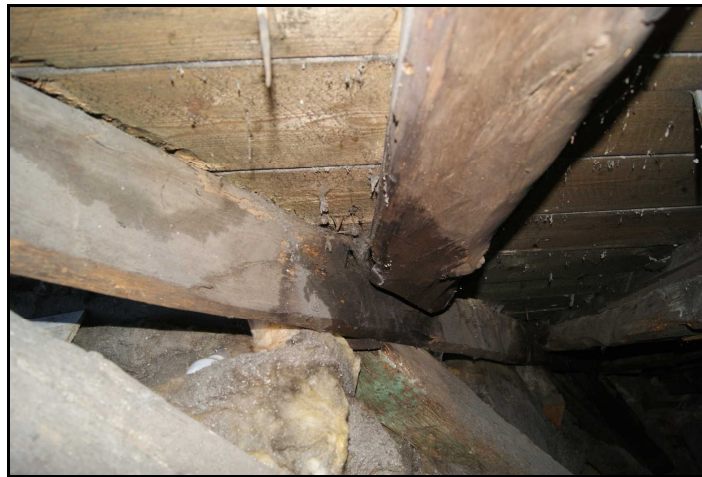
*Photo valley timber 23B and rafter 21B*

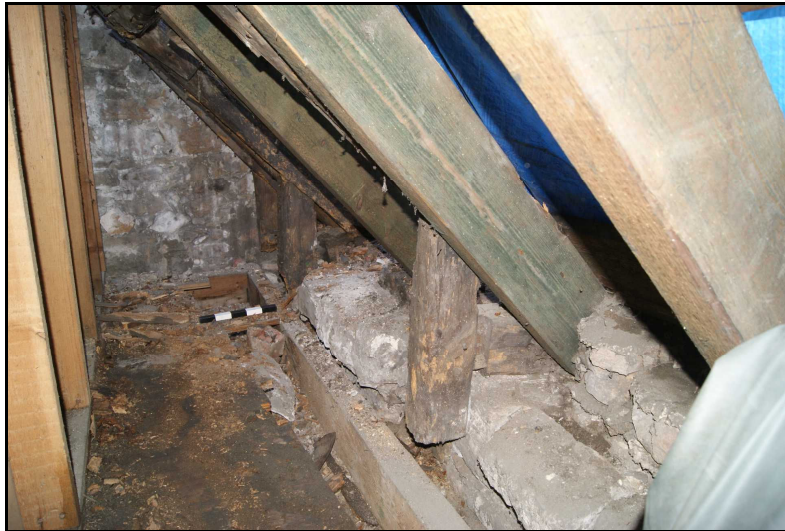
Most of the S roof had been repaired with modern circular sawn timber; essentially replacement rafters nailed to the sides of original ones. In fact only 6 out of 20 rafters still support their own weight (rafters 12A, 17A, 18B, 19B, 20B and 21B). Some of the original rafters have been cut in half, their lower ends removed when fitting the replacements.

*Photo showing replacement rafters on the W side of the S roof*

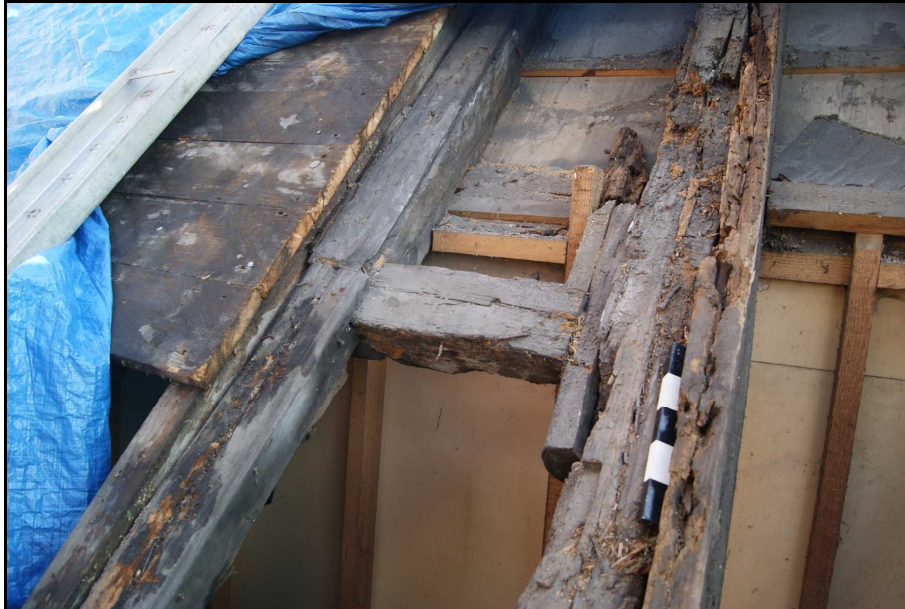
*Photo of bridle 36 on the W side of the S roof*

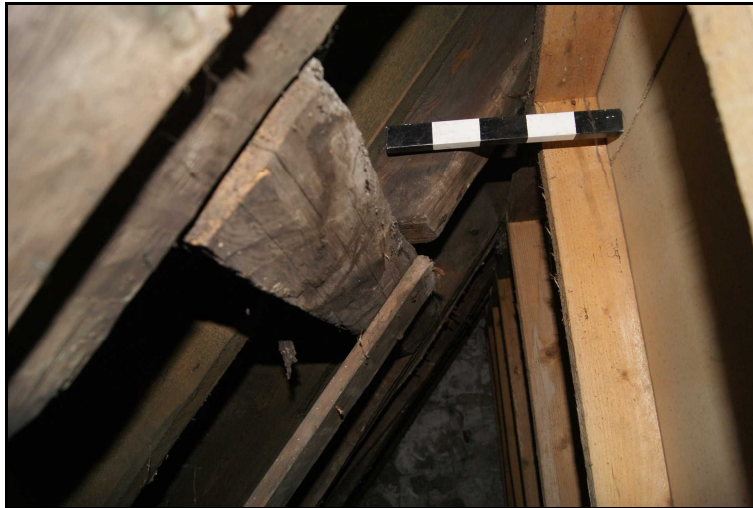
*Photo of bridle 28 on the E side of the S roof*

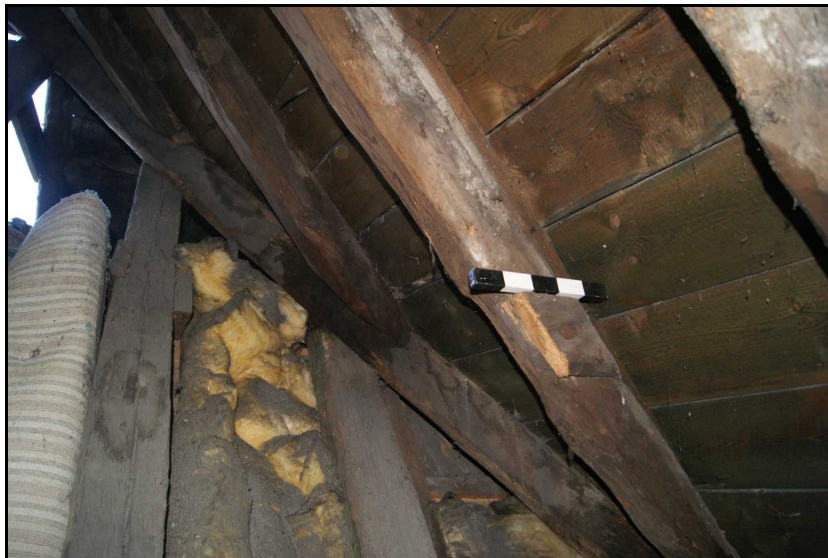
*Photo showing a sawn off collar stub in the S roof*

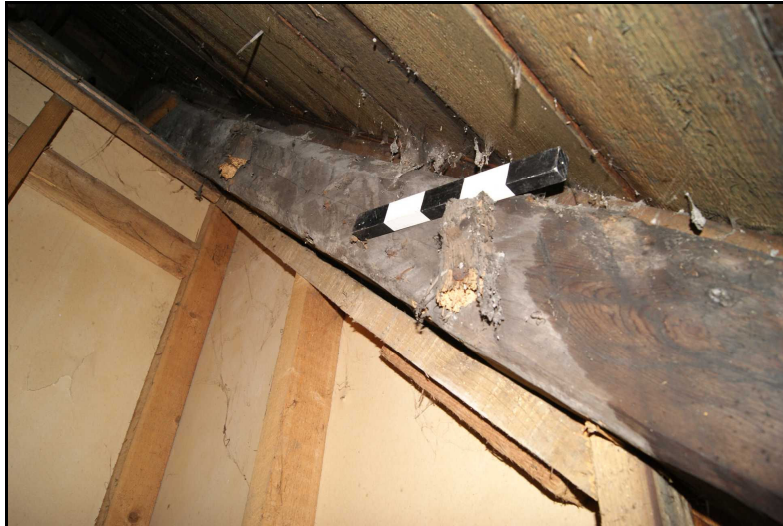
*Photo of studs nailed to rafter 17A*

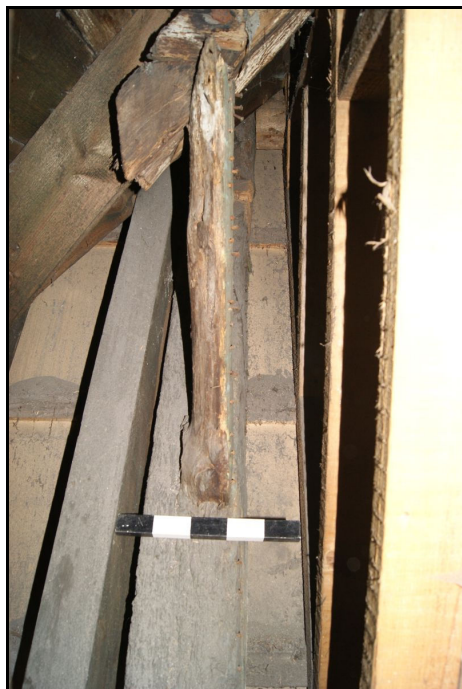
*Photo of stud nailed to rafter 4B*

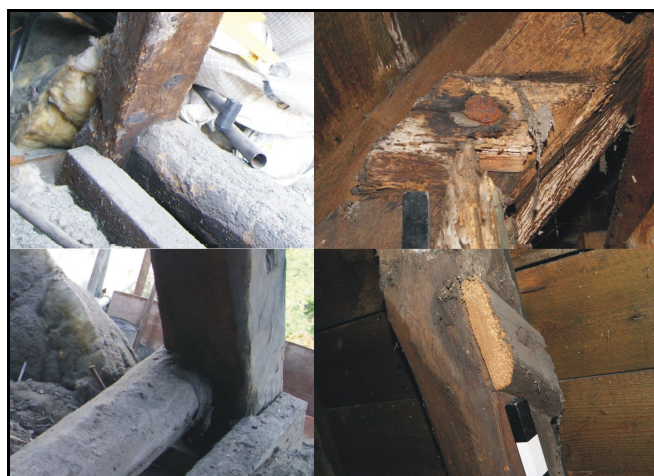
*Photos showing the differences between widths of collars between the N and S roofs. The N roof collars (whole) are shown on the left whilst the narrow S roof collar stubs are shown on the right*

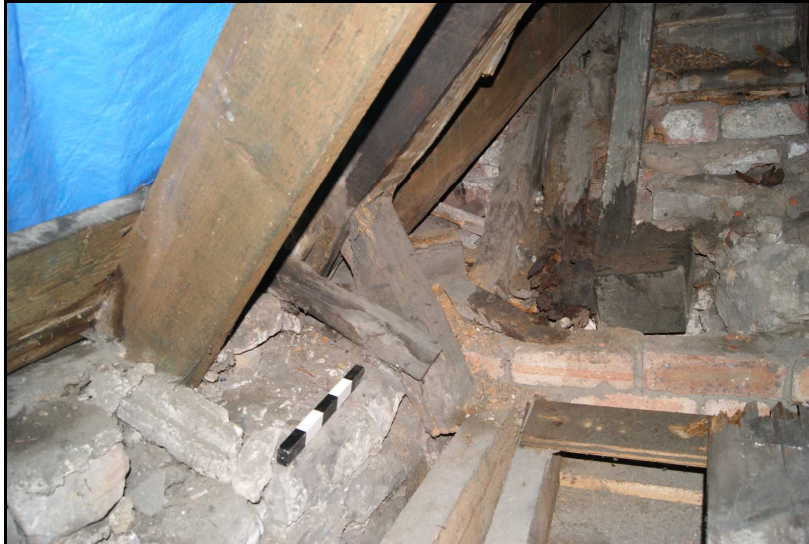
This phase is represented by the relatively recent repairs to the roof excepting the modern attic conversion. Most of these repairs were focused around the S roof and the SW quarter of the N roof. Timbers from this phase are largely replacement rafters made from circular-sawn pine, much deeper than they are wide. These have been simply nailed to the rafters, though the two against the external walls (11C, 12C) had to be fixed with bolts due to lack of space to swing a hammer. Repairs seem to have been necessary because of water damage to the original rafters, and in fact the damage on many rafters must have been so severe that they were either removed or cut short (16A, 18A, 19A, 21(W side), 20(W side)). Strengthening on the S half of the S roof was also undertaken because the roof was spreading outwards, causing the sole plates to move sideways at the wall head; this had also led to the failure of several ashlar posts.

*Photo showing that the ashlar post connected to rafter 17A as been pushed sideways due to the S roof spreading outwards*

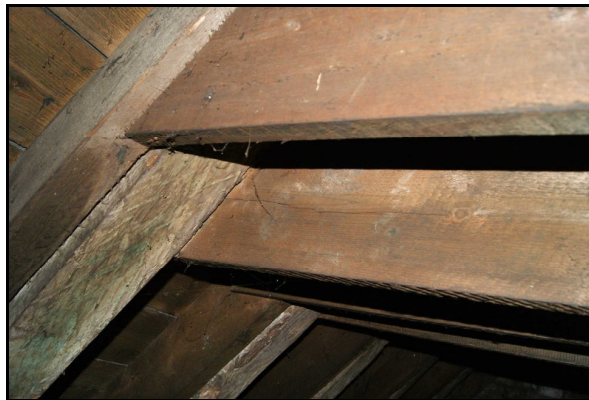
This sideways movement was probably also the reason why the W side of the wall was built up over the sole plates and ends of the rafters. The double sets of collars along the S half of the S roof were probably added at the same time as the replacement rafters to remedy this problem.

*The double sets of modern collars nailed to the rafters in the S roof*

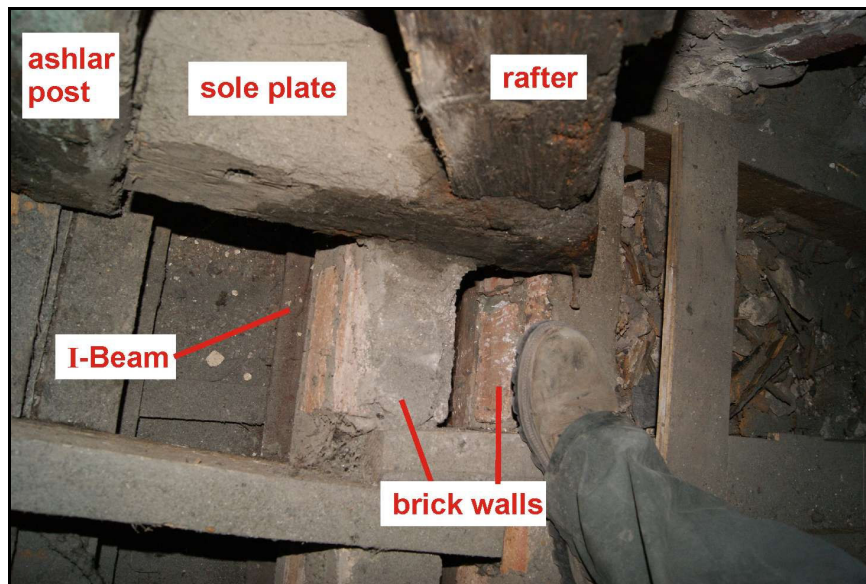
*Photo showing brick walls and one of the steel I-beams*

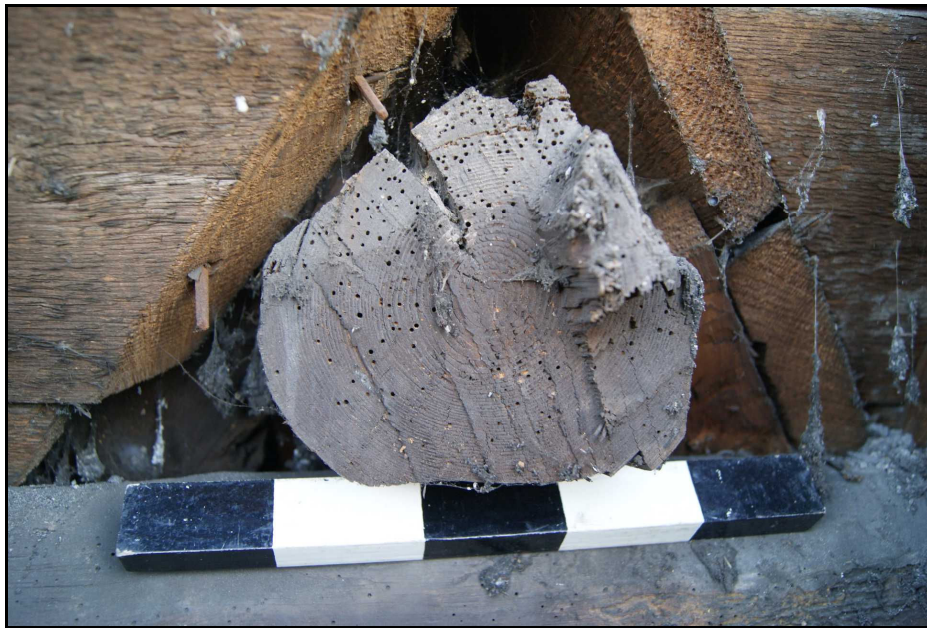
*Photo of N end of ridge plate, the E side (left) would be suitable for taking a core for dendrochronology*

It remains a possibility that a date for the building could be obtained via dendrochronology. The timbers particularly suited to this type of investigation, having surviving outer sapwood layers and showing few signs of rot, are the rafters of the S pitch of the N roof and the ridge plate (see illus 3 for specific timbers). Such a study would be particularly interesting to not only get a construction date, but also to find out if the S roof was constructed later than the N.
