Photographic Survey
Coldrochie Farm
Moneydie
LUNCARTY
PERTH & KINROSS
LJ01

**PHOTOGRAPHIC SURVEY
COLDROCHIE FARM
MONEYDIE
LUNCARTY**

LJ01

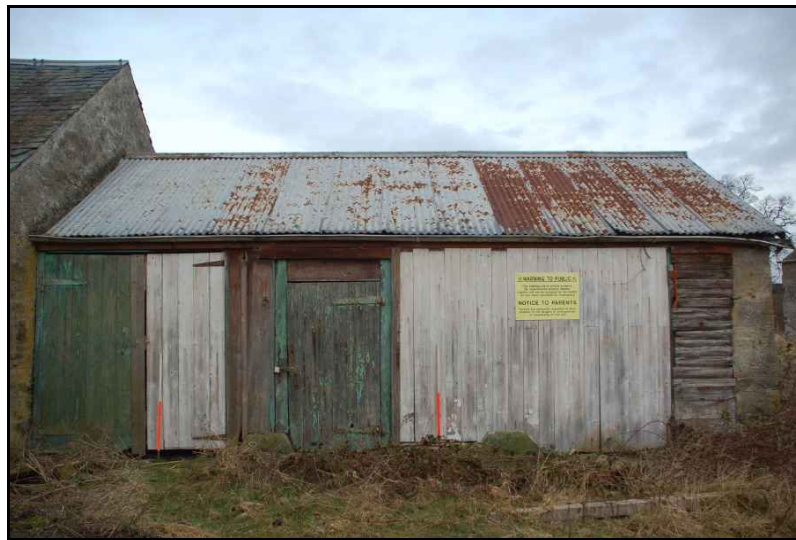
Front elevation of the Cart Shed

The internal faces of these walls (whitewashed/painted) appear much the same as each other, comprising roughly evenly sized sub-rounded stones. Smaller stones, possibly field or river stones have been incorporated into the E wall. The E end of the barn has been built abutting the N wall of the cart shed suggesting the latter is earlier. The floor of this building has been concreted and there are two concrete foundations for divisions which ran behind the plinths, showing that the building was divided into 3 bays.

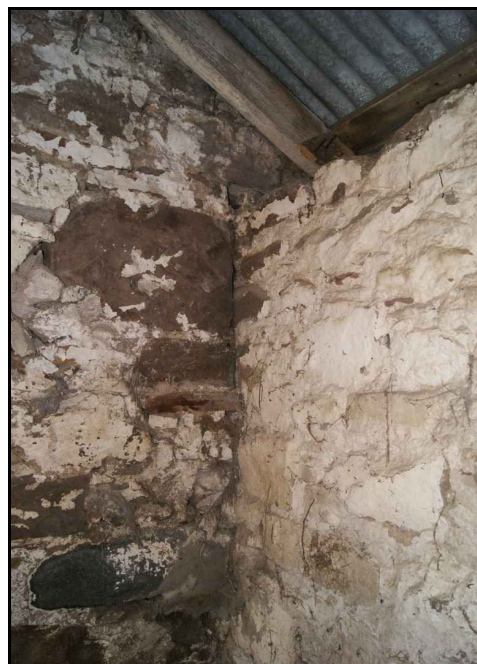
Shot showing where the E wall of the Barn has been built around the N wall of the Cart Shed

The N wall of this building seems to be constructed in a different style to the E. This, along with the stratigraphic evidence for the Barn wall having been built around the N wall, suggests we may be looking at an early building that was modified to form the Cart Shed. The Shed would have been 3 bayed and open to the front with two wooden posts on the plinths visible. Later this structure was converted into a garage and the front openings blocked.

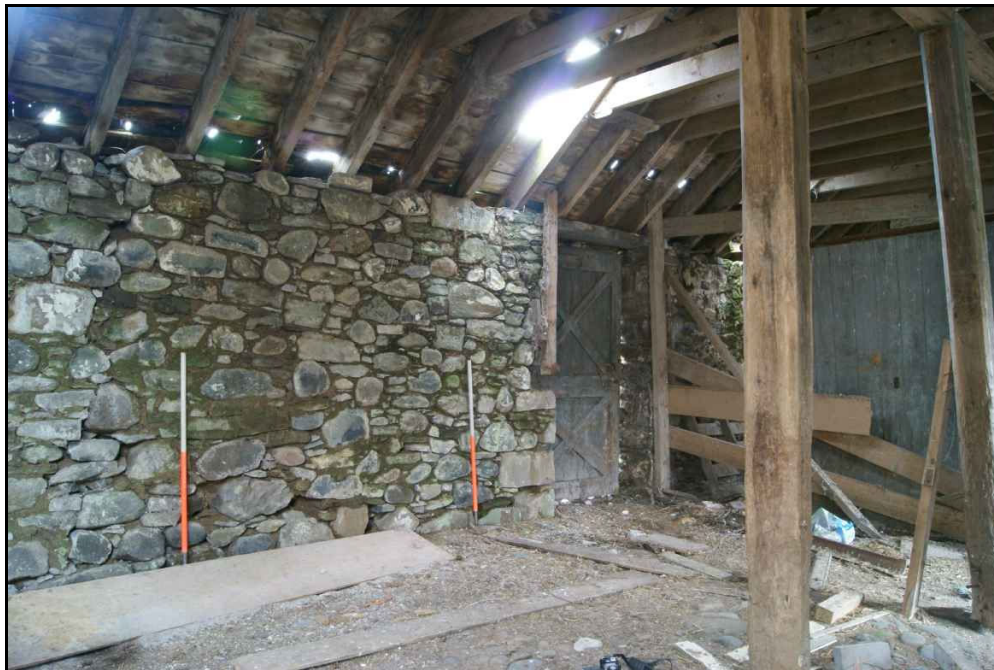
Smaller, more rounded stones have been used for the internal faces of the walls, which are whitewashed. The floor is cobbled and running next to the S wall from the W entrance is a stone lined drain. The barn is divided by a wooden partition incorporating a large wooden sliding door to the E of the two opposing doorways, creating a separate room. The roof is of common collared rafter form connected by narrow sarking planks. The collars are supported centrally by a long beam, a series of scarf jointed pine timbers, attached to 3 vertical posts. This arrangement was presumably necessary for a building of this width. The posts are supported on square stones built into the cobbled floor. In the NE corner where the N wall of the cart shed joined this building, the gable wall has been heavily patched up with cement, bricks and mortar, suggesting this was a weak part of the wall, presumably because the barn wall has been built around the cartshed wall.

Inside the Barn

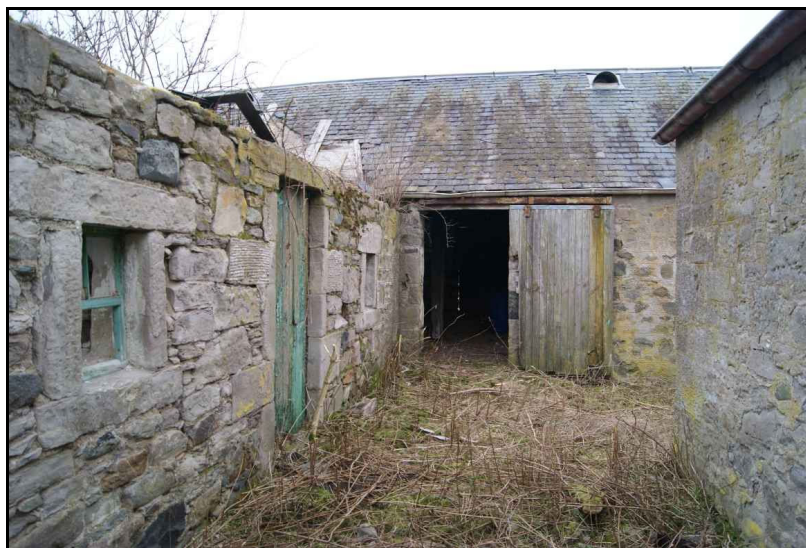
The N half of the byre was probably originally inhabited, as there are two small windows with good frames and window glass. The lower half of the windows have wooden shutters opening inwards. Between them is a double door which had been hinged in the middle so it opened sideways. The floor of this part of the byre could not be seen owing to roof collapse and soil build up. In the W part of the building there are byre stalls separated by three large sandstone slabs (one collapsed) and between them concrete feed troughs. The W wall of this end of the byre had partly collapsed.

The N end of the Byre (left hand side)

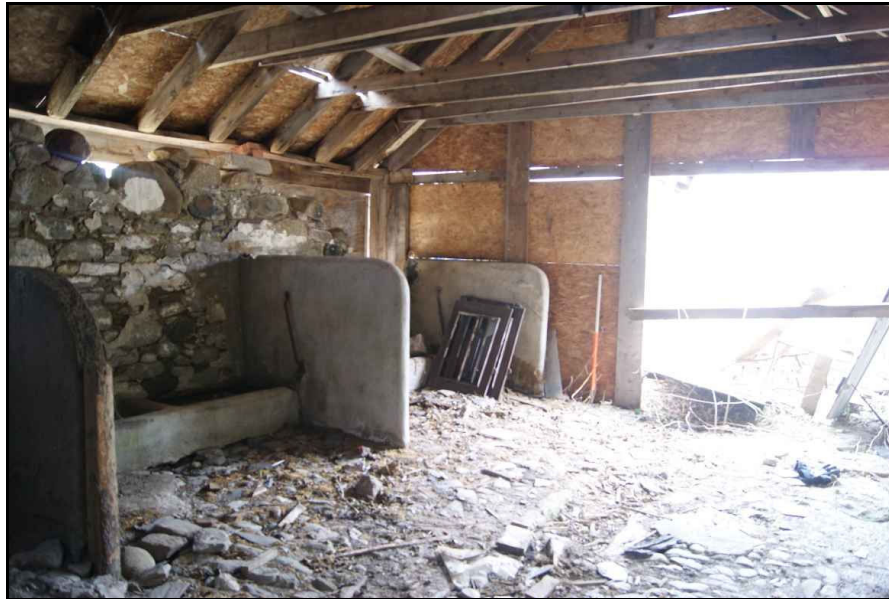
The middle section of the byre still had its roof, of common collared form, pine with rafters resting on wall plates. The floor is cobbled with a stone slab lined drain running down the middle. On the W side, just as to the N, are large divisions for stalls made from sandstone slabs, some coated in concrete.

The middle section of the Byre

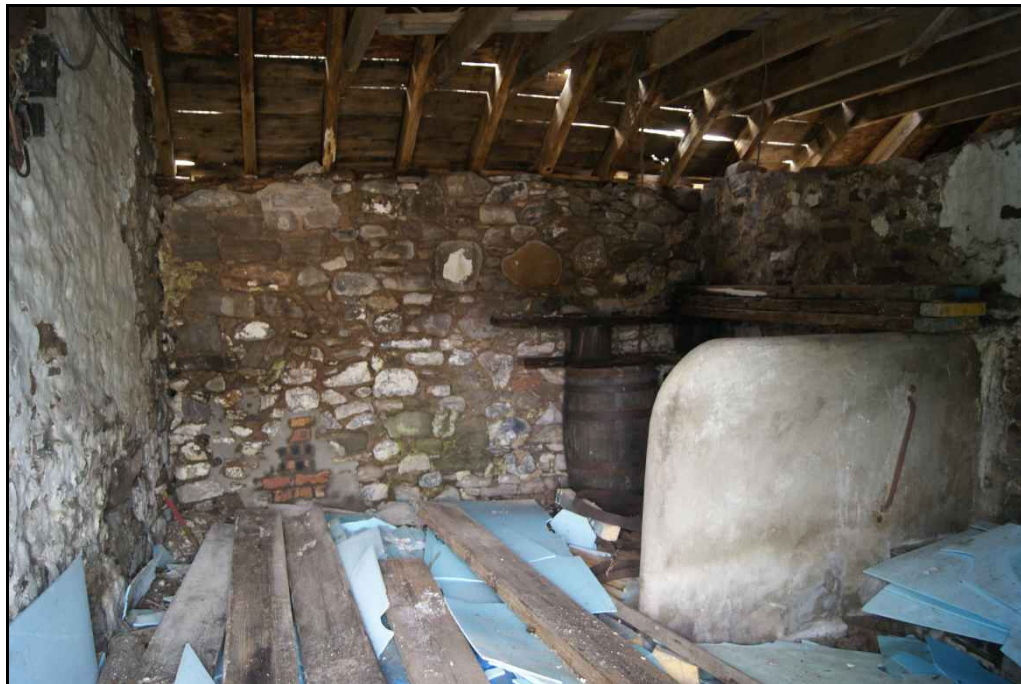
Dividing this area from the S room is a rubble built internal stone wall. The S room has stalls built against this wall and a stall division (also probably a concreted stone slab) projects S. The feed troughs here were ceramic separated by brick plinths. The floor in the S room was obscured by rubbish and could not be seen.

The S room of the Byre

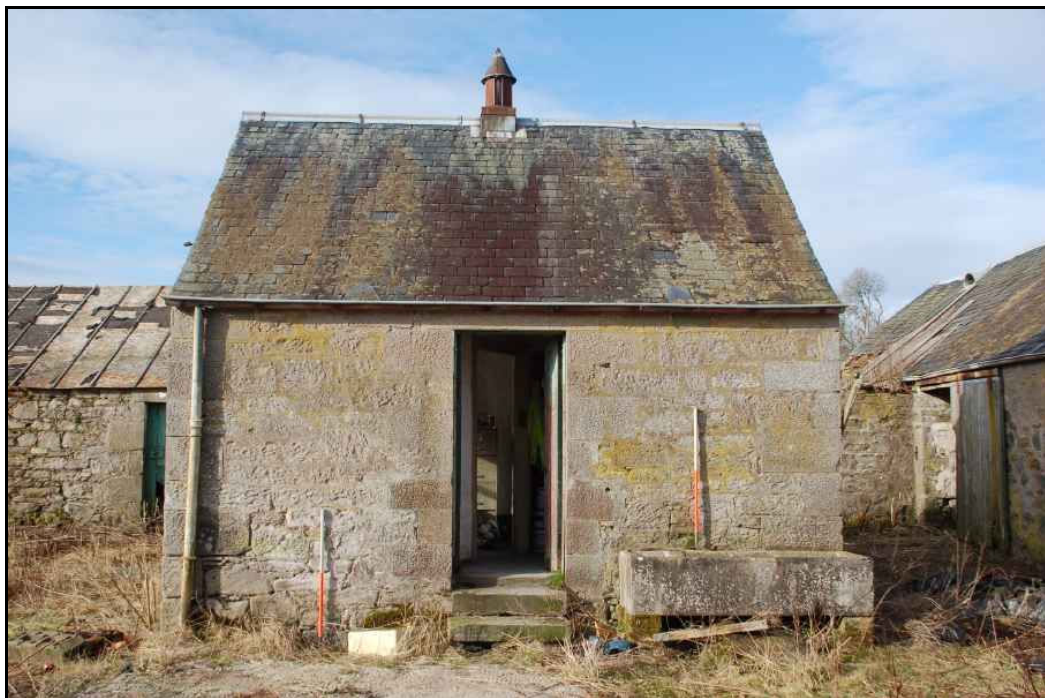
The front elevation of the Dairy

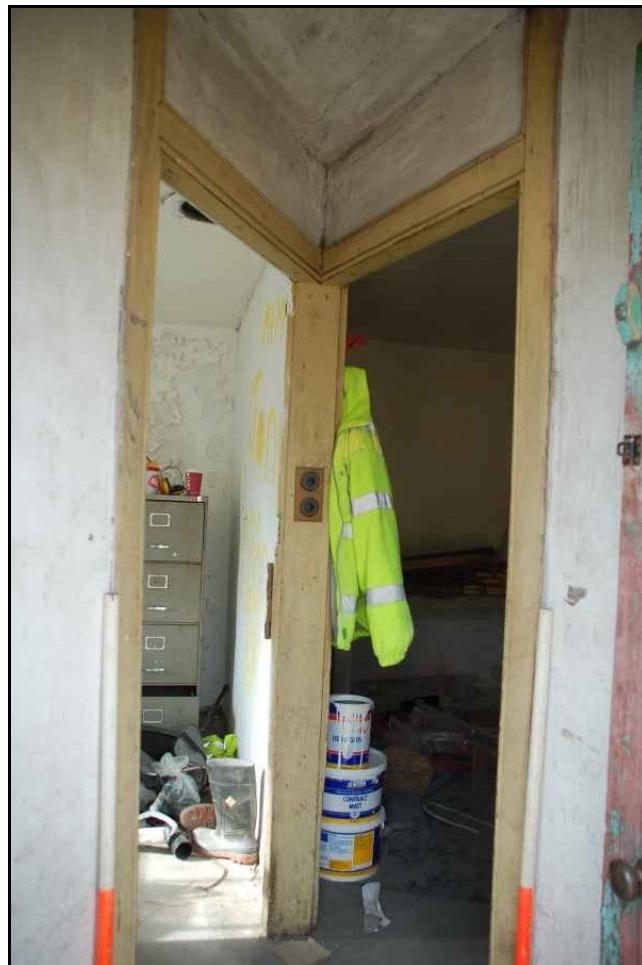
Inside, the dairy has been partitioned into two rooms with plastered walls, probably brick. The floors of both spaces are concreted, with traces of linoleum in the S room. There are two features of interest in the S room, a vent in the S wall exiting where the pipe was noted above, and a much wider hole in ceiling. This latter feature may have been a hole for a chimney from a boiler that may have been installed in the centre of the dairy before it was partitioned. The N room is painted cream / light yellow and around the walls are shelves made from stone slabs, presumably preparation surfaces for butter and cheese making which could be easily cleaned.

Shot showing later internal divisions in the Dairy

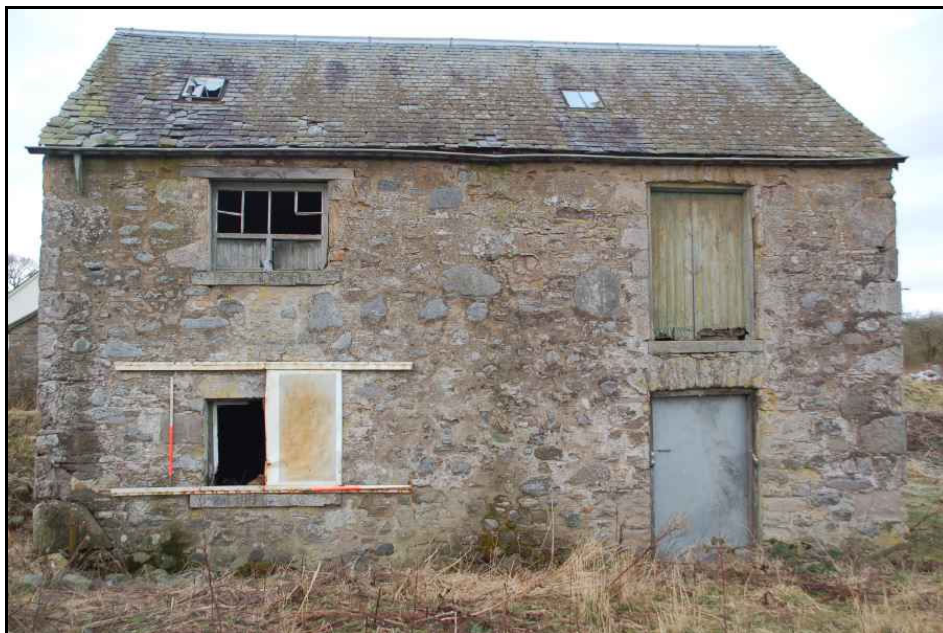
The front (E) elevation of the Mill

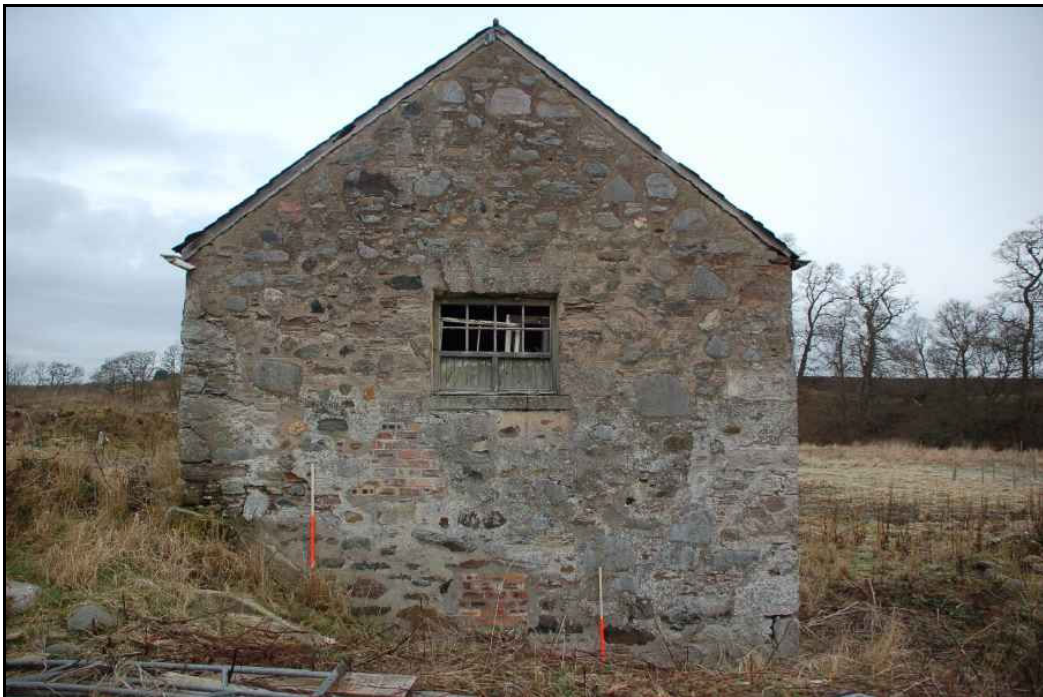
The S elevation of the Mill

The S elevation has been repaired with 20th century brick in places, and beside this elevation is a water channel which seems to be lined with stone slabs (debris prevented this from being seen) with stone kerbs on one side and a concrete kerb on the other. The channel curves downwards sharply to the E and would have delivered water to what would have been an undershot water wheel. The axle hole for this wheel can be seen in the S elevation and has been bricked up with 20th century. To the E of this hole is a partly buried square hole in the wall, the exit for a drainage channel from inside the mill.

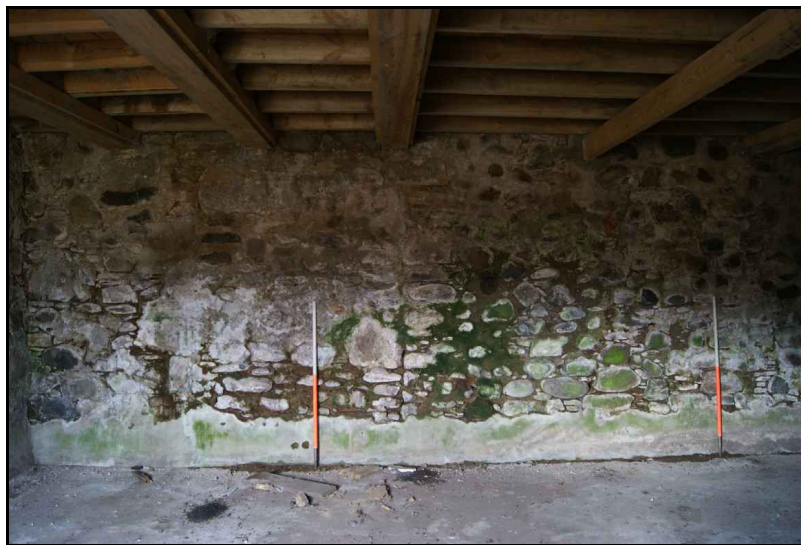
The blocked doorway in the W wall of the Mill, ground floor

This entrance was presumably blocked when it was decided to create easy access to the first floor by piling up extra material next to the lade against the SW corner of the mill to create a ramp/causeway from the farmyard.

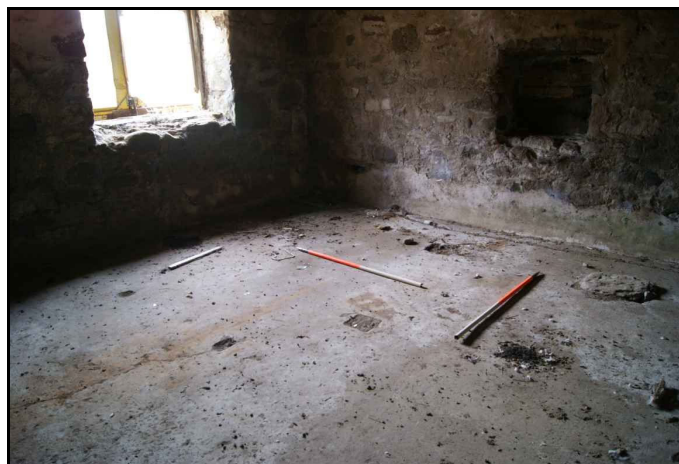
Shot showing holes and plinth in concrete floor for grinding equipment/cogs

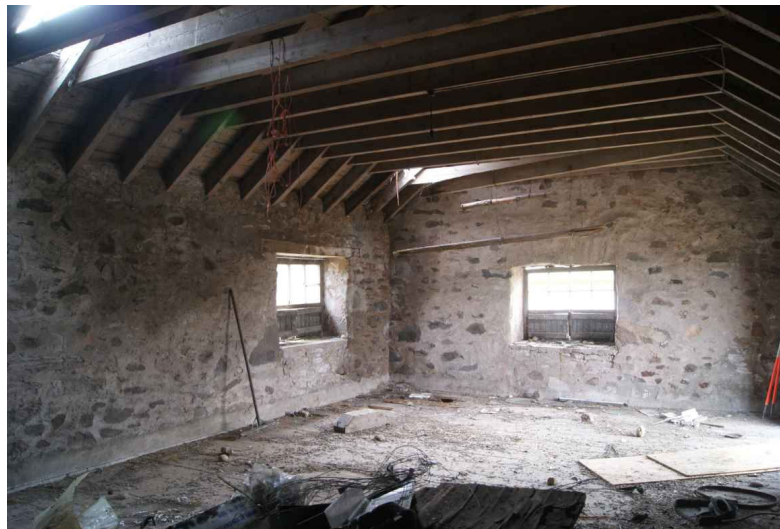
On the first floor the floorboards had rotted and the interior was covered in rubbish which made surveying somewhat treacherous. However the floor was cleaned above where the grindstones would have been, which revealed a circular hole cut into the floorboards which may be related to the former grinding mechanism. The roof was found to be of common collared form.

Photo of 1st floor of Mill
