Archaeological Building Recording Former Steadings at Monzie Perth and Kinross

MN01

**ARCHAEOLOGICAL BUILDING
RECORDING
FORMER STEADINGS AT MONZIE
PERTH AND KINROSS**

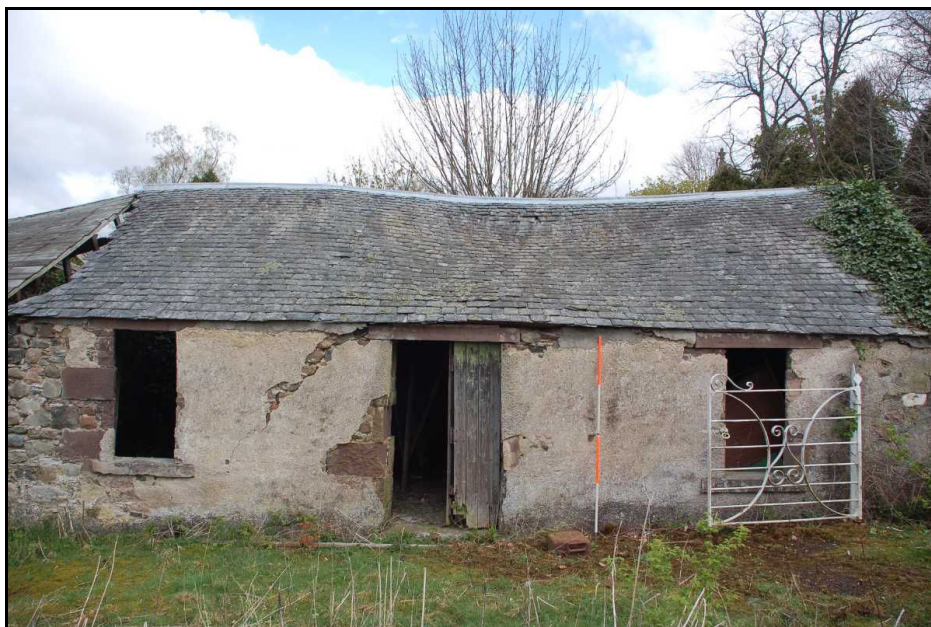
The front (S) elevation of Unit 1, looking N

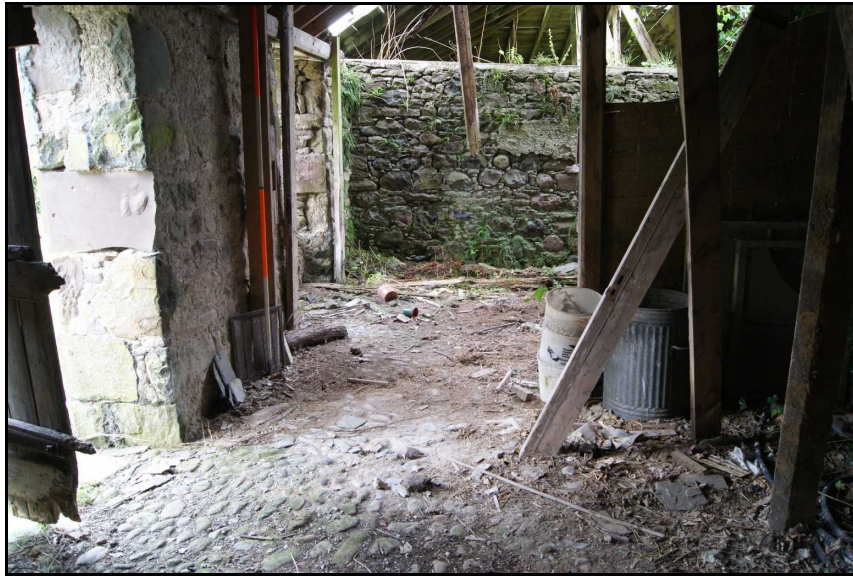
Interior of Unit 1 showing cobbled floor and props for roof, looking W

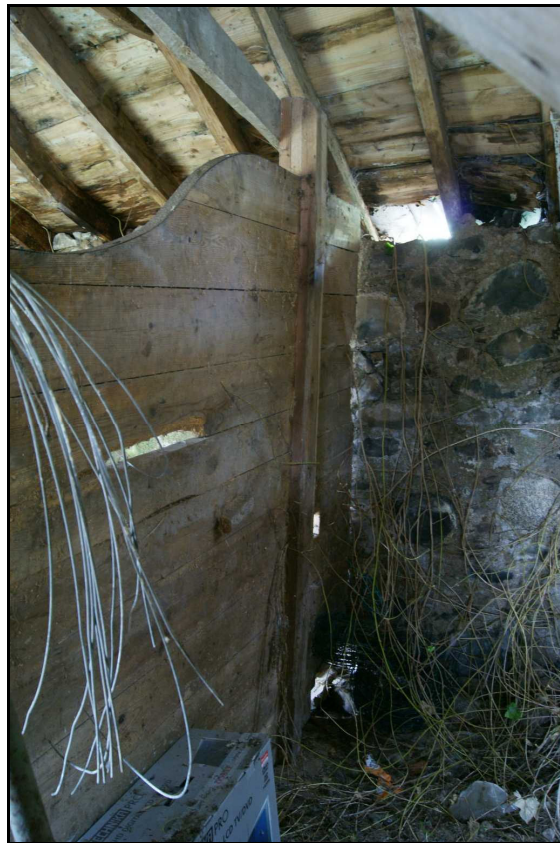
A stall division, Unit 1, looking NW

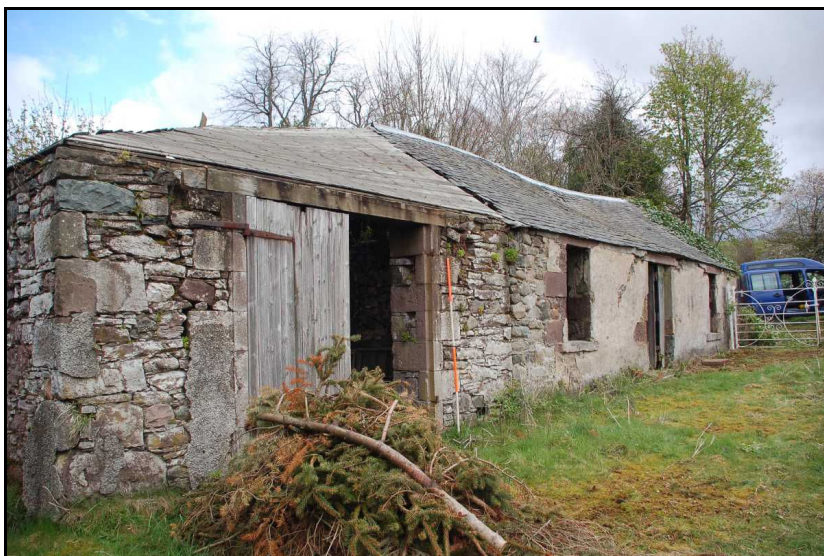
The S end of Unit 2a, looking NE

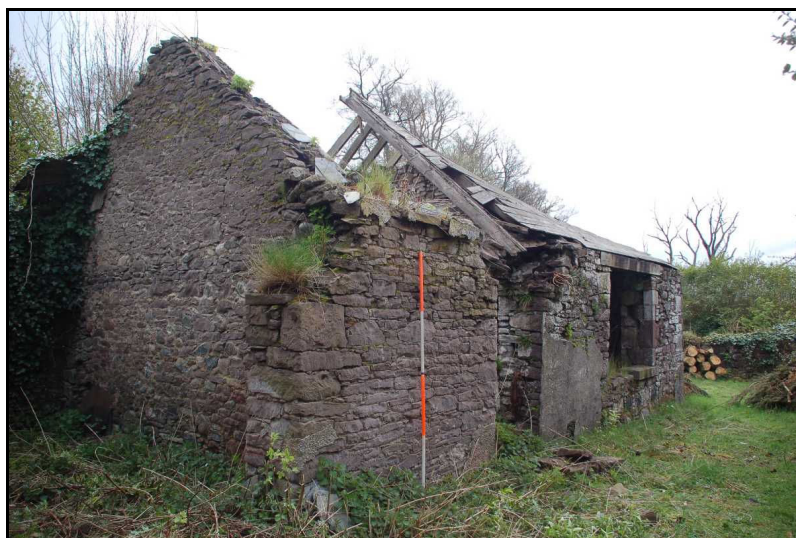
The N end of Unit 2b, looking SE

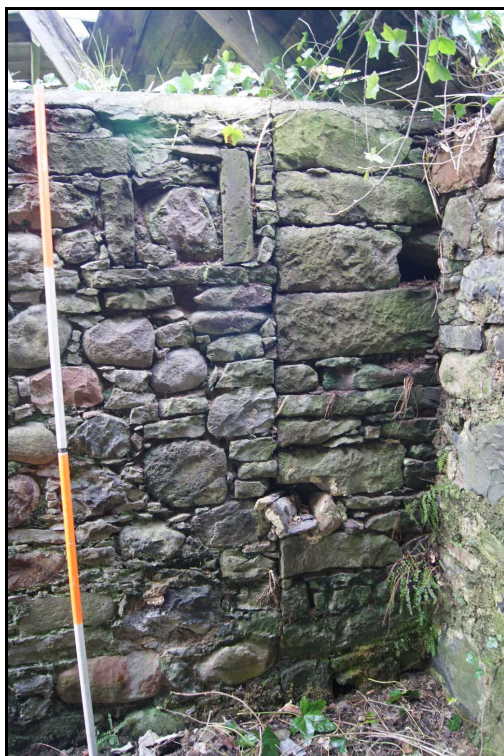
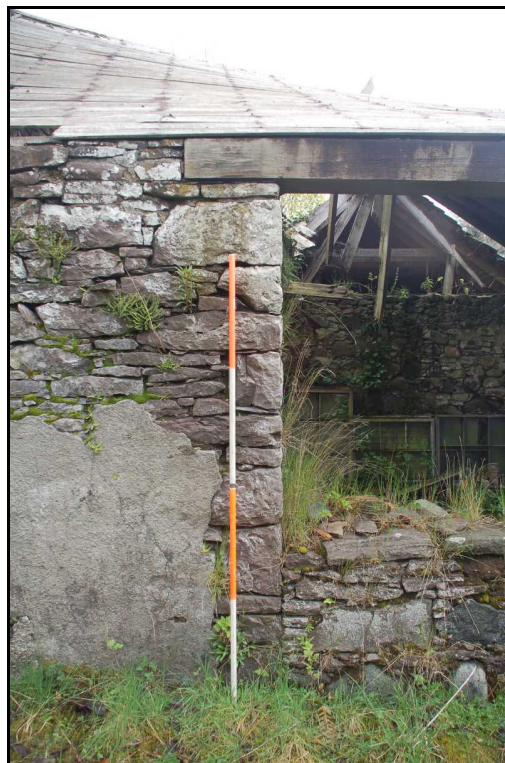
The rybats of the two former doorways in Unit 2. Left, E wall, right, W wall

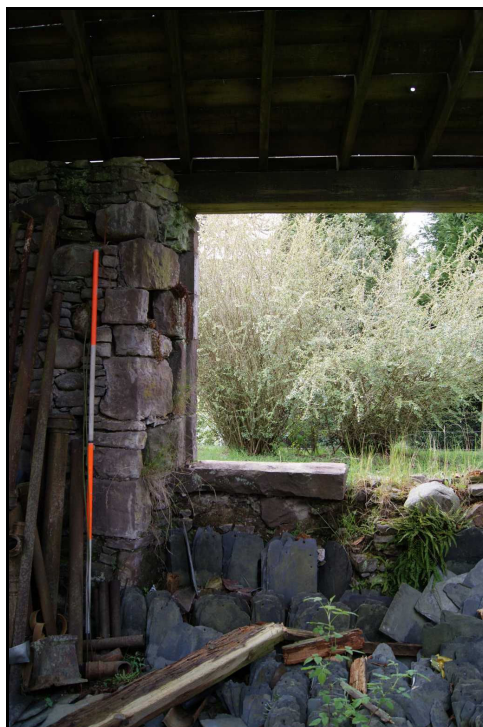
The widened window in unit 2a, looking W

The window in unit 2a was widened, presumably when this room was converted into a garage.

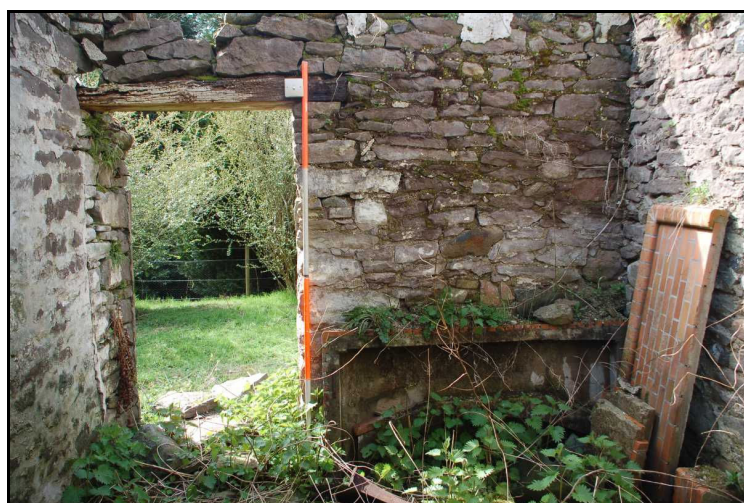
The interior of Unit 2b, looking W

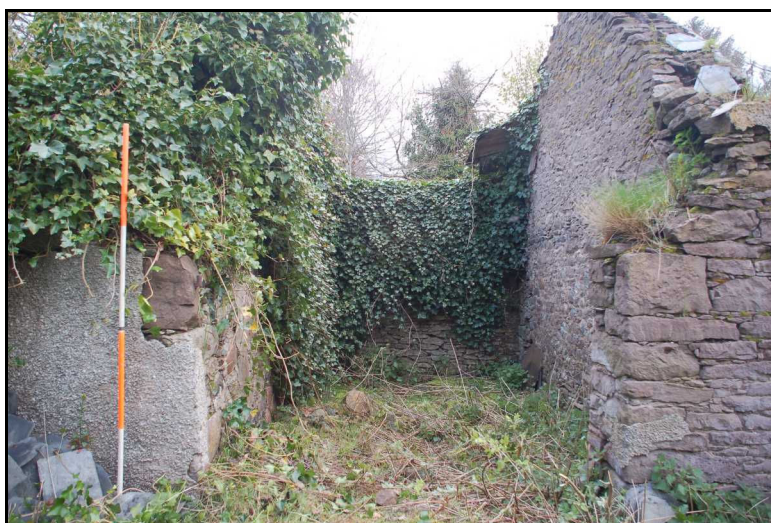
Unit 2c, looking E

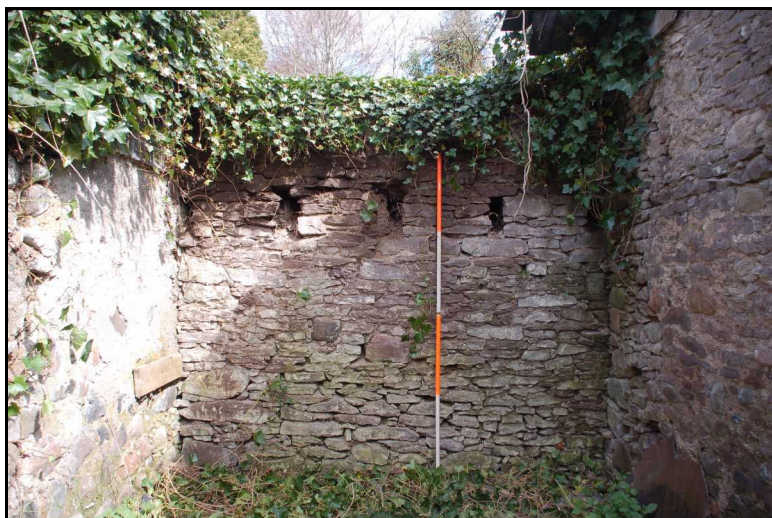
The internal face of the E wall has 5 beams slots at head height marking the former position of floor joists for an upper room. The walls of this upper room were originally covered in lime mortar or plaster followed by a thick layer of brown cement or concrete. Parts of this coating still adhere to the upper parts of the gables, though much of it has fallen down to the ground. The roof, which has almost entirely collapsed apart from a small area in the SE corner, is blue slated. The entrance to this upper room would have been through the doorway in the S gable wall of unit 3a. Water has penetrated the gable wall below this doorway causing cracks to form. On the walls of the lower room, patches of thick lime render or harling survived under the ivy.

Unit 2c showing beam slots for upper floor, looking E

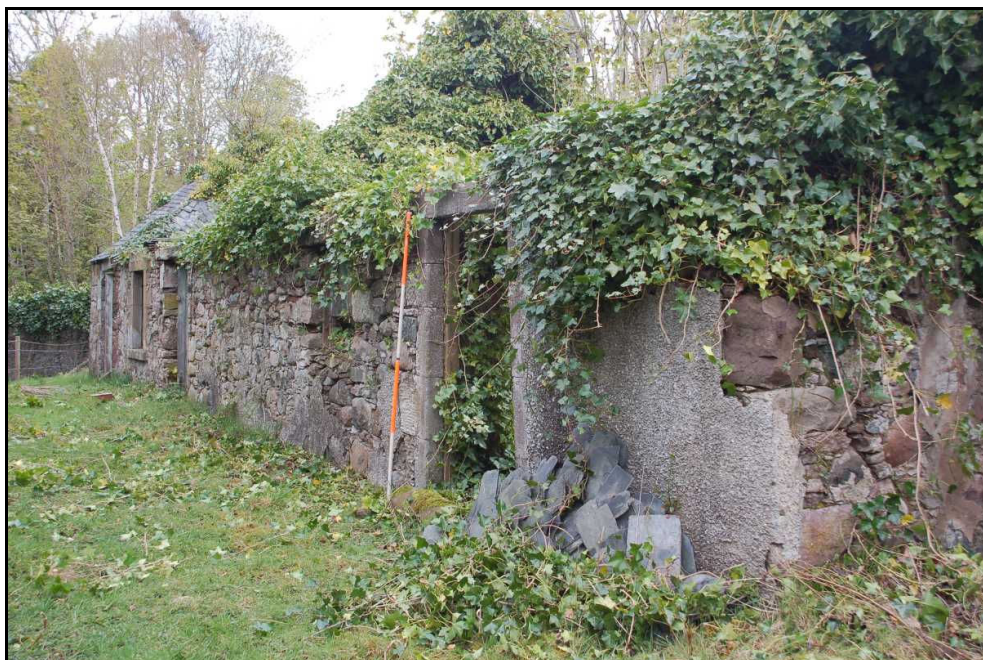
Unit 3a, looking NE

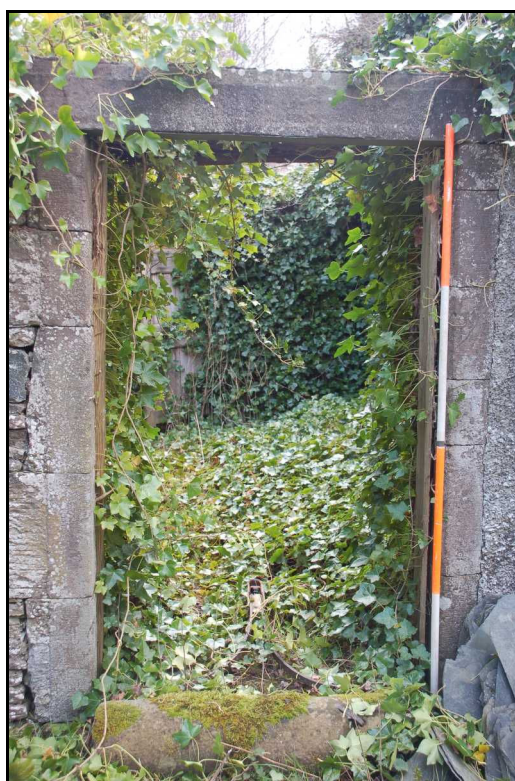
To the N of this doorway is an irregular crack running down the wall, a sign that the rybats are a later replacement; there may well be a corresponding mark on the opposite side of the doorway but this could not be seen owing to the pebble dash.

The W doorway in Unit 3a, looking E

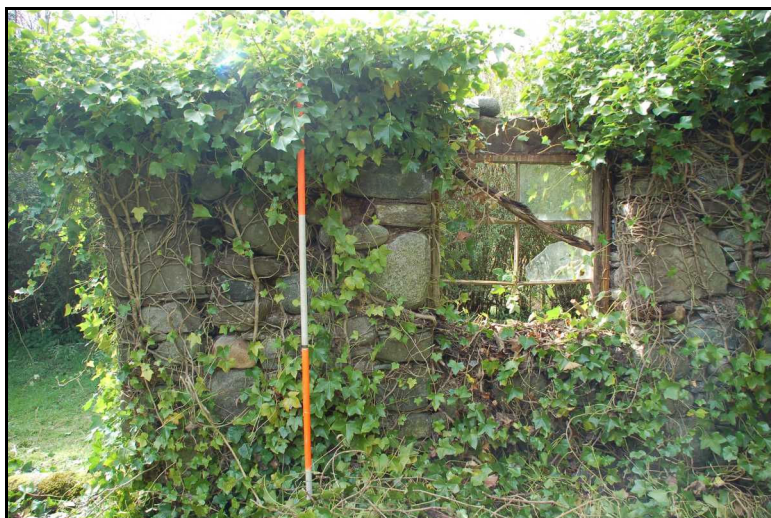
The inside face of the W wall showing the window (located in a blocked doorway), looking W

The window in the W wall sits in a former blocked doorway. The rybats are of roughly squared rubble and the lintel a squared block of sandstone, roughly shaped with pecking visible on the outer face. The blocking for the window is composed of rounded to sub-angular boulders / stones and there is no sill. The window itself is of 6-paned fixed design, formerly painted white. The doorway in the E wall is wider than that in the W with a large door still in place, painted light blue. The rybats and lintel of the doorway are of high quality, similar to the E doorway and are also a replacement.

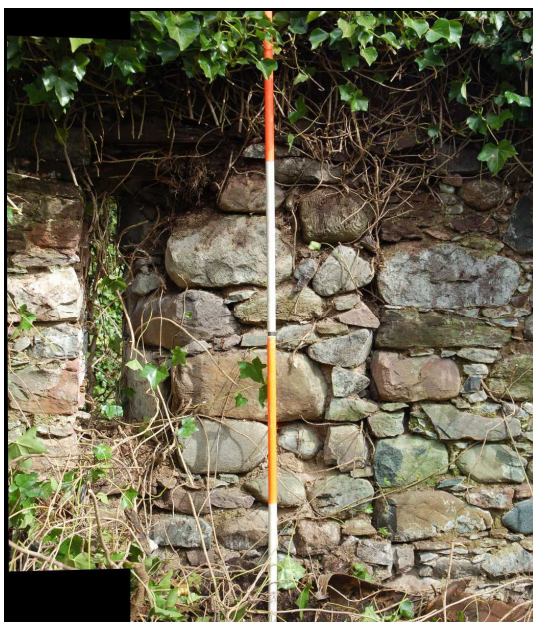
N of this is a blocked doorway that has been converted into a narrow slit window or vent. The rybats of the doorway are medium to large sub-angular boulders, occasionally faced. The doorway has been blocked with random rubble, large sub-rounded boulders and smaller stones.

The blocked doorway in the E converted into a slit window / vent, looking E

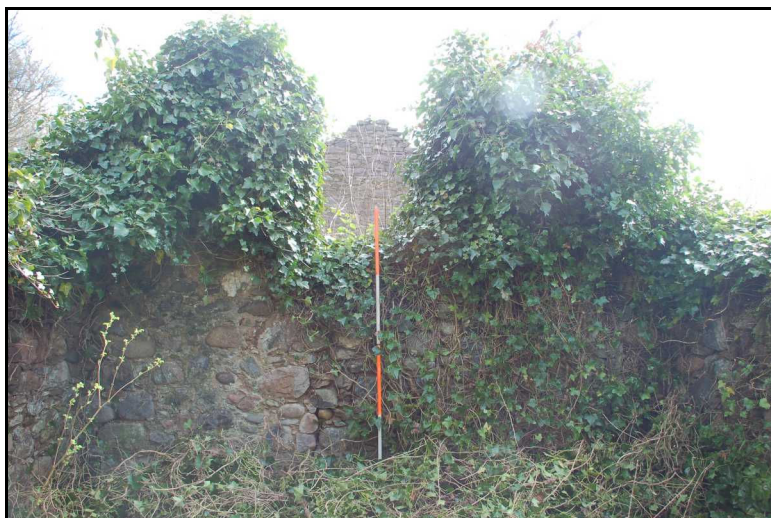
The doorway for accessing the loft above Unit 2c, looking S

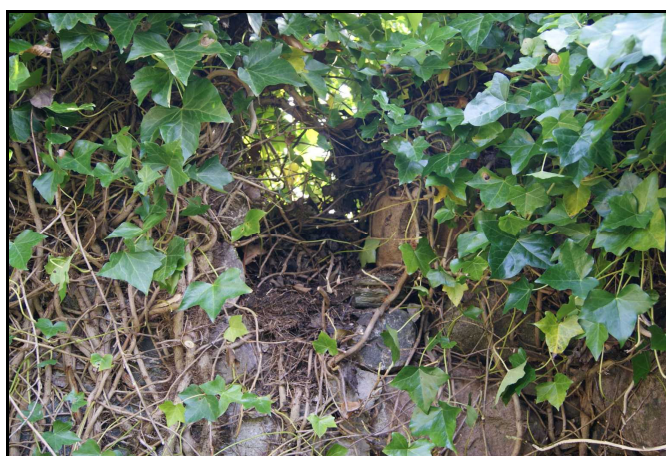
One of the beam slots for the possible stair platform, looking S

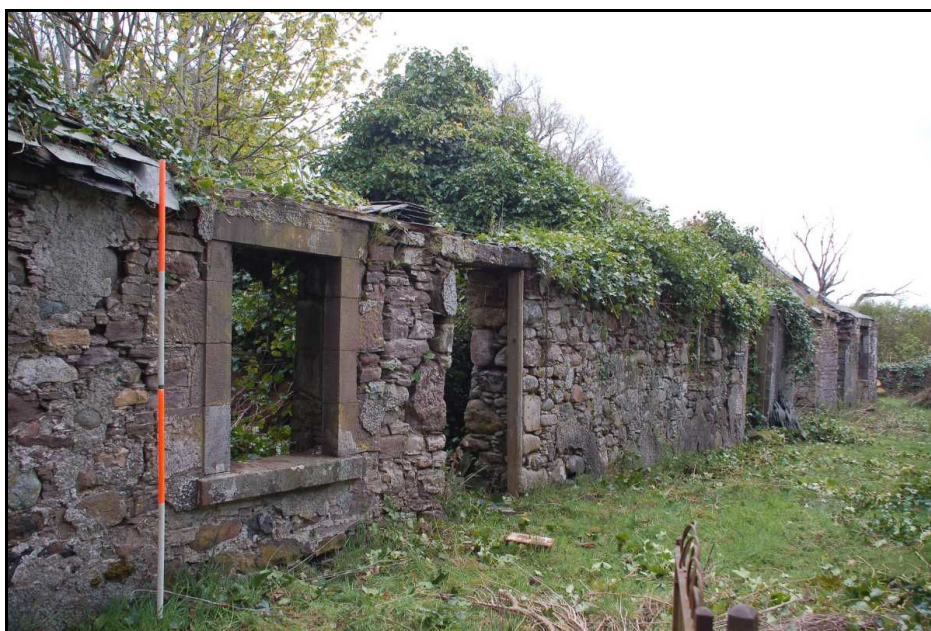
The W facing elevation of Unit 3b

The door is of pine, painted light blue. The doorway rybats on the S side are original, made from natural sub-rounded river boulders. Those to the N are probably replacements - coarsely shaped blocks of sandstone, differing sizes. This stonework appears to be part of blocking inserted to narrow a much wider original doorway. The lintel is a large rectangular slab of grey sandstone. To the N, the window (which has no glass or frame) is of high quality design with uniform, tooled projecting margins. Rybats, sill and lintel are all made of high quality sandstone. This window appears to be a late insertion: To the N the window rybats have been carefully incorporated into the main W wall but a slight irregular crack with ladder pinning marks where the window was inserted. On the S side the masonry for the window ends in a vertical line next to the blocking, the location of one side of the original wide doorway.

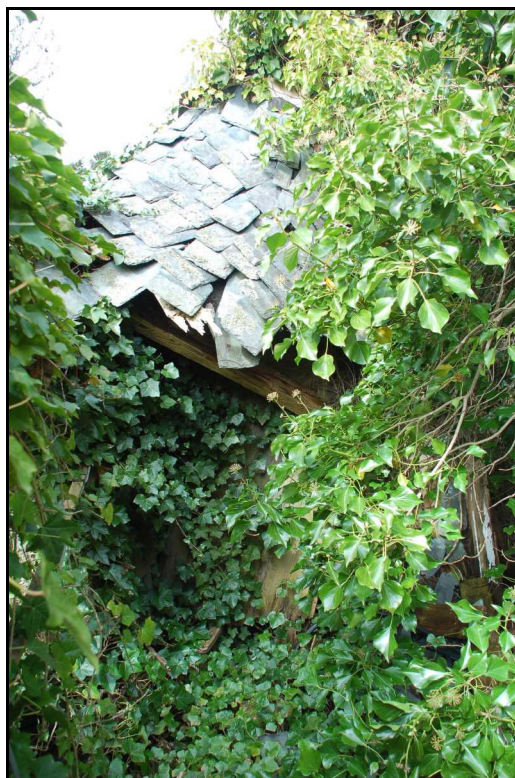
The interior of Unit 3b, looking N

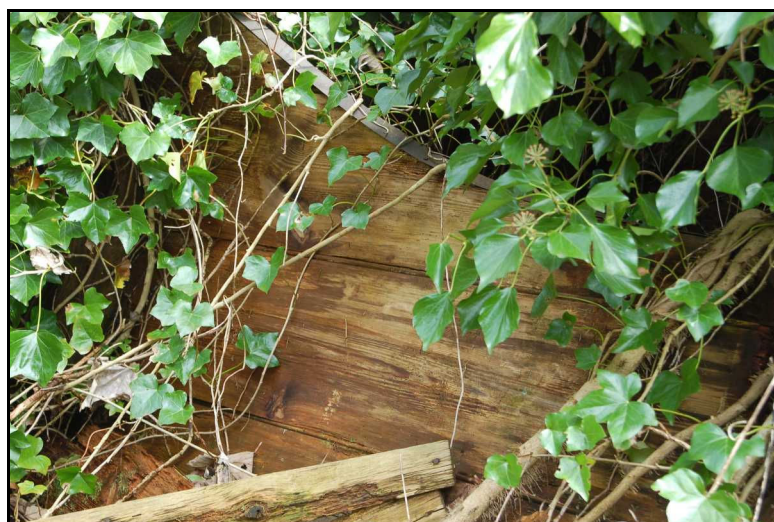
A stall division in Unit 3b, looking SE

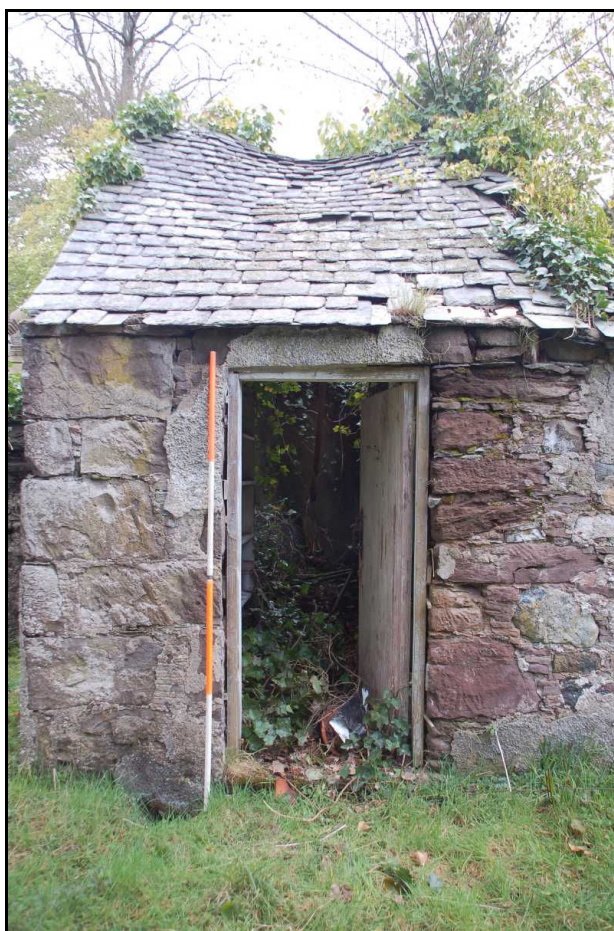
The W elevation of Unit 4, looking E

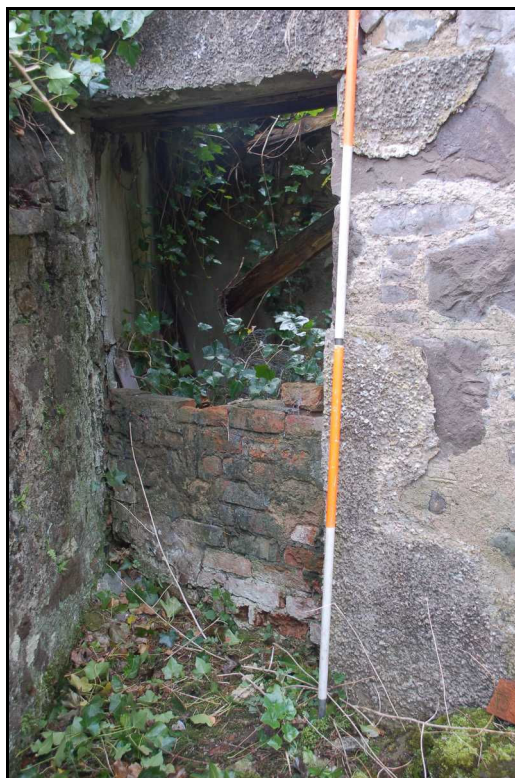
The blocked doorway in the N elevation of Unit 4, looking SE

The N doorway in the N extension was blocked using red clamp bricks to form a window.

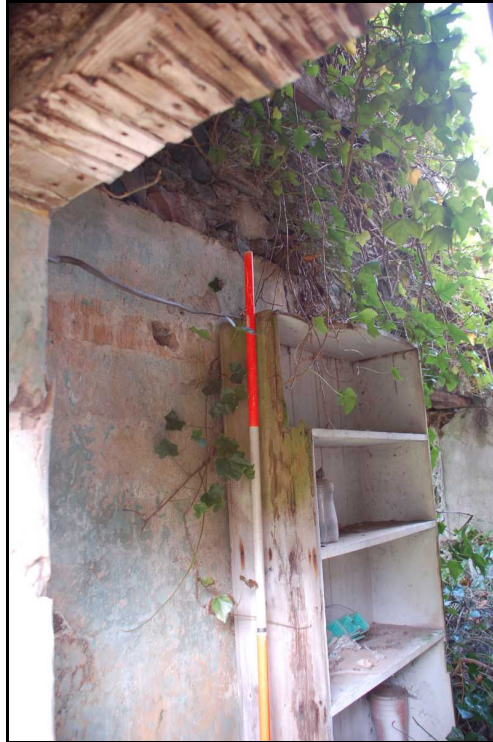
The interior of Unit 4, looking NE

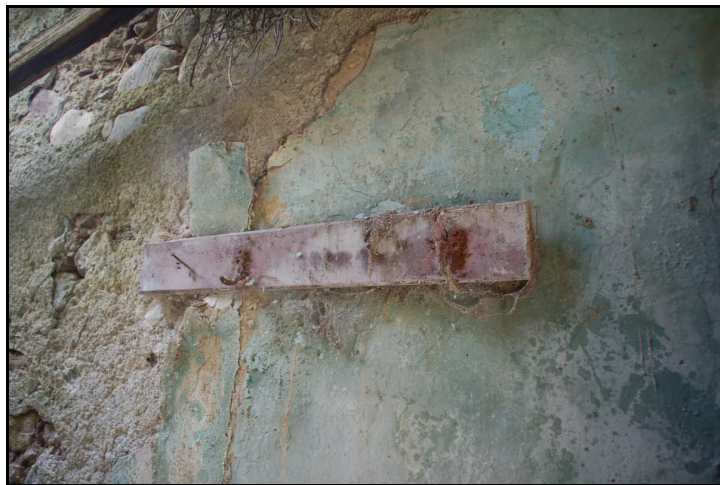
The N facing internal wall of Unit 4 showing plaster above harling, looking SE

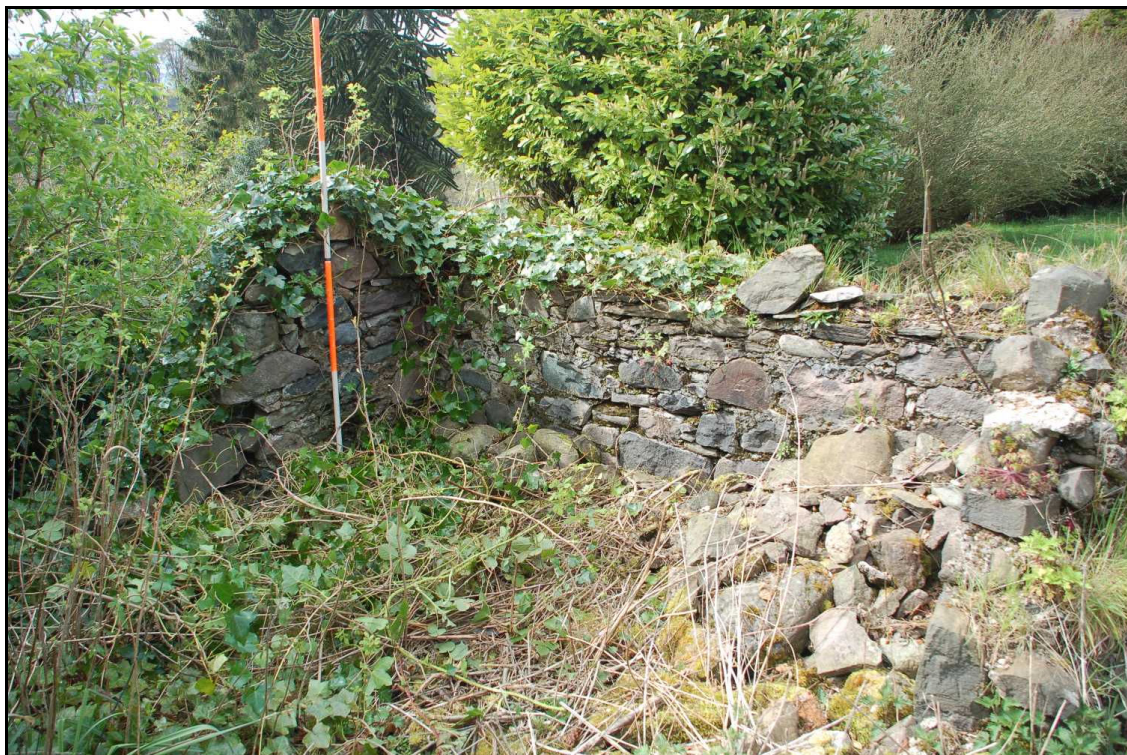
The small C-shaped structure S of the main buildings has collapsed random rubble walls surviving to a maximum height of 1.5m. The stones comprise mainly squared rubble but occasionally sub-rounded and sub-angular stones have been incorporated into the wall. The N wall, which survives to its full width, is joined to two southward projecting walls at 90 degrees. These walls extend only for a short distance and are completely collapsed at their S end. The cornerstones of the structure are large well squared blocks of sandstone.

The small structure, looking NW
