Finavon Doocot Angus

Historic Building Recording for
The National Trust for Scotland

FF14

FINAVON DOOCOT
ANGUS
FF14

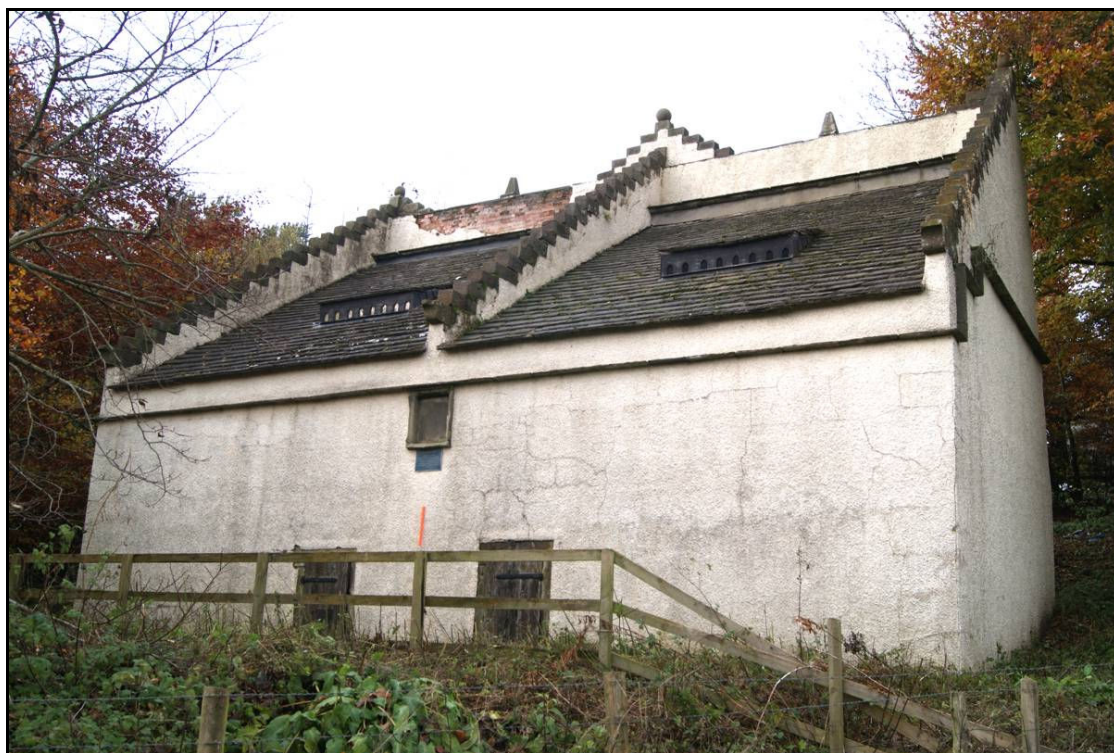
The front elevation (illus 3 and Images\External\Front\Oblique\DSC03408.jpg)

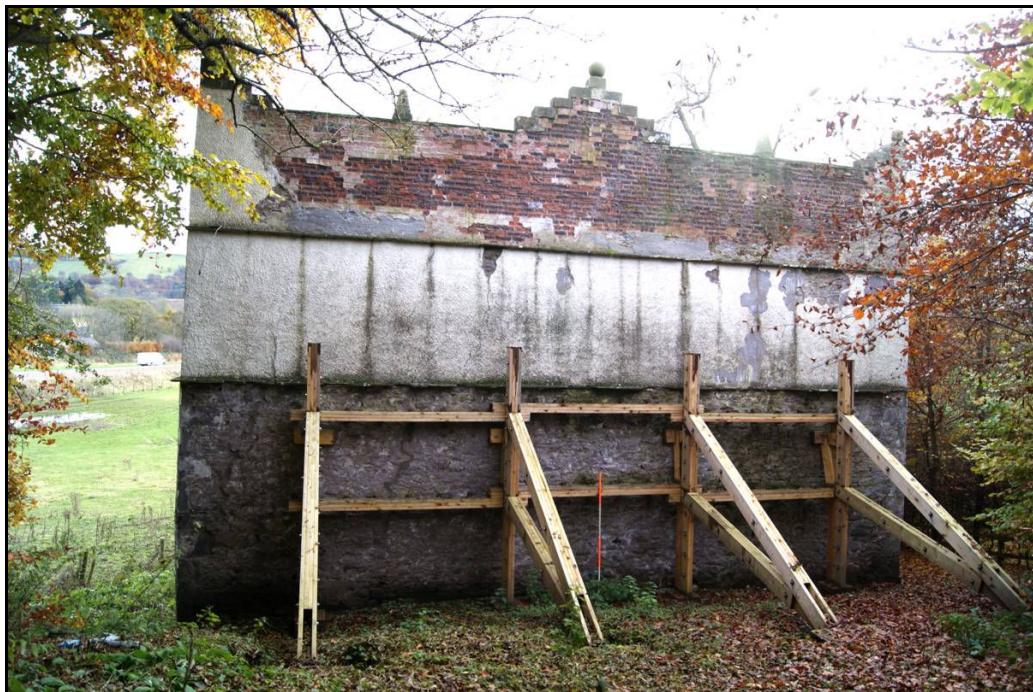
The rear elevation (illus 5 and Images\External\Rear\Oblique\DSC03444.jpg)

Three horizontal string courses are incorporated into the rear wall composed of rectangular sandstone slabs of a variety of widths and roughly uniform thicknesses. The lower course, which runs at head height, is broken off, but the middle course still projects some 12cm, though many of its stones are broken. The middle course continues around the E and W sides of the structure where it descends in steps towards the front elevation. This string course is entirely intact on the side elevations and is probably a replacement here. The lower course may also have once run around the E and W sides of the building, but was subsequently covered over with harling. This possibility was noted when closely inspecting photographs of the E elevation where it looks like there is a horizontal raised bulge giving away the former location the course. The upper string course on the rear elevation is largely intact and is likely to be a replacement.

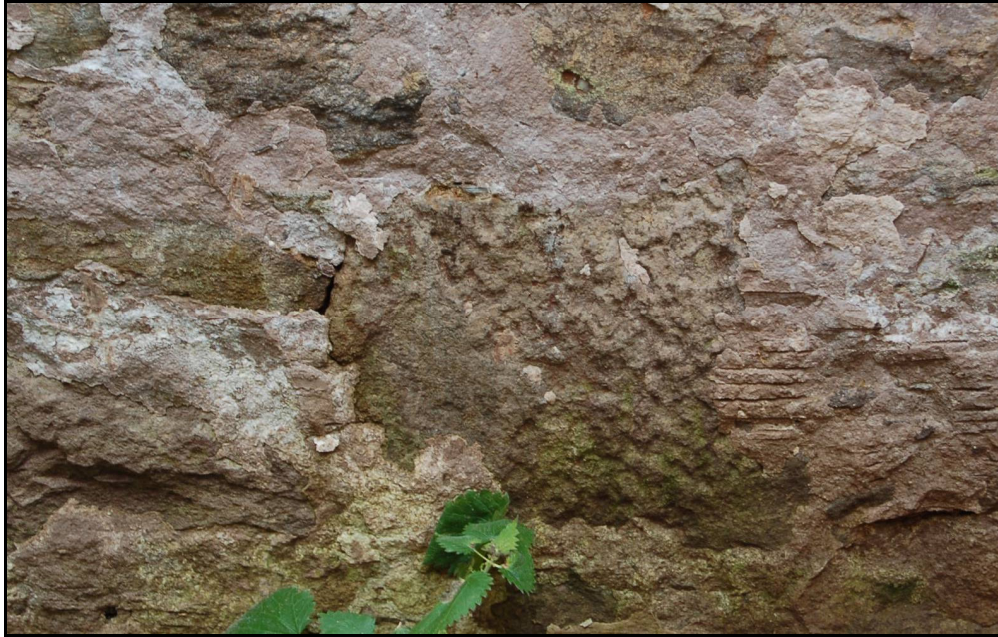
A pecked stone in the rear elevation
(Images\GeneralDetails\TooledStonesRearElev\DSC_0025.jpg)

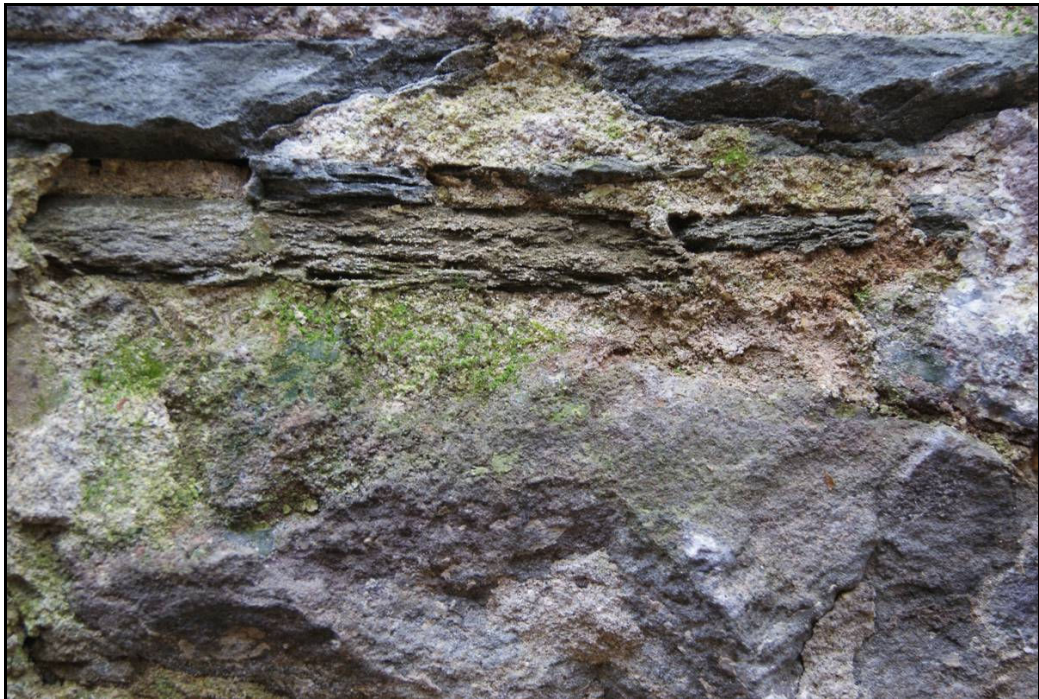
Close inspection of the stonework in the rear wall shows that the gaps between the stones have been pointed with a white lime mortar which may be original but is probably 19th century. This mortar can also be seen in the interior of Room B where the N wall has collapsed. In other areas, traces of original harling survive on the faces of some of the stones and in between the string course stones. This is a yellowish lime render with a fine grit component. Over this is a layer of cement render for the harling applied in the late 1970s.

The original yellowish harling (Images\GeneralDetails\Harling\DSC03650.jpg)

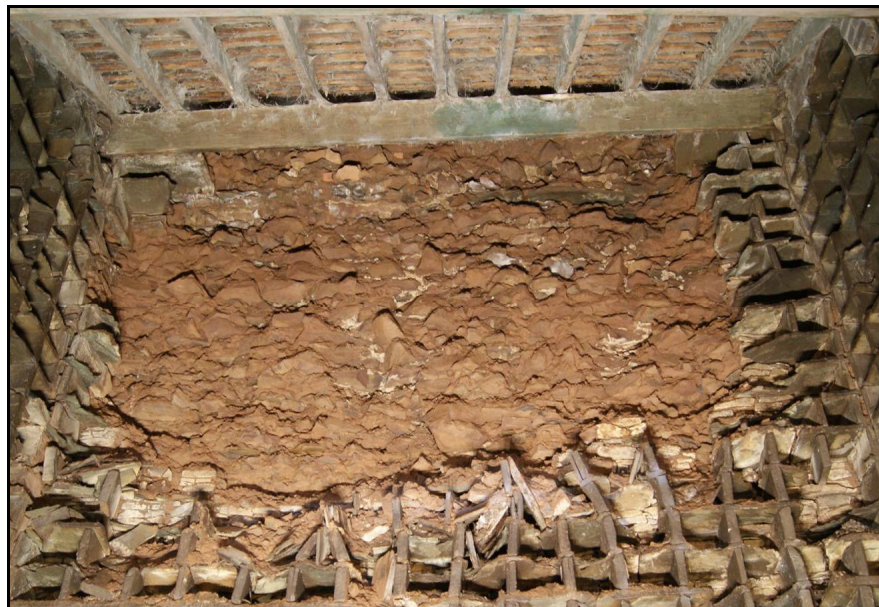
The core of the N wall is exposed in the E room (Room B) where the internal face has collapsed. The random rubble of the external face has been bonded into a core composed of a mixture of sand and clay with small angular fragments of rubble. The mortar which can be seen in this face is probably the white lime pointing applied to the outer wall face. Inner faces of the wall have been built carefully, incorporating a series of nest boxes constructed from sandstone slabs. The horizontal and vertical members of the nest boxes are embedded slightly into the wall and project some 32cm into the room. Well-selected small squared blocks of sandstone have been used to form the back faces of the nest boxes. The nest boxes themselves have been built in the linear egg-crate arrangement typical of lectern doocots.

*The clay and sand core of the N wall exposed in Room B
(illus 8 and Images\Internal\B2\DSC03172.jpg)*

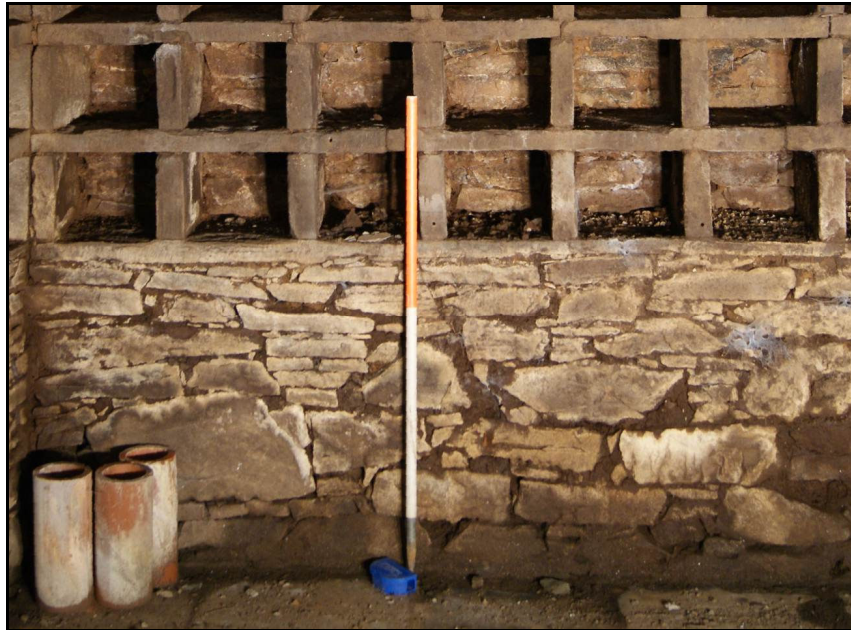
*Below the nest boxes where the wall reaches full thickness, Room A
(Survey\SfM\A2\photos\DSC03013.jpg)*

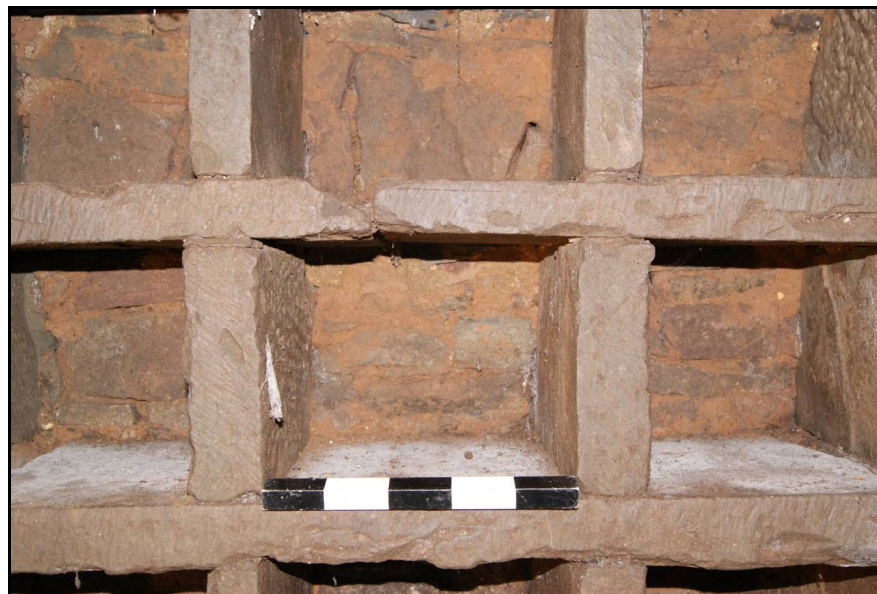
*Close up of the shelving for the nest boxes in Room A. Scale = 25cm
(Images\GeneralDetails\NestBoxes\DSC03645.jpg)*

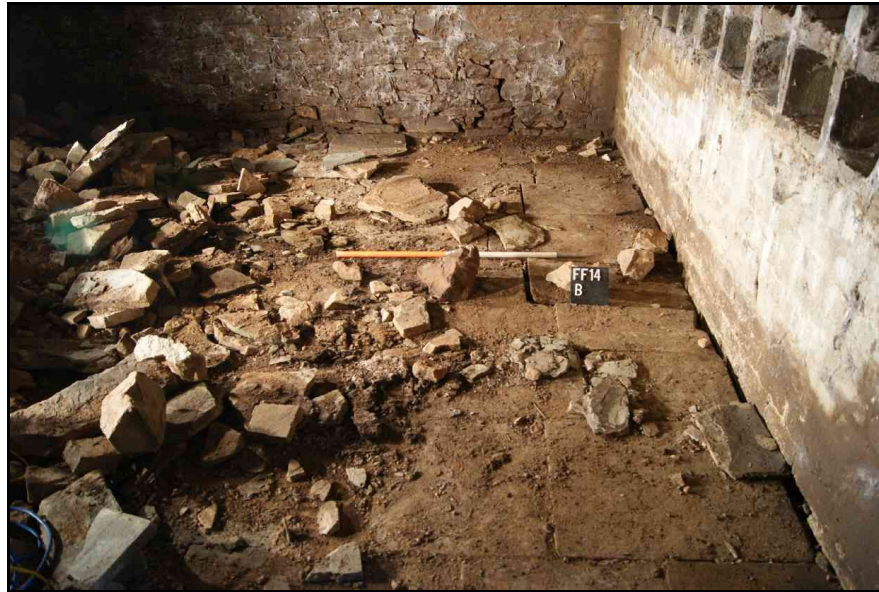
The floor of the rooms are covered in rectangular flagstones of varying sizes with those in the W room (Room A) cemented during the 1970s restoration. The flags are likely to be the original floor surface as it would have been important to have a solid floor for periodically shovelling up pigeon guano. However, it is likely that both floors were re-set or re-levelled over the years. Inspection of the floor in the E room was difficult due to the pile of collapsed material from the N wall, but it appeared that the flags here were held in place with earth.

The flagstone floor in Room B (illus 2 and Images\Internal\BFloor\DSC03354.jpg)

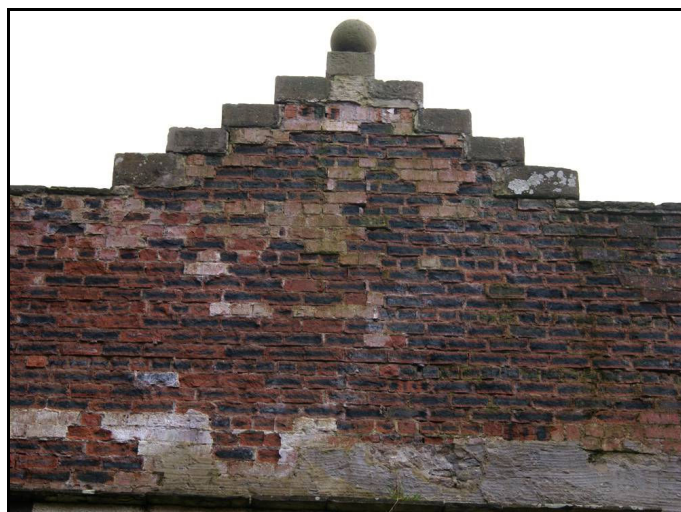
*The upper portion of the N (rear) wall reconstructed in brick
(illus 5 and Images\External\Rear\Closeups\DSC03429.jpg)*

The other major structural alteration was the partial dismantling of the upper part of the rear wall. Much of this repair was carried out in red brick and the upper string course was probably also replaced during this work. What remained of the W and E gablets was altered and stabilised in red brick; the central finial was completely reconstructed. The stone ledge just above the roof line towards the bottom of the rear parapet (see photo below) also seems to have been rebuilt as it fairly uniform. As already mentioned above, it is likely that the string courses along the W and E elevations were removed and new courses inserted during the restoration.

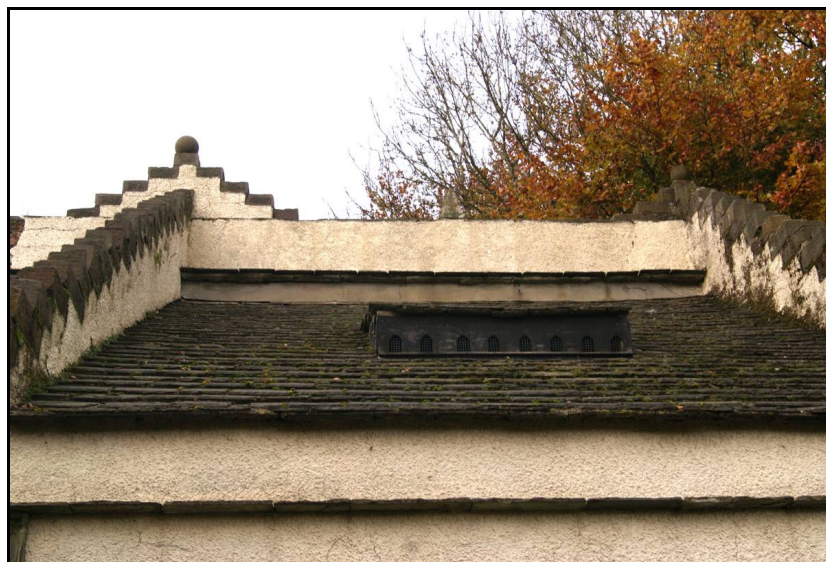
New roofs were constructed in pine, with the rafters spanning three purlins. This involved rebuilding the tops of the W, internal and E walls with brick and stonework to incorporate the new roof purlins. For some reason the angle of the E roof is at a slightly shallower angle than the W roof; this would not have been part of the original design which would have been symmetrical. Perhaps the instability of the rear wall on the E side caused measurements to go slightly awry when the timberwork for the roof was being ordered?

The E roof (Images\External\Front\Oblique\DSC03404.jpg)

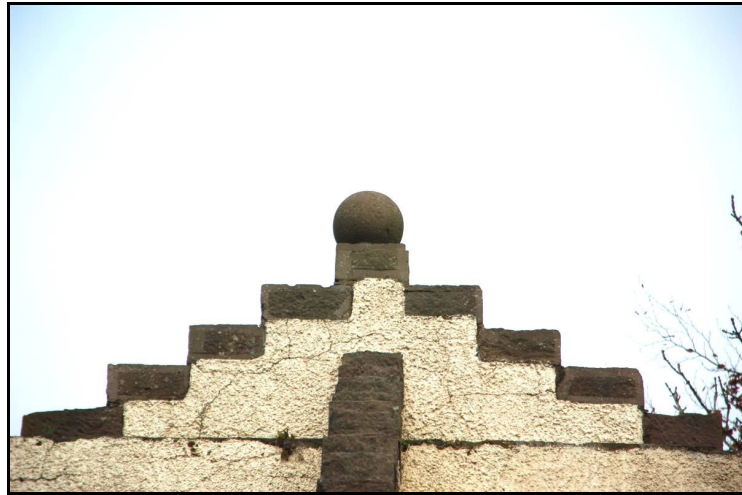
The central finial (Images\GeneralDetails\Roof\DSC_0004.jpg)

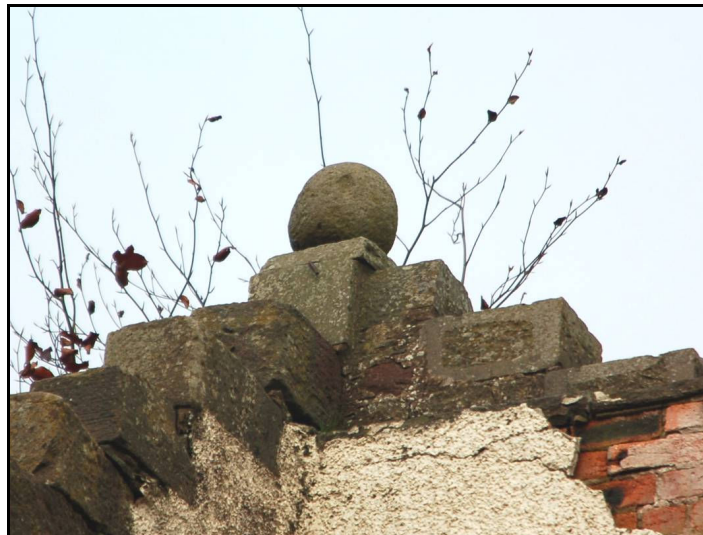
The W ball finial (Images\GeneralDetails\Roof\DSC_0001.jpg)

Of the two pyramidal finials, the one on the E looks more weathered and may well be older than that on the W, however further analysis is not possible without a proper inspection close up.

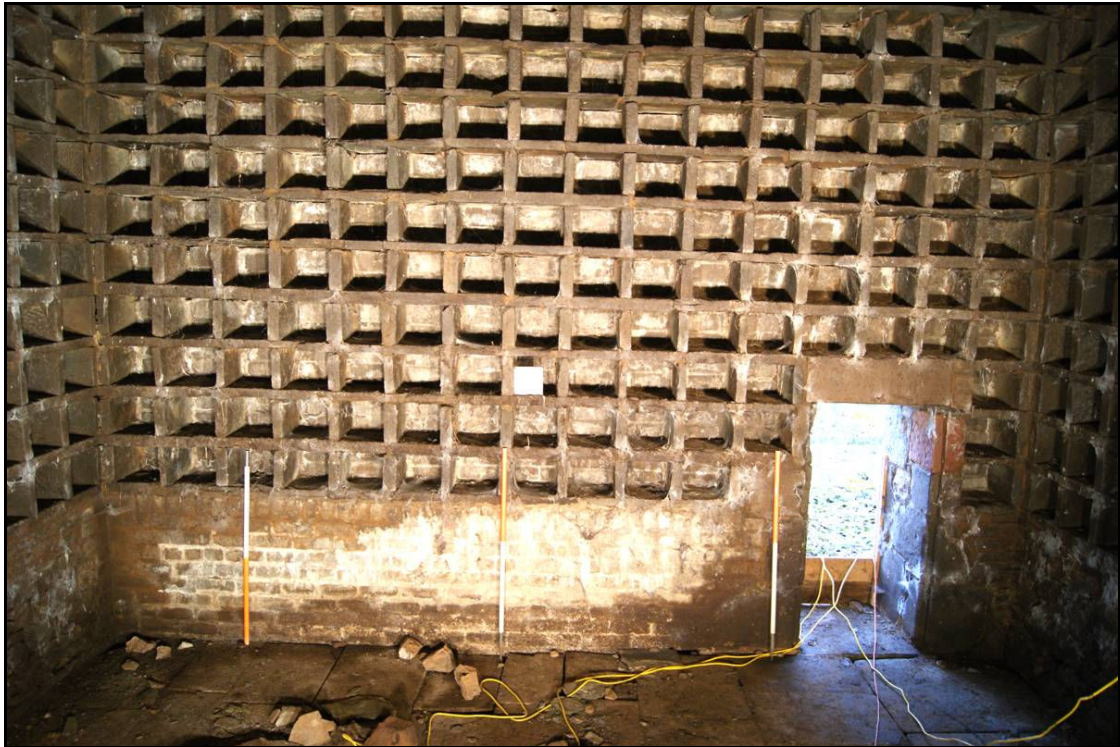
When the S wall was being reconstructed during the restoration, grey bricks were used for the internal face so the re-build looked less obvious. The brickwork was constructed so that the horizontal and upright slabs for the nest boxes recovered from the old S wall were re-used and the nest boxes re-created.

The internal face of the S wall in Room B (illus 9 and Images\Internal\B4\DSC03317.jpg)

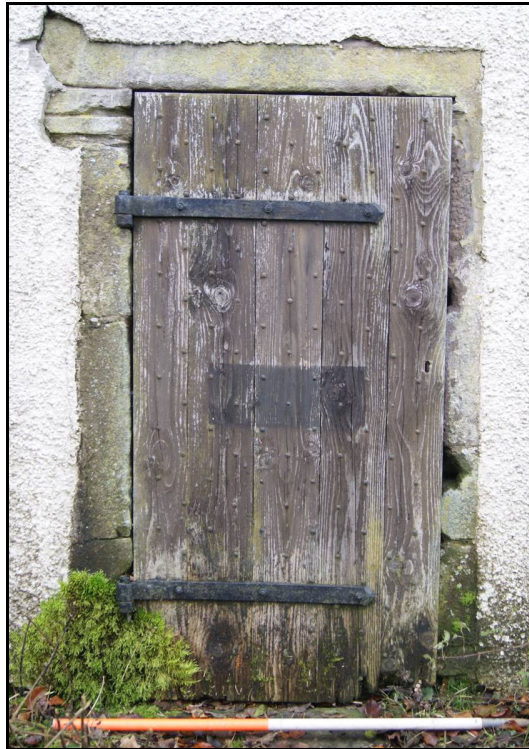
The W Doorway (Images\External\Front\Details\DSC03397.jpg)

The two large stones above the W doorway appear to be original lintels, though thinner stones have been incorporated below them. The face of the outer lintel has a worn notch to enable the door or yett to be pulled open from its recess. On the face of the inner lintel, coarse chisel marks can be seen. The W side of the interior face of the W doorway has a single original stone with a round bolt hole cut into the recess. This is exactly the sort of position where one would expect a bolt holding an inner door closed

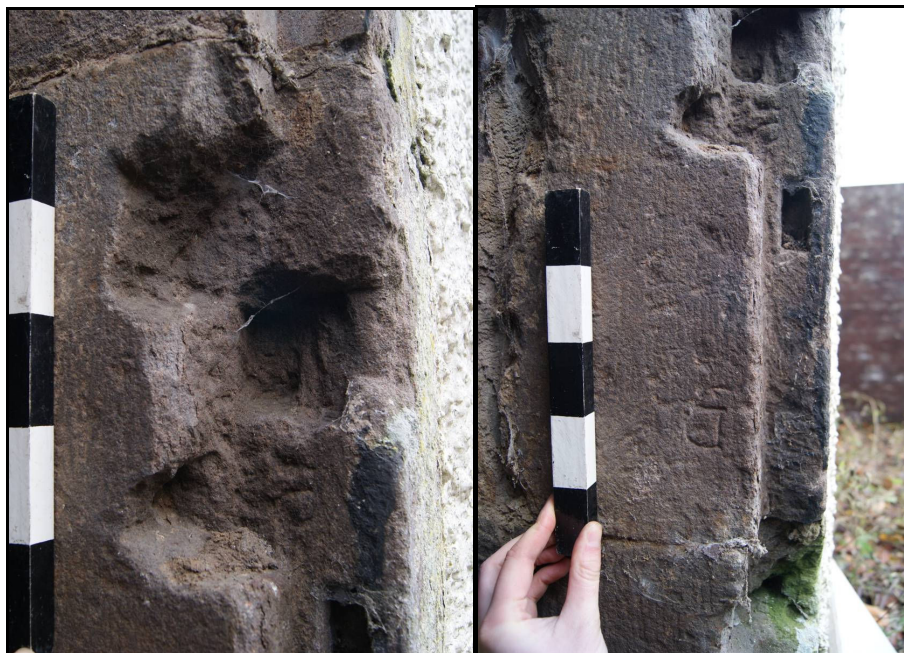
*The 3 recess in the W doorway recess and the carved letter below
(Images\GeneralDetails\WDoor\DSC03613 and DSC03614)*

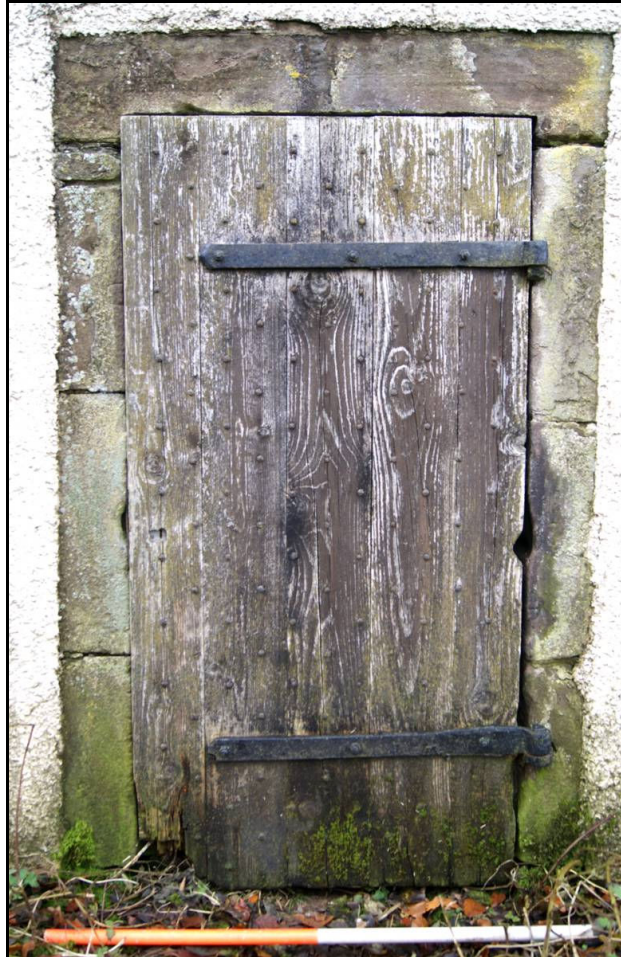
The E Doorway (Images\External\Front\Details\DSC03398.jpg)

The rybats of the outer face of the E doorway are largely unaltered and most retain their original chiselled recesses. All the stones are pink coarse sandstone and most have the same fine vertical tooling on their inner faces as stones in the W doorway. On the W side of the door is a single hole for the current lock bolt. On the E, old hinge pivot holes in stones at the top and bottom have been re-used to hang the current door. The second stone up on this side has an empty hinge pivot hole which is interesting given that only one pivot hole is located around the inner door recess. It seems likely that originally there were two pivots for each for the outer and inner doors (or possibly an outer yett and the inner door) and the stones were mixed up during the restoration. The front lintel stone retains an unaltered original recess.

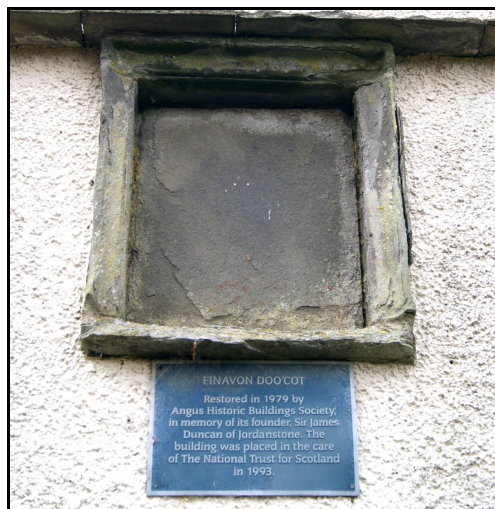
The Plaque (Images\External\Front\Details\DSC03400.jpg)

The sandstone plaque which has been re-built into the S wall above the doorways is unfortunately blank. Its flat face is probably a replacement stone rather than the original weathered armorial panel. The sides, lintel and sill of the plaque have ornamental curved chamfered inner edges.

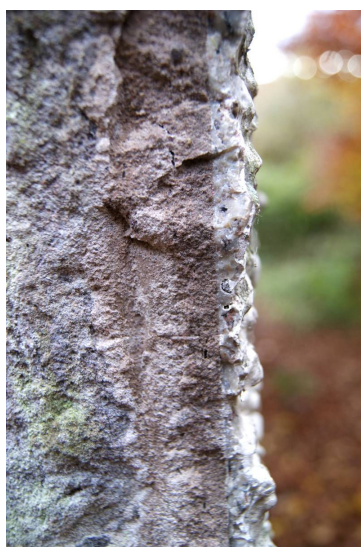
In the late 1970s, use of traditional harling techniques to restore historic buildings was not widely practiced. Consequently the harling chosen for the Dovecot restoration was essentially modern in character; first a cement based render was applied to the surface of the stonework which was then scored. Following this a mixture of stone chips, hydrated lime and some form of synthetic translucent adhesive (see picture below) was applied to the surface. The harling has now cracked off in several places, most notably on the rear elevation exposing in places the cement render below. Such a technique is essentially non-breathable, and the moisture in the clay bonded rubble is now unable to escape from the outer face of the wall which may have caused damage to the building's fabric.

*Close up of a section through the modern harling
(Images\GeneralDetails\Harling\DSC03608.jpg)*
