Archaeological Building Recording
The Lodge, Blackcraig
Ballintuim
BLAIRGOWRIE
BL03

**ARCHAEOLOGICAL BUILDING RECORDING
THE LODGE, BLACKCRAIG
BALLINTUIM**

BL03

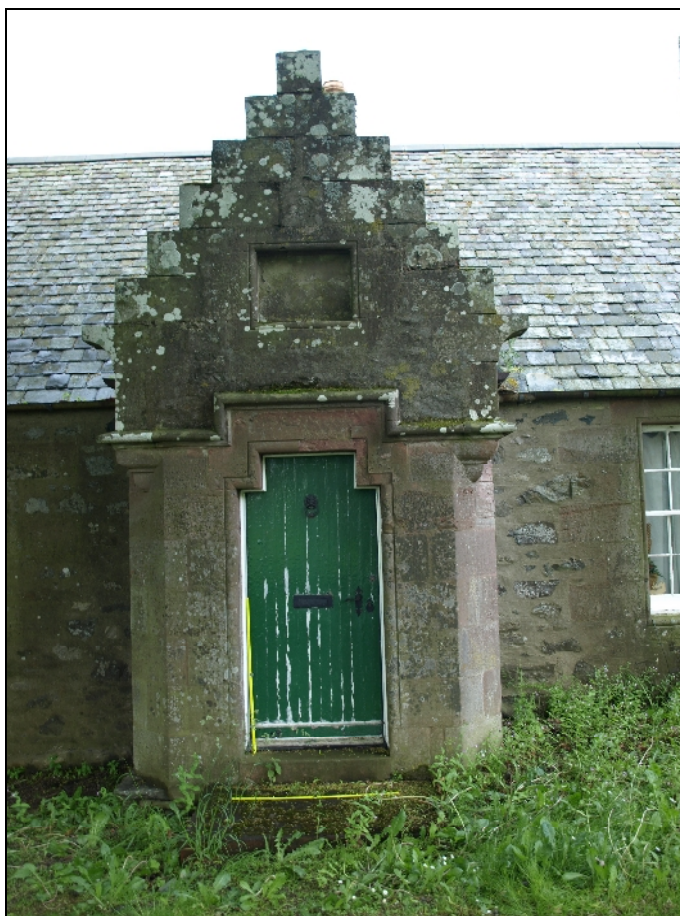
Porch

The key feature on this side of the Lodge. The porch is gabled and crowstepped with two small sash and case windows in each of the side elevations. The front corners of the porch are chamfered and constructed of finely tooled ashlar masonry. A carved stop-chamfer marks the top of this feature and sits just below the convex moulding that runs round the whole of the porch. The door opening narrows at the top, a feature which is also respected by the shape of the convex moulding. A shallow moulding has been applied to the rybats and this has suffered some damage at the top right corner. Above the moulding the stonework that creates the gable is of slightly poorer quality. The panel which appears in the centre does not appear to contain any carving or inscription though it may be that erosion has removed any decoration that once existed.

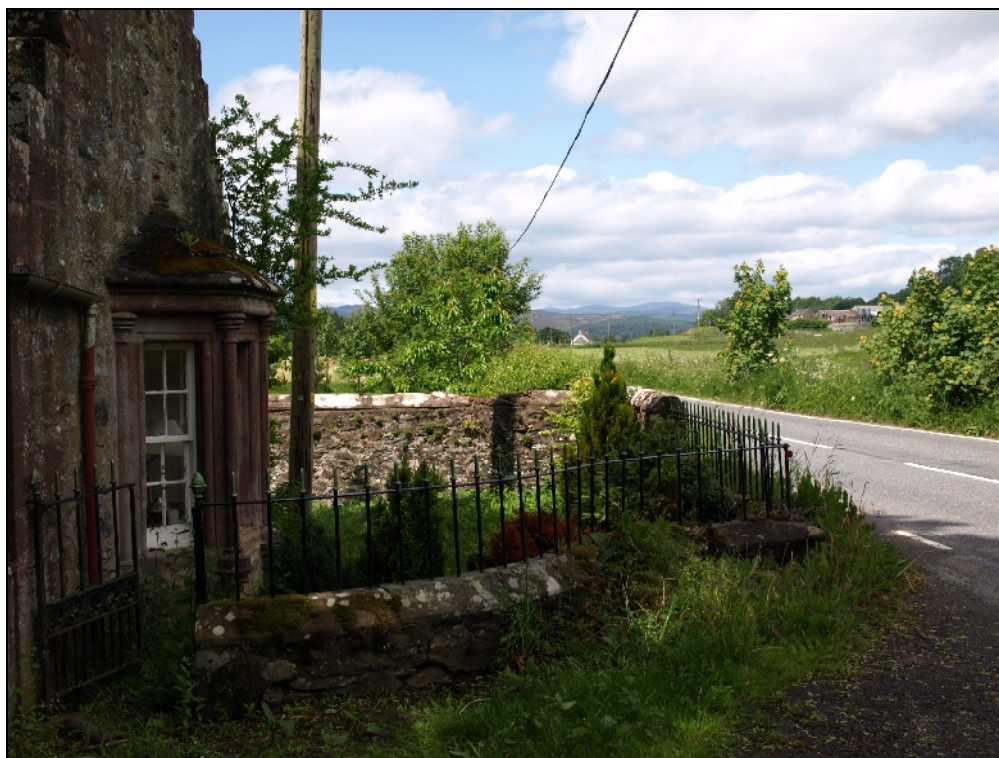
South-East Elevation – NE of porch

To the NE of the porch the rising ground means that the elevation is not as tall as in the SW. The prominent feature is again a centrally positioned sash and case window with a six-over-six arrangement. To the left of the window and in the angle formed by the

porch some recent repointing and limited rebuild has been carried out in an attempt to repair water damage. It is noticeable that the guttering in this location is in a poor state of repair and the valley between the roof components is heavily overgrown.

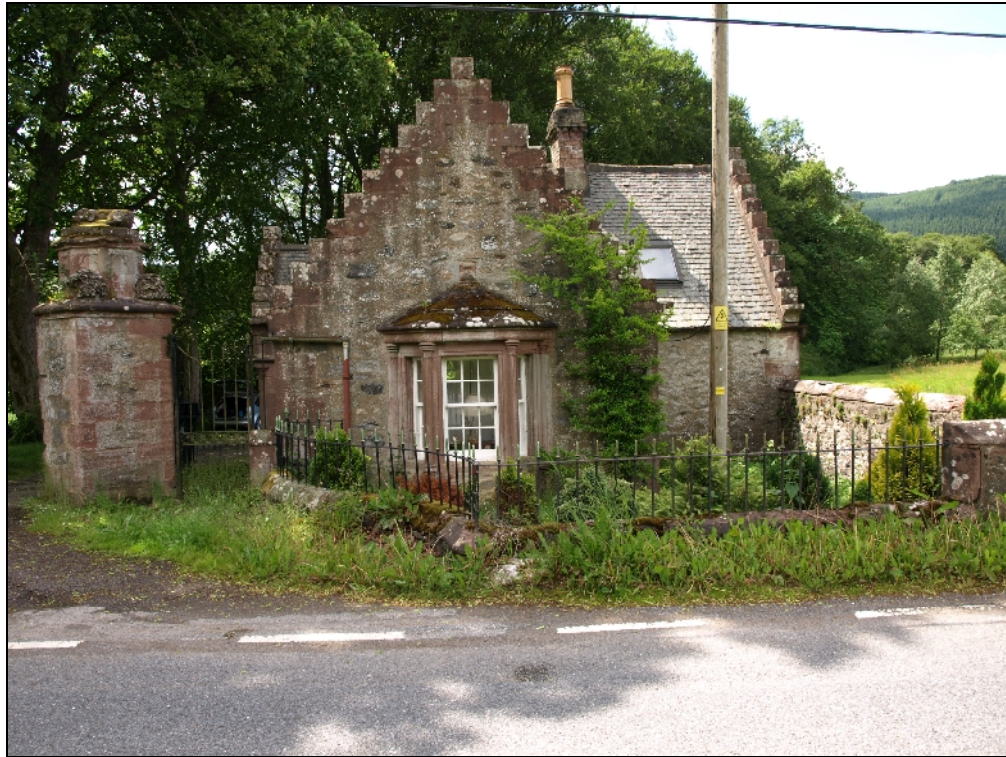
The North-East Gable

The key feature of the gable is the canted bay window. The presence of a bay window in itself is worthy of mention in a building of this nature as this style, first introduced by the Victorians, did not become common till after about 1870. Complete with decorative column-mullions and a 'Scotia' type moulding below the sloping roof this bay window is a good example of the architectural style adopted for the Lodge which could be described as well executed but not overly ornate. As mentioned above, Gifford noted similarities between the column-mullions on the Lodge and the more ornate ones on the Castle.

The sills on the bay windows and the walls below are heavily eroded, a fact that has required some repair and rebuilding work in recent times.

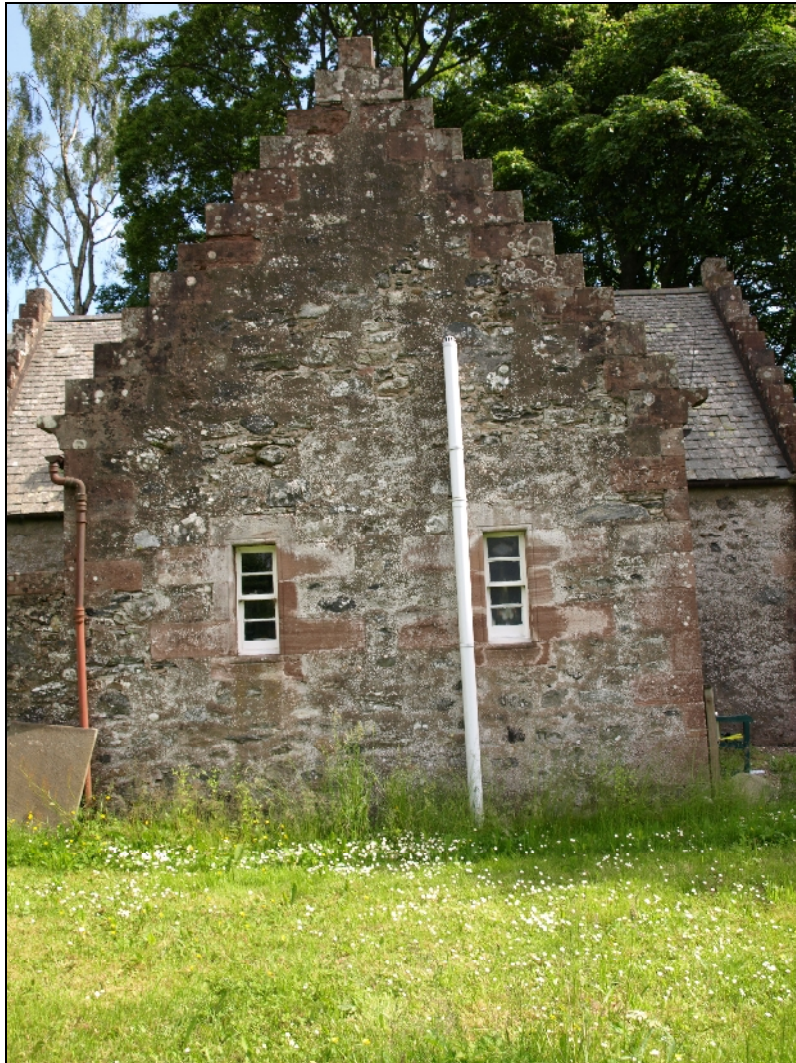
The North-West Wing – North-West Gable

Two narrow sash and case windows, in two-over-two arrangement, are the prominent features of this elevation. The NE one serves the kitchen while the SW window serves the bathroom. These very narrow openings are formed of long outbands which are out of proportion with the much shorter inbands. The elevation has been very heavily

weathered in places which has removed some of the thick layer of cement pointing to reveal a part of the wall core. In places lime mortar is visible indicating that this was the original bonding material used in construction before it was covered up by the liberal application of cement pointing. The gable has eleven crowsteps in total including the skewputt. A cast iron down pipe is fixed near to the NE corner and a large modern plastic vent pipe is attached to the wall beside the bathroom window.

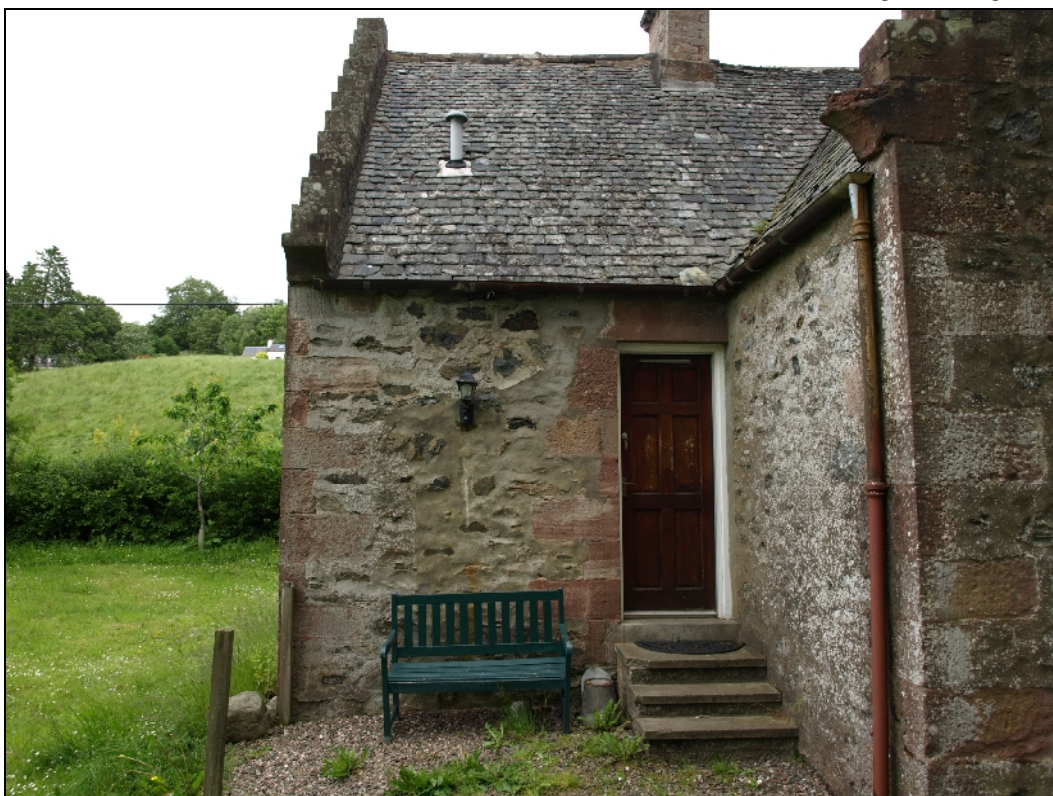
The North-West Wing – South-West Elevation

The main feature in this elevation is the addition of a new door which has been slapped through the wall next to the angle. A modern concrete sill has been added though the rest of the opening is in keeping with the rest of the building by being constructed of red sandstone. However, the quality of the stone masonry seen in this addition is of lesser quality than that shown by the original builders. Three concrete steps provide access to this new door which now forms the main access to the Lodge as the original door in the porch is not currently in use. A modern exterior light is fixed to the wall rebuild and on the roof a modern plastic flue has been added to serve the kitchen.

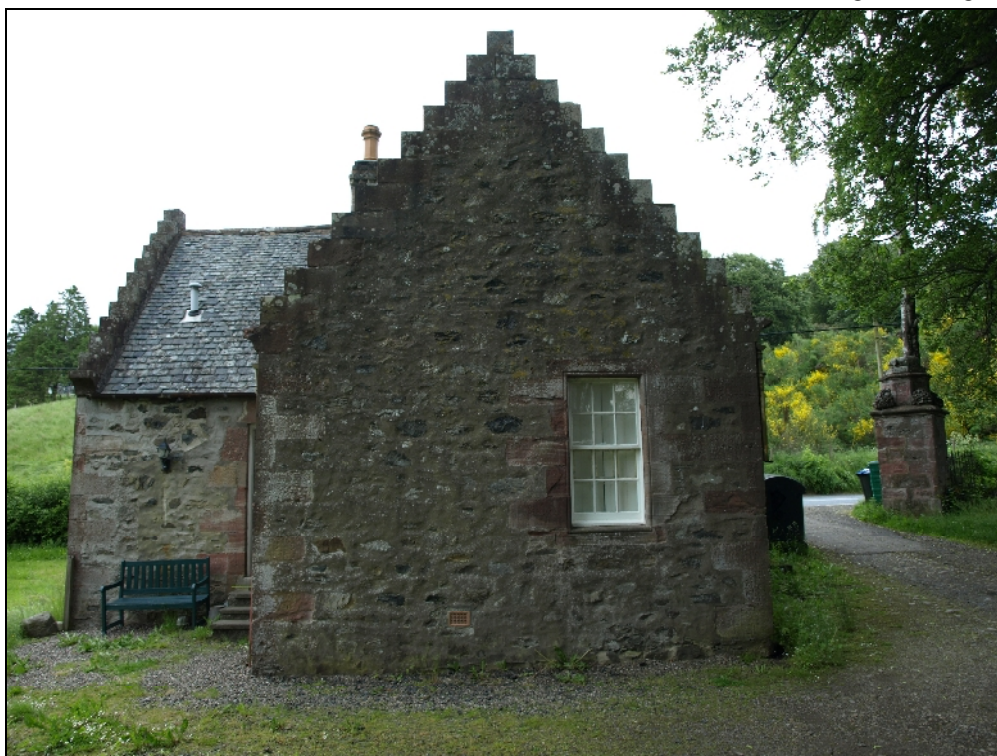
South-West gable

A single sash and case window in six-over-six arrangement is located approximately 1.2m from the south corner of the building. Some of the surfaces of the rybats have delaminated because of weathering, particularly to the left of the window. The lower ground level at this end of the building has revealed some of the foundations.
