Archaeological Building Record  
Billiard Hall, 108-114 High Street  
KINROSS

**ARCHAEOLOGICAL BUILDING RECORD**  
**BILLIARD HALL,**  
**108 – 114 HIGH STREET, KINROSS**  
**KR09**

*Alder Archaeology Ltd recorded a derelict Billiard Hall attached to the former Carnegie Museum and Library in Kinross High Street, site code KR09.*

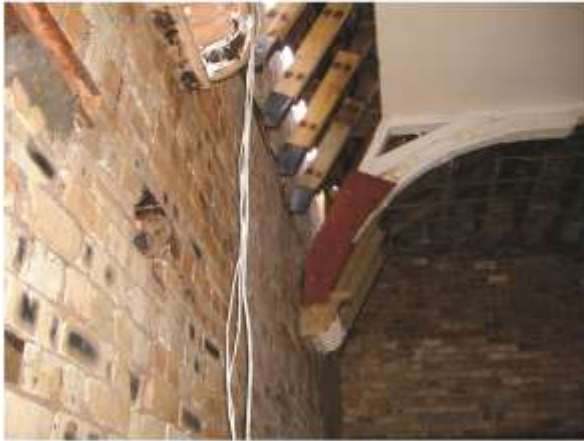
Image 011 South roof truss and corbels

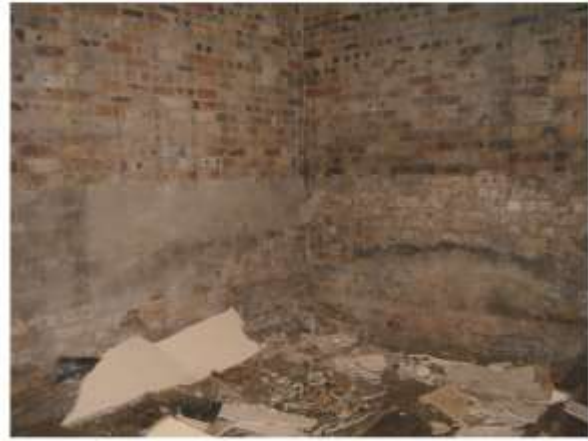
022	Detail of W (exterior) wall. Grey cement scar on wall is continuous at waist height. Cast iron ventilator cover with flap open. Corbel of N roof truss just visible. Collapsed plasterboard on floor indicates 20 <sup>th</sup> -century ceiling repair, failed.	NW
023	As above, detail of NW corner.	NW
024	Detail, N gable wall. Grey cement scar continues. Two N – S dwarf walls to support floor joists.	N
025	Detail, NE corner, doorway into store room. Door sill shows original floor height. Heating pipes on store room wall.	NE
026	Detail, NE corner. Rafters and sarking boards replaced on E slope of roof. Detail of N roof truss, timber and iron straps bolted to together with square nuts and bolts. Two part corbel. Ceiling at upper roof level, partly collapsed. Plaster board fixed onto laths, perhaps previously plastered. Laths fixed to varnished cross-beams, ie meant to be seen. Ceiling a secondary insertion in previously open roof.	NE

Image 023 NW corner. Cement scar on wall shows height of wall lining boards.

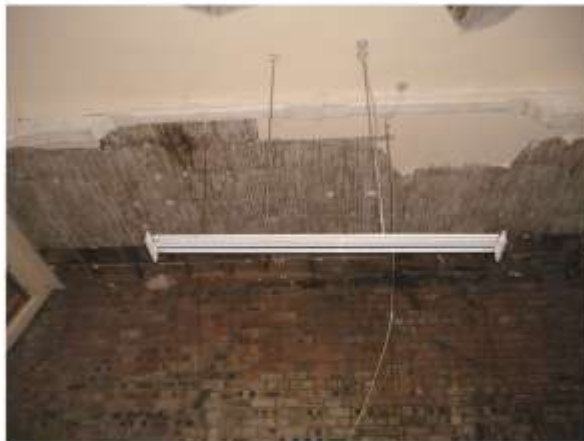
027	Detail, fluorescent light fitting suspended from ceiling under N roof truss. Shows previous of billiard table. Cross beam of roof truss with central iron strap, shows position of central post, hidden above. Iron strap disappears awkwardly into ceiling, confirms ceiling a secondary insertion.	N
028	Detail, SW corner. S roof truss. Remains of boarded lining to lower slope of E roof. Two colour schemes, one white, one tangerine (!).  Exposed ceiling shows marks of laths (N-S) on light cross-beams (E-W), fixed to heavy joists (N-S), cut off before reaching cross beam of truss. Higher joists (N-S) now disused, but continue N to rest on truss cross-beam.  Doorway in S gable wall confirms presence of balcony, now missing. Grey cement scar on W wall suggest board lined up to ceiling where accessible from balcony.  Yellow glassfibre insulation visible above surviving ceiling.	SW

Image 027 North roof truss partly masked by later ceiling

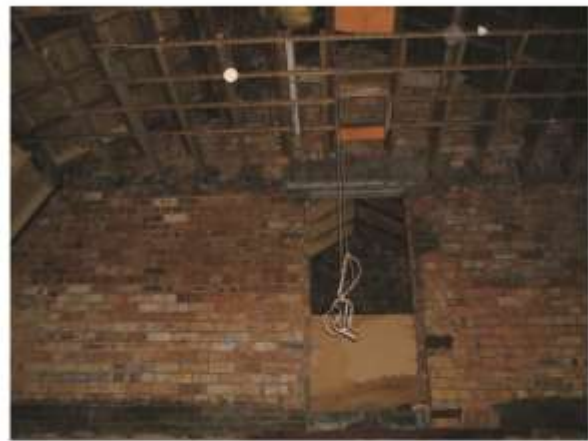
029	<p>Detail of S gable wall, with entrance door to balcony (missing) from stair annexe. Inserted concrete double lintel over doorway. Relieving arch above.</p> <p>Complex of joists and cross-beams as in 028 above. Lower joists seem practically unsupported.</p> <p>Original rafters where visible are varnished, confirming roof originally open. Horizontal dark mark on gable wall aligns with door sill, confirming position of balcony floor. See 014 above.</p>	S
030	Not used	-
031-2	Ground floor of stair annexe. View down into underground boiler room. Remains of late 20 <sup>th</sup> -century heating boiler. Flue connects into square chimney at SW corner of Billiard Hall.	W
033	View from balcony door down into Billiard Hall. Two suspended fluorescent light fittings and wires of third show probable positions of three billiard tables. Two N-S dwarf walls visible on ground to support timber floor, now gone.	N

Image 029 North gable wall with doorway to balcony and balcony floor line on wall. Varnished roof timbers above ceiling beams.

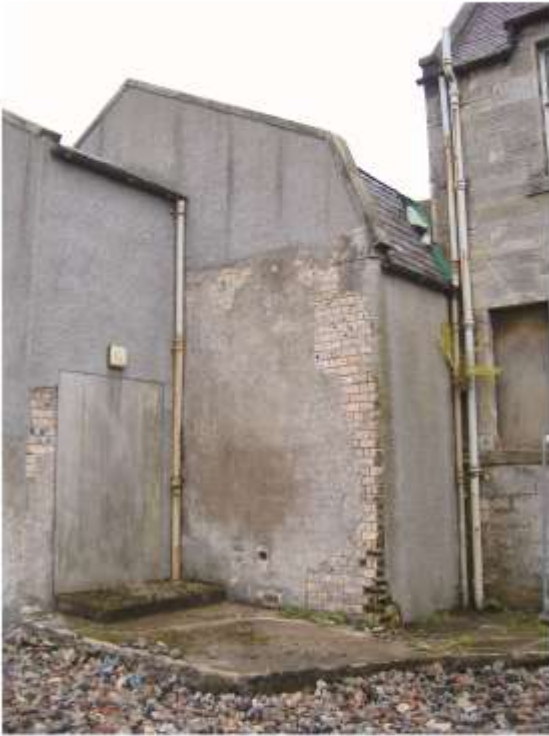
Image 037 SE corner with 'Dutch barn' roof.

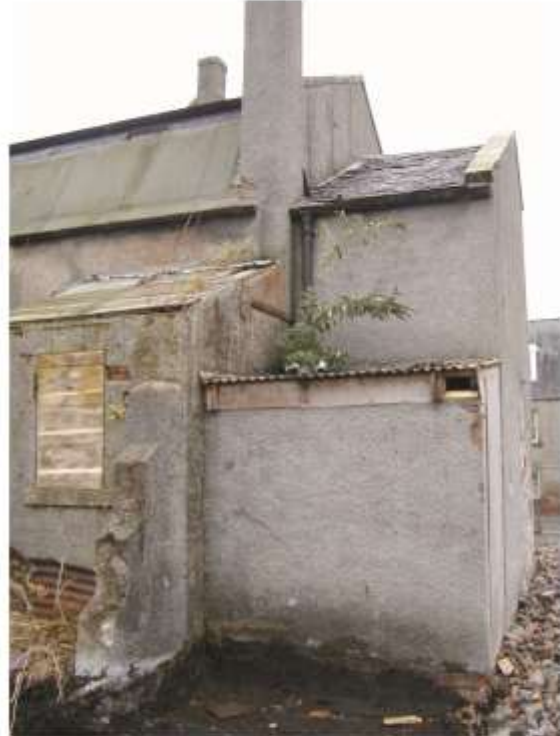
There is a gent's toilet annexe at the SW corner of the building. Despite its small size and presumably minimal weight, the toilet is badly damaged by cracking and settlement, imperfectly arrested by external buttresses and iron strapping. There must be a defect in the foundations. There is similar cracking in an adjacent brick structure at the NW corner of the hall, similarly repaired with iron strapping.

Image 040 SW corner with toilet annexe and chimney.

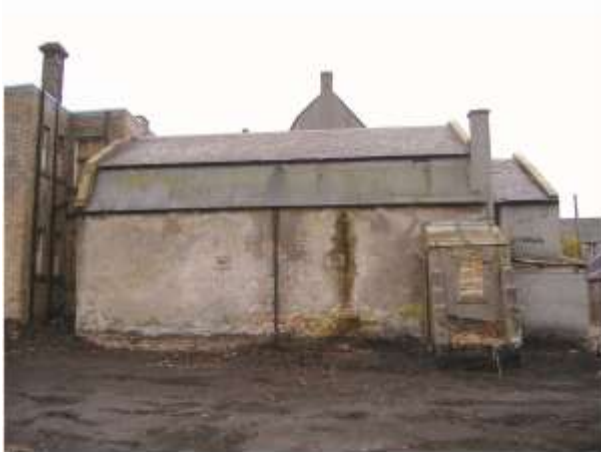
In the W wall there are two ventilators at about head height, visible externally and internally, where they are covered by movable cast-iron flaps. There are also three external ventilators at floor height. At the NW corner there is a concentration of two modern ventilators and one original, all at floor height. The reason for this is unknown, perhaps an attempt to cure a rising damp problem.

Image 042 West elevation with ventilators and roof truss bolts.

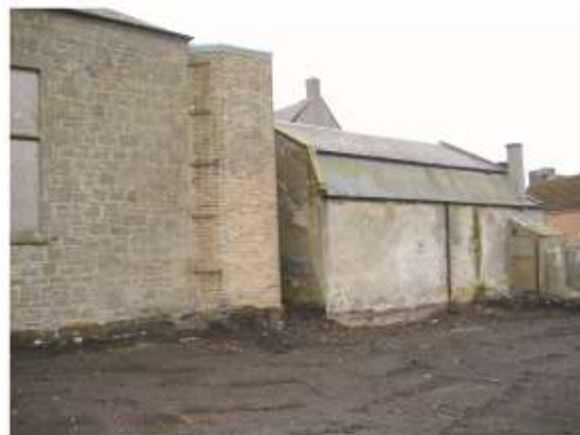
049	Not used	-
050	<p>General view of Billiard Hall, adjacent brick building and adjacent stone building. Rear view of dark feature against E face of chimney (see 38 above). Even more irregular than front (S) face.</p> <p>Adjacent brick building (toilet block) is buff brick, unrendered, stretcher bond. Sheet metal roof, possibly flat. Severe cracking and settlement at base of wall. Tied to adjacent stone building with five external iron bars.</p> <p>Adjacent stone building is sandstone rubble, faced and built to courses. Quoins with raised, dressed margins. Faced squared course along wall head. Half-round cast iron gutter above.</p>	SE
051	<p>As above, with fuller view of adjacent stone building.</p> <p>Large, four-light window (boarded up with OSB board), with well-dressed sandstone sill, lintel, jambs, mullion and transom. Lintel cracked. Flat relieving arch above. Hipped roof, with zinc ridges, slates uniform, but smaller, greener, probably older than Billiard Hall slates.</p> <p>Tall, slim sandstone ashlar chimney appears behind roof. Broad ogee cornice at chimney head. Chimney leans markedly to S.</p>	SE

Image 050 NW corner with adjacent buildings.
