Archaeological Standing Building Survey
Former Royal Hotel
Milnathort
PERTH & KINROSS

MI01

**ARCHAEOLOGICAL SBS
FORMER ROYAL HOTEL
MILNATHORT**

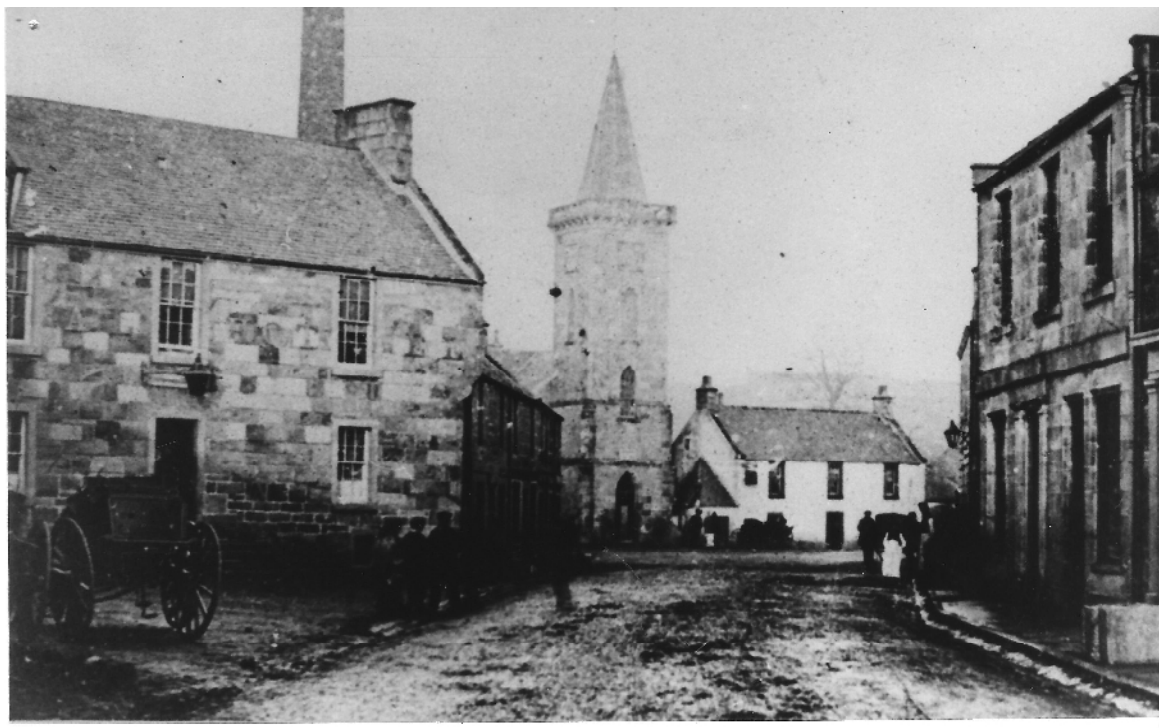
Royal Hotel, 1901

Two floodlight fittings mounted on the first floor were recent attachments, but were present by 1970 (see *Historic Images*). A glazed porch visible in the 1970 photograph was no longer present across the main entrance in the centre of the elevation, which featured a replacement Victorian-style four-panel door. A flight of four concentric semi-elliptical stone steps ascending from the street to the main doorway appear to have been present by 1901 and may be original, although the pavement level has been raised by several centimetres since 1970. Three chimney stacks were spaced along the roof, with a smaller example topped with two pots at the west gable end and larger, five-pot stacks (both partially adapted with metal vents) at the east end and just west of the western-most dormer. All three were present in 1901, although the ceramic pots were added some years after this date.
