Archaeological Historic Building Record
Grundcruie Sawmill
Methven
MV04

09th June 2017

**ARCHAEOLOGICAL HISTORIC
BUILDING RECORD
GRUNDCRUIE SAWMILL
METHVEN**

MV04

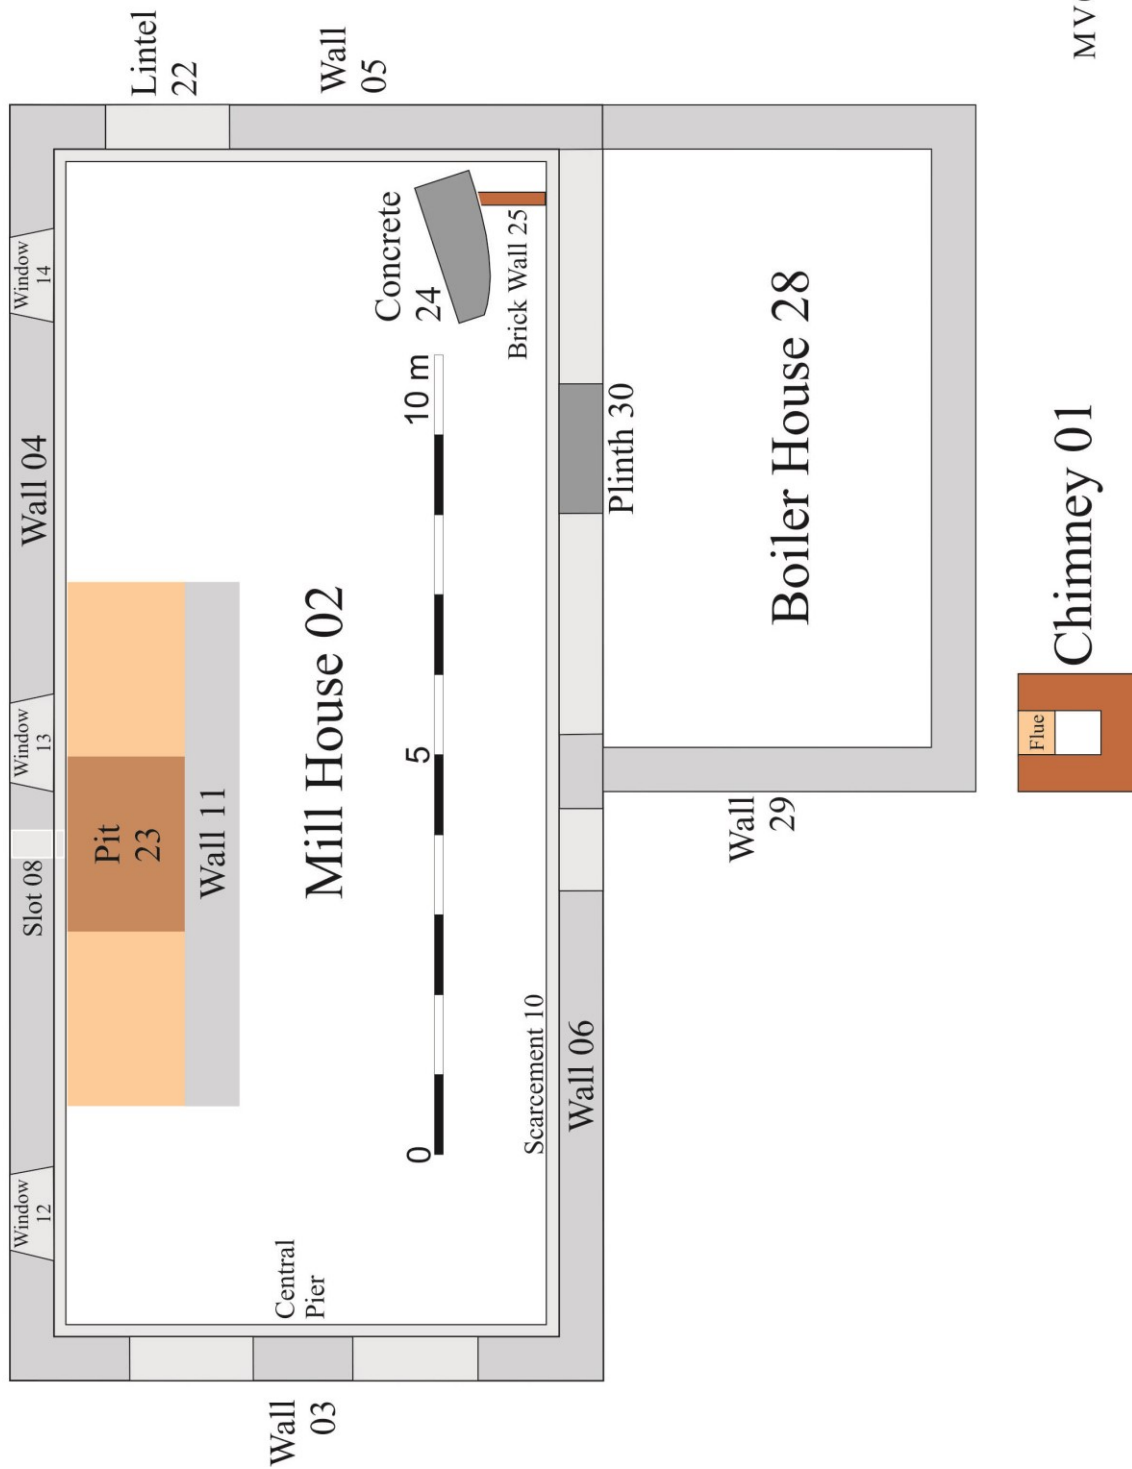
Illus 3

Grundcruie Sawmill, Methven, Plan

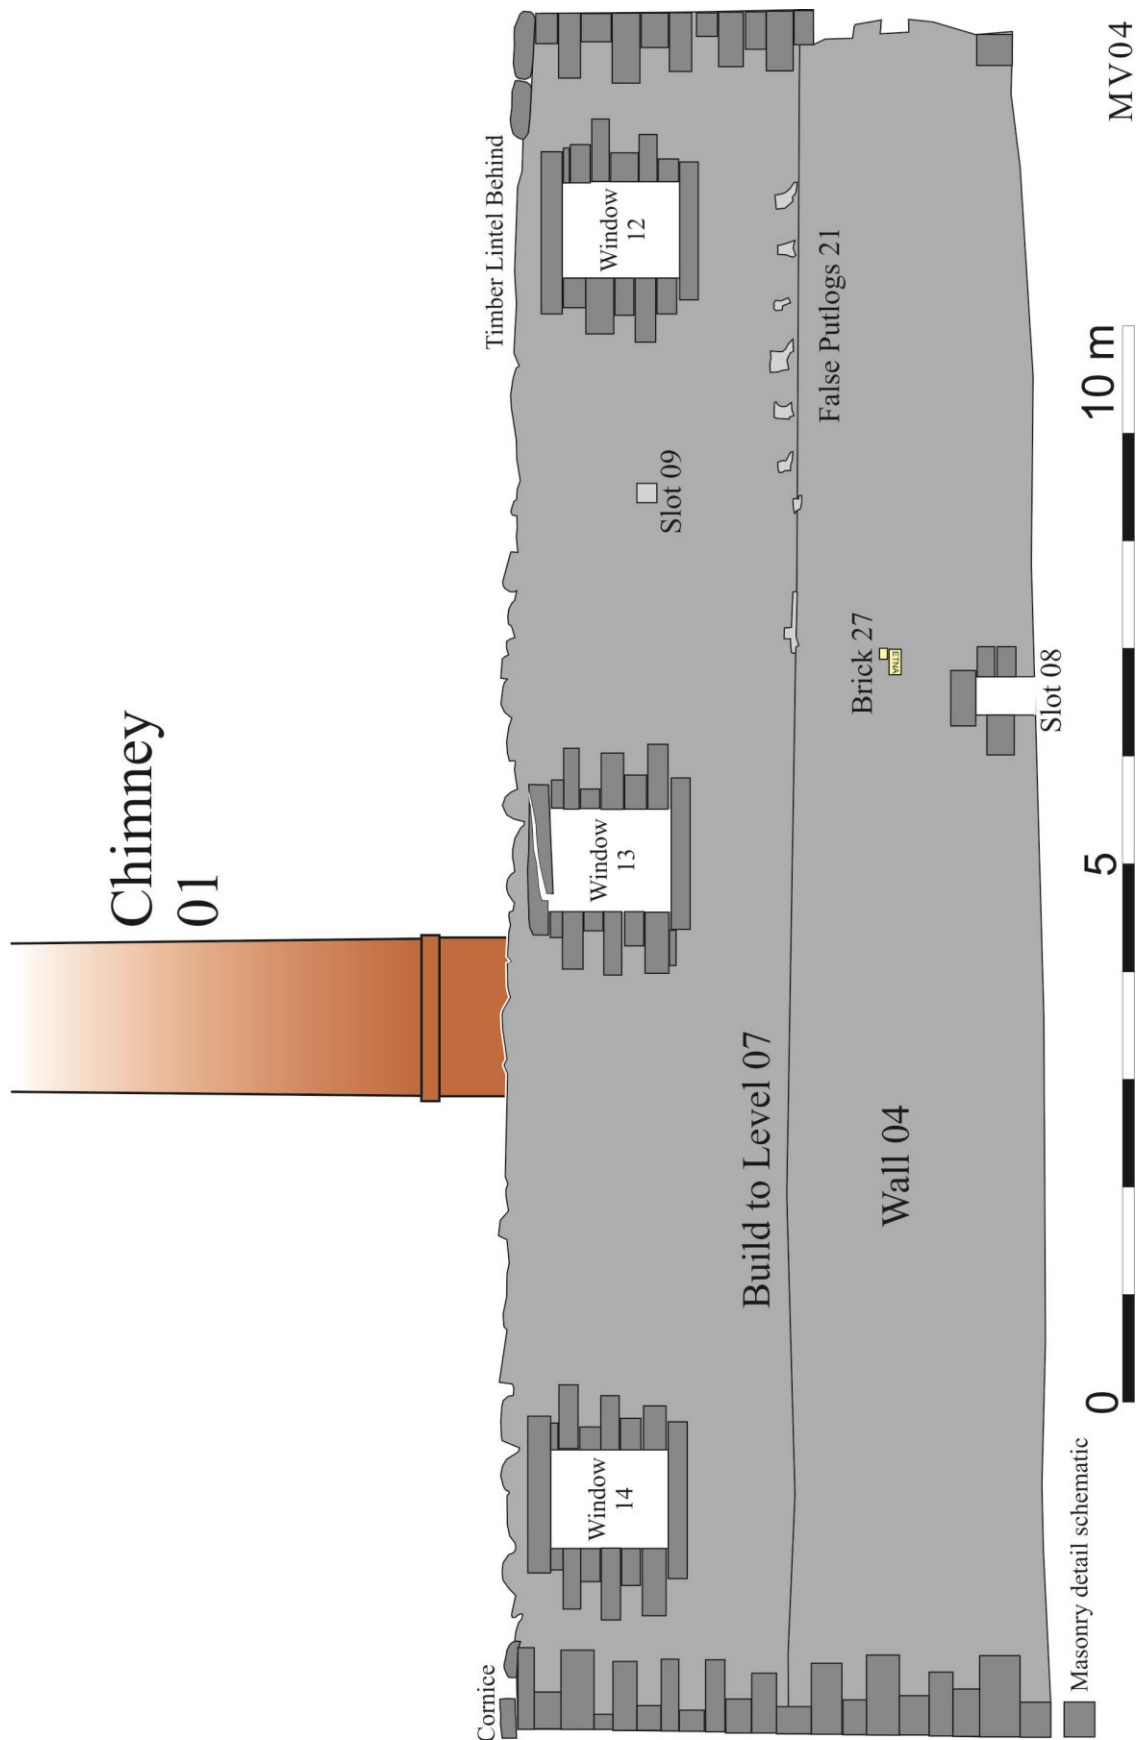
Illus 4

Grundcruie Sawmill, Methven, NE Elevation

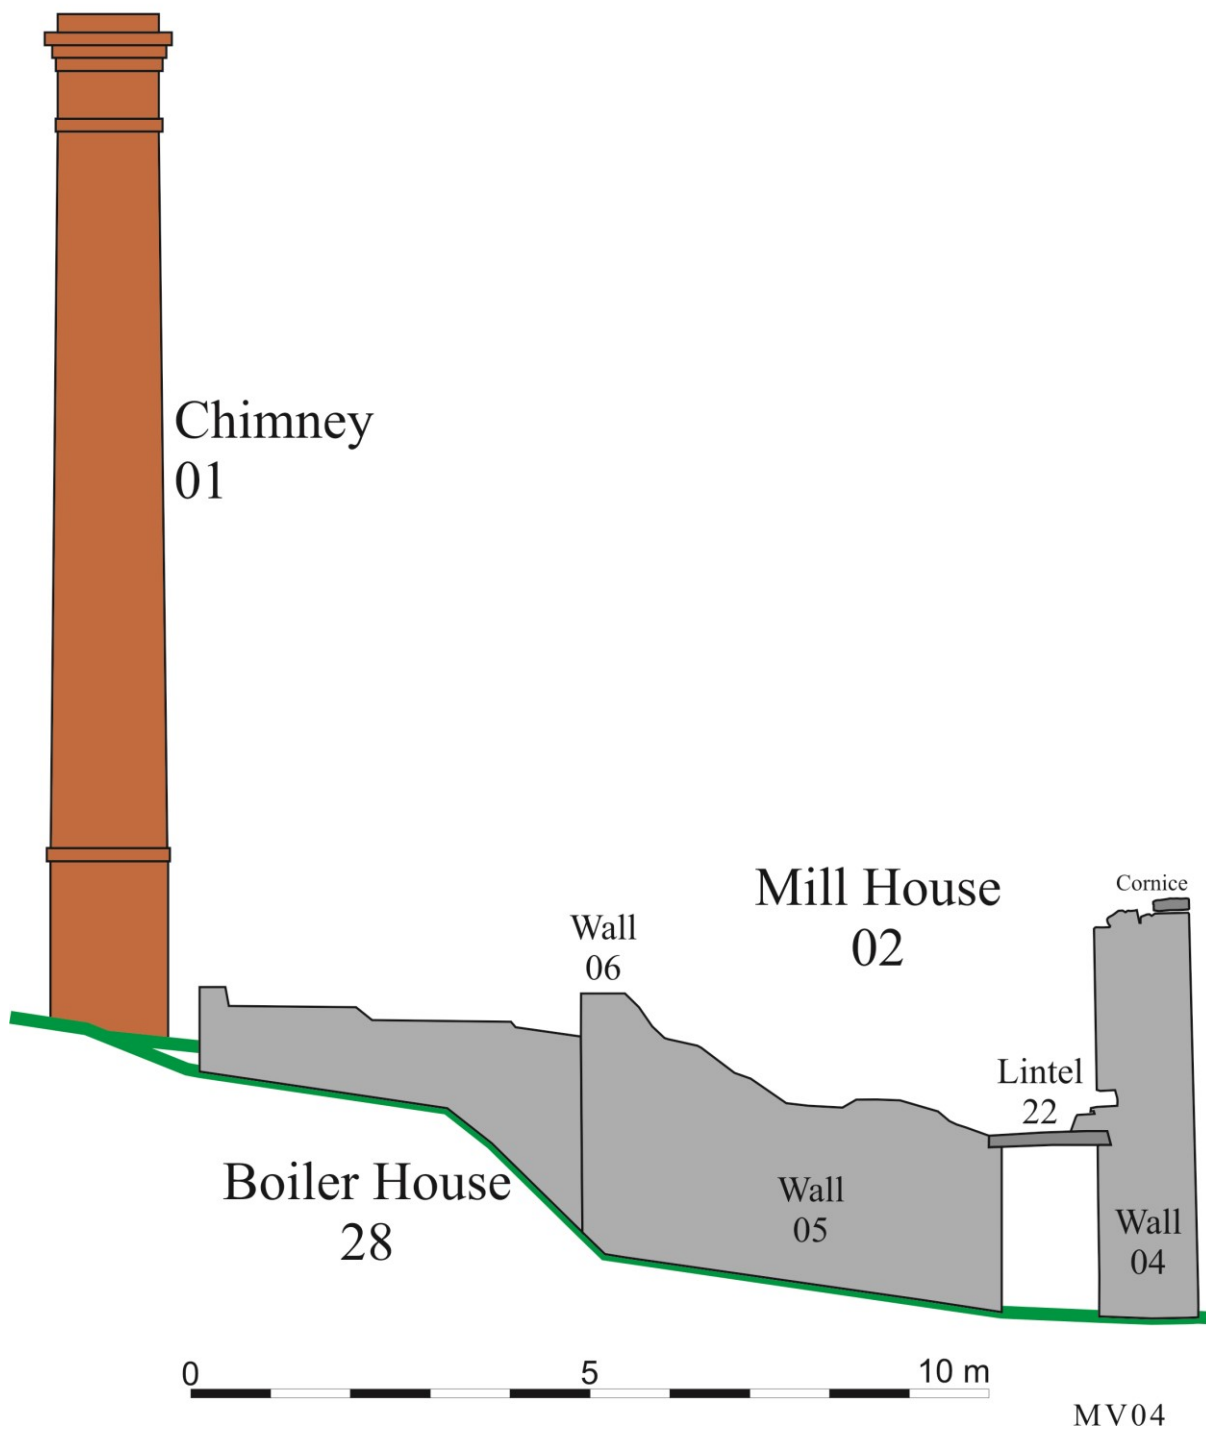
Illus 5

Grundcruie Sawmill, Methven,
E Elevation

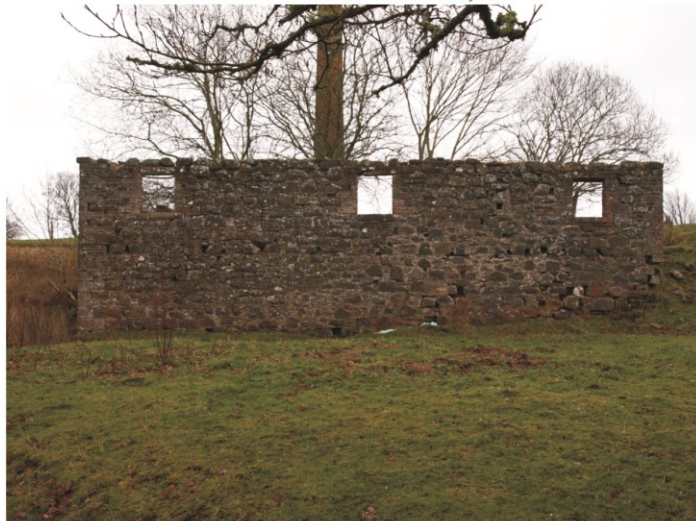
Illus 6 Mill House 02, N Elevation. Chimney 01 behind.

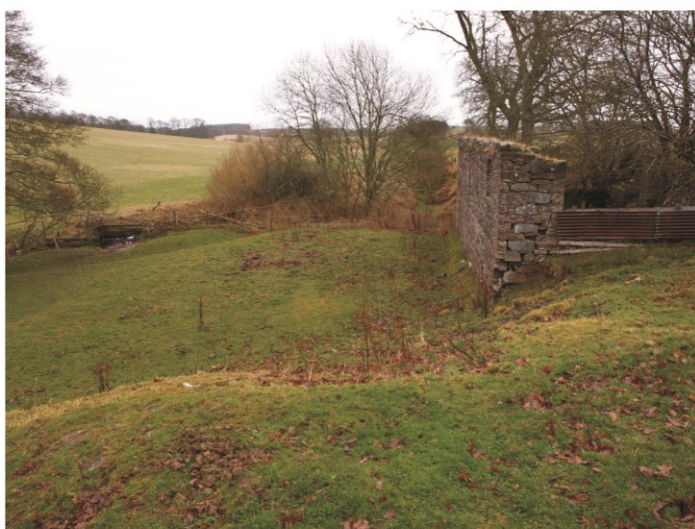
Illus 7 Mill House 02 and Lower Lade 31 from Upper Lade 32.
Grassy Ramp 33 in foreground. Carse Burn to L.

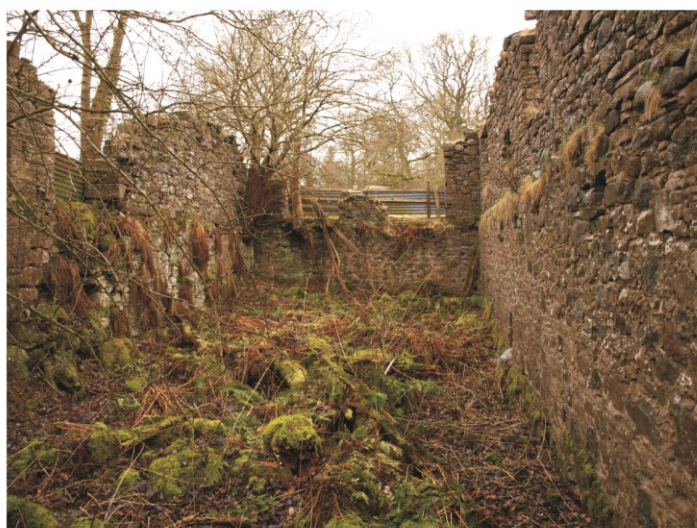
Internally the mill house 02 was filled with collapsed timbers and vegetation. Parallel to and 1.5 m S of the N Wall was a low stone wall 11, 0.72 m wide and up to 0.7 m high, defining an oblong depression or pit 23, with a deeper part in the middle, 2.2 m long, centred on the slot 08. This could have been connected with the water wheel and saw machinery inside the mill. In amongst the collapsed and broken timbers was a threaded bolt and washer with a square nut 35, still attached to rotted timbers. The metal was corroded brown, but without extensive delamination, perhaps indicating wrought iron rather than mild steel. Similarly, the use of a square rather than hexagonal nut suggests a 19th or early-20th century date. Square nuts and bolts are rare today except on the railway, and then usually with obsolete bull-headed rail. The timbers were too decayed to judge whether this was a fragment of roof or floor timbers, or mill machinery.

Illus 8 Mill House 02 interior. W Wall 03 ahead. Pit 23 and
Wall 11 under vegetation in foreground. Wall 04 to R with
Scarcement 10 and Putlogs 15 - 20 below.

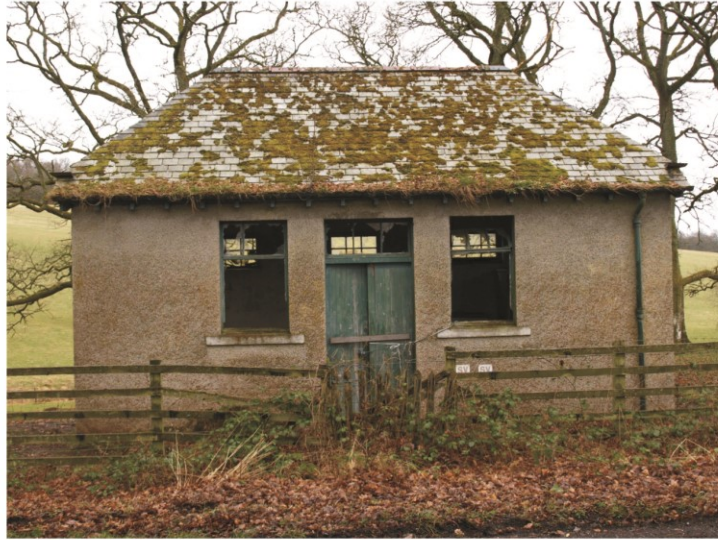
Illus 12 Water Treatment House 34 from road.

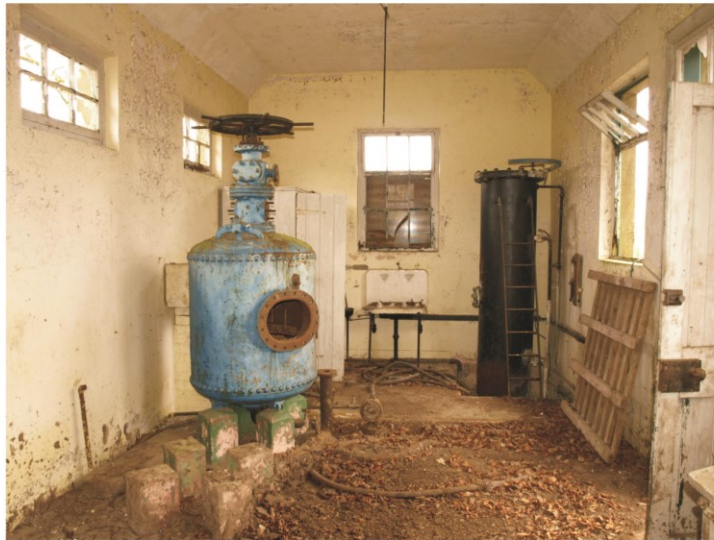
The building is now disused, but at one time served to treat the main water supply to Methven, presumably running in a pipe under the public road. Internally, it contains disused water treatment machinery, and wooden bins with remains of white powder, probably treatment chemicals, for example to neutralise acid or kill bacteria. Most conspicuous was a mixing machine 38. This was a riveted steel drum, painted blue, with cast-iron fittings. A cast-iron capstan wheel turned a central spindle, fixed to internal cast-iron and steel mixing blades. It was presumably used to mix treatment chemicals into the water.

Illus 13 Water Treatment House 34 interior. Machine 38.

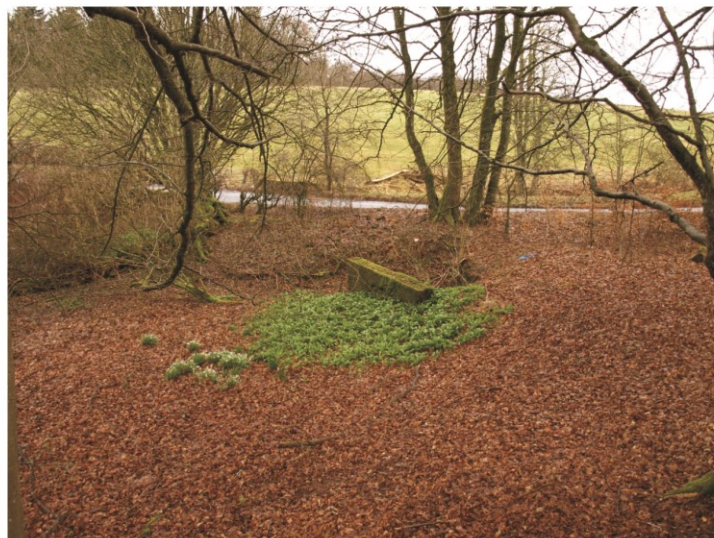
The concrete was much overgrown with moss, and had an open, porous fabric, with a rounded natural pebble aggregate, quite different from the dense vibration-compacted structure and angular aggregate of modern concrete. It could have been connected with the early 20th-century water supply, or perhaps a WWII defensive structure guarding the crossing of the Carse Burn. Directly beside the concrete, set in the ground, was a metal fitting with a ferrous rust colour, but a smooth surface. It could have been of bronze or a special alloy steel. The rounded profile and curves of the metal suggest hot forging, not casting, pressing or cutting. Attached to it was a threaded rod with a square nut (not hexagonal), suggesting a mid 20th century date or earlier. It could have been part of water supply equipment, or of a WWII gun mounting or sighting slit.

Illus 14 Concrete Structure 39 overlooking road crossing of Carse Burn.
