Archaeological Historic Building Record
Grundcruie Sawmill
Methven
MV04

09th June 2017

**ARCHAEOLOGICAL HISTORIC
BUILDING RECORD
GRUNDCRUIE SAWMILL
METHVEN**

MV04

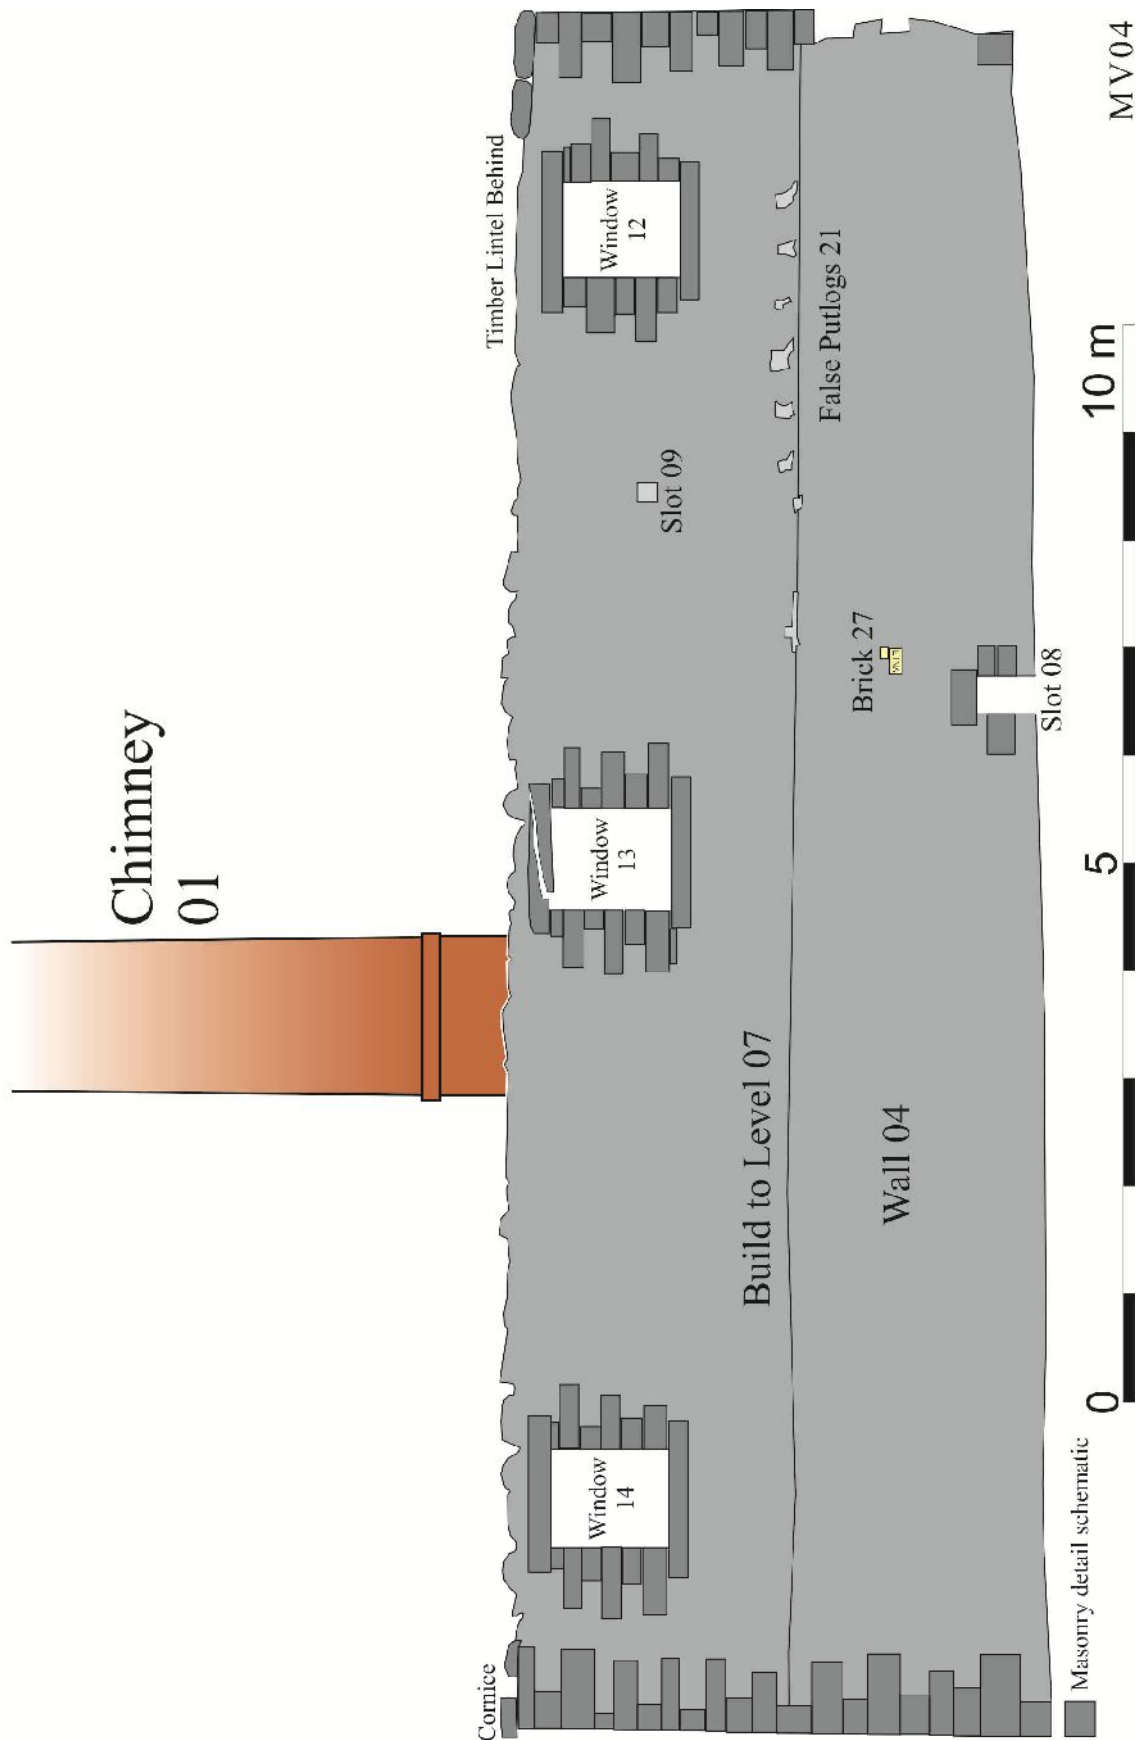
Illus 4

The N and E walls leaned out slightly at ground floor level, correcting to vertical at first floor level. The S and W walls might have done the same, if enough of them had survived and been visible. This was not accompanied with obvious cracking, and may have been the result of heavy stone walls sinking into soft ground as they were being built, and being corrected 'on the fly' by the masons as they worked upwards. A similar pattern can be seen in many 19th-century houses in Perth, for example in the Balhousie area, where the ground is very soft sand.

The N Wall 04 survived almost to its full height, with a well-defined build to a level 07 externally at first floor level. This almost corresponded to the internal Scarcement 10, but was in fact 15 cm (6") lower. Above these features were three similar windows, 12, 13 and 14, in the middle and near either end of the wall. These had internal splays, with hard sandstone lintels and sills, and jambs formed of quoins. They originally had internal timber safe lintels, but only one of these survived, over the W Window 12.

Grundruie Sawmill, Methven, NElevation

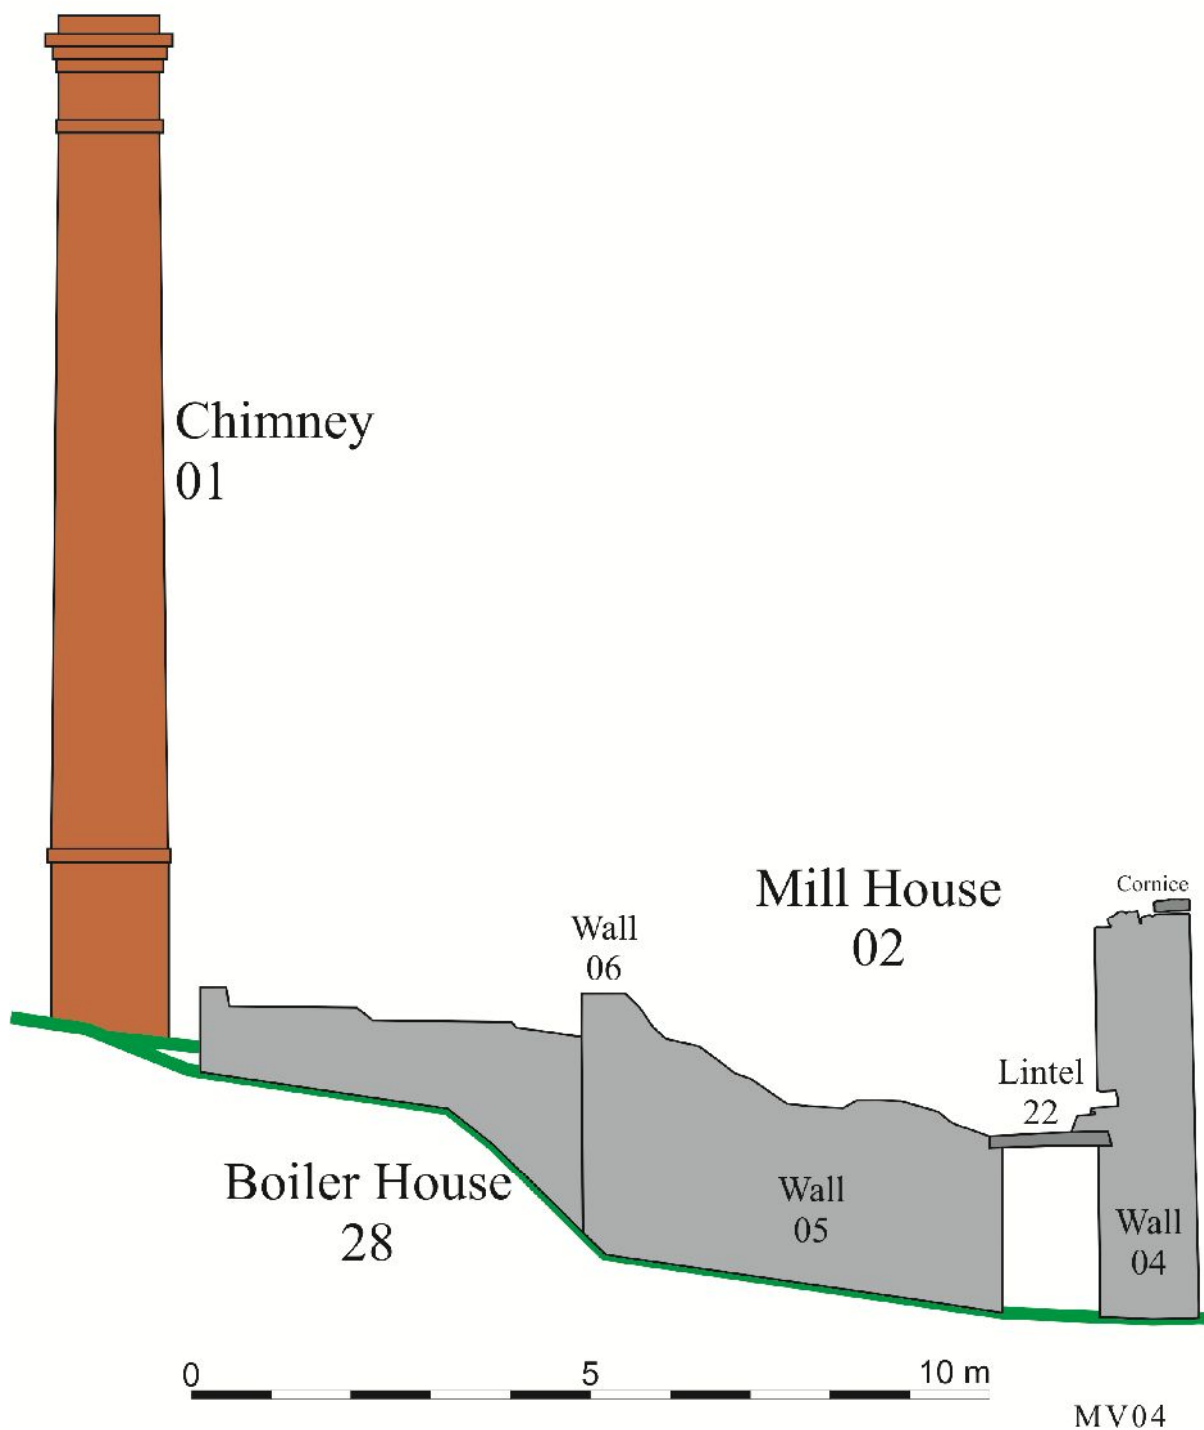
Illus 5

The E Wall 05 was largely missing, hidden below ground, or consisted of doorways, but at the NE corner it survived almost to its full height, with single block at the very top projecting slightly N and E to form a cornice along what must have been the wall head. A sandstone lintel/ threshold 22 spanned a wide gap in the E Wall 05, separating the two doorways on the ground and first floors, the natural curve of the stone arranged to form a slight arch.

Grunderuie Sawmill, Methven,
E Elevation

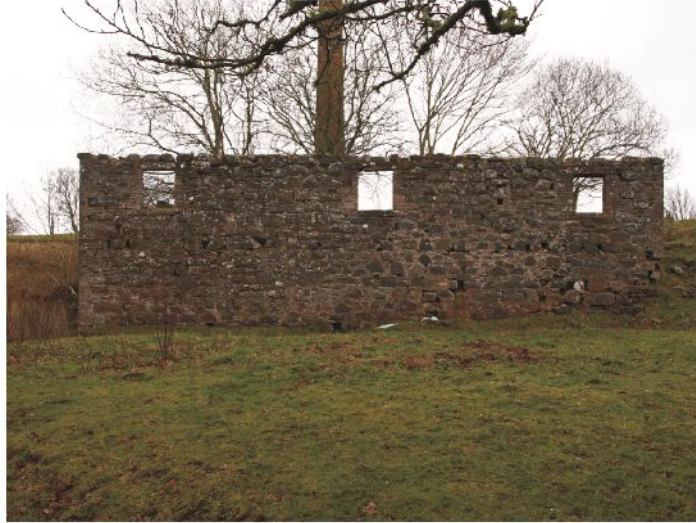
Mill House 02

Illus 6 Mill House 02, N Elevation. Chimney 01 behind.

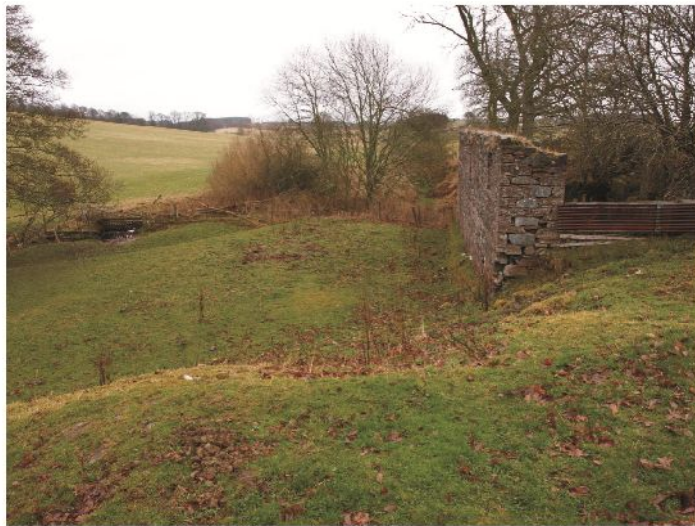
The Lower Lade 31 runs along the foot of the N Wall 04 of the Mill House 02, converging to the Carse Burn, which it eventually joined downstream, at a junction now blocked. The channel is wet and muddy, but no longer carries running water.

Illus 7 Mill House 02 and Lower Lade 31 from Upper Lade 32.
Grassy Ramp 33 in foreground. Carse Burn to L.

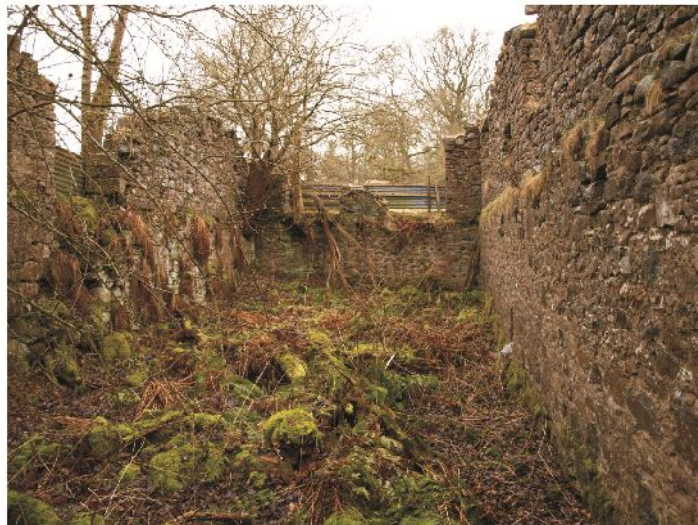
Internally the mill house 02 was filled with collapsed timbers and vegetation. Parallel to and 1.5 m S of the N Wall was a low stone wall 11, 0.72 m wide and up to 0.7 m high, defining an oblong depression or pit 23, with a deeper part in the middle, 2.2 m long, centred on the slot 08. This could have been connected with the water wheel and saw machinery inside the mill. In amongst the collapsed and broken timbers was a threaded bolt and washer with a square nut 35, still attached to rotted timbers. The metal was corroded brown, but without extensive delamination, perhaps indicating wrought iron rather than mild steel. Similarly, the use of a square rather than hexagonal nut suggests a 19th or early-20th century date. Square nuts and bolts are rare today except on the railway, and then usually with obsolete bull-headed rail. The timbers were too decayed to judge whether this was a fragment of roof or floor timbers, or mill machinery.

Illus 8 Mill House 02 interior. W Wall 03 ahead. Pit 23 and
Wall 11 under vegetation in foreground. Wall 04 to R with
Scarcement 10 and Putlogs 15 - 20 below.

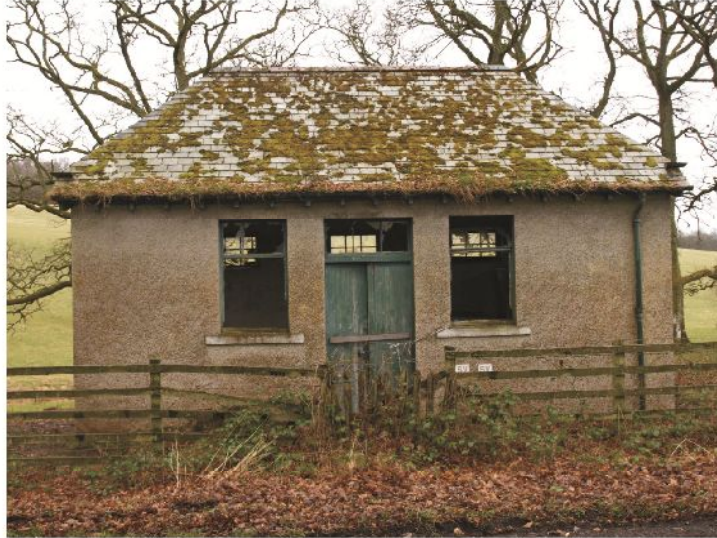
The building is now disused, but at one time served to treat the main water supply to Methven, presumably running in a pipe under the public road. Internally, it contains disused water treatment machinery, and wooden bins with remains of white powder, probably treatment chemicals, for example to neutralise acid or kill bacteria. Most conspicuous was a mixing machine 38. This was a riveted steel drum, painted blue, with cast-iron fittings. A cast-iron capstan wheel turned a central spindle, fixed to internal cast-iron and steel mixing blades. It was presumably used to mix treatment chemicals into the water.

The general form and style of the building and its contents suggests an early 20th-century date, while their condition suggests disuse for some decades at least. Directly to the N of the building was the wooden cover 37 of a large rectangular square tank. Its position centred on the Treatment House shows that it was part of the same water supply system.

Illus 12 Water Treatment House 34 from road.

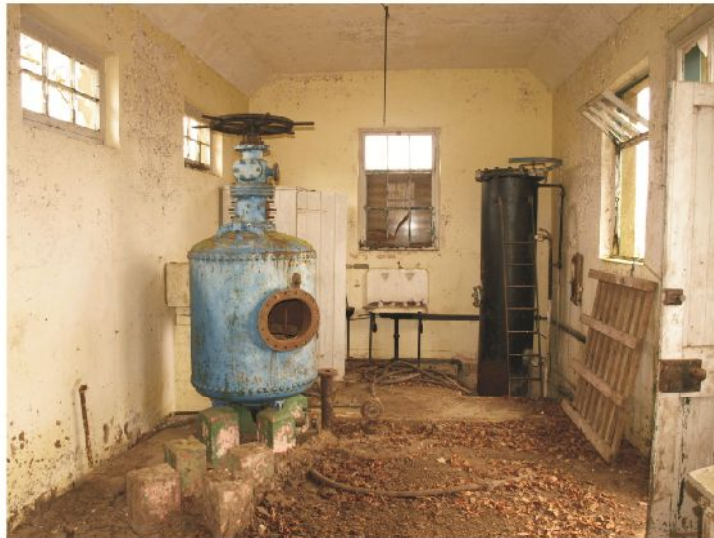
Illus 13 Water Treatment House 34 interior. Machine 38.

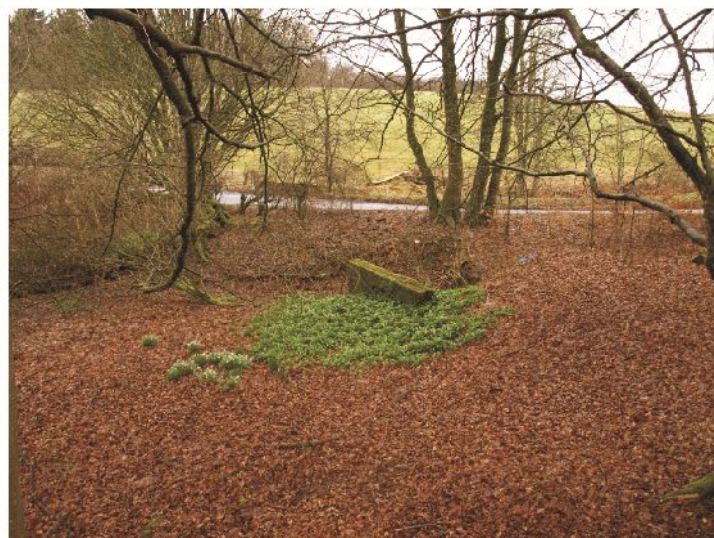
The concrete was much overgrown with moss, and had an open, porous fabric, with a rounded natural pebble aggregate, quite different from the dense vibration-compacted structure and angular aggregate of modern concrete. It could have been connected with the early 20th-century water supply, or perhaps a WWII defensive structure guarding the crossing of the Carse Burn. Directly beside the concrete, set in the ground, was a metal fitting with a ferrous rust colour, but a smooth surface. It could have been of bronze or a special alloy steel. The rounded profile and curves of the metal suggest hot forging, not casting, pressing or cutting. Attached to it was a threaded rod with a square nut (not hexagonal), suggesting a mid 20th century date or earlier. It could have been part of water supply equipment, or of a WWII gun mounting or sighting slit.

Illus 14 Concrete Structure 39 overlooking road crossing of Carse Burn.
