# Archaeological Historic Building Record Grundcruie Water Treatment Works Methven MV05

DPB/MV05 08 January 2019

# ARCHAEOLOGICAL HISTORIC BUILDING RECORD GRUNDCRUIE WATER TREATMENT WORKS METHVEN MV05

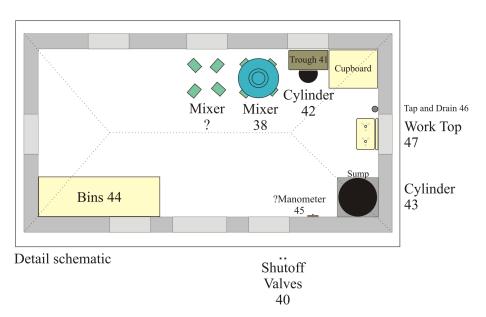
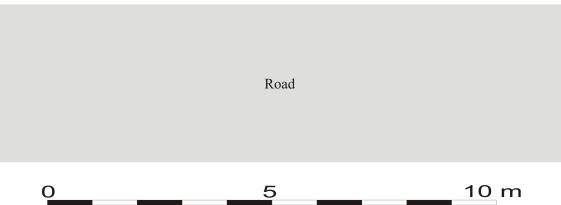
# Illus 3 Grunderuie Water Treatment Works, Methven Plan

Tank Cover 37

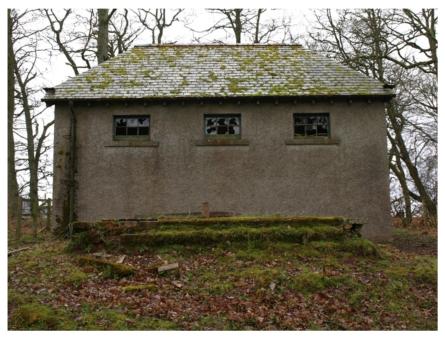
About 3 m to the N of the Water Treatment House 34 is a mainly concrete deck 37 over what appears to be a reservoir or perhaps a settling tank, about 3.8 m x 3.2 m, its edges formed by red colliery bricks. A loose example bore the stamp AIRDRIE. The E end of the deck was covered with wooden planks.

4 North elevation, with Tank Cover 37 in foreground

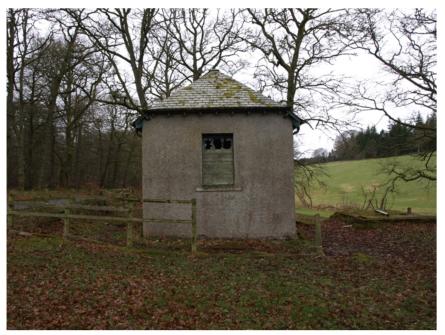
5 East elevation

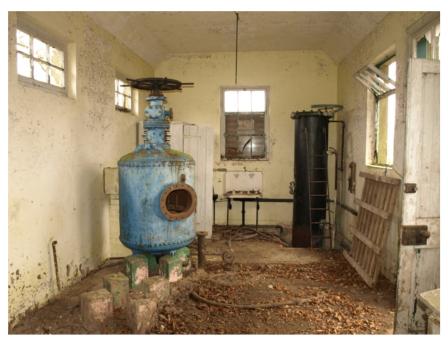
Internally, the Treatment House 34 contained various items of water processing machinery. Most notable was a mixing drum 38, of riveted steel painted blue, with an arrangement of mixing arms or paddles inside, presumably for mixing soluble chemical powders into the water. The riveted construction strongly suggests a mid 20<sup>th</sup>-century date; compare for example the boilers of 1950s and early 1960s steam locomotives. Riveting has almost entirely been superseded by welding in modern pressure vessels. An arrangement of concrete blocks to the W suggested the base of another similar machine, now removed.

6 Interior, E, with Mixer 38 and other machinery

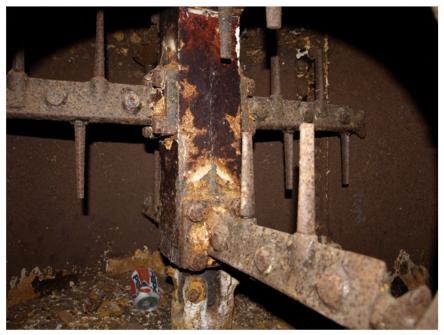
Internally, Six triangular section mixer arms bolted on to square central shank. Each arm carries two (top and bottom arms) or four (middle arms) tapering steel or iron prongs, about 15 mm diameter, pointing up and down. All apparently rotated by turning the steel capstan wheel above.

7 Detail, mixing arms inside Mixer 38
