Archaeological Watching Brief
West Mains of Huntingtower
Perth
HR02

07 April 2020

**ARCHAEOLOGICAL WATCHING BRIEF
WEST MAINS OF HUNTINGTOWER
PERTH**

HR02

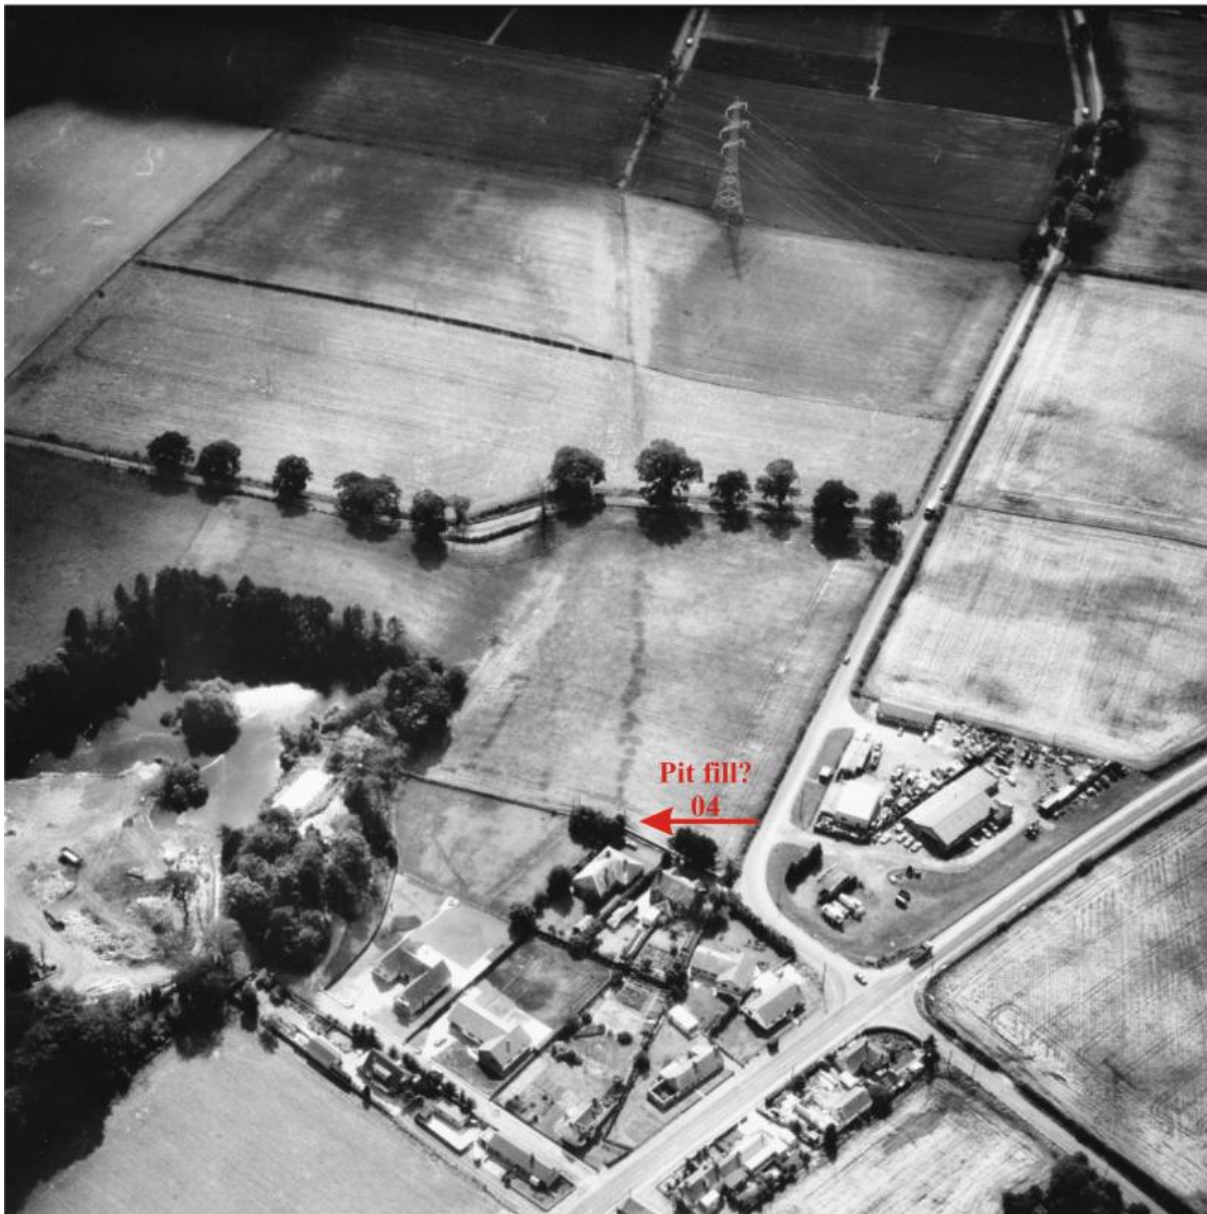
Illus 4 West Mains of Huntingtower, Aerial Photograph looking WSW

Presumed Roman pit alignments. Location of pit fill? 04 hidden by trees.
Historic Environment Scotland Aerial Photograph Collection SC0170623

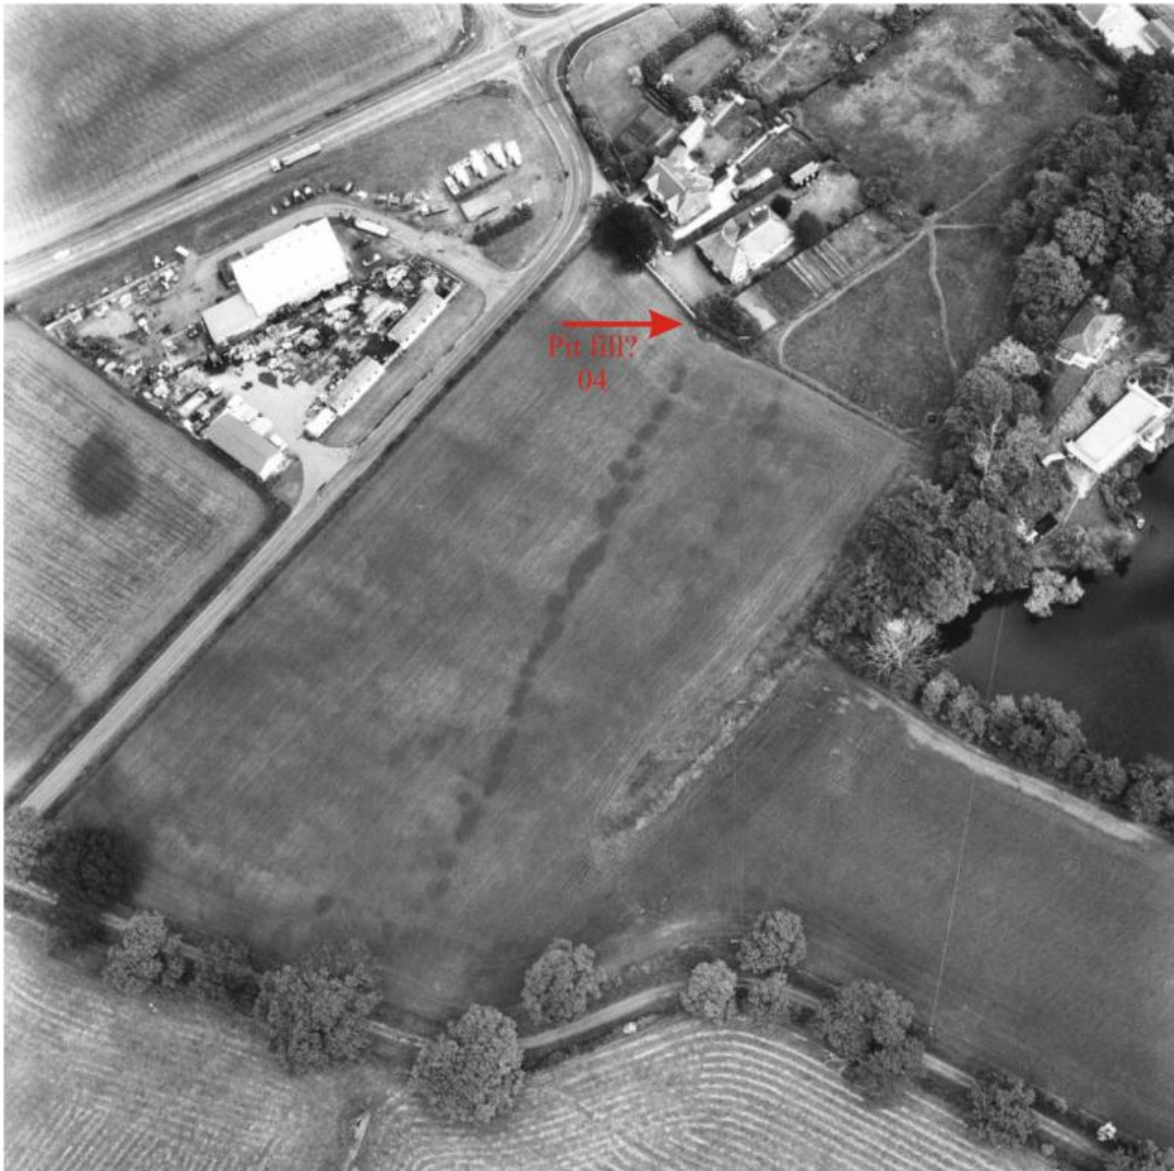
Illus 5 West Mains of Huntingtower, Aerial Photograph looking ENE

Presumed Roman pit alignments. Location of pit fill? 04 obscured by mud or vegetation.
Historic Environment Scotland Aerial Photograph Collection SC0170736

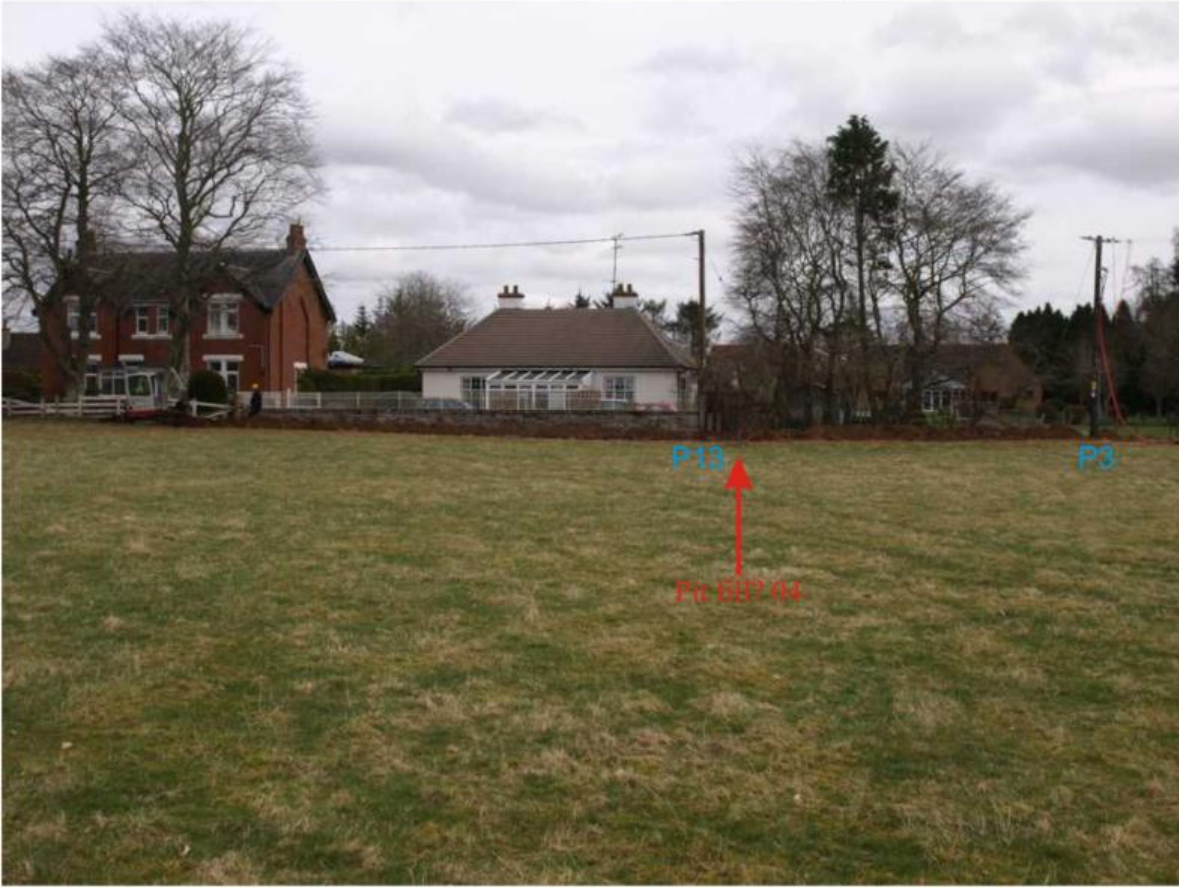
The silty loam 04 was very obviously the fill of a feature cut into the natural gravel 03 and 05, about 1.8 m across N – S. Comparison with aerial photographs shows that it lines up well with the presumed Roman gravel-pits along the N edge of the Roman road, and may be identical with an uncertain smudge at the very E end of the pit alignment, in the shadow of the hedgerow and partly masked by surface changes in vegetation and soil.

6 General view E. Location of ?pit fill 04.

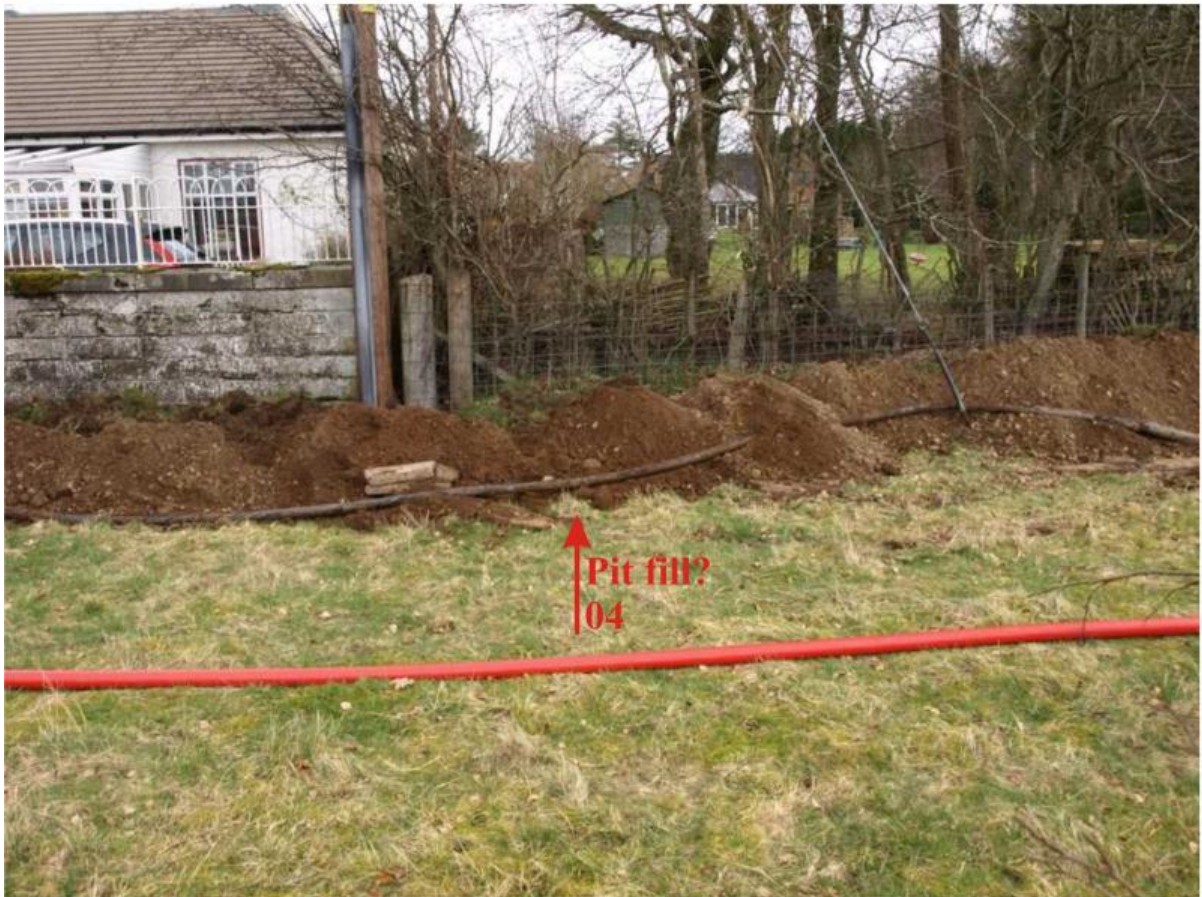
Under these layers was the failed electricity supply cable. When this was removed, clean yellow natural gravel 03 became visible in the trench base, about 1 m down. This gravel was interrupted by a stretch of fine brown silty loam 04, appearing 2.3 m S of the bend in the E boundary, and continuing N for about 1.8 m. Natural gravel (numbered 05) then resumed, at 0.5 m S of the bend, and continued uninterrupted, all the way to the N end of the cable trench.

These changes were measured in on the trench bottom, and photographed with difficulty, but can also be clearly seen in photographs of the spoil heap along the W side of the trench. The change in the colour and texture of the upcast material is quite

9 Detail, E. Brown pit fill 04 visible in upcast, compared with gravel on either side.
