Historic Building Record
College Mill Trout Farm
Almondbank
PERTH & KINROSS
HR03

**COLLEGE MILL TROUT FARM
HISTORIC BUILDING RECORD
ALMONDBANK
PERTH & KINROSS**

HR03

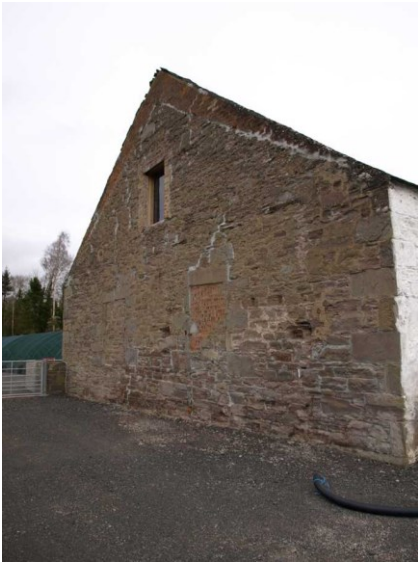
The W gable end wall leans markedly outwards to the W, and shows extensive evidence of cracking and repair. This wall has not been whitewashed, so it is possible to clearly see the sandstone rubble masonry, with well-defined sandstone quoins at the N and S corners.

At ground floor level there are two blocked openings, either side of the centre, with sandstone quoins and lintels, but no obvious sills. In both openings the quoins are present only above waist height, as if they had both begun as windows. The N opening is blocked with sandstone rubble. The S opening appears to have been opened up to form a doorway, then blocked in two stages, with sandstone rubble at the bottom, and red brick at the top, probably 20th century.

At loft level there is a single central rectangular window with inserted brick jambs, a timber lintel perhaps re-used, a fixed timber frame, and a single fixed pane of modern float glass. This is evidently a modern insertion, perhaps late 20th-century. At the top of the gable wall is a band of red brick, perhaps half a metre at the ridge, tapering to zero at the eaves, added to form the upward sweep of the roof. The brick looks older than the jambs in the loft window or the blocking in the ground floor window. It might date to the early 20th century.

Illustration 7: W gable. Blocked openings, inserted window and raised roof line

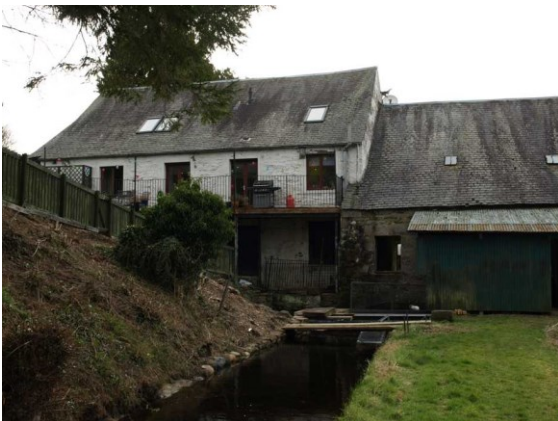
At the N wall of the mill, the lade divides. Part flows straight on, through the mill, and out on the S side. Part turns ninety degrees to the W, flows in front of the W range, under a stone arch, then on into a double culvert to be diverted around the mill. This W-flowing channel is enclosed with stone walls and a concrete wall, so that it cannot overflow and flood the complex.

Illustration 8: Lade flowing S into W Range

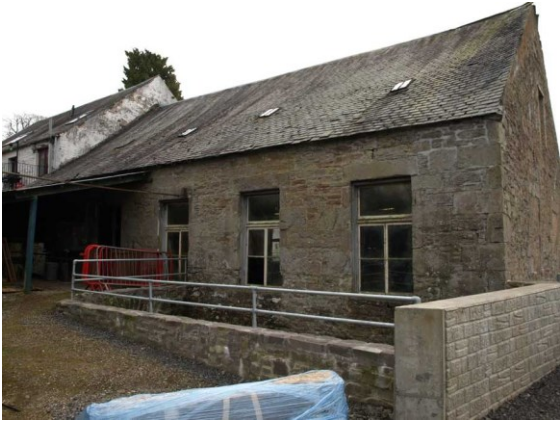
The N wall of the W range is unpainted, and of sandstone rubble masonry, with sandstone quoins and lintels, but no well-defined sills. There are five evenly-spaced openings in the N wall. At the E end there is low archway to admit the lade into the mill, with a rectangular open hatchway or window above. Next to this is an entrance door. West of this are three similar glazed windows. The entrance door is reached by a stone arch footbridge over the side branch of the lade. This area is covered over by a modern corrugated iron and timber shelter.

Illustration 9: W Range, N and W elevations.

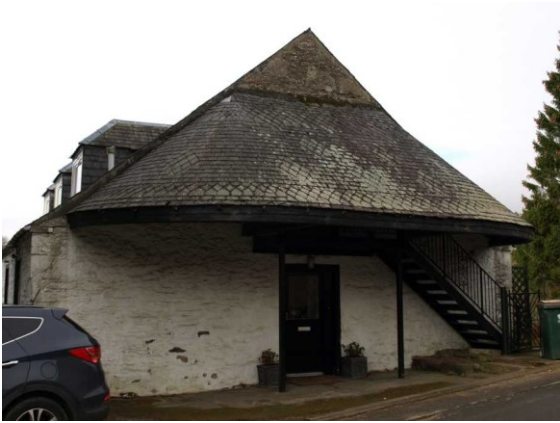
The doors and balcony are covered over by a D-shaped slate and timber canopy, which occupies the full width of the gable end, and reaches up to within a metre of the apex. The canopy is cantilevered out from the gable wall. Around the base or eaves of the canopy is a curved timber beam, probably laminated, which defines the D-shape of the structure. The ends butt up against the gable wall, and the middle is supported by two horizontal timber struts, one of which butts up against the wall, while the other is now fastened to the steel balcony structure. The D-beam is suspended from above by four wrought iron or steel bars, fastened to the wall near the top of the structure, and to brackets on the beam at the bottom. The feet of the rafters are notched to fit over the internal edge of the D-beam. The tops of the rafters are fastened to a horizontal beam fixed to the wall. Externally the canopy is slated, decorated with diamond and fish-scale patterns.

This feature is obviously the curved awning over the cart loading entrance noted in the Historic Environment Record. The rafters, sarking boards and slates are in excellent condition. It may be that this feature has been carefully restored in modern times, perhaps in the late 20th century.

Illustration 10: Canopy at E end of E range.

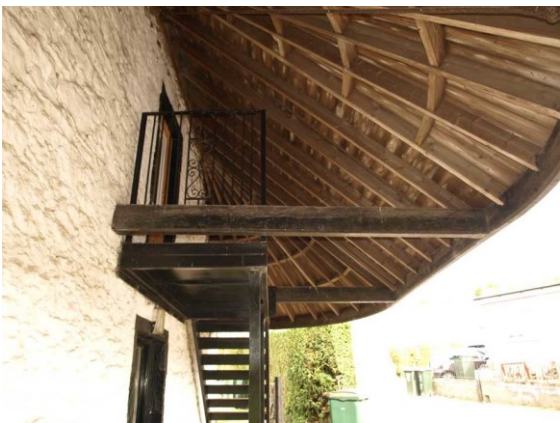
The D-shaped canopy at the E end of the mill is an important feature, and is in very good condition. It is not under any current threat, and adds significant interest to the street.

Illustration 11: Detail of canopy

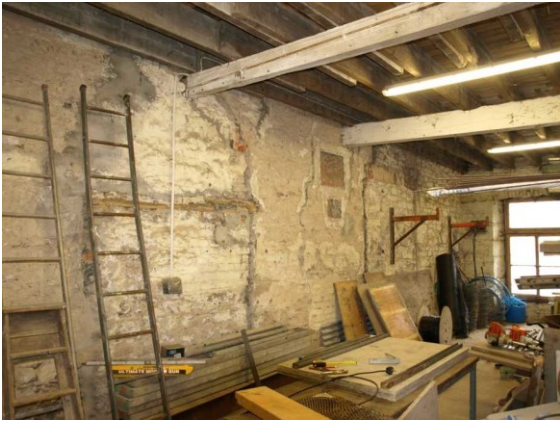
Internally the W range has a concrete floor, and bare walls, generally painted white. There is extensive evidence of cracking movement, especially at the W end. The door and window openings are generally splayed all the way down to the floor, and there are usually brick arches above, and in some cases wooden lintels. The evidence of blocking is generally as seen externally. Two additional small bricked up openings are visible near the middle of the W gable wall. Their function is unknown, but might have served as flues or air intakes for a stove or similar device. The loft floor above is entirely exposed. The floorboards run E – W, the joists run N – S. The joists are inserted into the walls, and are also supported on two long E – W beams, supported on

Illustration 12: W gable of W Range. Blocked openings, and floor timbers above

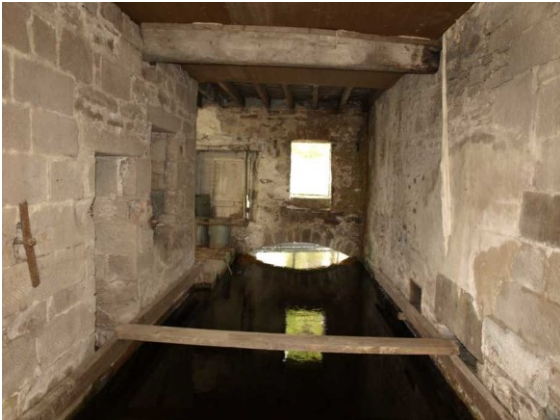
It is very likely that the mill used an undershot wheel, controlled by the sluice directly to the N. In the dividing wall were a doorway and window to allow easy access and inspection of the wheel without wading in the lade. No trace was found of the drive mechanism, or any cloth finishing machinery.

Illustration 13: Internal mill lade, N. Wheel mark on wall

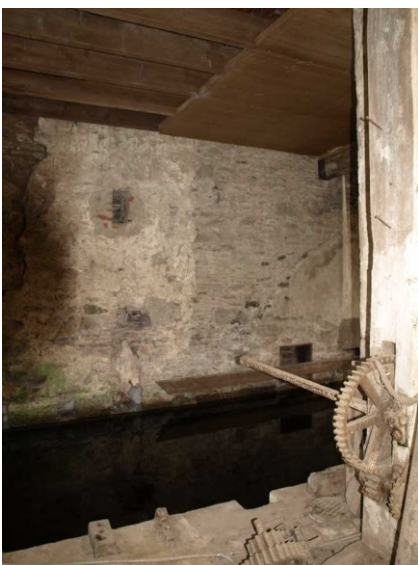
The internal dividing wall, and the exposed W face of the E range gable end wall are of very solid sandstone ashlar construction, quite different from any other part of the building. There is a circular scar on the gable wall strongly suggesting the position of the mill wheel. The lade runs through at floor level, and near its N (upstream) is a notch in the floor on the W side and a matching scar on the E side where vertical wooden rails had supported a sluice gate to control water flow to the wheel chamber. On the W side was a reduction gear and pawl and ratchet still in situ, part of the winding mechanism for raising and lowering the sluice. Lying nearby were wooden rails with an iron rack and pinion, also part of the sluice mechanism.

Illustration 14: Sluice mechanism in W Range

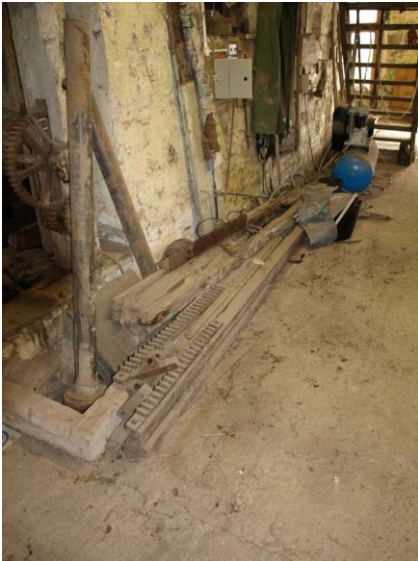
Illustration 15: Sluice mechanism in W Range

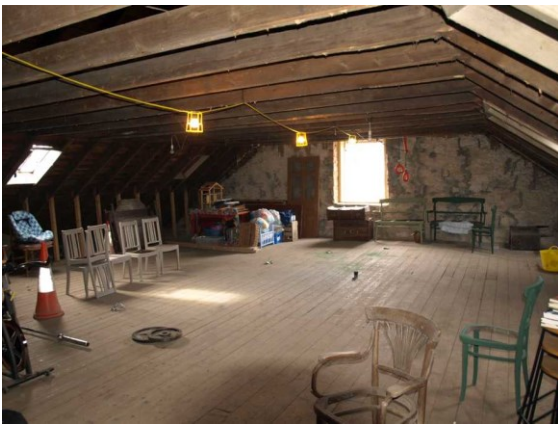
Illustration 16: W Range Loft. Inserted window in W gable

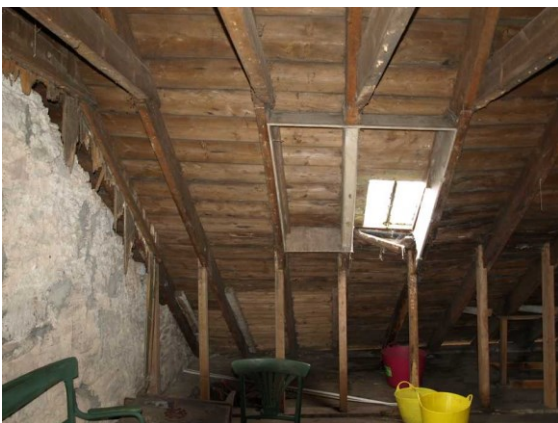
On the underside of the rafters and collars there are traces of a lining, perhaps nailed boards. Along the eaves on either side there are light-coloured vertical posts nailed onto the rafters and resting on sill beams over the floorboards, which would have supported some sort of vertical lining. On the N-facing slope of the roof, the three small cast-iron rooflights have actually been reduced from much larger openings with white-painted wooden surrounds, which have been boarded over. A fourth skylight in the NE corner is similar. In the S-facing slope of the roof, two rooflights have been completely boarded over, and one reduced. The fact that these changes cannot be seen externally suggests the roof may subsequently have been re-slatted.

Illustration 17: Reduced roof light in NW corner. Traces of lining boards on W gable wall.

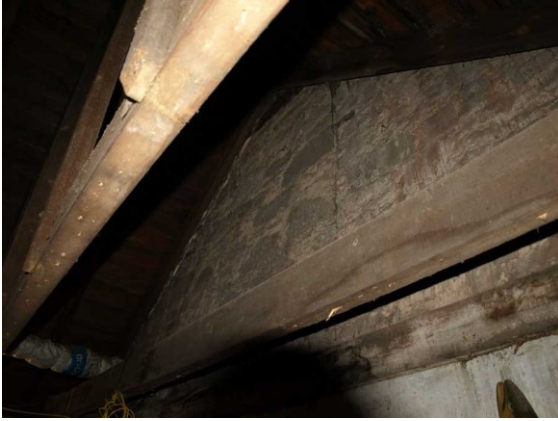
In the NW corner of the loft is a modern stud and plasterboard storage enclosure. In the E party wall, above the collars, there is a joint or perhaps a blocked opening, filled with rubble masonry, with perhaps a timber lintel above. This might suggest a window in the W gable of the E range, blocked when the W range was built up against it.

Illustration 18: W Range Loft. Blocked opening in E wall?

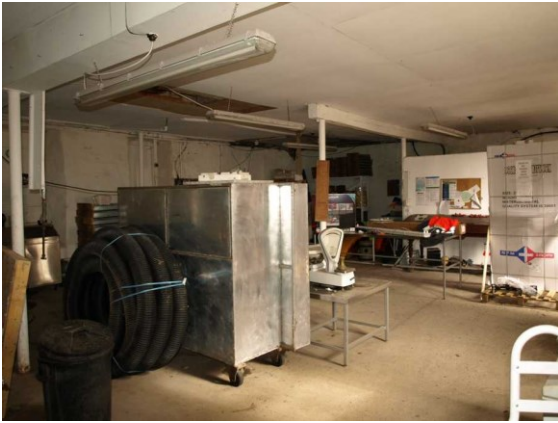
The ground floor of the E range is accessed from the W range by a light plank bridge over the lade, and a doorway in the party wall, with a lintel made of iron or steel bars. The ground floor is a single room, with doors, windows and blocked openings as seen from outside. This was the fish-processing room, and still contains a processing machine invented by Mr Brien. The walls are generally finished and painted, so do not reveal very much about the structural history. The overhead floor is in places supported by wooden beams on welded steel columns, with a boarded up opening near the middle. At the E end of the room is small plaster-board enclosure or store room.

Illustration 19: E Range, ground floor
