Historic Building Record  
College Mill Trout Farm  
Almondbank  
PERTH & KINROSS

HR03

**COLLEGE MILL TROUT FARM  
HISTORIC BUILDING RECORD  
ALMONDBANK  
PERTH & KINROSS**

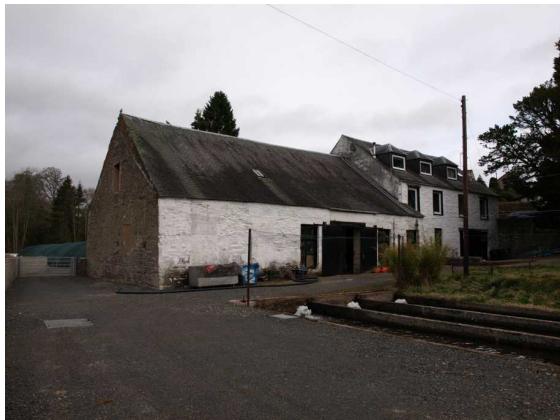
Illustration 6: General view, NE

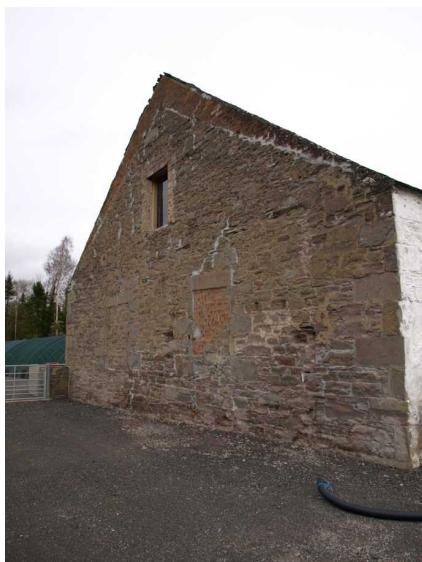
The W gable end wall leans markedly outwards to the W, and shows extensive evidence of cracking and repair. This wall has not been whitewashed, so it is possible to clearly see the sandstone rubble masonry, with well-defined sandstone quoins at the N and S corners.

At ground floor level there are two blocked openings, either side of the centre, with sandstone quoins and lintels, but no obvious sills. In both openings the quoins are present only above waist height, as if they had both begun as windows. The N opening is blocked with sandstone rubble. The S opening appears to have been opened up to form a doorway, then blocked in two stages, with sandstone rubble at the bottom, and red brick at the top, probably 20<sup>th</sup> century.

At loft level there is a single central rectangular window with inserted brick jambs, a timber lintel perhaps re-used, a fixed timber frame, and a single fixed pane of modern float glass. This is evidently a modern insertion, perhaps late 20<sup>th</sup>-century. At the top of the gable wall is a band of red brick, perhaps half a metre at the ridge, tapering to zero at the eaves, added to form the upward sweep of the roof. The brick looks older than the jambs in the loft window or the blocking in the ground floor window. It might date to the early 20<sup>th</sup> century.

Illustration 7: W gable. Blocked openings, inserted window and raised roof line

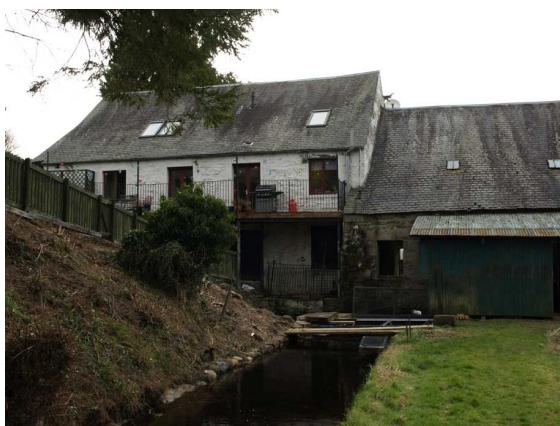
Illustration 8: Lade flowing S into W Range

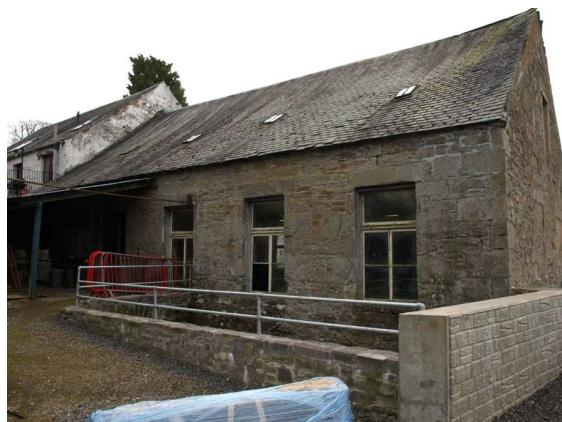
The N wall of the W range is unpainted, and of sandstone rubble masonry, with sandstone quoins and lintels, but no well-defined sills. There are five evenly-spaced openings in the N wall. At the E end there is low archway to admit the lade into the mill, with a rectangular open hatchway or window above. Next to this is an entrance door. West of this are three similar glazed windows. The entrance door is reached by a stone arch footbridge over the side branch of the lade. This area is covered over by a modern corrugated iron and timber shelter.

Illustration 9: W Range, N and W elevations.

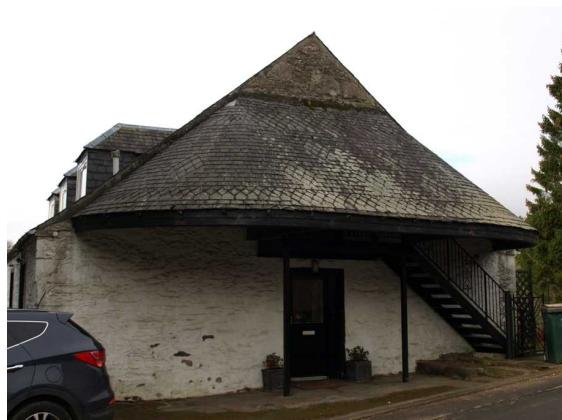
The doors and balcony are covered over by a D-shaped slate and timber canopy, which occupies the full width of the gable end, and reaches up to within a metre of the apex. The canopy is cantilevered out from the gable wall. Around the base or eaves of the canopy is a curved timber beam, probably laminated, which defines the D-shape of the structure. The ends butt up against the gable wall, and the middle is supported by two horizontal timber struts, one of which butts up against the wall, while the other is now fastened to the steel balcony structure. The D-beam is suspended from above by four wrought iron or steel bars, fastened to the wall near the top of the structure, and to brackets on the beam at the bottom. The feet of the rafters are notched to fit over the internal edge of the D-beam. The tops of the rafters are fastened to a horizontal beam fixed to the wall. Externally the canopy is slated, decorated with diamond and fish-scale patterns.

This feature is obviously the curved awning over the cart loading entrance noted in the Historic Environment Record. The rafters, sarking boards and slates are in excellent condition. It may be that this feature has been carefully restored in modern times, perhaps in the late 20<sup>th</sup> century.

Illustration 10: Canopy at E end of E range.

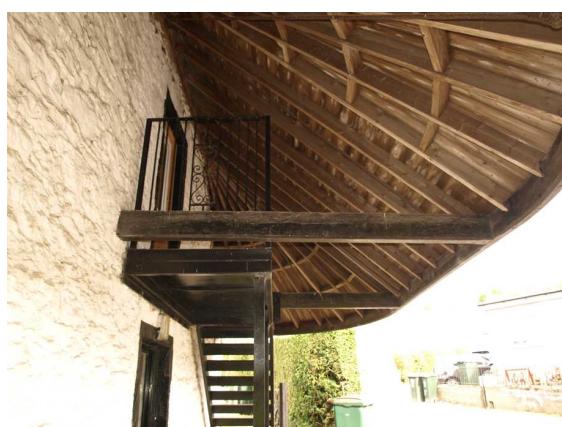
Illustration 11: Detail of canopy

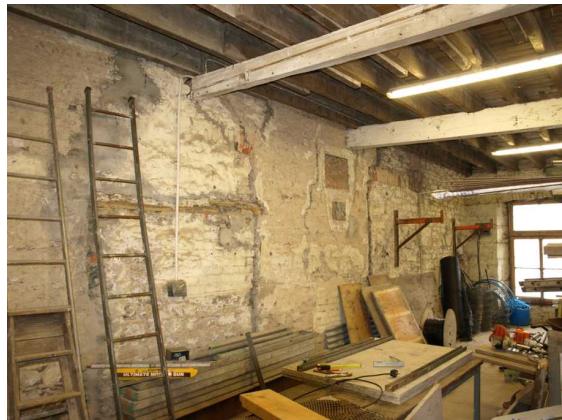
Illustration 12: W gable of W Range. Blocked openings, and floor timbers above

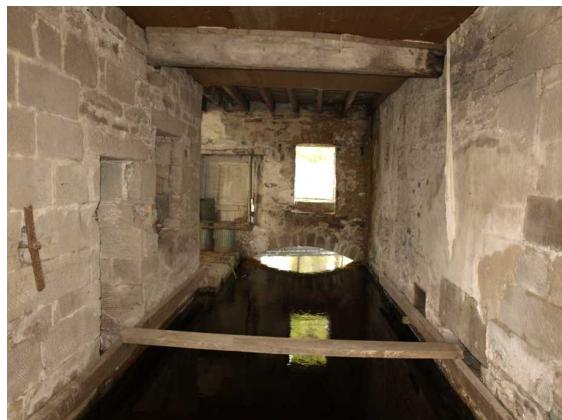
It is very likely that the mill used an undershot wheel, controlled by the sluice directly to the N. In the dividing wall were a doorway and window to allow easy access and inspection of the wheel without wading in the lade. No trace was found of the drive mechanism, or any cloth finishing machinery.

Illustration 13: Internal mill lade, N. Wheel mark on wall

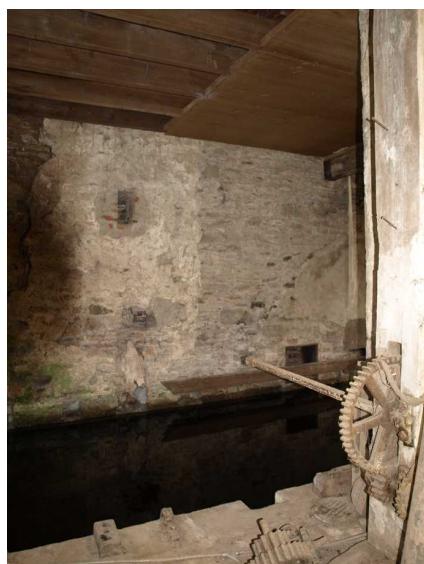
Illustration 14: Sluice mechanism in W Range

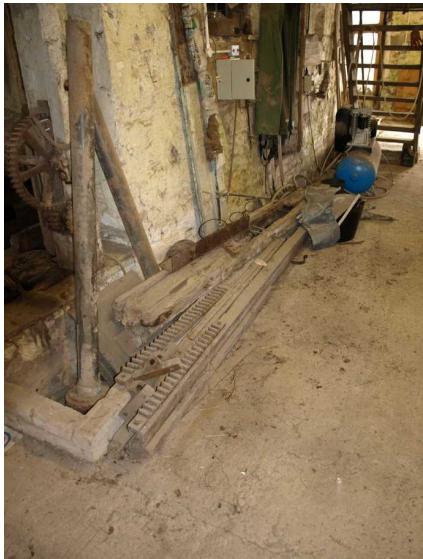
Illustration 15: Sluice mechanism in W Range

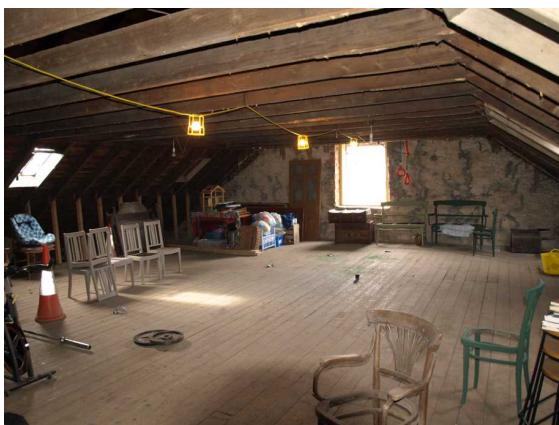
Illustration 16: W Range Loft. Inserted window in W gable

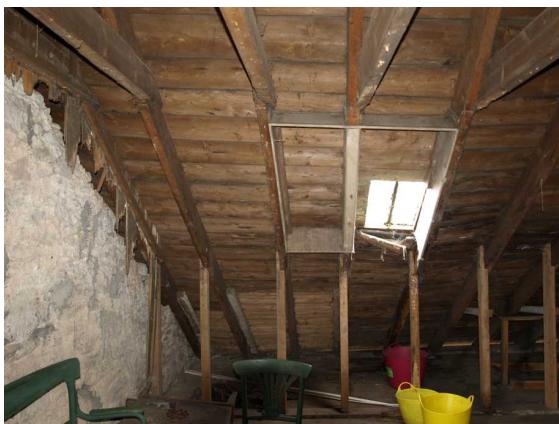
Illustration 17: Reduced roof light in NW corner. Traces of lining boards on W gable wall.

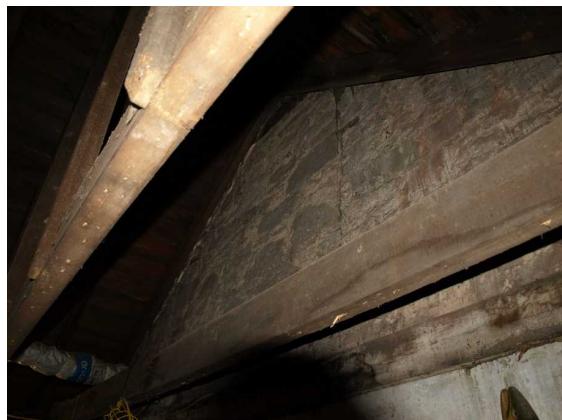
In the NW corner of the loft is a modern stud and plasterboard storage enclosure. In the E party wall, above the collars, there is a joint or perhaps a blocked opening, filled with rubble masonry, with perhaps a timber lintel above. This might suggest a window in the W gable of the E range, blocked when the W range was built up against it.

Illustration 18: W Range Loft. Blocked opening in E wall?

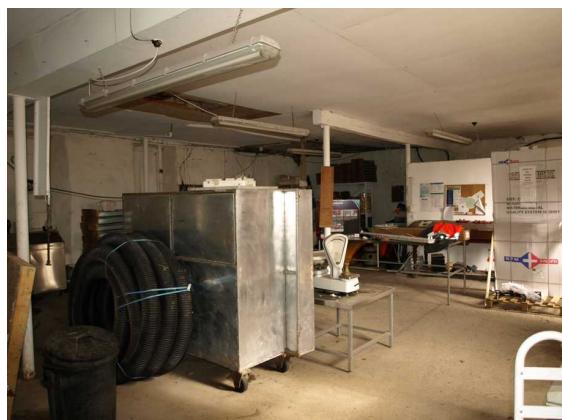
Illustration 19: E Range, ground floor
