Archaeological Watching Brief,
Soil Stripping, Drummond Castle,
Muthill

**ARCHAEOLOGICAL WATCHING BRIEF,
SOIL STRIPPING,
DRUMMOND CASTLE, MUTHILL
CF17**

Alder Archaeology conducted a watching brief (CF17) on remediation of heating fuel contamination at the rear of Drummond Castle, Muthill. Stripping of contaminated deposits revealed the deep rubble bedding for the 19th-century estate drive, and the foundations of a 19th-century tower and buttress, as well as various 19th-century and later drainage features. A finely decorated porcelain fragment might be oriental, 18th-century or earlier.

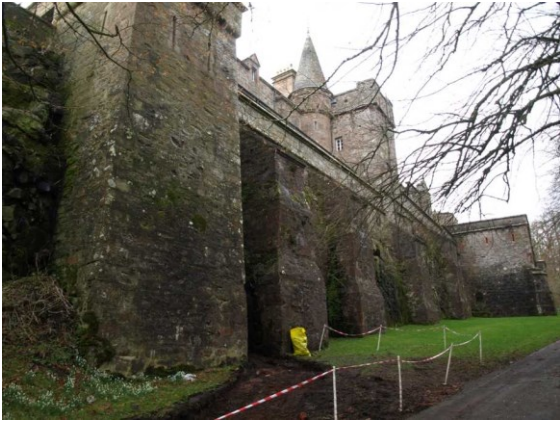
Illus 4 Tower and buttresses against cliff face.

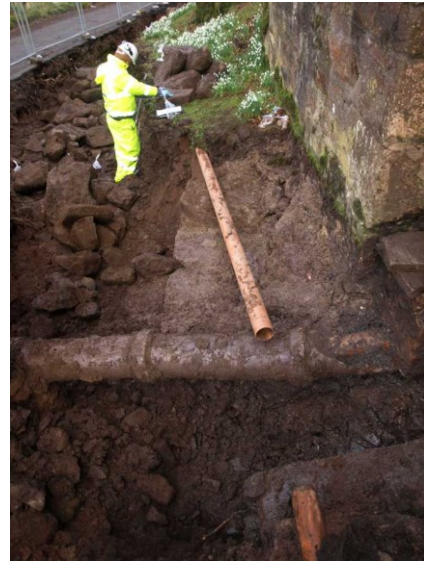
At the base of the tower, below the modern drain 004, the foundations 014 of the tower were exposed, about 0.2 m down, 0.2 m thick, made of two courses of stone slabs, mortar bonded. The foundation was roughly rectangular, projecting about 1.1 m N of the tower wall face. The foundation was slightly skewed in relation to the wall face, so that the forward projection reduced to the E. Foundation 014 rested on a bed of crushed rubble 015, which was observed to a depth of 1.3 m below the modern surface. Over the surface of the foundation was a spread of soft mortar 016, probably spilled when the tower was being built. This was partly cut into by the modern plastic drain 004. Directly to the W, the base of the buttress rested over the stub of the slab drain 018.

Below drain 018 was a much larger flat slab 020, possibly the base of the drain, but probably the foundation of the buttress. This was visible at the base and side of the trench, when the modern pipes 004 and 009 were temporarily disconnected.

Illus 7 Foundation 014 and slab 020 under tower and buttress.

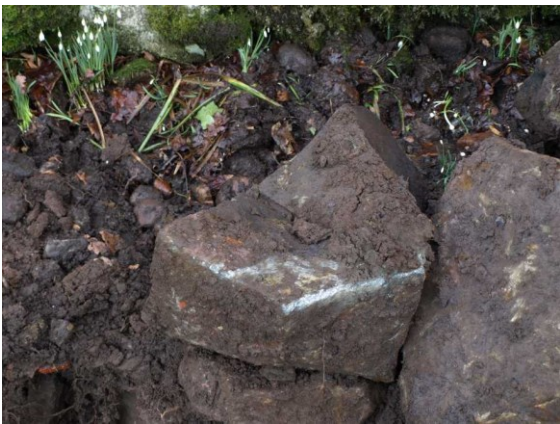
All the layers contained fragments of 19th-century brick, earthenware and china. Two conjoining sherds were of a very finely decorated porcelain plate or dish, probably oriental, perhaps of 18th-century date. The deep rubble 012 included some squared stone blocks, perhaps faulty building stone rejected at the quarry. There was one angular fragment with half of a drill hole, evidence of quarrying and probably of blasting.

Illus 5 Stone with drill hole in rubble 012.

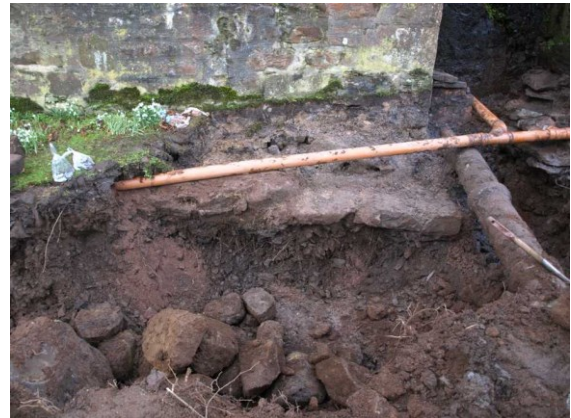
Illus 8 Foundation 014 and slab 020 under tower and buttress (R). Bedding 015 and rubble 012 under foundation 014.

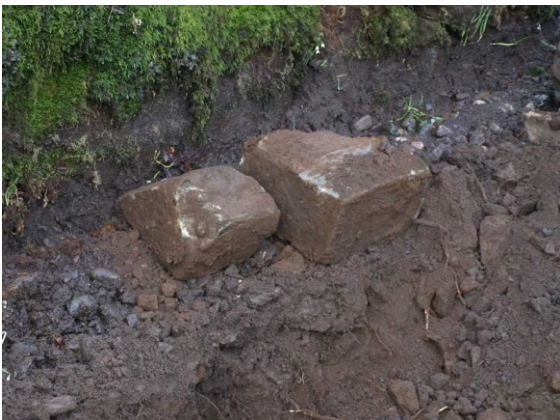
Illus 6 Squared quarried blocks in rubble 012.

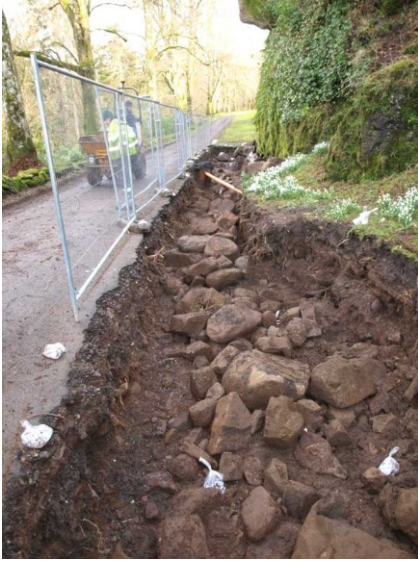
Illus 9 Rubble 012 extent.

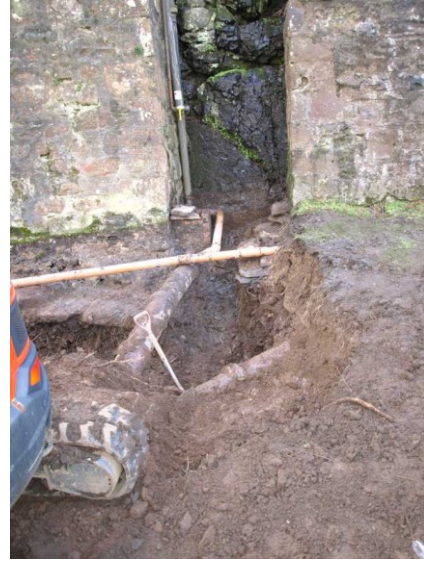
The fuel tank is filled from the level of the drive, by a tanker lorry connected to the bottom of the filler pipe, pumping fuel up to the top of the tower. The fuel tank itself is of course completely invisible from the drive. This resulted in the tank being accidentally overfilled. Some 1,000 – 2,000 litres of kerosene overflowed into the top of the tower, and then down and through the cliff face into the ground at the foot of the tower. From here it soaked into and partly dissolved the S edge of the drive. At this point the drive and the grassy strip to the S slope gently down to the E. The kerosene soaked through the ground a considerable distance to the E, and in places passed into the storm drains and under the drive to a soakaway on the N side.

Illus 11 Foundation 014 and slab 020 under tower and buttress. Oily cliff face. Fuel filler pipe on side of tower.

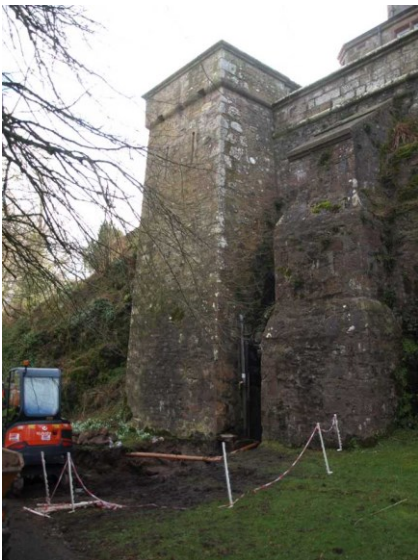
At some point, the tower and buttresses were added to the cliff face. These were not founded on bedrock at the foot of the cliff, by now hidden perhaps 10 m below the surface, but on broad shallow foundations, resting on the consolidated rubble which also supported the drive. Evidently the builders trusted the work of their immediate predecessors, and in fact it seems to have held up remarkably well. The buttress partly rests on the slab drain 018, confirming that some time had elapsed between the laying out of the drains and the addition of the buttress.

Illus 10 Tower and buttress on foundation 014 and slab 020.

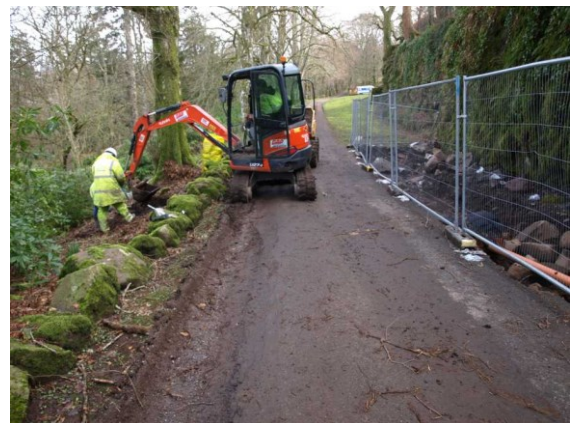
The stripping of topsoil around drainage outfall areas N of the drive was monitored, but no archaeological features were observed.

Illus 12 Clearing around outfall on N side of drive.
