Archaeological Watching Brief,
Soil Stripping, Drummond Castle,
Muthill

**ARCHAEOLOGICAL WATCHING BRIEF,
SOIL STRIPPING,
DRUMMOND CASTLE, MUTHILL
CF17**

ABSTRACT

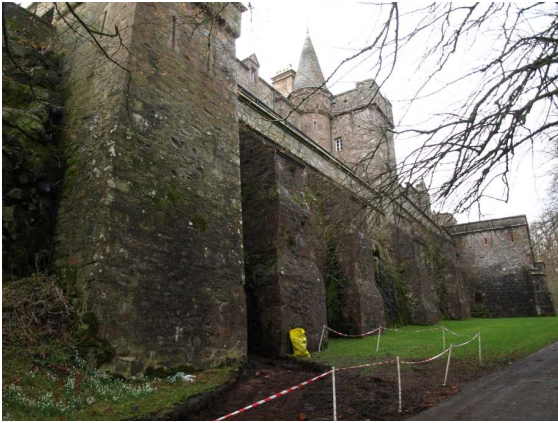
Illus 4 Tower and buttresses against cliff face.

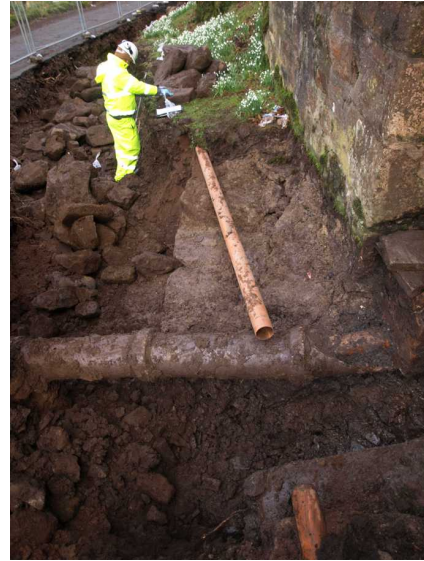
At the base of the tower, below the modern drain 004, the foundations 014 of the tower were exposed, about 0.2 m down, 0.2 m thick, made of two courses of stone slabs, mortar bonded. The foundation was roughly rectangular, projecting about 1.1 m N of the tower wall face. The foundation was slightly skewed in relation to the wall face, so that the forward projection reduced to the E. Foundation 014 rested on a bed of crushed rubble 015, which was observed to a depth of 1.3 m below the modern surface. Over the surface of the foundation was a spread of soft mortar 016, probably spilled when the tower was being built. This was partly cut into by the modern plastic drain 004. Directly to the W, the base of the buttress rested over the stub of the slab drain 018.

Below drain 018 was a much larger flat slab 020, possibly the base of the drain, but probably the foundation of the buttress. This was visible at the base and side of the trench, when the modern pipes 004 and 009 were temporarily disconnected.

Illus 7 Foundation 014 and slab 020 under tower and buttress.

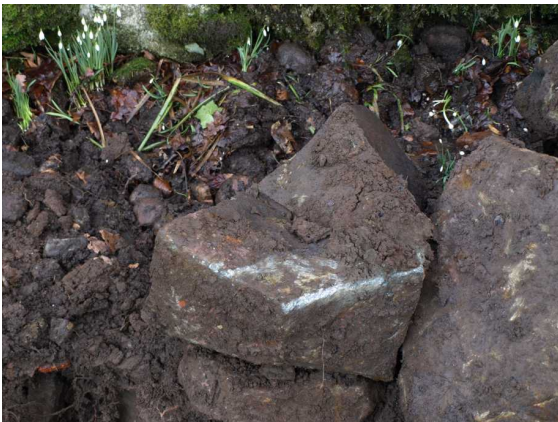
All the layers contained fragments of 19th-century brick, earthenware and china. Two conjoining sherds were of a very finely decorated porcelain plate or dish, probably oriental, perhaps of 18th-century date. The deep rubble 012 included some squared stone blocks, perhaps faulty building stone rejected at the quarry. There was one angular fragment with half of a drill hole, evidence of quarrying and probably of blasting.

Illus 5 Stone with drill hole in rubble 012.

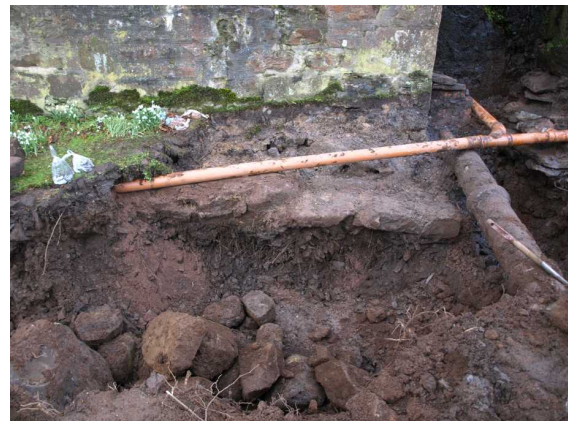
Illus 8 Foundation 014 and slab 020 under tower and buttress (R). Bedding 015 and rubble 012 under foundation 014.

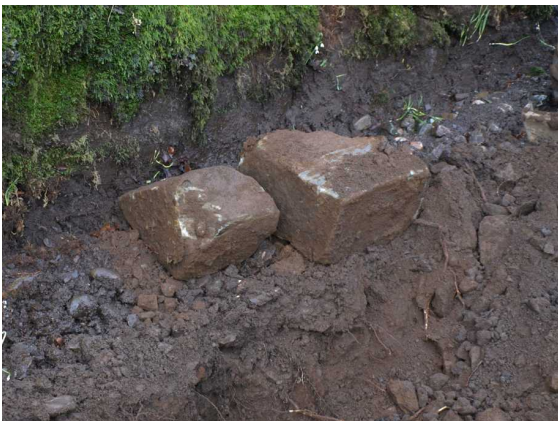
Illus 6 Squared quarried blocks in rubble 012.

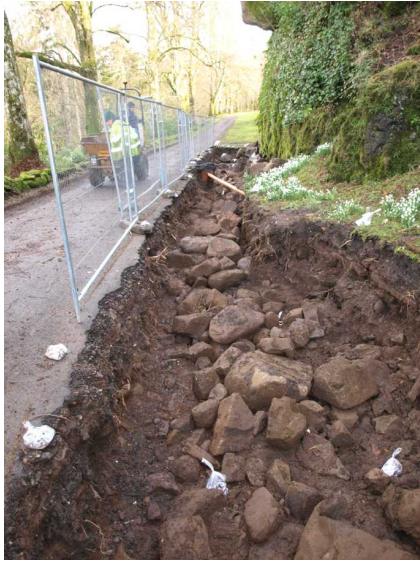
Illus 9 Rubble 012 extent.

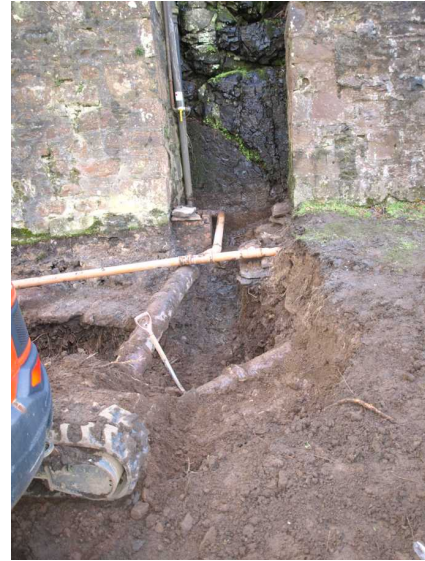
The fuel tank is filled from the level of the drive, by a tanker lorry connected to the bottom of the filler pipe, pumping fuel up to the top of the tower. The fuel tank itself is of course completely invisible from the drive. This resulted in the tank being accidentally overfilled. Some 1,000 – 2,000 litres of kerosene overflowed into the top of the tower, and then down and through the cliff face into the ground at the foot of the tower. From here it soaked into and partly dissolved the S edge of the drive. At this point the drive and the grassy strip to the S slope gently down to the E. The kerosene soaked through the ground a considerable distance to the E, and in places passed into the storm drains and under the drive to a soakaway on the N side.

Illus 11 Foundation 014 and slab 020 under tower and buttress. Oily cliff face. Fuel filler pipe on side of tower.

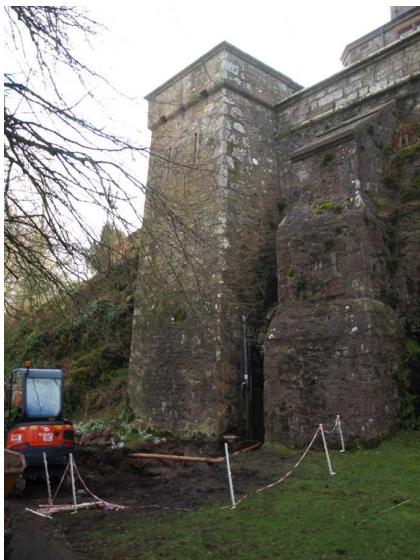
At some point, the tower and buttresses were added to the cliff face. These were not founded on bedrock at the foot of the cliff, by now hidden perhaps 10 m below the surface, but on broad shallow foundations, resting on the consolidated rubble which also supported the drive. Evidently the builders trusted the work of their immediate predecessors, and in fact it seems to have held up remarkably well. The buttress partly rests on the slab drain 018, confirming that some time had elapsed between the laying out of the drains and the addition of the buttress.

Illus 10 Tower and buttress on foundation 014 and slab 020.

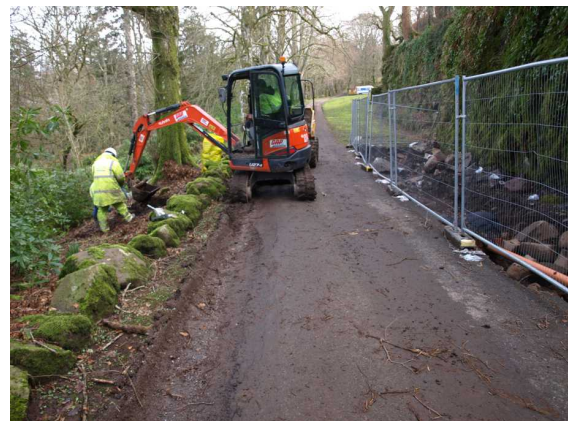
The stripping of topsoil around drainage outfall areas N of the drive was monitored, but no archaeological features were observed.

Illus 12 Clearing around outfall on N side of drive.
